# **Inherent hazards, poor reporting and limited learning in the solid biomass energy sector: a case study of a wheel loader igniting wood dust, leading to fatal explosion at wood pellet manufacturer**

Project No.  
Document no. Aars 2010  
Version 20  
Date of issue April 4, 2014

Frank Huess HEDLUND,  
Technical University of Denmark, (DTU) DK-2800 Kongens Lyngby, Denmark. Tel: +45 45252525 E-mail [fhue@dtu.dk](mailto:fhue@dtu.dk)\*  
COWI, Parallelsvej 2, DK-2800 Kongens Lyngby, Denmark. E-mail [fhue@cowi.dk](mailto:fhue@cowi.dk)

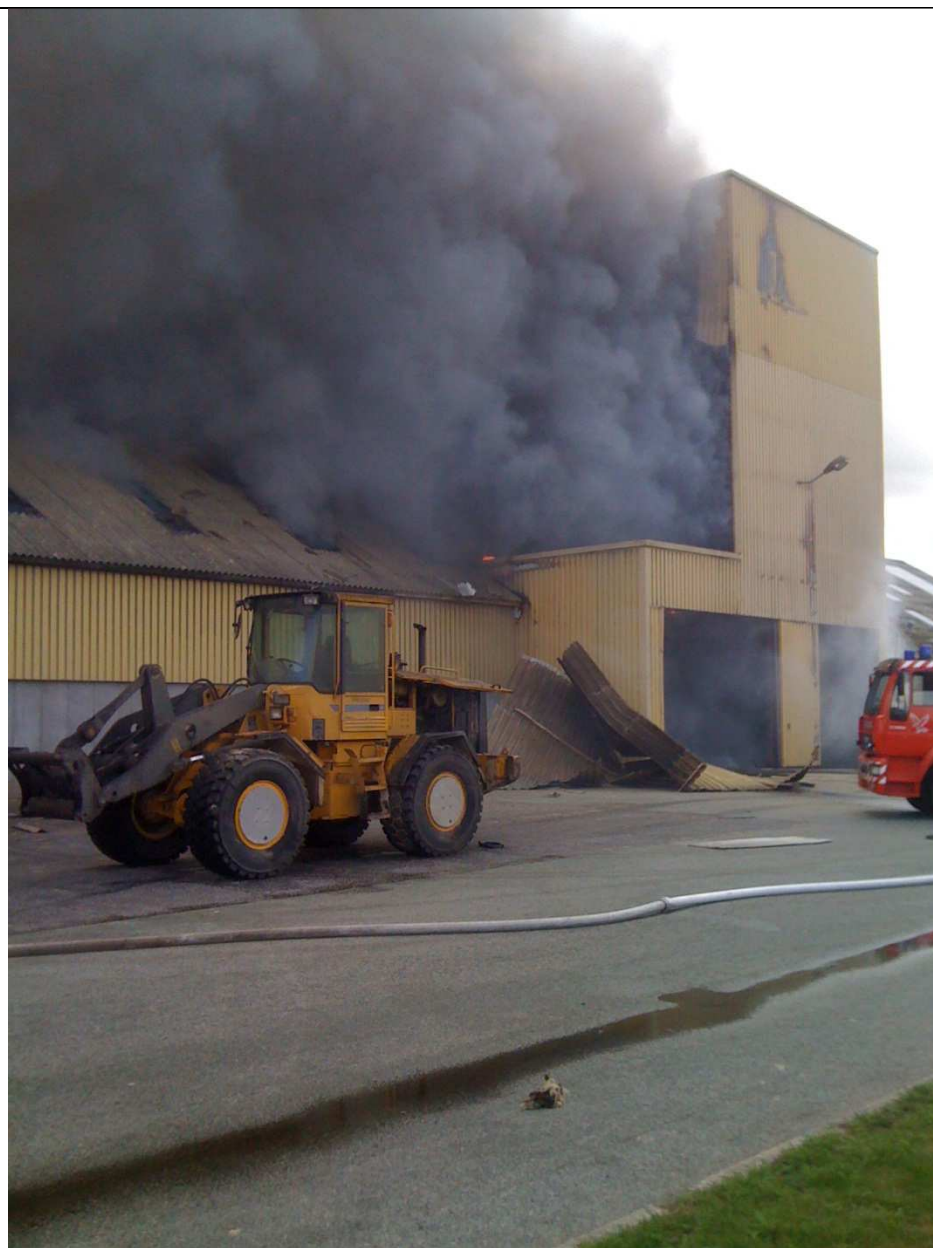
*Figure 3* Photo taken one hour after the explosion. The wheel loader is similar to the accident wheel loader, note blown out wall panels. Picture taken from north. Photo courtesy: Beredskab Vesthimmerland (the local fire and rescue services) photo kindly provided by official of the county Vesthimmerland Kommune.

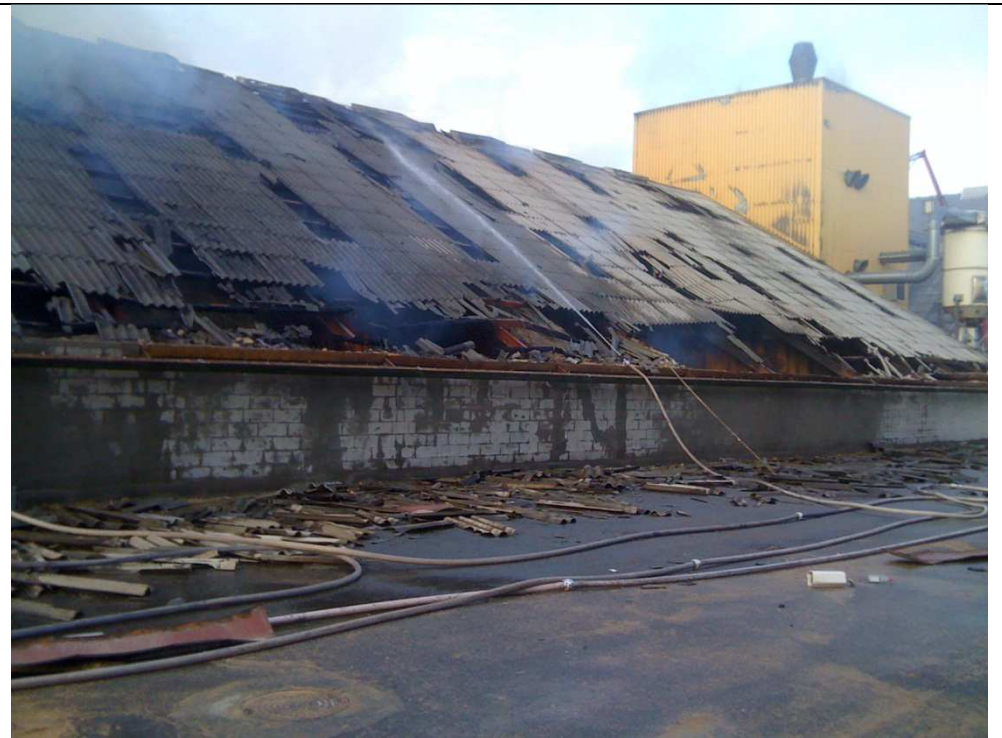
*Figure 4 The many light fibre cement roofing panels that remained in place indicate that the explosion overpressure was modest. Note that the wall made of lightweight porous concrete blocks shows no blast damage. Wood dust compartment wall dividers are visible inside building. Photo taken from south. Photo courtesy: Beredskab Vesthimmerland (the local fire and rescue services) photo kindly provided by official of the county Vesthimmerland Kommune.*

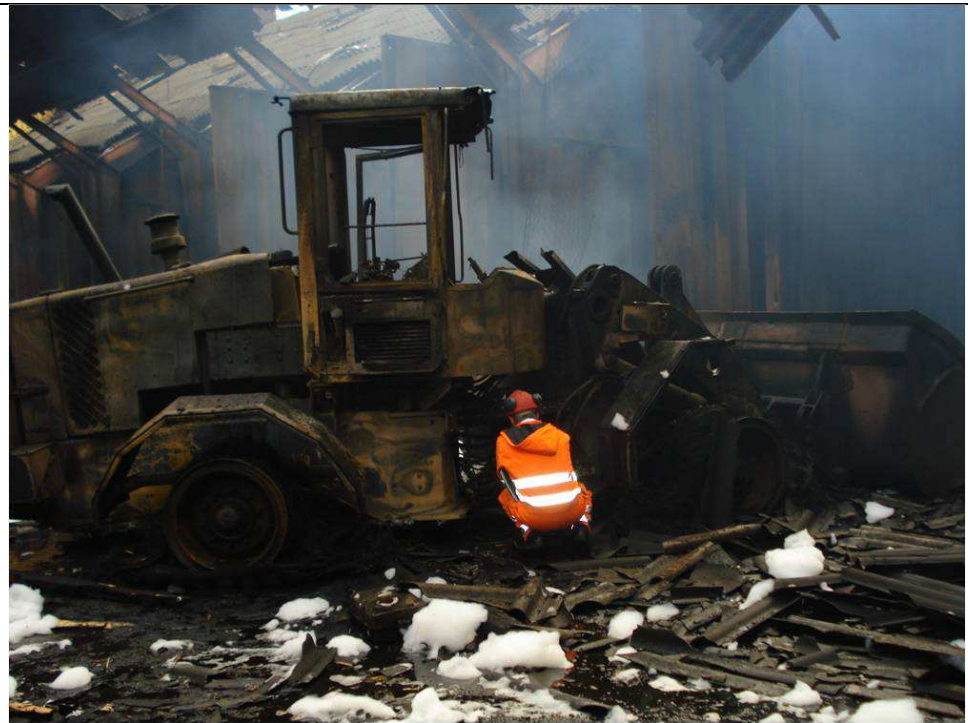
The wheel loader, a Volvo L70D, year 2000, was examined by a police vehicle inspector the next day (Figure 5). This model is pivot controlled; articulation of the center hinge provides improved maneuverability for tight job sites. The examination revealed that the universal joint shaft (in Europe known as a cardan joint shaft) that provides power transmission to the front axle was missing. It was concluded that the transmission shaft had failed mechanically, damaging the numerous electrical cables that were routed underneath the chassis resulting in arcing and sparking, which had ignited the dust (Figure 6). The joint and shaft were later discovered under the bucket. There were small signs that the shaft had been weakened by fractures near the weld zone. These findings concluded the police investigation as there was no indication of wrongdoing, only of bad luck.

*Figure 5 Examination of the wheel loader revealed that the universal (cardan) joint and shaft was missing. Windows in the driver's cabin melted in the intense heat. Tires are burned away. Source: Police investigation, photo in useful quality kindly provided by an official from The Danish Working Environment Authority.*

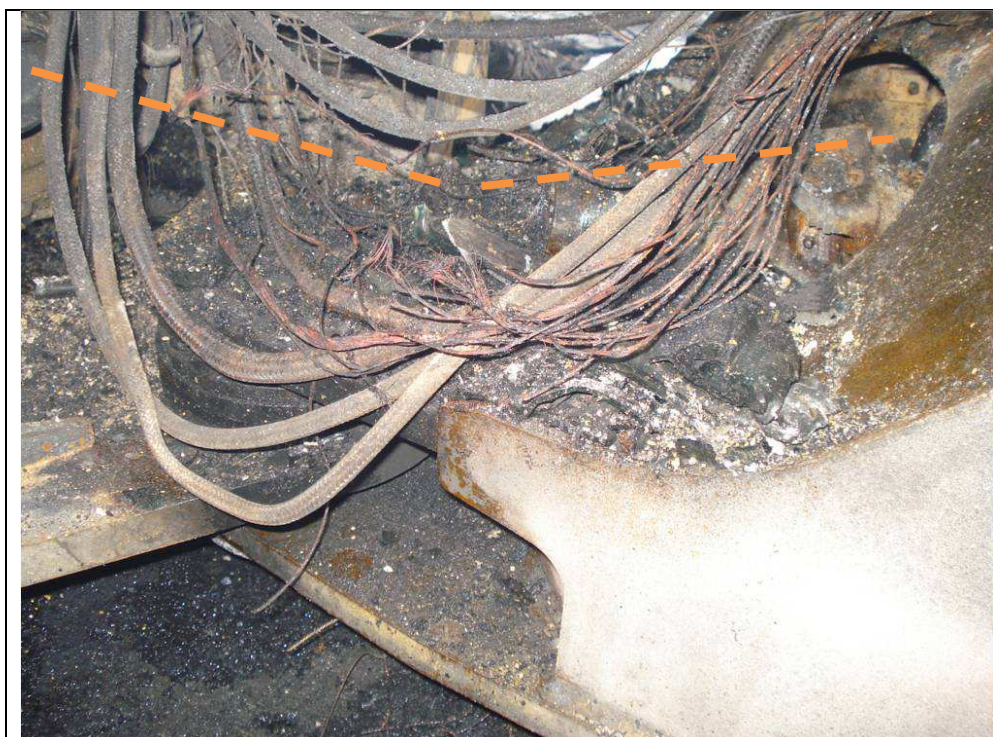
On Sep 17, the police released a statement to mass media that the cause of the explosion was identified. Due to weld failure a mechanical component broke loose under the vehicle and damaged electrical cables, causing a combustible dust explosion. The manager of the facility expressed emotion and disbelief, as the facility was in full compliance with the most recent norms and guidelines; this explosion should not be possible.

*Figure 6 Torn electrical cables and fire damaged hydraulic hoses. Dotted line shows approximate position of missing universal (cardan) joint shaft. Hydraulic hoses appear intact.  
Source: Police investigation, photo in useful quality kindly provided by an official from The Danish Working Environment Authority*
