Inherent hazards, poor reporting and limited learning in the solid biomass energy sector: A case study of a wheel loader igniting wood dust, leading to fatal explosion at wood pellet manufacturer

Hedlund, Frank Huess; Astad, John; Nichols, Jeffrey

Published in:
Biomass & Bioenergy

Project No.
Document no. Aars 2010
Version 20
Date of issue April 4, 2014

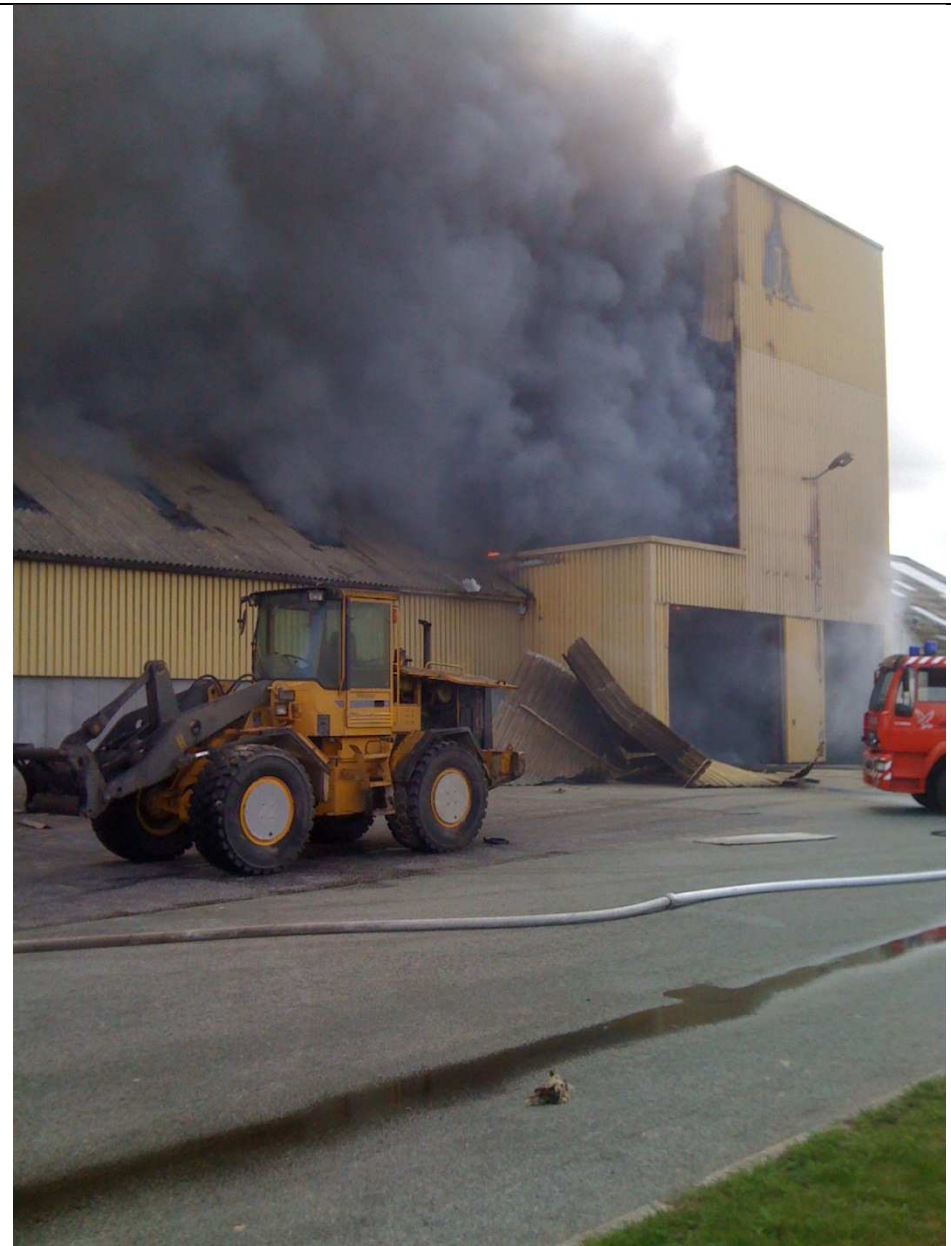
Figure 3 Photo taken one hour after the explosion. The wheel loader is similar to the accident wheel loader, note blown out wall panels. Picture taken from north. Photo courtesy: Beredskab Vesthimmerland (the local fire and rescue services) photo kindly provided by official of the county Vesthimmerland Kommune.
