A case of peeling

International RILEM Conference on Materials, Systems and Structures in Civil Engineering 2016

A CASE OF PEELING

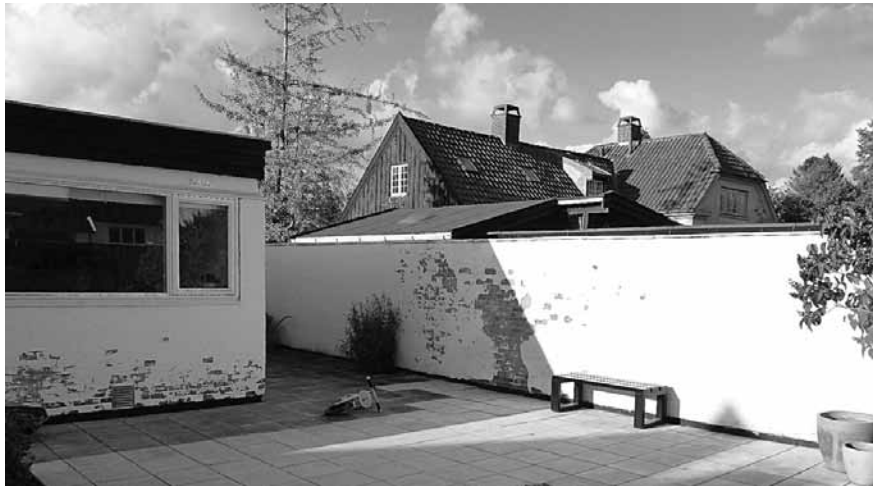
Figure 1. Part of the southern wall of the examined house and its gardens walls.
May 27, 2015, 18.28 o'clock.

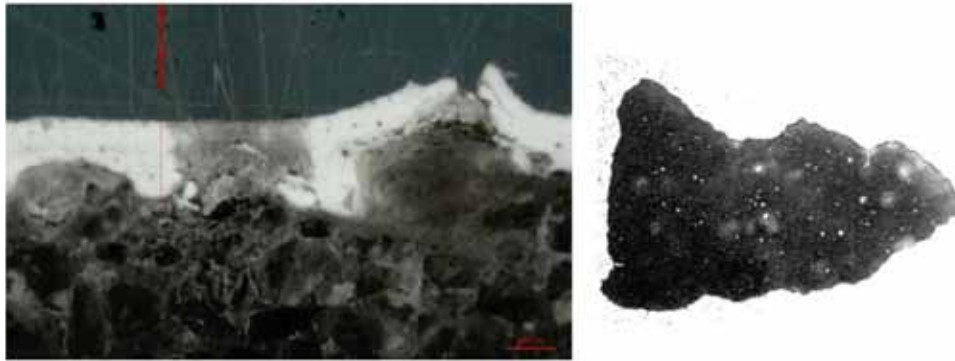
The specimens were examined on polished sections, Figure 2. The thickness of the inner layer were measured to 0,185 - 0,359 mm, and of the outer layer to 0,066 - 0,350 mm. Further it was observed that the paint contained inorganic material, probably kaolin.

Figure 2, left: Micro photo of cross section of the treatment on the south facade of the house. Lowest the cement plaster (grey and black), above the two white paint layers. The paint layer is broken over a protruding stone. The breath of the picture is equal to 2,5 mm. Photo DTI.
 Figure 2, right: A piece of the paint layer in transmitted light. A lot of pinholes are seen. The breath of the picture is equal to 11 mm. Photo AN.

Firstly, the application to the rough surface of the cement plaster gives a paint layer, which in no way is “a homogeneous layer”. The paint film is punctured over the protruding sand particles from the plaster, because the capillary forces in the fluid paint draw the film away from the top of the particles, cf. Figure 2.

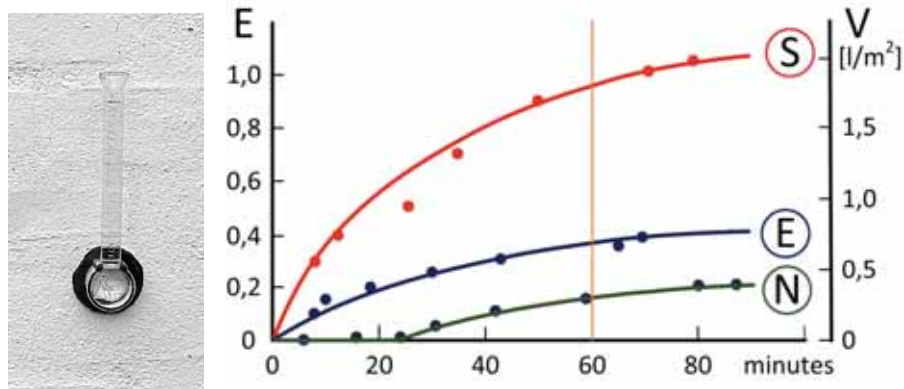
Figure 3. Karsten tube measurements. The glass tube at the device, left, is divided in units, E, which are transformed to suction, $V \text{ l/m}^2$. The height of the tube is 15 cm.

The capability of the surface treatment to suck up water was measured on three different walls by means of the so-called Karsten tube, cf. Figure 3. The measurements were taken in May 2015, i.e. four years after the painting. Measurement S was taken at the South faced façade, which is the most exposed. The suction here is around $1,8 \text{ l/m}^2$ after 1 hour. Measurement E is from the East faced façade, which is less exposed. Here the suction is $0,7 \text{ l/m}^2$ after 1 hour. Measurement N was taken on the North faced façade. Here it is seen that nothing happens in the first 24 minutes, hereafter the suction starts. This seems to correspond to the information about the high amount of kaolin in the paint: When the kaolin has expanded due to the water up-take, the paint layer has been opened so much that the water penetration can begin.

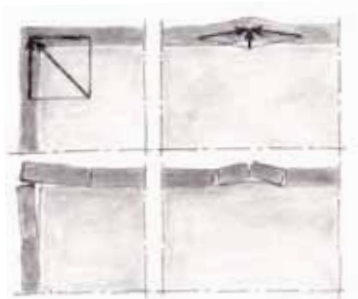
Figure 4. The compression forces in the surface layer cooperate at corners and unevenness's in resultants, which exceed the adhesion, thus causing peeling.

forces exceeding the adhesion; thus the plaster will peel of, cf. Figure 4. For this reason the peeling most often starts at the corners.

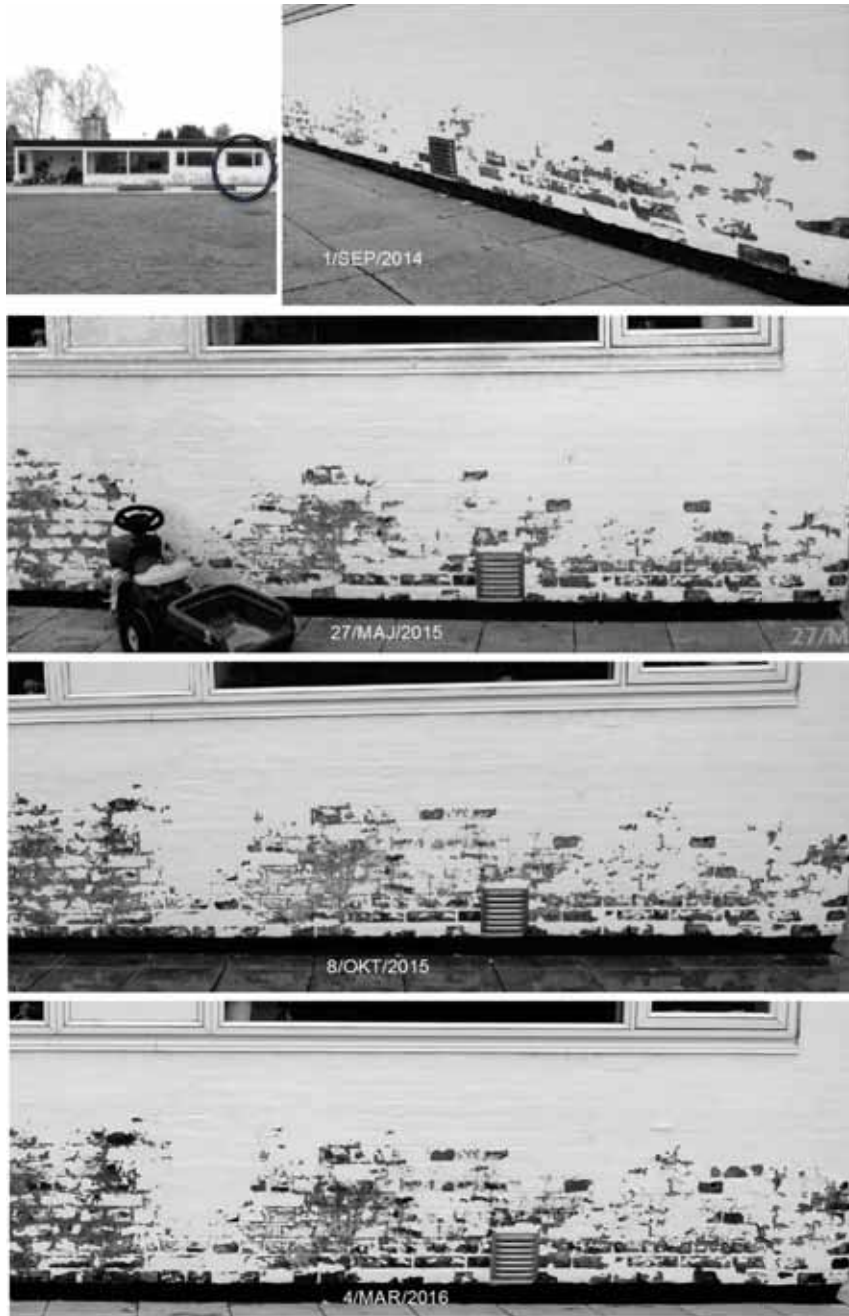
- Thermal expansion. As the peeling occurs all the year round it seems as if the difference in thermal expansion values between the tile and the cement plaster is the main reason of the damages. Frost damages may occur and cooperate with the peeling when cracking first opens the surface. Frost damage on the undamaged parts of the treatment of plaster and paint is unlikely, as water cannot penetrate the combined layer of plaster and paint in a degree, which can create ice-lenses.

Figure 5. Development of the peeling from September 1, 2014 to March 4, 2016.

- The correct repair in this case will be to remove all plaster and paint, and treat the walls with air lime mortar and lime wash, as should have been done from the beginning.
