Fatal Accidents During Marine Transport of Wood Pellets Due to Off-Gassing: Experiences from Denmark

Frank Huess Hedlund and
Øssur Jarleivson Hilduberg

Abstract

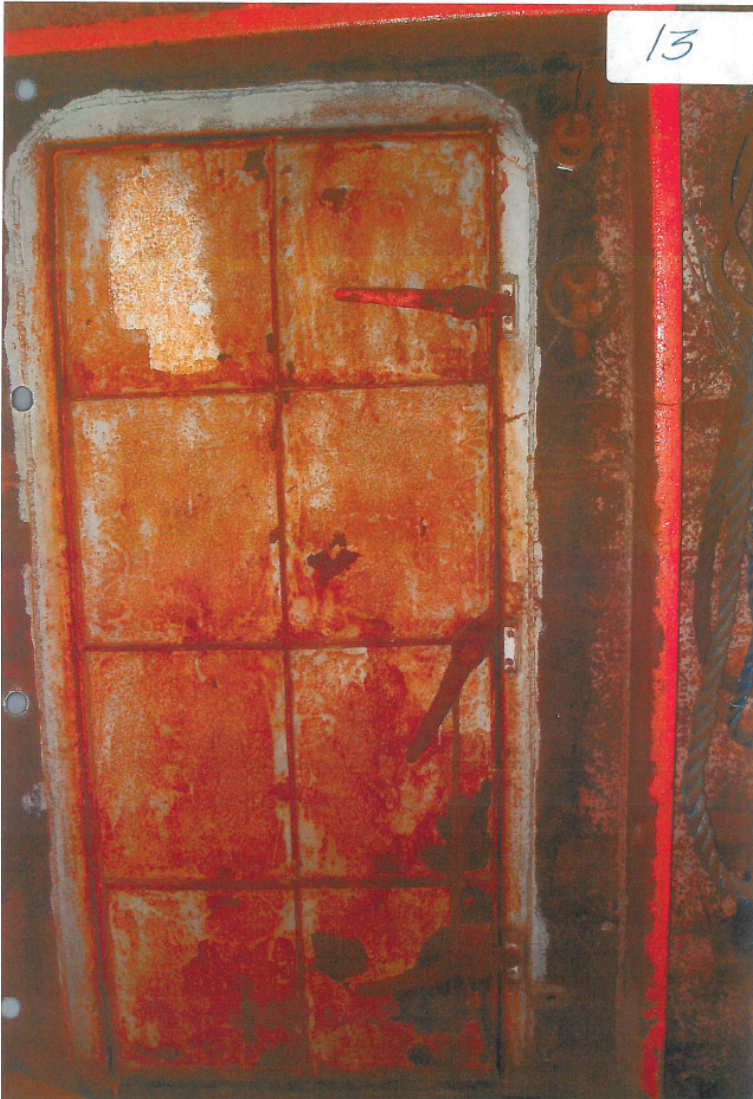
Figure 1. The door in the forepeak compartment, which led the front cargo hold. The door had three closing hinges but only two were engaged. Gasses travelled from the cargo hold to the forepeak through a crevice where the third hinge was not engaged. (AMIRANTE). Source: Police photo file #13 [8].

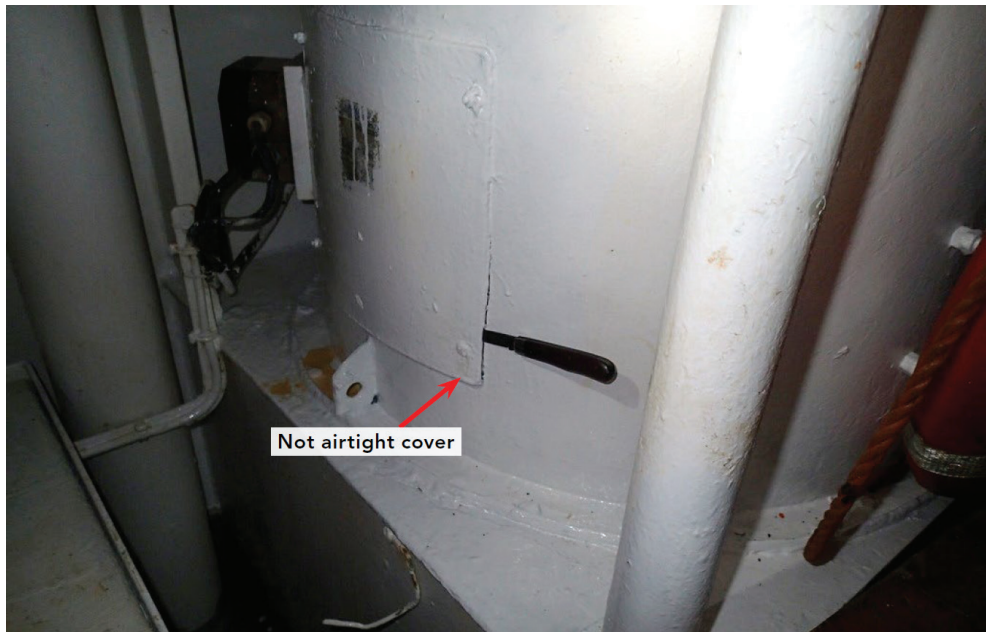
The CO₂ room, forecandle and bow thruster room are adjacent to each other and gasses might travel from one room to another through a number of connecting conduits. The shipping company contracted the classification society to investigate how carbon monoxide could have travelled from the cargo hold to the bow area. The investigation identified a minor gap in a section of the rim of an inspection cover on a ventilation duct that runs from the cargo hold through the forecandle as the most likely route (**Figure 2**).

Figure 2. The inspection hatch on a ventilation duct that ran from the cargo hold through the forecastle. A minor gap in a section of the rim (knife blade inserted) allowed gasses to travel from the cargo hold to the bow area. (LADY IRINA). Source: [13].

In response to the fatal accident, the shipping company acquired multi-gas meters and introduced a new work procedure mandating that the person making “First Entry” must carry an operational multi-gas meter. New warning placards with the instruction “ATTENTION—No first entry without use of multi-gas meter” were been put up on access doors.

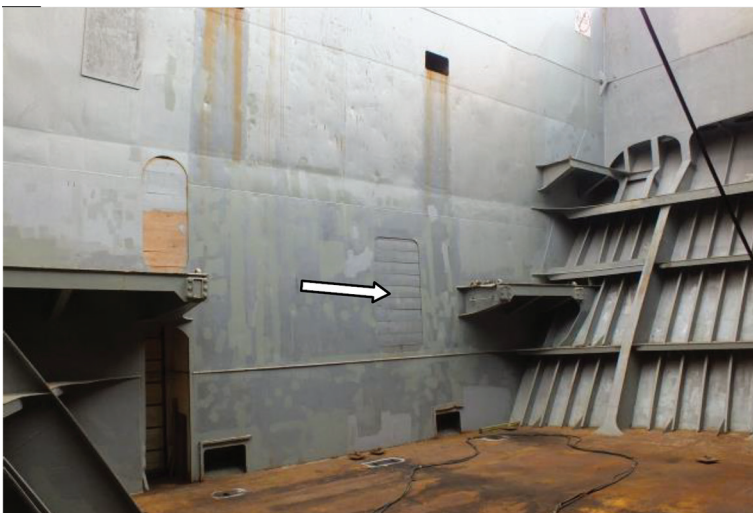
Figure 3. An opening in the front cargo hold allowed easy access to the lashing equipment room. When carrying bulk cargo, the opening was closed with planks of wood inserted into guide bars (CORINA). Source: [16].

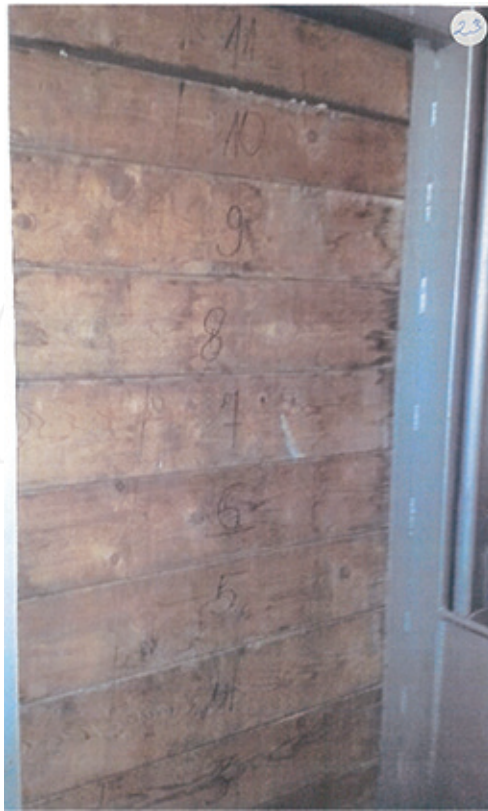
CORINA was general cargo multipurpose vessel adapted to transport of containers. Containers must be lashed, and in order to ease the handling and movement of lashing gear, the vessel was designed with a 2100 mm × 1150 mm opening in the forward bulkhead of cargo hold no. 1. The opening allowed easy access to the neighbouring storage room, where chains, stacking cones and other lashing equipment for containers were kept (Figure 3). When carrying bulk cargo, the opening was closed with planks inserted into guide bars. This barrier was not gas tight and gasses from the cargo hold could therefore travel to the forecandle (Figure 4).

Figure 4. The plank barrier seen from the lashing equipment room. Wood pellets in the cargo hold are visible between planks 10 and 11. The barrier is evidently not gastight. (CORINA). Source: Police photo file #23 [8].
