Fatal Accidents During Marine Transport of Wood Pellets Due to Off-gassing – Experiences from Denmark

Hedlund, Frank Huess; Jarleivson Hilduberg, Øssur

Published in:
Biomass Volume Estimation and Valorization for Energy

Abstract

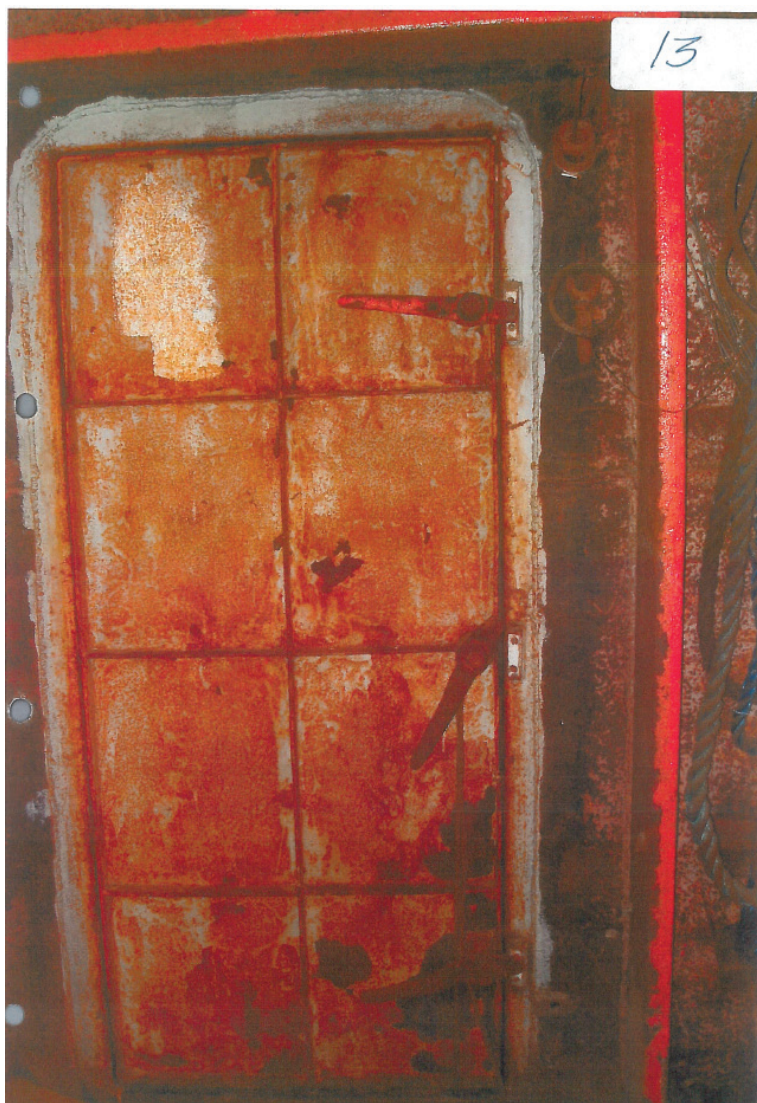
Figure 1. The door in the forepeak compartment, which led the front cargo hold. The door had three closing hinges but only two were engaged. Gasses travelled from the cargo hold to the forepeak through a crevice where the third hinge was not engaged. (AMIRANTE). Source: Police photo file #13 [8].

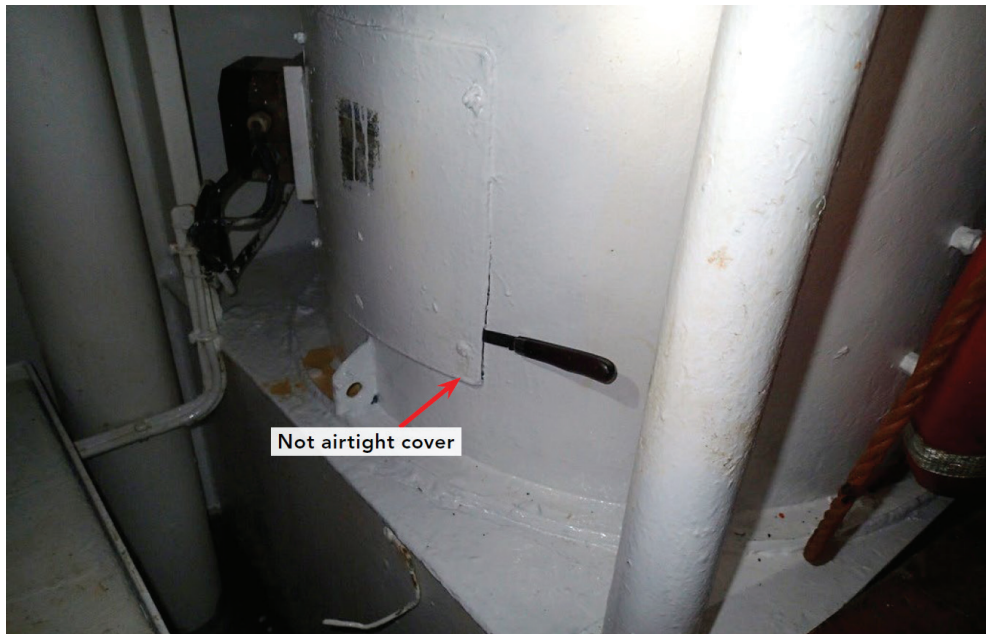
The CO₂ room, forecandle and bow thruster room are adjacent to each other and gasses might travel from one room to another through a number of connecting conduits. The shipping company contracted the classification society to investigate how carbon monoxide could have travelled from the cargo hold to the bow area. The investigation identified a minor gap in a section of the rim of an inspection cover on a ventilation duct that runs from the cargo hold through the forecandle as the most likely route (**Figure 2**).

Figure 2. The inspection hatch on a ventilation duct that ran from the cargo hold through the forecabin. A minor gap in a section of the rim (knife blade inserted) allowed gasses to travel from the cargo hold to the bow area. (LADY IRINA). Source: [13].

In response to the fatal accident, the shipping company acquired multi-gas meters and introduced a new work procedure mandating that the person making “First Entry” must carry an operational multi-gas meter. New warning placards with the instruction “ATTENTION—No first entry without use of multi-gas meter” were been put up on access doors.

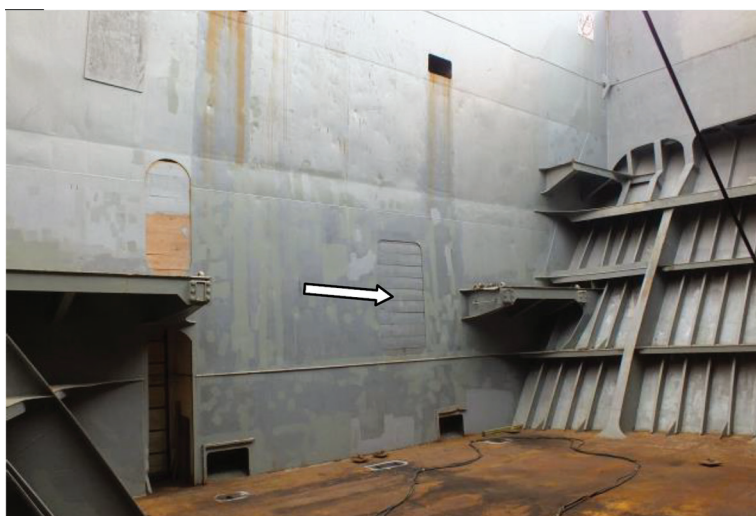
Figure 3. An opening in the front cargo hold allowed easy access to the lashing equipment room. When carrying bulk cargo, the opening was closed with planks of wood inserted into guide bars (CORINA). Source: [16].
