Microstructural investigations of Ni and Ni₂Al₃ coatings exposed in biomass power plants

Wu, D. L.; Dahl, K. V. ; Christiansen, T. L.; Montgomery, M.; Hald, J.

Published in:
Materials at High Temperatures

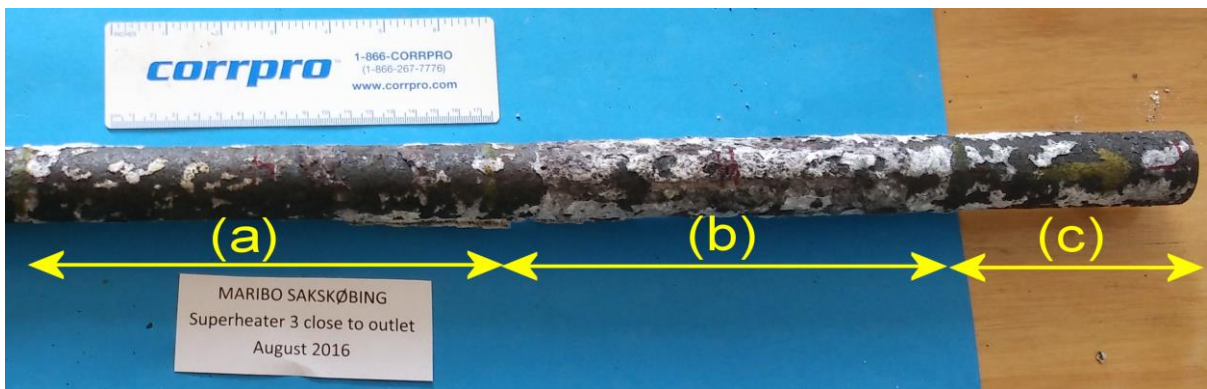
The exposed tubes after removal from the power plant are shown in Figure 2. Prior to removal of the tubes, the superheater had to be cleaned and this resulted in removal of deposit and some of the surface corrosion products. The Ni_2Al_3 coated tube was covered with a thick layer of corrosion product together with deposit in most areas. Some of the corrosion product and deposit was scraped off the tube and prepared for analysis. Lesser amounts of deposit were present for the Ni coated tube and uncoated tube.

Figure 2. Morphology of (a) Ni coated, (b) Ni_2Al_3 coated and (c) uncoated tubes after boiler exposure

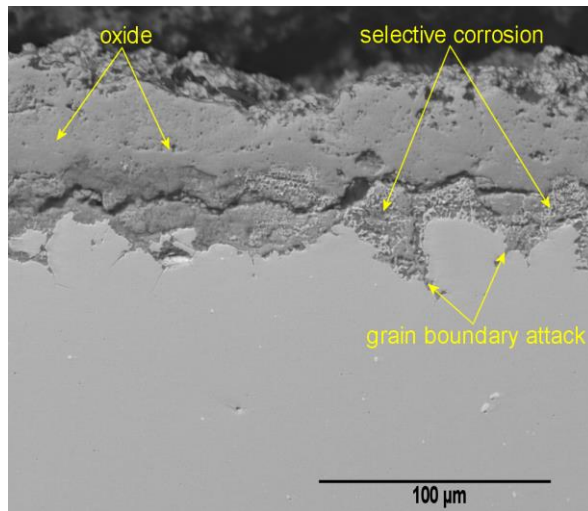
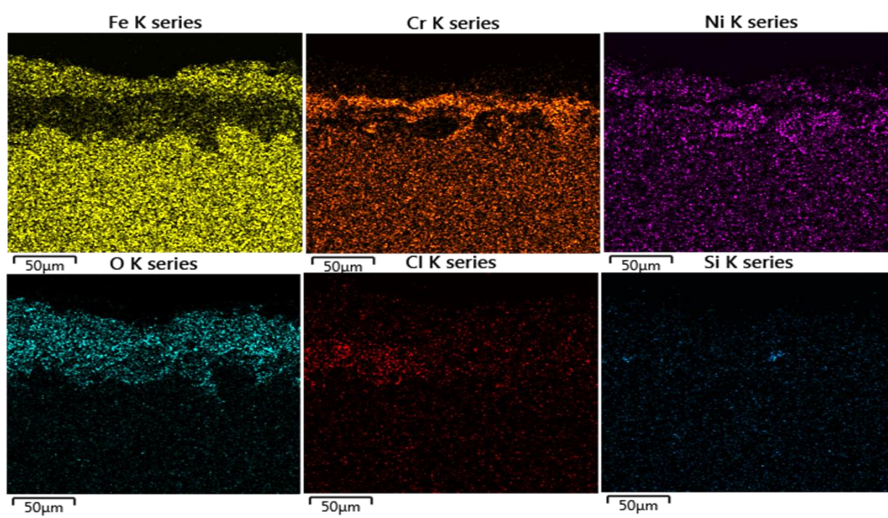
Different corrosion morphologies were evident on the exposed uncoated tube. In some areas, an oxide layer was present with limited underlying grain boundary attack (Figure 4), while deep grain boundary attack was observed in other areas (Figure 5). The corrosion product consisted of an outer oxide, an inner selective corrosion area and grain boundary attack. The oxide located in the outermost corrosion product was rich in iron, and the oxide below was rich in chromium. There was selective corrosion attack beneath the oxide, and chromium depletion was detected together with nickel enrichment (EDX results in Figure 4). Enrichment of chlorine was identified close to the corrosion front in the selective corrosion area. The indications of silicon enrichment close to the selective corrosion area were probably due to use of SiC papers in the grinding process.

Figure 4. SEM/BSE image of the corrosion morphology and EDX chemical element distribution for the uncoated tube after boiler exposure

According to the element distribution in Figure 4, potassium was not present at the corrosion front. Thus, Cl species must have been released, which could be due to reactions between KCl and metal oxides or sulphation of KCl. Cl^- ions could also be generated by reaction of HCl and oxygen [13] or via reaction 1.

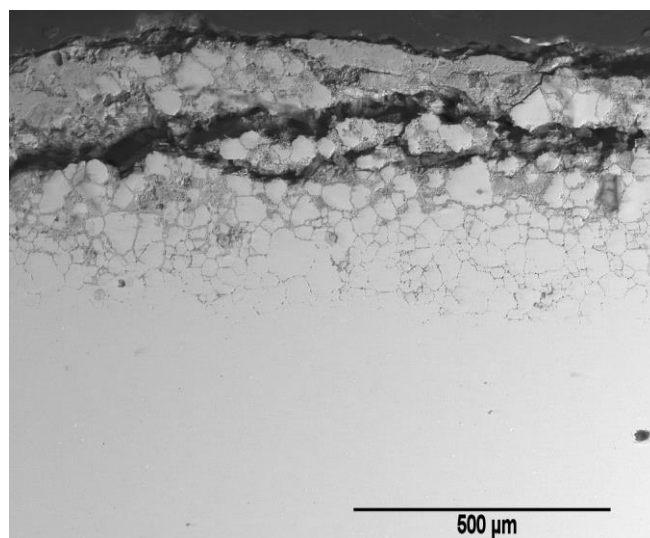
Figure 5. SEM/BSE image of corrosion morphology showing deep grain boundary attack in the uncoated tube after boiler exposure.

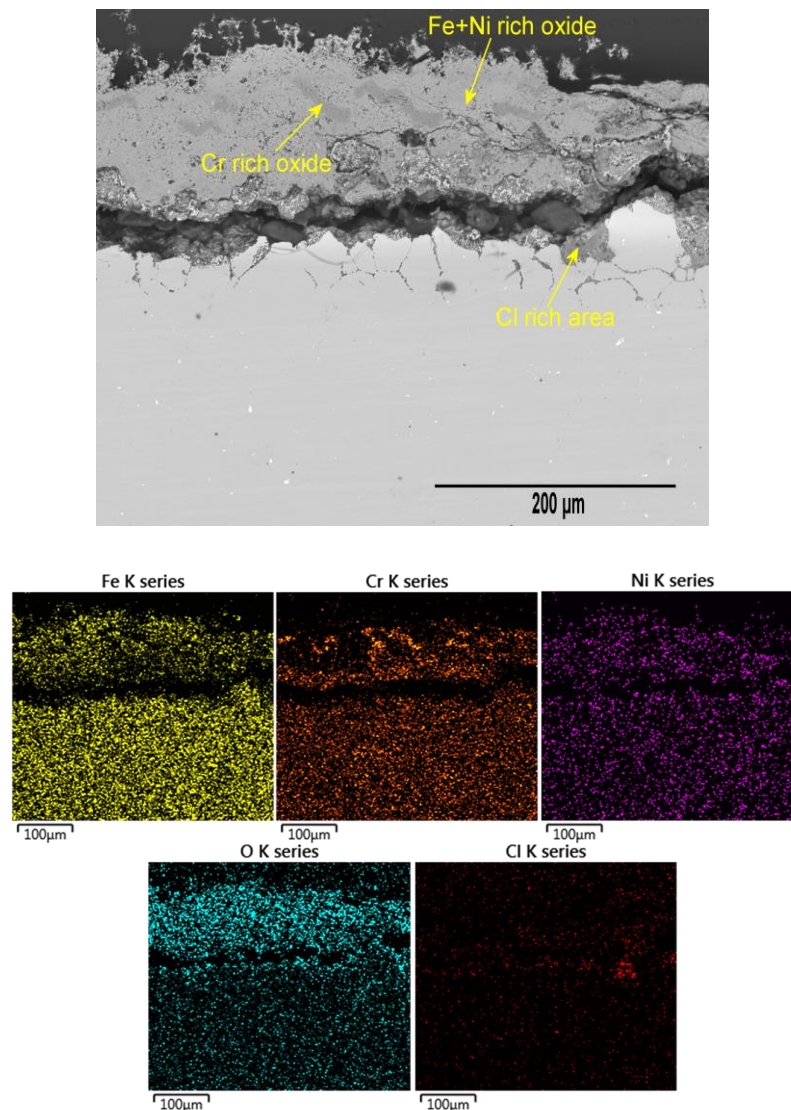
The morphology of corrosion products and chemical element distribution are given in Figure 6. The pure Ni layer was no longer present on the Ni coated tube after exposure. A voluminous corrosion product was formed at the outermost surface. The corrosion products were rich in iron and nickel in the outer part and rich in chromium in the inner part. Clear enrichment of chlorine was observed close to the underlying metal.

Figure 6. SEM/BSE image of corrosion morphology and EDX chemical element distribution for Ni coated tube after boiler exposure

The Ni coated tube shows similar corrosion morphology as the uncoated tube. The pure nickel layer is no longer present, indicating that the nickel layer was not protective during the biomass boiler exposure. In fact, the corrosion attack is more severe than on the uncoated tube, however it is not known how much corrosion product has spalled during removal of the tube from the plant. In laboratory investigations by Jonsson et al. [18] the

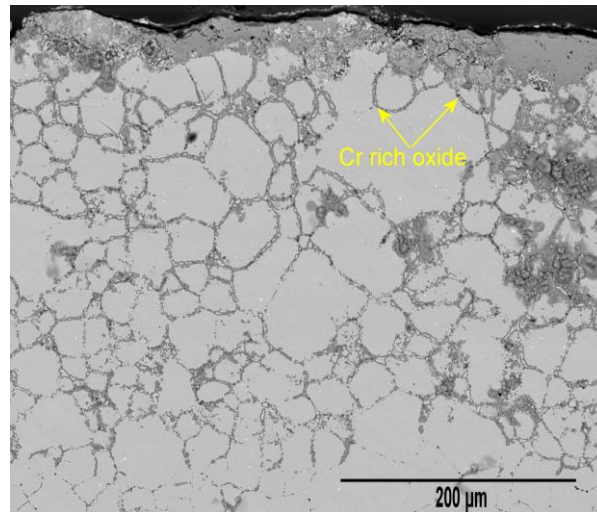
Localised grain boundary attack could be seen in locations with voluminous outer oxide, while deeper grain boundary attack was apparent in areas with thinner corrosion products (Figure 7), similar to the findings for the uncoated tube. Since the KCl was not revealed on cross-sections, some surface oxide could have spalled during tube removal and handling.

Figure 7. SEM/BSE image of a location with severe grain boundary attack for Ni coated tube after boiler exposure

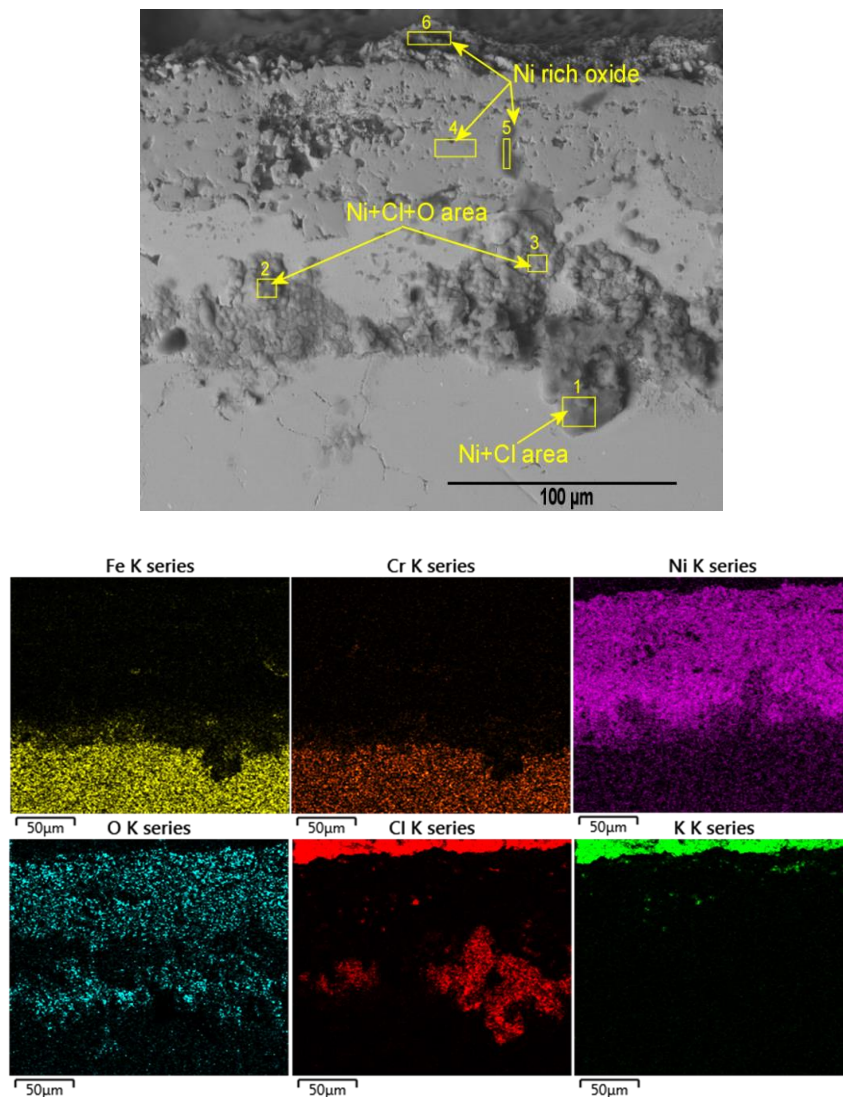
After boiler exposure, the Ni₂Al₃ coated tube exhibited two distinct corrosion features, a) where there were no remnants of the coating and only the TP347H tube was present and b) where the electroplated Ni layer was still present. Areas where the Ni layer was absent were similar to the attack on the uncoated TP347H tube, see Figures 4-7. Where the electroplated Ni layer was present, it is assumed that the Ni₂Al₃ layer had peeled off as no evidence of aluminium was observed within the corrosion products (Figure 8). Remnants of the Ni₂Al₃ layer could be found in the deposit (described later in this section), further supporting this assumption. Figure 8 reveals an area where the nickel layer is present above the stainless steel tube material (shown in the maps as Cr and Fe rich). At locations above the Ni-layer, SEM/EDX revealed the presence of both

potassium and chlorine within the deposit indicating the presence of potassium chloride, and therefore no spallation of corrosion products during handling.

Figure 8. SEM/BSE image of corrosion morphology and element distribution on the Ni_2Al_3 coated tube after boiler exposure at a location where the Ni layer was present. In the SEM image, location of EDX measurements was reported in Table 2.

SEM-EDS analysis shows that the external oxides are rich in nickel only (Table 2). A large area with chlorine enrichment could be identified below the nickel enriched outer oxide. Above the nickel coating-TP347H interface, the chlorine species are associated with nickel (region 2 and 3), however within the TP347H layer, the Cl species are associated with Ni, Fe and Cr (region 1). The morphology of the Cl species seems to indicate that they have emerged from the metallic material after polishing and that they

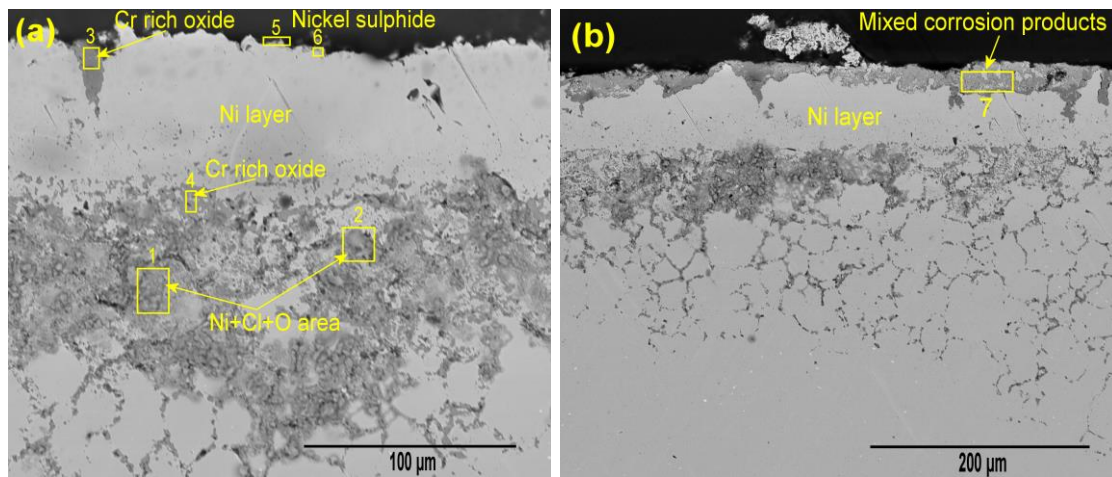
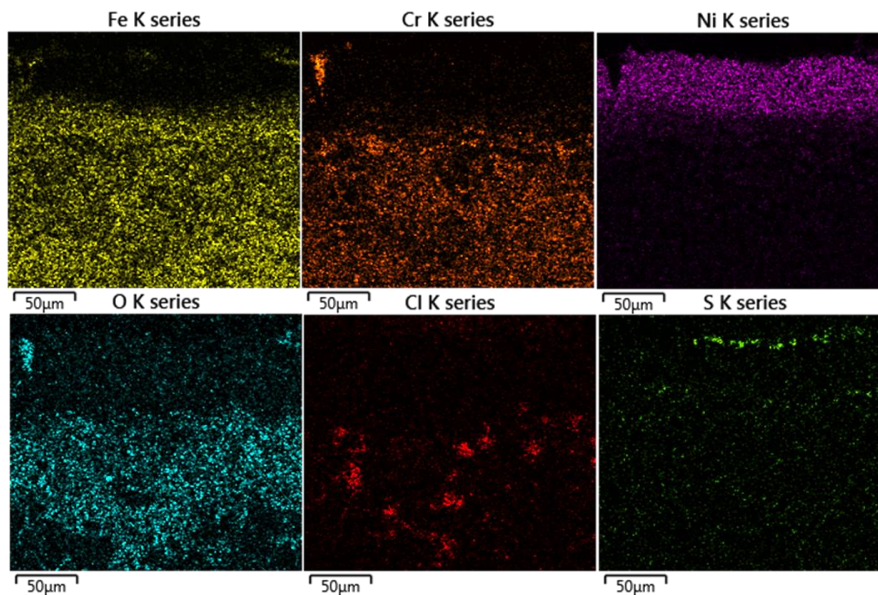
At other locations, where the nickel layer was still present, a large part of the original nickel layer remained with a thickness of about 70 μm (Figure 9a). In some areas, a thick zone of mixed corrosion products could be found above the nickel layer (Figure 9b).

SEM/EDX (Figure 9a and Table 3) show a local area of Cr-rich oxide close to the surface (region 3) and sulphur enrichment in the outer surface (regions 5 and 6) as well as within sulphur rich phases in the nickel layer. The absence of K and Cl on the surface could indicate that the surface corrosion products have been removed during removal and handling of the tubes. Cl enrichment as well as severe grain boundary attack were observed in the underlying TP347H metal. Cl was distributed everywhere where there was grain boundary attack and enriched in localised places (regions 1 and 2).

Figure 9. SEM/BSE of corrosion morphology on the Ni₂Al₃ coated tube after boiler exposure for locations with (a) nickel layer and (b) nickel layer with outer corrosion product and EDX chemical element distribution corresponding to (a). Compositions of selected areas in (a) and (b) are shown in Table 3.

The nickel and sulphur rich layer indicates the formation of nickel sulphide (Ni₃S₂) on the outer surface and within the nickel layer (regions 5 and 6 in Table 3). The performance of nickel in sulphur containing atmospheres has been widely investigated [21–25]. In the temperature range between 480°C and 620°C, NiO is thermodynamically preferred over Ni₃S₂, even under oxidising SO₂ atmospheres. However, when the gas atmosphere tends to more reducing conditions, the sulphur attack becomes more prevalent [21]. This leads to the formation of Ni₃S₂ by the reaction in equation 4 [26].

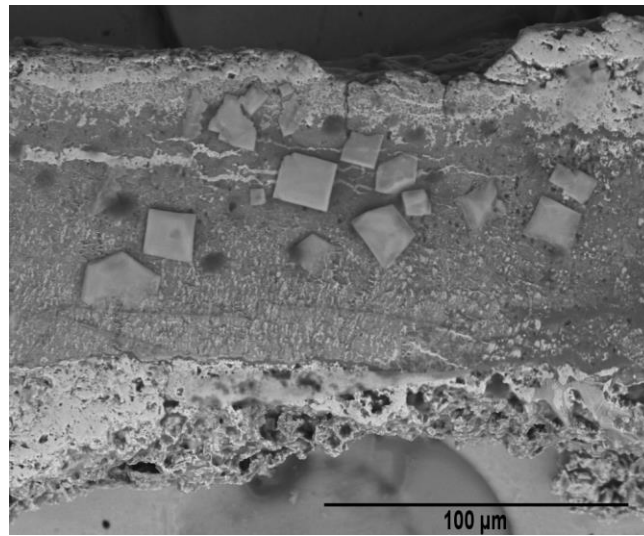
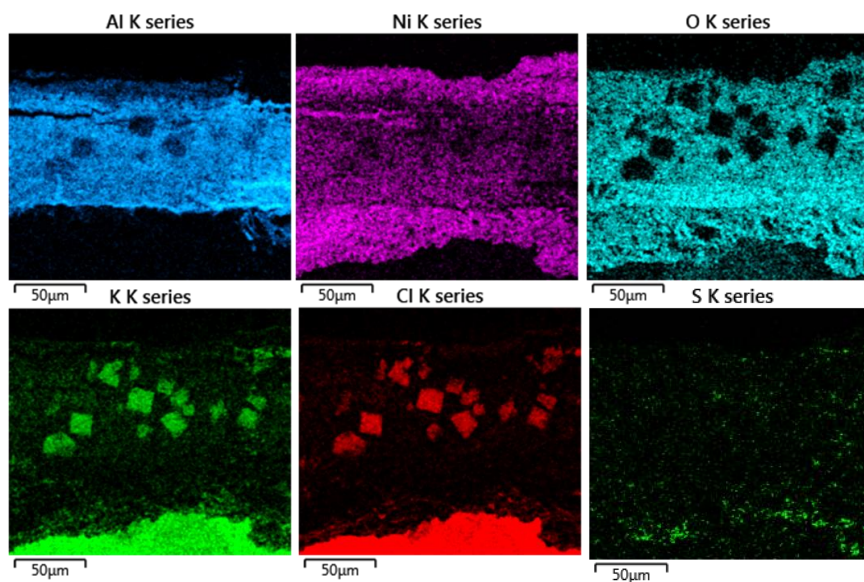
Within the deposit, remnants of the Ni₂Al₃ coating could be found, and their analysis can give further information as to how the attack progressed on the Ni₂Al₃ coated tubes. The corrosion morphology and the distribution of chemical elements in the deposit are shown in Figure 10. The top part of the micrograph was closest to the flue gas environment. The coating element aluminium, which was absent at the tube surface locations, was observed in the deposit of Ni₂Al₃ coated tubes. A multi-layered oxide scale that must have spalled from the tube surface could be found intact in the deposit. The oxide scale had a porous nickel-rich oxide scale at both sides and an aluminium-rich oxide in between. A number of blocky structured potassium chloride particles are dispersed on the top of the multi-layered oxide scale.

Figure 10. Corrosion morphology and element distribution of the deposit on Ni_2Al_3 coated tube after boiler exposure.

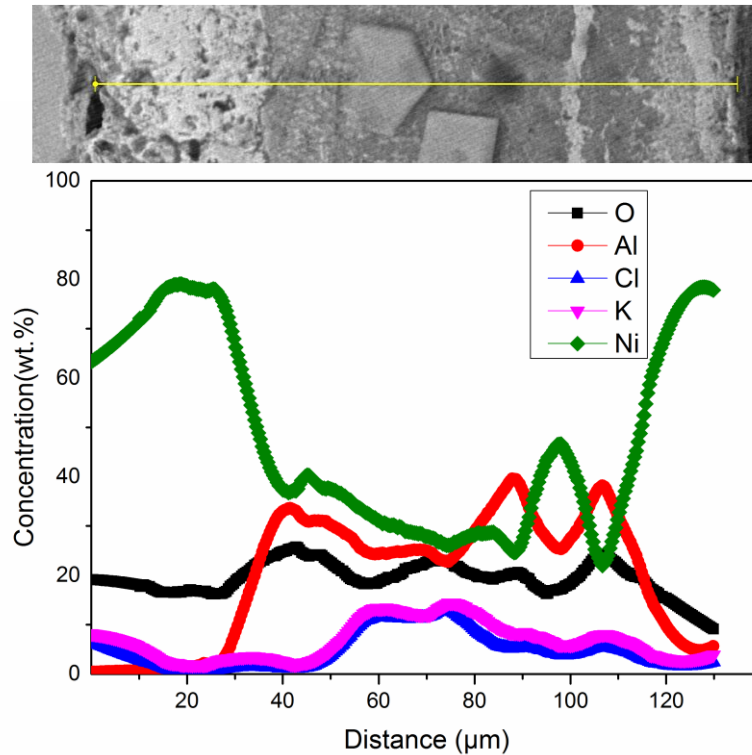
A composition profile measured by EDS shows that the concentration of aluminium is around 30 wt. % in the centre of the spalled scale, which should still be sufficient for the formation of protective aluminium oxide (Figure 11). The two peaks in the aluminium profile lie on each side of a Ni-rich band, which is visible as a white layer within the aluminium-rich oxide.

Figure 11. Composition profiles measured by EDS of the deposit on Ni_2Al_3 coated tube after boiler exposure.
