Corrosion of welds in biomass power plants

Montgomery, Melanie; Dahl, Kristian V.; Hald, John

Published in:
Materials and Corrosion

Publication date:
2019

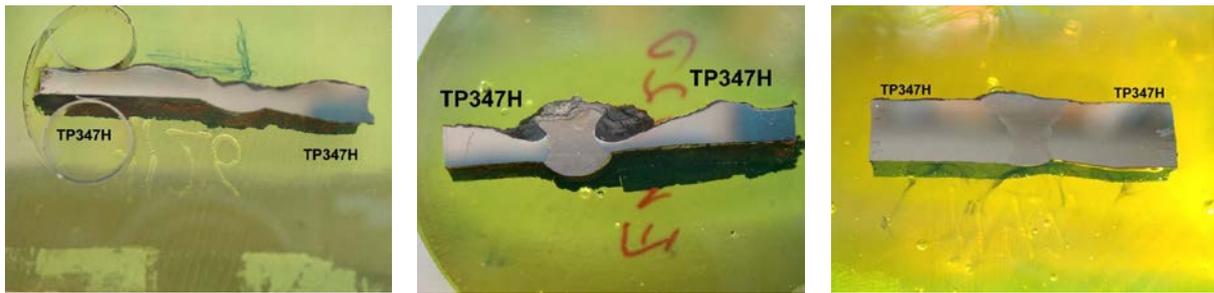
filler material (Nibas) [16]. The test superheater loop was exposed for only 3500 hours and both Nibas filler and CN 18/11 IG filler material (composition similar to the austenitic steels that were welded) were utilized. Cross-sections of some of the investigated welds are shown in Figure 1. The CN 18/11 IG weld showed no increased corrosion at the tube-weld transition zone (Figure 1a), however this was observed on a Nibas weld just 10 cm away and therefore exposed to similar operation parameters (Figure 1b). The severity of corrosion attack of the tube adjacent the Nibas weld decreased as the steam temperature decreased such that at an estimated steam temperature of 514°C, it was no longer observed (Figure 1c).

weld decreases with decreasing temperature (Figure 1) is probably due to the fact that the conductivity of the electrolyte falls since the amount of molten phase within the electrolyte decreases.

a) CN 18/11 IG, 568°C

b) Nibas, 570°C

c) Nibas, 514°C

Figure 1. Attack of 18% Cr stainless steel tubes adjacent welds for different filler materials and different estimated steam temperatures. Figure 1b shows preferential attack of the tube immediately adjacent the Nibas weld.

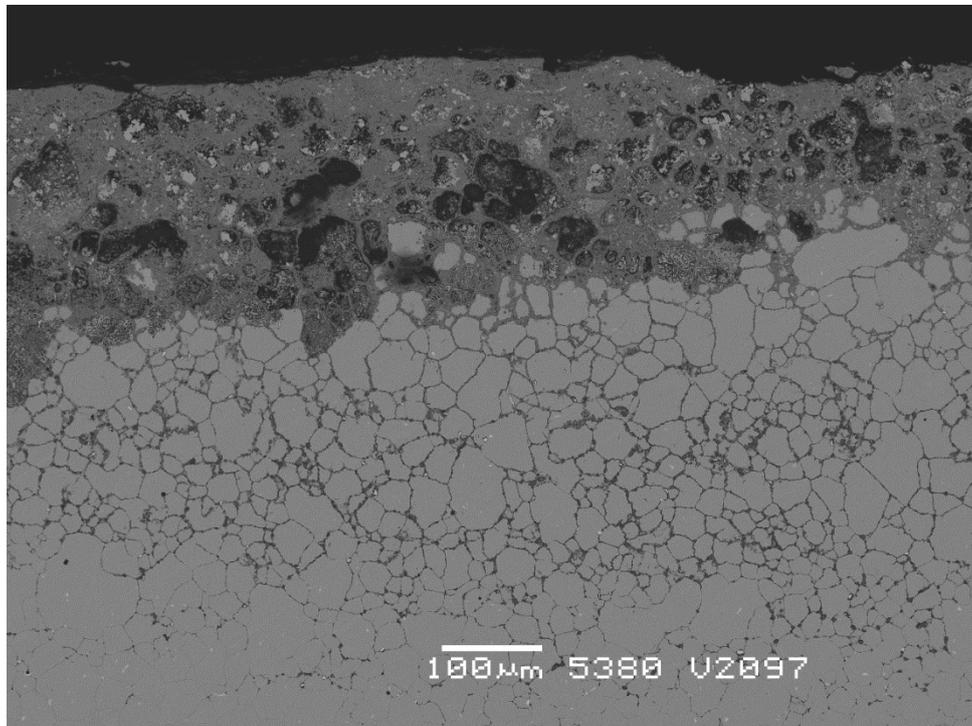
Over the years, many tubes have been investigated and the typical morphology of the attack for an 18%Cr 12%Ni steel (TP347H) is shown in Figure 2 revealing grain boundary

attack at the corrosion front and selective attack above this. Figure 2 is from the tube from Plant B but approximately 10cm from a weld, and a similar morphology has been seen for tubes from many different power plants in Denmark [12] including Plant A. Within the inner part of the corrosion product, selective attack was evident where Cr depletion was observed. Towards the surface of the tube, porous chromium and iron oxide layers were present. Metallic nickel was present within this oxide as isolated particles.

Figure 2: Typical corrosion attack of TP347H austenitic steel tubes located far from welds at steam temperature 540°C from Plant B.

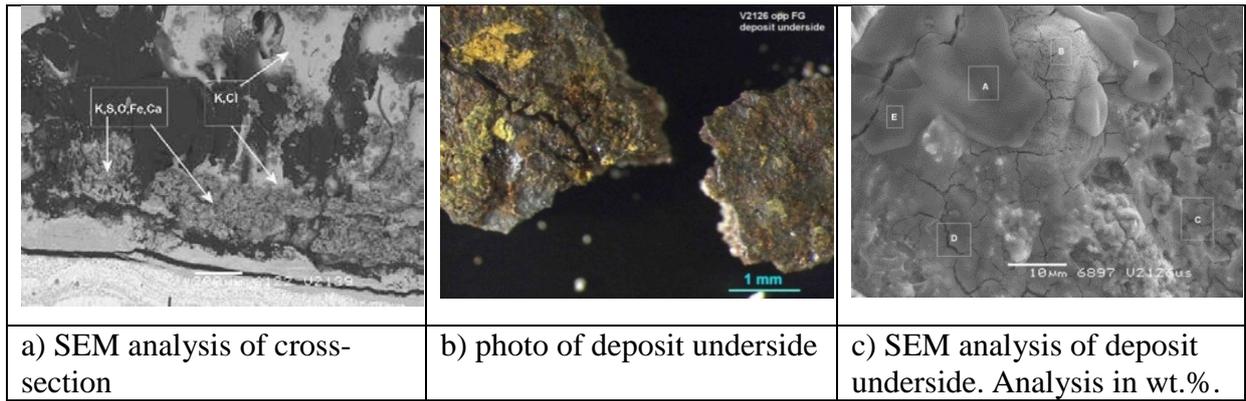
Analysis of deposits on the tubes from both plants revealed the presence of potassium chloride and potassium sulphate adjacent the oxide. The deposit in Figure 3a was from the higher steam temperature (536°C) whilst the deposit in Figure 3b and 3c were from the lower steam temperature section. The presence of compounds containing calcium, magnesium and silicon was more prevalent for Plant B (Figure 3a). Figure 3b and 3c shows the underside of the deposit/corrosion product (which was adjacent the tube) where K, Cl and Fe are major components of a phase with a molten appearance (analysis A, E and F). Another morphology was rich in Cr, O and Fe (C and D), whereas analysis B is an iron rich oxide. The surface of the corrosion product is uneven and there are presumably different phases on top of each other, so the EDX analyses probably include elements from underlying phases and should be only used as an indication of possible compounds. In addition, since hydrogen and carbon cannot be analysed, the presence of carbonates or hydroxide can neither be confirmed nor dismissed.

To have galvanic corrosion, an electrolyte has to connect two dissimilar alloys. The exact composition of such an electrolyte has not been identified, but the presence of a molten phase on the underside of the deposit is observed that is rich in K, Cl and Fe (Figure 3). Thus KCl together with iron chloride [19] could form a melt phase. Indications of formation of a FeCl₂-KCl melt were also revealed with top-down SEM analysis of corrosion products/deposits from laboratory exposures [10]. At the anode, the reaction will be the oxidation reaction: $M \rightarrow M^{n+} + ne^{-}$, metal oxidized to cations + electrons which would travel through the cathode, however the reaction at the cathode is more complicated. Nishikata et al [22] investigated with polarization measurements the presence of oxidizing agents like water vapour and oxygen in KCl-NaCl salts at 700°C and showed how OH⁻ or O²⁻ ions can occur resulting in higher corrosion rates. As outlined in ref [23], due to the incoming oxidizing species, removal of corrosion product and thermal gradient, the corrosion deposit is always in contact with incoming oxidizing species, so the molten deposit will continue to be replenished in oxidizing species resulting in cathodic reactions at the weld surface.

Figure 3: Morphology and analysis of deposit underside (Fig 3c) removed from tube from Plant B.

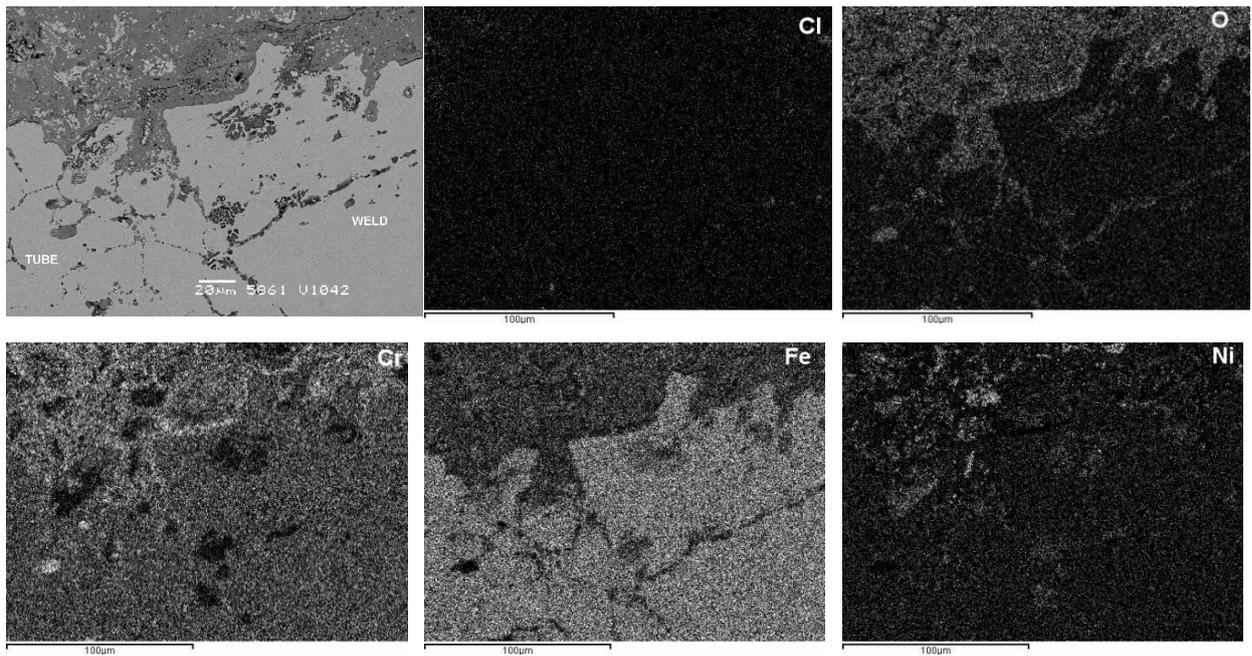
Figure 4 shows the attack on the CN 18/11 IG weld after 17000 hours exposure in Plant A at 554°C. On the tube side, there is grain boundary attack and a similar morphology to Figure

2. On the weld side there is preferential interdendritic attack (not shown). There is no increased corrosion attack on either the weld, tube or the transition zone. The corrosion attack of the weld and tube is similar in that there is attack along the interdendritic zone or grain boundaries at the corrosion front, and these function as pathways allowing ingress of corrosive species. The outer oxide is a mix of iron and chromium rich oxide with islands of metallic nickel.

Figure 4. Attack of 18% Cr stainless steel tubes adjacent the CN 18/11 IG weld. Estimated steam temperature 554°C.

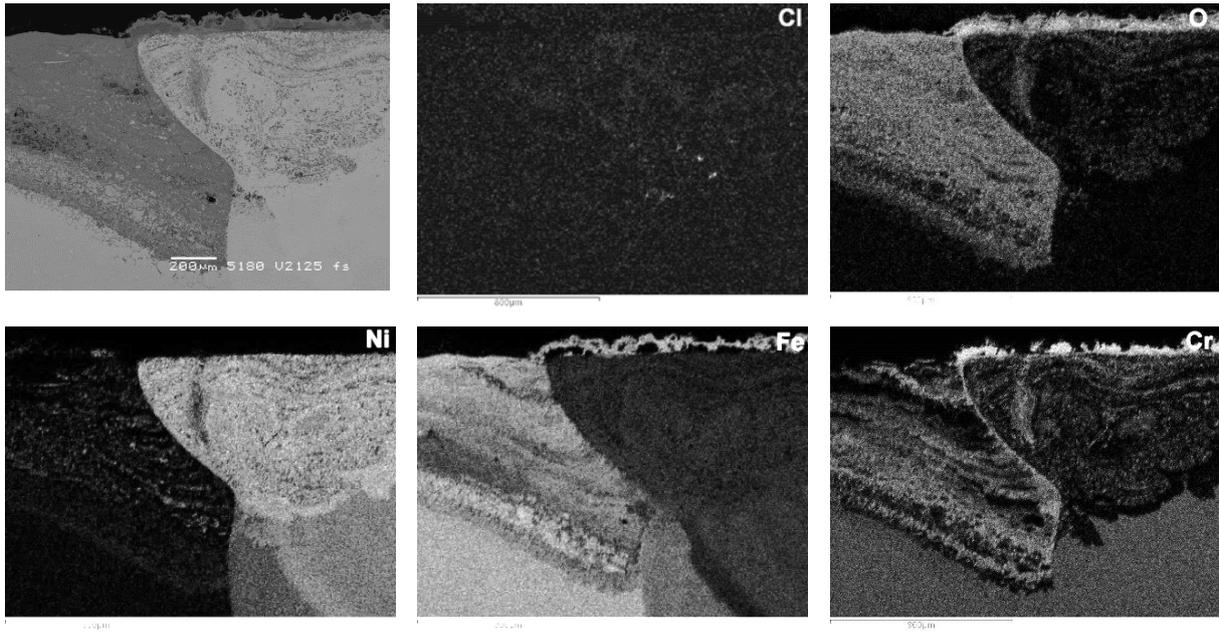
Figure 5 shows the attack for the tube adjacent the nickel weld after 30000 hours exposure in plant B at a temperature of 536°C. Similar to the weld from Plant A, the attack at the corrosion front for the weld seems to be within the interdendritic phase. However, there is significant corrosion attack of the austenitic tube adjacent the Ni weld which decreases with distance from the weld. This is similar to that observed for [16]. The corrosion rate for the tubes in Plant B is lower than that for Plant A probably due to the lower temperature (Table 2), so the increased corrosion near the weld is not due to more severe operation parameters.

The nobility of the weld will also depend on the dilution of the weld metal during welding. For the Ni weld from plant B, the iron content of the weld at the steamside was 20-30 wt.% and decreased to 10% at the top centre of the weld. Therefore the weld composition adjacent the tube can vary (Figure 5) as the location of the corrosion front moves during exposure which would result in a lower shift in electrode potential and therefore less galvanic corrosion as the weld material further down is less cathodic. In contrast the composition of the weld becomes more noble during exposure as iron and chromium are being preferentially attacked leaving more nickel rich alloy and therefore a greater shift in potential encouraging the galvanic corrosion of the adjacent tube.

Figure 5. Attack of 18% Cr steel tube (on the left) adjacent the Ni weld (right). Estimated steam temperature 536°C.

- It is suggested that galvanic corrosion can occur in biomass plants where the electrolyte is KCl deposit products and/or metal chlorides. This will be more severe at higher metal or flue gas temperatures.
- The use of more noble weld filler material compared to the tube should be avoided within the combustion zone where molten compounds could be present.

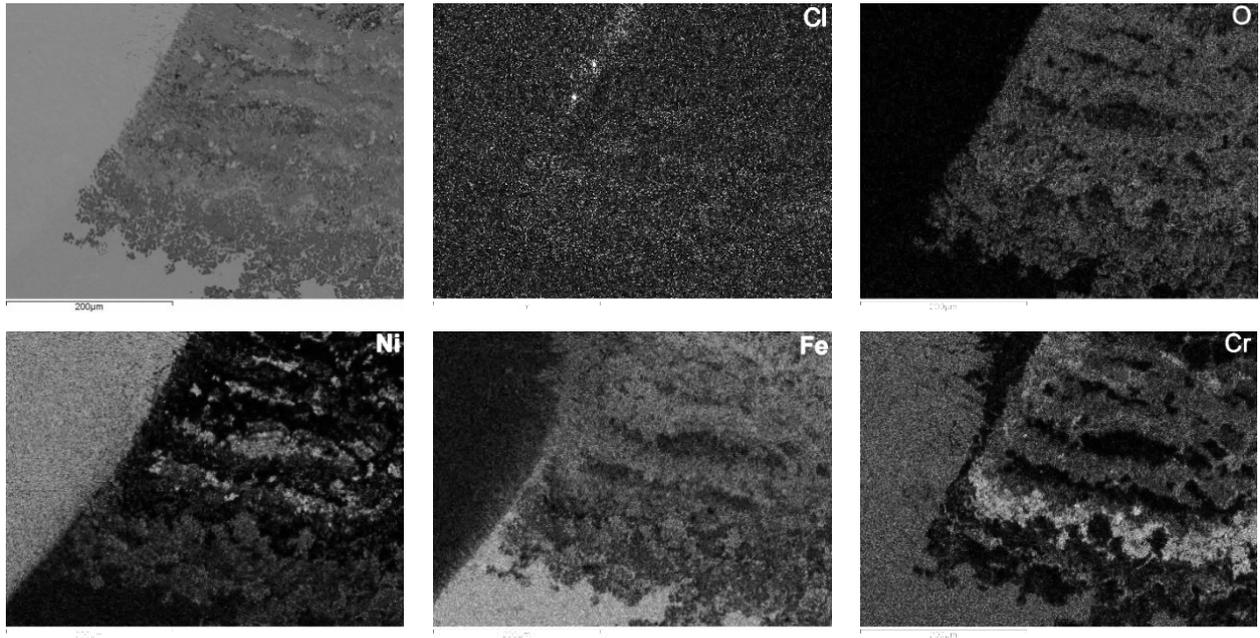
Closer analysis of the area adjacent the weld at the corrosion front shows the presence of a layered structure of Fe-Cr oxide and Fe-Ni oxide and not the typical grain boundary attack (Figure 6). There is also a measurable trace of chlorine within this area, but no traces of potassium. The Cl levels shown in the mapping is background and a maximum Cl content of 1 wt.% was measured close to the corrosion front. Nickel is still present as metallic nickel in islands between the corrosion products but is also present as Fe-Ni oxide.

Comparing the morphology in Figure 2a and Figure 6, it is clear that nickel has reacted to form corrosion products on the tube adjacent the weld but not away from the weld. In a galvanic couple, there will be a shift in potential of the anode and thus elements which were inert can become active. This can explain that nickel is reactive in the anodic tube adjacent the cathodic weld. The shift in electrode potential will also affect chromium and iron potentially increasing the localized attack. The layered structure of Cr and Fe and Ni corrosion product can be explained based on the work of Abramov et al [27] who conducted experiments for stainless steel in inert chloride melts and measured the presence of metallic chloride ions (e.g. NiCl_4^{2-} , CrCl_4^{2-} , FeCl_4^{2-}) with in situ electronic absorption spectroscopy. Fe and Cr chloride ions were usually detected initially, however if the steels had been previously heat treated, nickel chloride ions were first detected, due to Cr being depleted from the surface. For the weld shown in Figure 6, it is suggested that the more electronegative components in the steel such as Fe and Cr react first, and then a Ni rich layer is left resulting in Ni reaction, and then the Fe and Cr are again preferentially attacked. In this

Figure 6. Attack of TP347H stainless steel tubes (right) adjacent Ni weld (left) at the corrosion front. Estimated steam temperature 536°C.

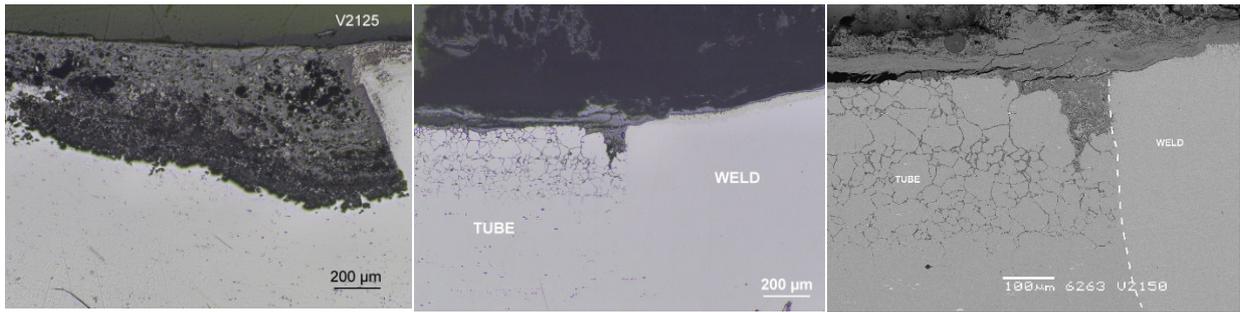
A specimen taken closer to the inlet with an estimated lower steam temperature of 499°C was also investigated and the regions adjacent the weld are compared in Figure 7. The colder weld reveals limited preferential attack of the tube adjacent the weld, which is only localized

to the outer area closest to the surface, and then grain boundary attack is observed similar to the rest of the tube (compare with Figure 2).

a) Steam temperature 536°C

b) Steam temperature 499°C

c) close-up of 7b

Figure 7: Weld-tube section from superheater in plant B showing effect of temperature.

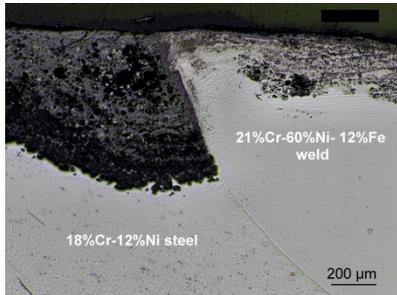
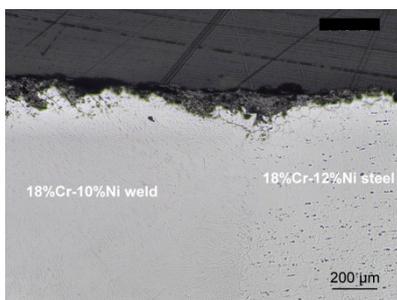
Galvanic high temperature corrosion has been observed in several plants in Denmark due to use of nickel weld materials.

Molten salts from the deposit and corrosion products form an electrolyte resulting in galvanic corrosion.

This can be avoided by the use of filler materials with a matching composition to the tube.
