Published in:
Wear

2D AND 3D CHARACTERIZATION OF ROLLING CONTACT FATIGUE CRACKS IN A MANGANESE STEEL WING RAILS FROM A CROSSING

Abstract: Rail wheel contact at switches and crossings (S&Cs) induces impact stresses along with normal and shear contact stresses, resulting in plastic deformation and eventually crack formation. Damaged and deformed wing rails of a manganese steel crossing are studied and the microstructure, hardness and 3D crack network within the steel are characterized. The surface of the rail receives the maximum deformation resulting in a hardened top layer. The deformation is manifested in a high density of twins and dislocation boundaries in the microstructure. A complex crack network is revealed in high resolution by X-ray tomography.

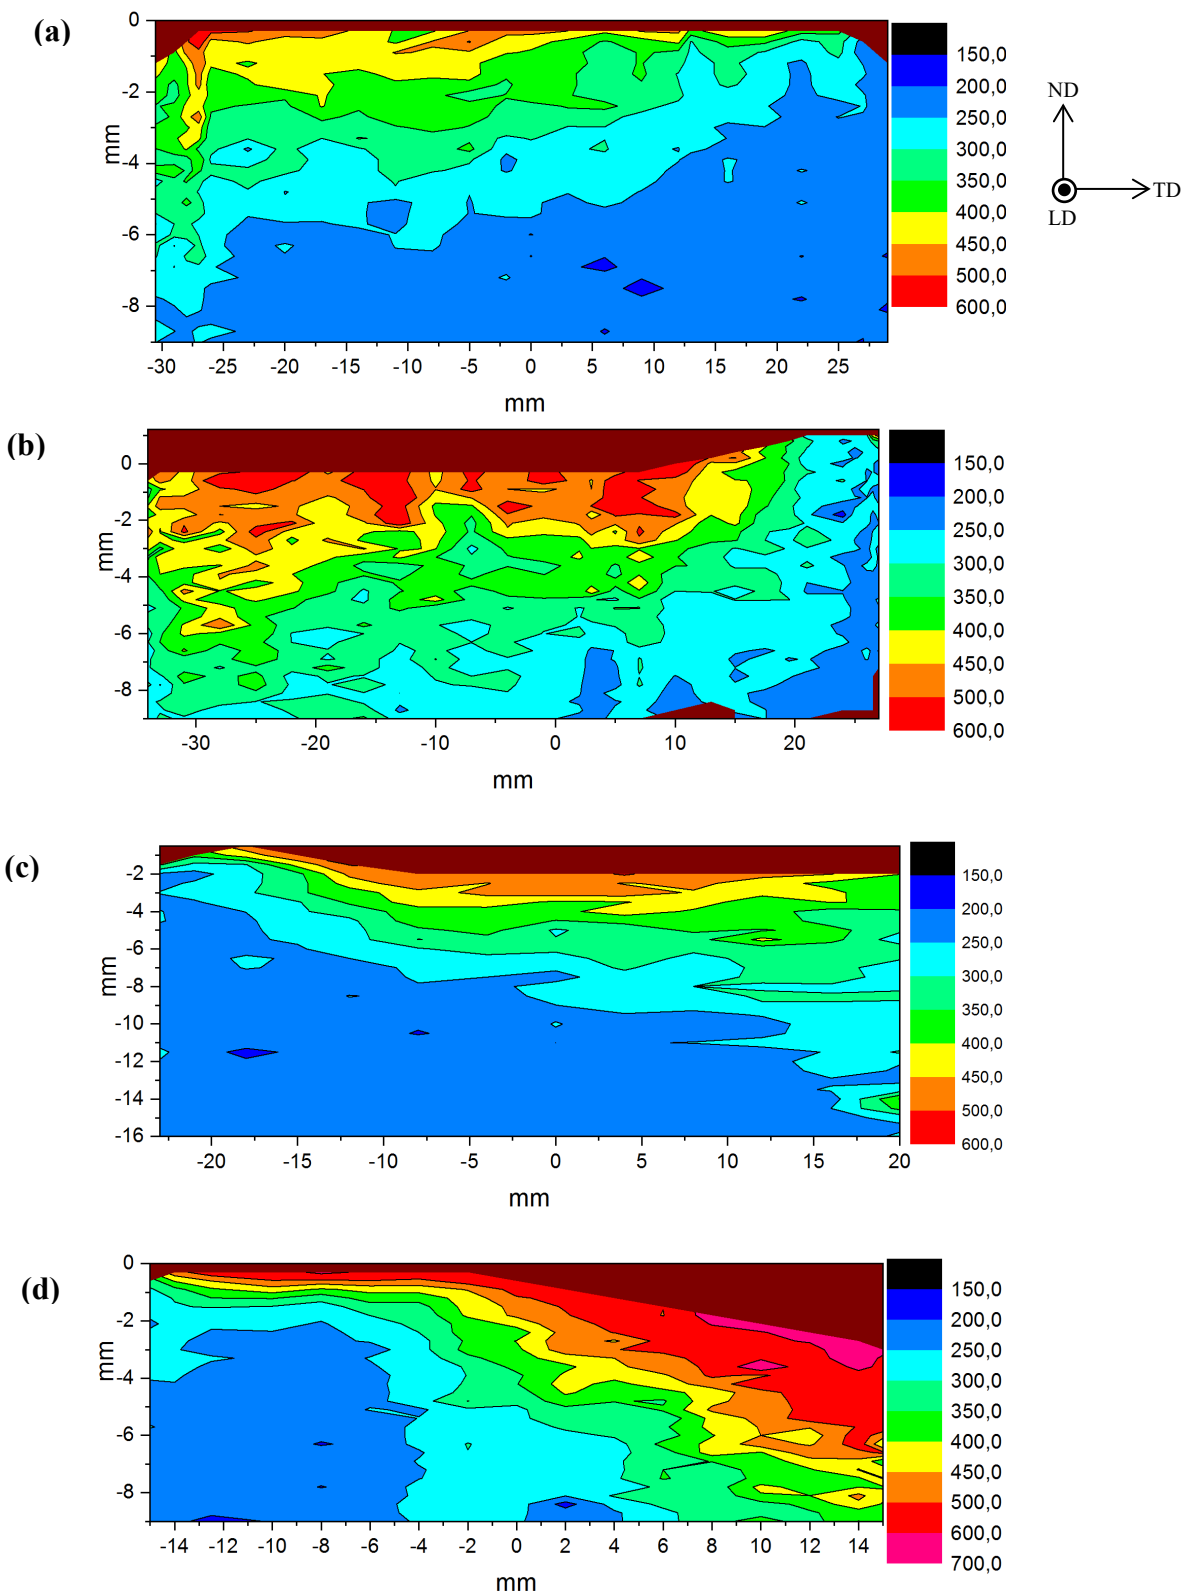
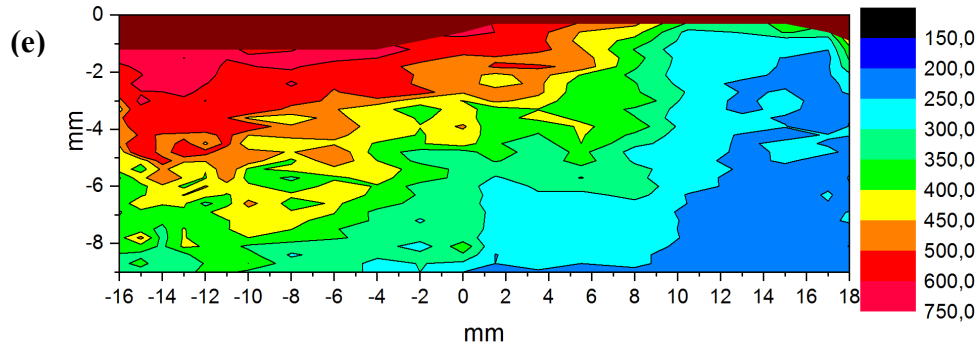
Figure 2 shows the hardness maps of the two wing rails at different locations. The positions (i), (iii) and (iv) belong to wing rail 1 and (ii) and (v) to wing rail 2, which had been repair welded. As shown, the hardness measurements were made on wing rail 2 at locations away from the weld. The figures show that the hardness gradient is different at different locations, due to the difference in rail wheel contact at those places. In positions (ii), (iv) and (v), the deformation hardening is most severe at the top layer showing a high hardness of more than 600 Hv. The hardness maps from locations (i) and (iii) show that these locations are comparatively less deformed. The extent of deformation varies due to the difference in the direction of traffic (diverging track or straight track). Below the wheel running surface the hardness values decrease, indicating less deformation at larger depths, with the undeformed region having a base hardness of around 220 Hv. Cracks were found at region (ii), although the hardness as well as depth of hardening are higher at region (iv) and (v). No cracks were found in these very hard regions; (iv) and (v).

Region (i) has the least deformation and maintains the original rail profile shape, whereas in the other cases, the rail profile changes with deformation. With increased deformation, the depression of the surface profile (as in Figure 2b, 2d and 2e) compared to the original profile gets more severe. The work hardened layer is observed to extend to 10 mm below the surface. This depth of the deformation in the investigated wing rails is found to be nearly the same as found in case of the manganese nose rail studied previously [9]. Although the previously studied crossing was fairly a new one (5 years in service) compared to the crossing in the present study (13 years in service), the yearly traffic density through both the switches was approximately the same (14MGT). The depth of hardening was the same in both cases. Similar depth of hardening is reported for manganese crossing experiencing 130 MGT loads during service in another study [10]. Depth of hardening by other deformation mechanisms like explosion hardening can be much higher up to 25 mm from the surface [11]. The depth of hardening from wheel/rail contact is significantly higher in manganese grade crossings compared to normal pearlite grade. In literature it has been reported that in pearlitic grade the depth of hardening extends to only 3-5 mm from the wheel running surface [12-13].

Figure 2: Hardness contour maps of the wing rails at different locations: (a) Wing rail 1 position i, (b) Wing rail 2 position ii, (c) Wing rail 1 position iii, (d) Wing rail 1 position iv and (e) Wing rail 2 position v. The axes only indicate the scale. The zero points are chosen arbitrarily.

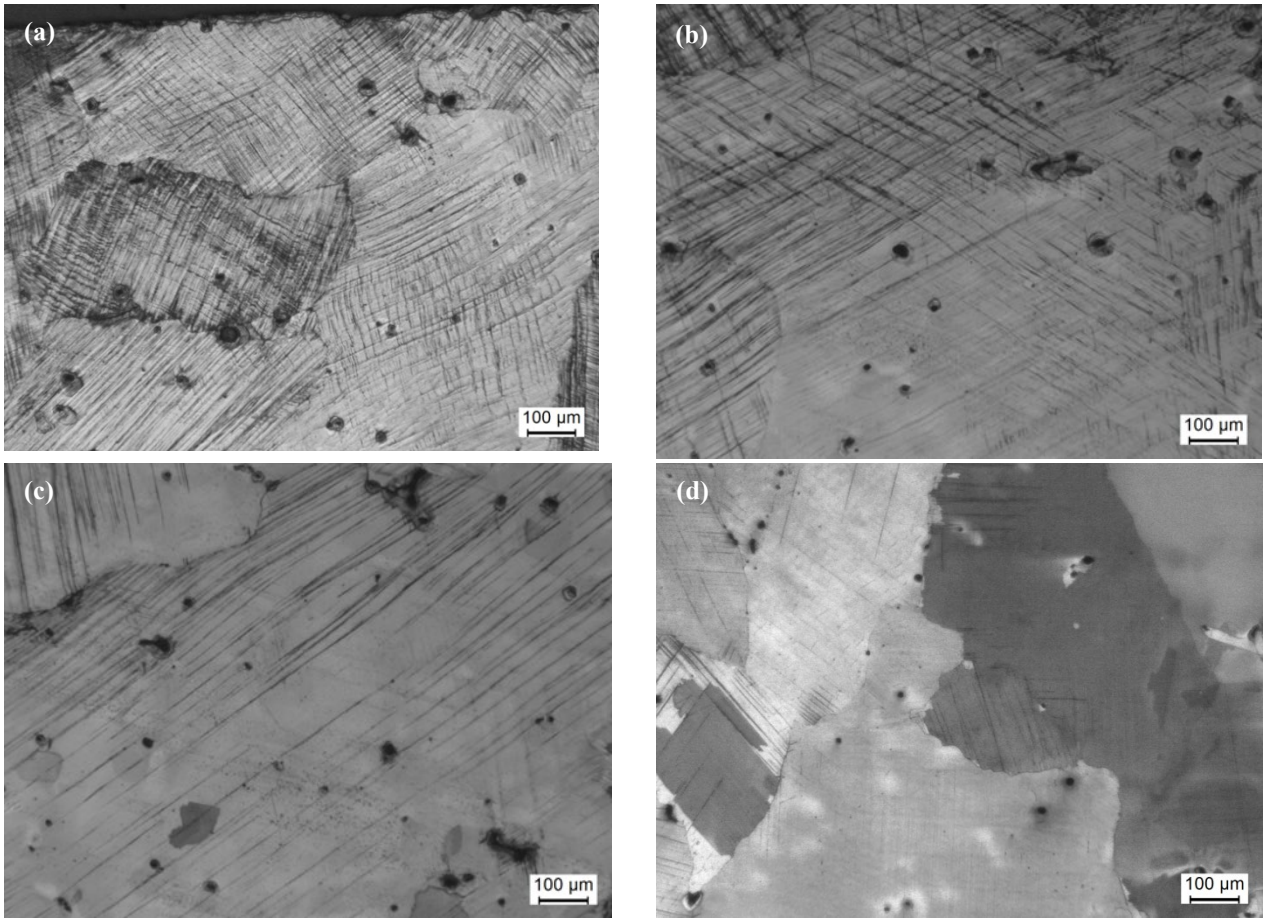
The microstructure is austenitic in manganese steel. The grain size is coarse, ranging up to 500 μm , and the grains do not deform by shearing as in pearlitic rails. Figure 3(a-d) shows optical micrographs of the deformed wing rail at different depths from the wheel running surface. At the rolling contact surface, Figure 3a, a large number of bands can be seen crossing each other within the grains. The deformation in manganese steels is manifested in the form of these bands and not by the usual elongation of grains as seen in pearlite. The surface receives the maximum deformation and hence the density of the bands is higher here and decreases with depth from the surface (Figures 3a-d). At around 12 mm in depth (Figure 3d) the microstructure is almost free from deformation bands. The deformation bands are inhomogeneously distributed with a wavy appearance and the direction of the bands varies from one grain to another. From optical microcopy it is not possible to reveal whether the deformation bands are mechanical twins or dislocation boundaries. The deformed microstructure in the wing rail was found to be similar to the manganese nose rail

Figure 3: Optical microscopy images of the transverse section (a) at the rolling contact surface, (b) at 6 mm depth from the surface, (c) at 10 mm from the surface, and (d) at 12 mm from the surface, where the base hardness has been reached.

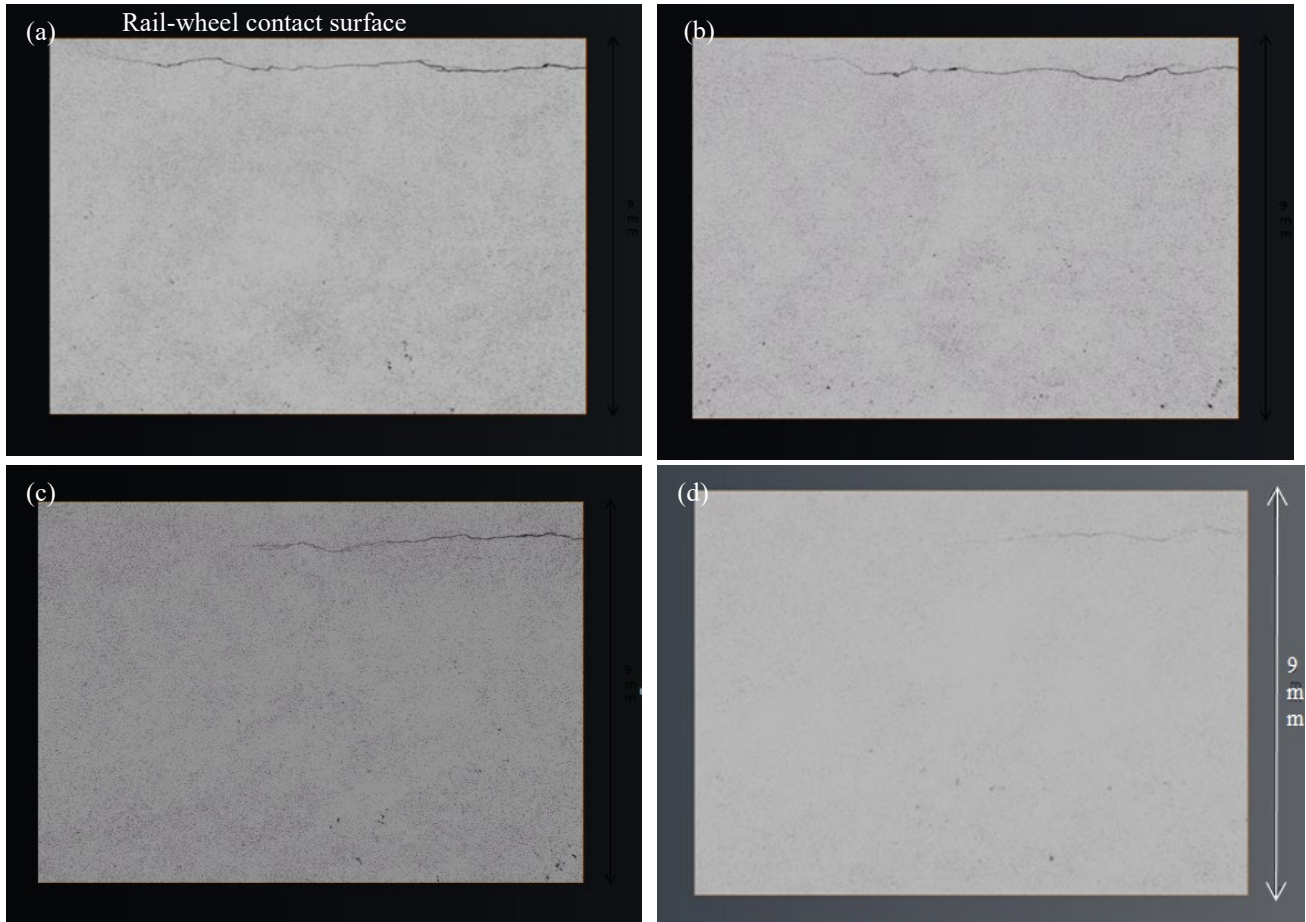
Two samples with size 10 mm by 10 mm by 40 mm from wing rail 2 (see Figure 1e) were characterized by X-ray tomography. Figure 4(a-d) shows 2D slices from one of the 3D tomographic reconstructions. Tomographical reconstructions are 3D density maps, which allow detection of even small cracks due to differences in density, thereby identifying cracks in 3D giving a detailed overview of the entire crack surface. Figure 4 shows a very long subsurface crack parallel to the running surface across the entire cross section of the specimen. However, the full 3D reconstruction also reveals the presence of cracks in contact with the surface. While most of the cracks run parallel to the running

surface, the crack network is extensive and continuous.

Figure 4: 2D slices showing the crack network within the wing rail at different locations along the longitudinal direction (a) at the trasverse cut (0 mm), (b) 10 mm from the transverse cut, (c) 18 mm from the transverse cut and (d) 29 mm from transverse cut.

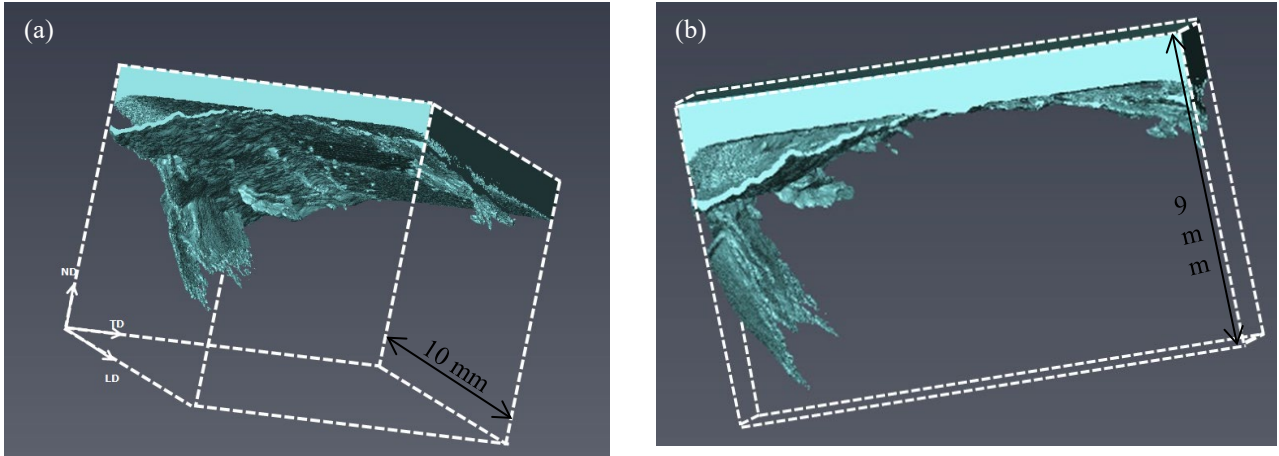
Figure 5 shows the 3D reconstructions of another crack network in sample 2. In this figure, the steel is represented as transparent and the blue colored areas represent air, including air inside the cracks, thereby making the crack network and running surface visible. The white box represents the volume of the wing rail which has been scanned. The interior crack surface has a rough and wavy appearance with ridges which are quite similar to the failure surfaces often seen in rolling contact fatigue. Figure 5 also reveals that the crack network is spreading quite deep into the rail, with seemingly random crack propagation. Most of the cracks move parallel to the running surface, as apparent from Figure 4, but there are also some diverging downward branching cracks which could cause rail break in the long run. The wing rail contains both surface and sub surface cracks, where some are interconnected, and some propagate individually.

Figure 5: (a and b) 3-D tomographic representations of the crack network within the wing rail of a manganese crossing seen from different directions. The steel is represented as transparent and the blue coloured area represent air, making the crack network and running surface visible.

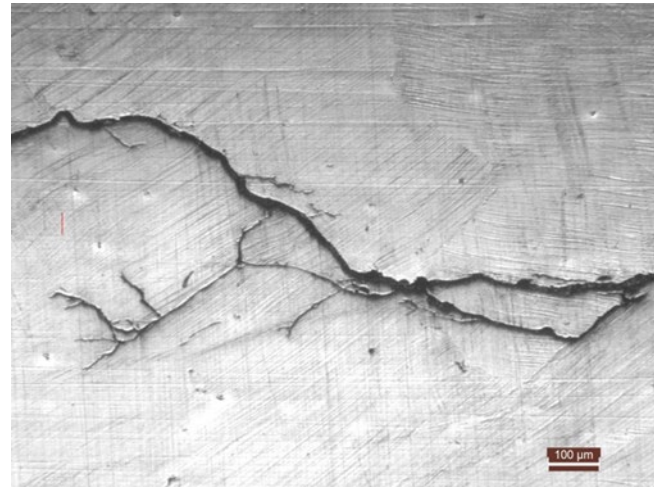
The two-phase microstructure in a pearlite grade material, consisting of ferrite and cementite, affects the deformation mechanism and eventually the crack initiation and propagation [14], where cracks tend to propagate through the softer ferrite phase, resulting in a wavy appearance. Figure 6 shows a rolling contact fatigue crack in pearlite grade steel from a straight track with a wavy crack propagation that passes through several grains. Figure 7 shows an optical micrograph of a subsurface crack in the wing rail of the manganese steel crossing investigated in this work having the same wavy appearance intersecting several grains with several crack branches and a seemingly random crack propagation. This is in correspondence to the cracks found in a manganese steel crossing nose studied previously in [9], where a more detailed study showed the cracks avoided the twinned regions (harder areas of the matrix) and were mostly transgranular giving the wavy appearance by following the weakest link in the microstructure. Therefore, although the plastic deformation is caused by slip in pearlitic grade without twinning, and for manganese steel deformation is from both dislocation motion as well as twinning, the crack networks have a similar appearance for pearlitic steel straight tracks and manganese steel crossings irrespective of the very different loading conditions in the two cases.

cracks found in pearlitic grade steel used in normal straight tracks. The cracks tend to be concentrated mostly within the plastically deformed layer and have a wavy surface appearance which is common for rolling contact fatigue cracks.

Figure 7: Optical micrograph of a rolling contact fatigue crack in the wing rail of manganese steel crossing.
