# Fatigue testing of a 14.3 m composite blade embedded with artificial defects – damage growth and structural health monitoring

Xiao Chen\*, Sergei Semenov, Malcolm McGugan, Steen Hjelm Madsen, Süleyman Cem Yeniceli, Peter Berring, Kim Branner

Department of Wind Energy, Technical University of Denmark, Frederiksborgvej 399, 4000 Roskilde, Denmark

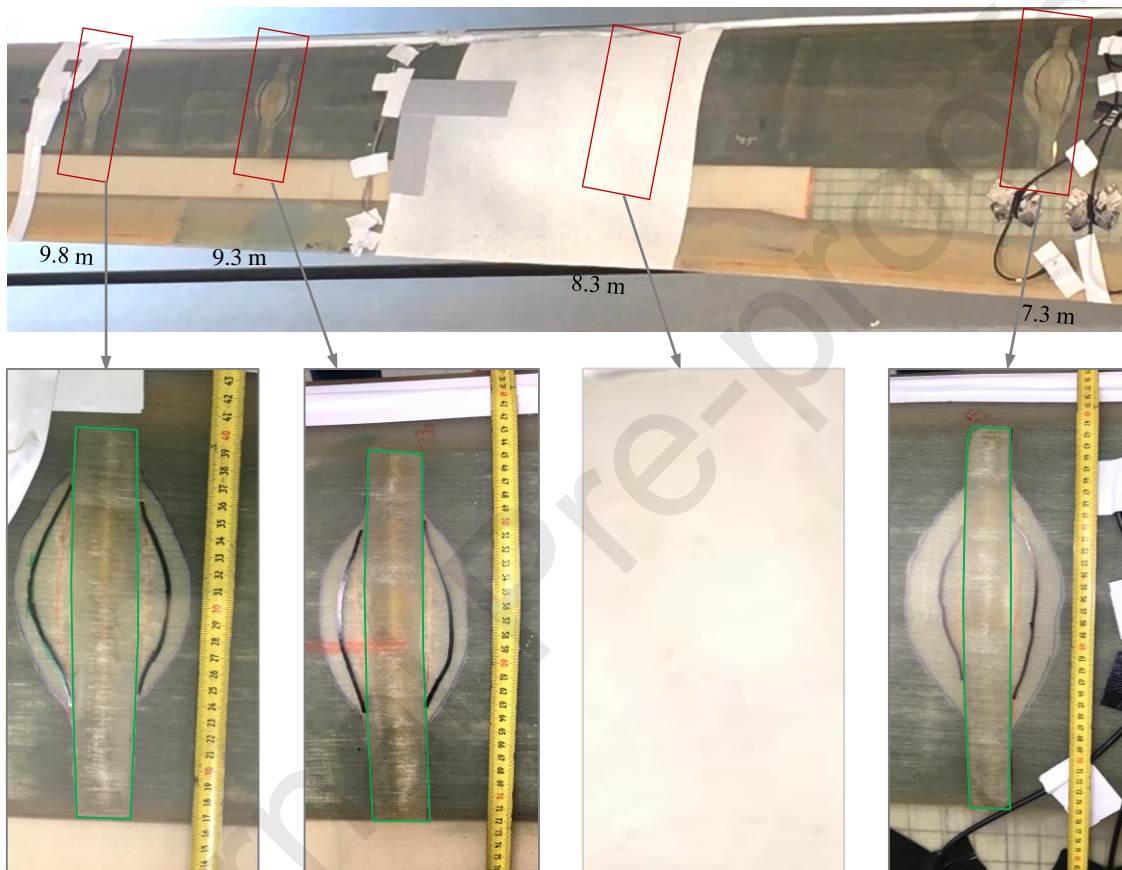
Figure 8

During the flapwise fatigue test, several damages initiate and progress from artificial defects. The most significant is the delamination originated from laminate wrinkles embedded in the spar cap. Fig. 8 shows three locations at 7.3 m, 9.3 m, and 9.8 m which have visible delamination growth with the increase of the fatigue cycle number. It is visual as the blade is not painted in these regions. It can be seen that the delamination regions at these three locations exhibit a similar belly shape at both sides of the embedded wrinkles. The center regions show maximum delamination growths as they are subject to higher cyclic strains due to the curvature of the spar cap in the transverse direction, i.e., meaning that the central regions are furthest away from the neutral axis of the cross sections when the blade is under flapwise fatigue loading. Different stages of delamination growth are marked with the increase of fatigue cycle numbers up to 38000 cycles under high-load fatigue. Note that the delamination at 8.3 m is not visible due to the paint for DIC measurements.

It should be mentioned that the delamination damage is observed from the blade surface. After the blade test, a post-mortem investigation is conducted by cutting the delaminated regions. It is found that the delamination has progressed not only along the blade length direction but also through the laminate thickness direction – meaning that there are multiple delamination cracks at different locations in the damaged regions. This damage phenomenon is similar to the observation found in a spar cap laminate of an in-service commercial blade studied in [6]. Delamination cracks interact with each other and compete for damage growth under fatigue loading. Modeling this complicated damage phenomenon requires extensive efforts using numerical approaches. A possible pathway is to first identify or assume initial crack location(s); second, calculate energy release rates at crack tips and corresponding growth rates; and then extend the crack length and/or add new cracks; after that, calculate energy release rates at new crack tips and eventually iterate the process until crack lengths exceed the predefined values or a failure occurs. In this work, we only focus on experimental investigations due to the scope of the study. The high-quality and well-documented experimental data can be used in a future numerical study.

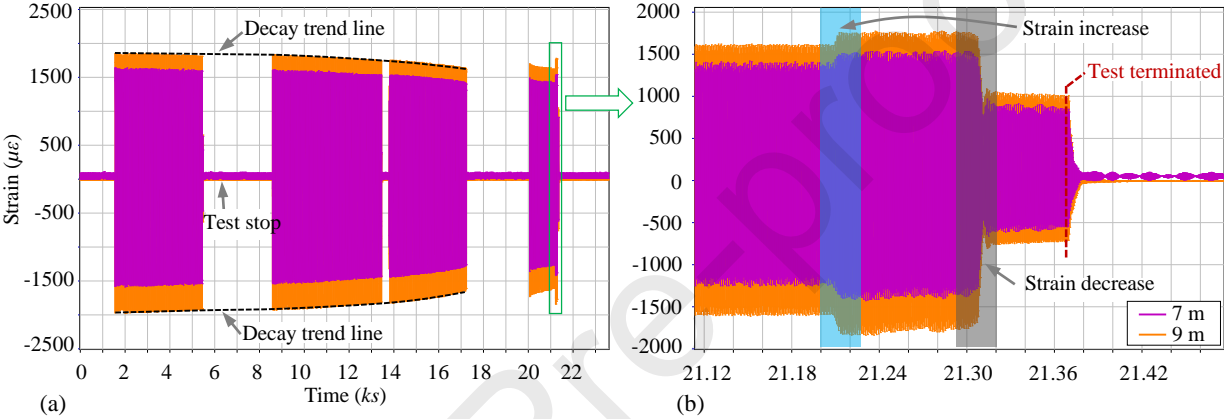
Figure 11

*Fig. 11. Time history records of strains on the pressure side of the spar caps at 7 m and 9 m section about 6 hours before terminating the flapwise fatigue loading. (a) The decay of the strain ranges is obvious with a test control strain at 9 m decreasing from 3800  $\mu\epsilon$  to about 3200  $\mu\epsilon$ . Multiple test stops are done to inspect the blade and they are also recorded in the strain measurements. (b) The close-up of the last part of strain records before the blade is fractured, showing that the strain ranges increase due to the change of the excitation frequency before they drastically decrease. During this process, significant tapping sounds are generated from the blade. The flapwise fatigue test is subsequently terminated.*

At the late stage of the flapwise fatigue test, it is found that strain ranges on the spar cap reduce gradually over time although fatigue test parameters are kept unchanged, see Fig. 11(a). Multiple test stops are carried out for inspection and no strain gauge malfunction is found. The strain range decay is thought to be caused by the change of dynamic properties, i.e., natural frequency and mode shape, of the blade due to the accumulated damage in the spar cap which is primarily responsible for providing bending stiffness to the blade under flapwise loading. Due to the change of the dynamic properties, the fatigue exciter does no longer excite the blade at its original resonant frequency which then decreases the cyclic strain ranges accordingly. This reasoning is justified by the observation that a slight decrease of the excitation frequency from the original 2.30 Hz to 2.22 Hz increases the cyclic strain ranges as shown in Fig. 11(b) from the time of about 21210 s. Continuing the fatigue loading afterward leads to a significant strain decrease and tapping sounds from the blade. The test is then terminated at 38000 cycles and the blade inspection is carried out subsequently.

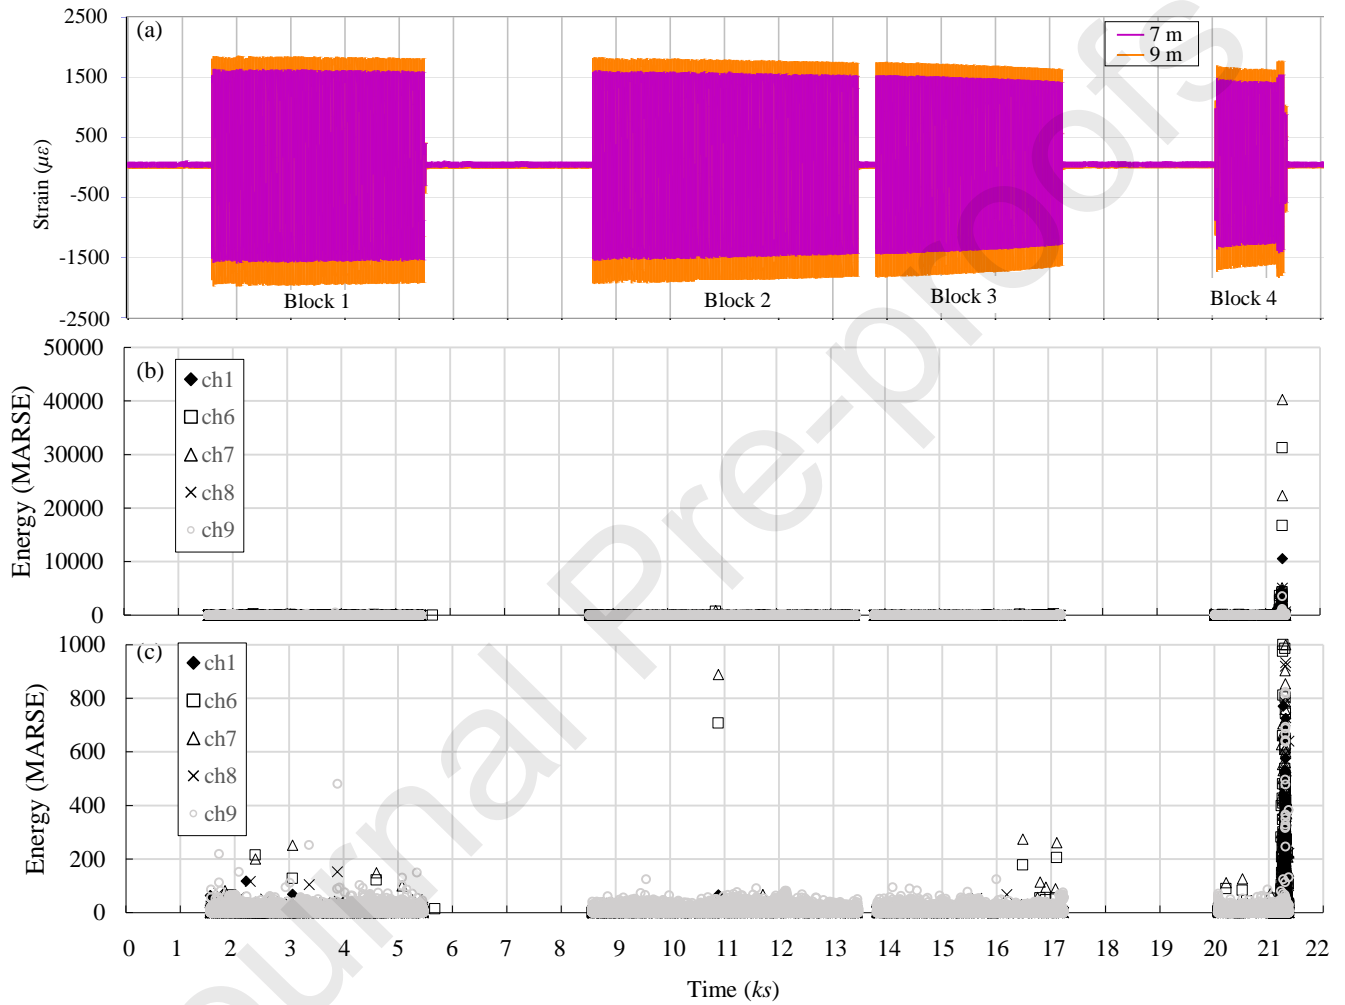
Figure 12

Acoustic emission is recorded throughout the fatigue test. Only the data of most interest are presented here due to a large number of measurements. Fig. 12 shows scatter plots of AE energy aligned with strain gauge measurements. There are four blocks of data separated by three test stops for blade inspection before the final failure of the blade. The AE energy measurements show that high energy activities occur in Block 1 when the strain range decay starts to appear during the fatigue test, indicating considerable damage builds up in the blade. High energy activities continue to occur in Block 2 and 3 in channel #6 and #7, see Figure 1, which indicates material damage around 8.3 m. Visual inspection has been conducted during the test stops and no damage is found in the trailing edge debond TD#2. At the end of Block 4, a boom of AE energy activities is recorded with very high values in all channels before the test is terminated.

*Fig. 12. Scatter plots of AE energy show detected activities before the blade failure with four blocks of activities matching the strain gauge trace. (a) Time history records of strains at 7 m and 9 m section. (b) The overview of AE energy shows a dramatic increase of AE activities right after 21000 s particularly in channel #1, #6 and #7. (c) A close-up zoom view of (b) with AE energy below 1000 MARSE shows that high energy activities occur in Block 1 when the strain range decay starts to appear. Two high energy activities occur in Block 2 in channel #6*

and #7, respectively. High energy activities occur at the end of Block 3 where the strain range decay is significant before the blade fails in Block 4 where a boom of AE energy activities is recorded.

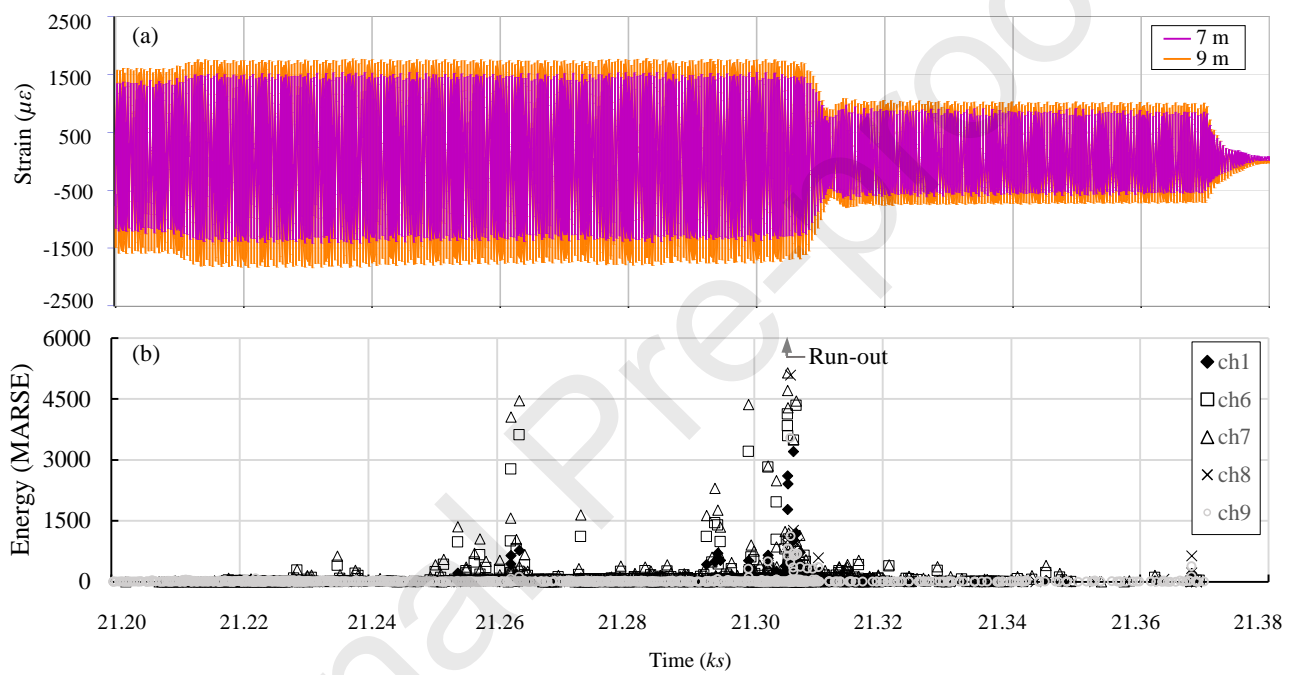
Figure 13

A detailed look at the data in Block 4 shows interesting features, see Fig. 13. The AE energy record shows two separate groups of peaks at about 21260 s and 21300 s in ch #1, #6 and #7. Most of the energy peaks are recorded within one minute from 21250 s to 21310 s. The imminent failure of the 8.3 m location can be indicated by the first AE energy peak at 21260 s although no change of strain levels is observed. A significant strain decrease is observed right after the second peak of drastic AE energy as a result of a critical structural failure of the blade.

*Fig. 13 Scatter plots of AE energy within Block 4 around the time when the blade fails. (a) Strain time history records at 7 m and 9 m section from 21200 to 21380 s. (b) The AE energy record shows two separate groups peaks at about 21260 s and 21300 s in ch #1, #6 and #7. Note that no change is observed in the strain record when the first peak occurs. A significant strain decrease is observed right after the second peak of drastic AE energy occurs followed by the failure of the blade in its spar cap.*

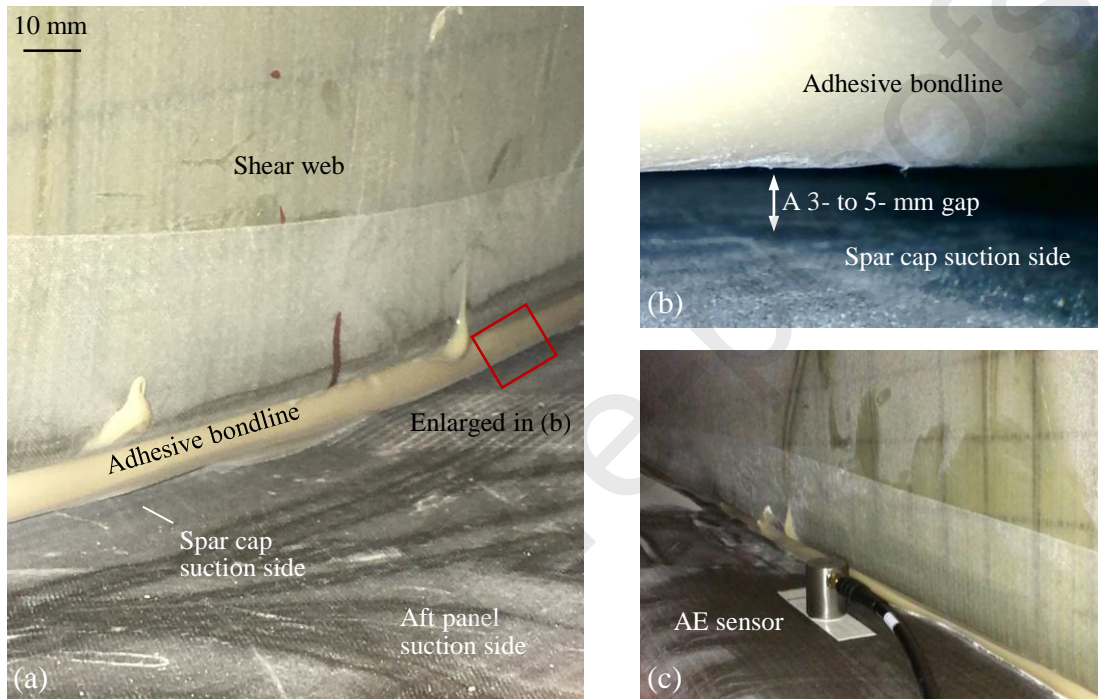
Figure 14

Note that channel #8 and #9 have been active during the fatigue test but they only generate low AE energy per hit with average values of 9.5 and 6.7 MARSE/hit, respectively. In comparison, ch #1, #6 and #7 generate 215.8, 37.0, and 150.5 MARSE/hit, respectively. Visual inspection reveals that the low AE energy activities in ch #8 and #9 are caused by the tapping, or cyclic contact, between the shear web and the spar cap on the blade suction side shell due to the adhesive joint debond when the blade is under fatigue, see Fig. 14 and Supplementary video S1.

*Fig. 14. Manufacturing-induced debonds between the shear web and the spar cap at the suction side of the blade. The initial debond is approximately 65cm long and starts 0.5 m from the shear web end, i.e., the debond spans from 1.00 m to 1.65 m along the blade axis. (a) An overview of the adhesive bondline between the shear web and the spar cap. (b) The debond region where a 3- to 5- mm gap exists. (c) An acoustic emission sensor ch #8 is installed close to the crack tip at a 1.65 m blade spanwise location.*

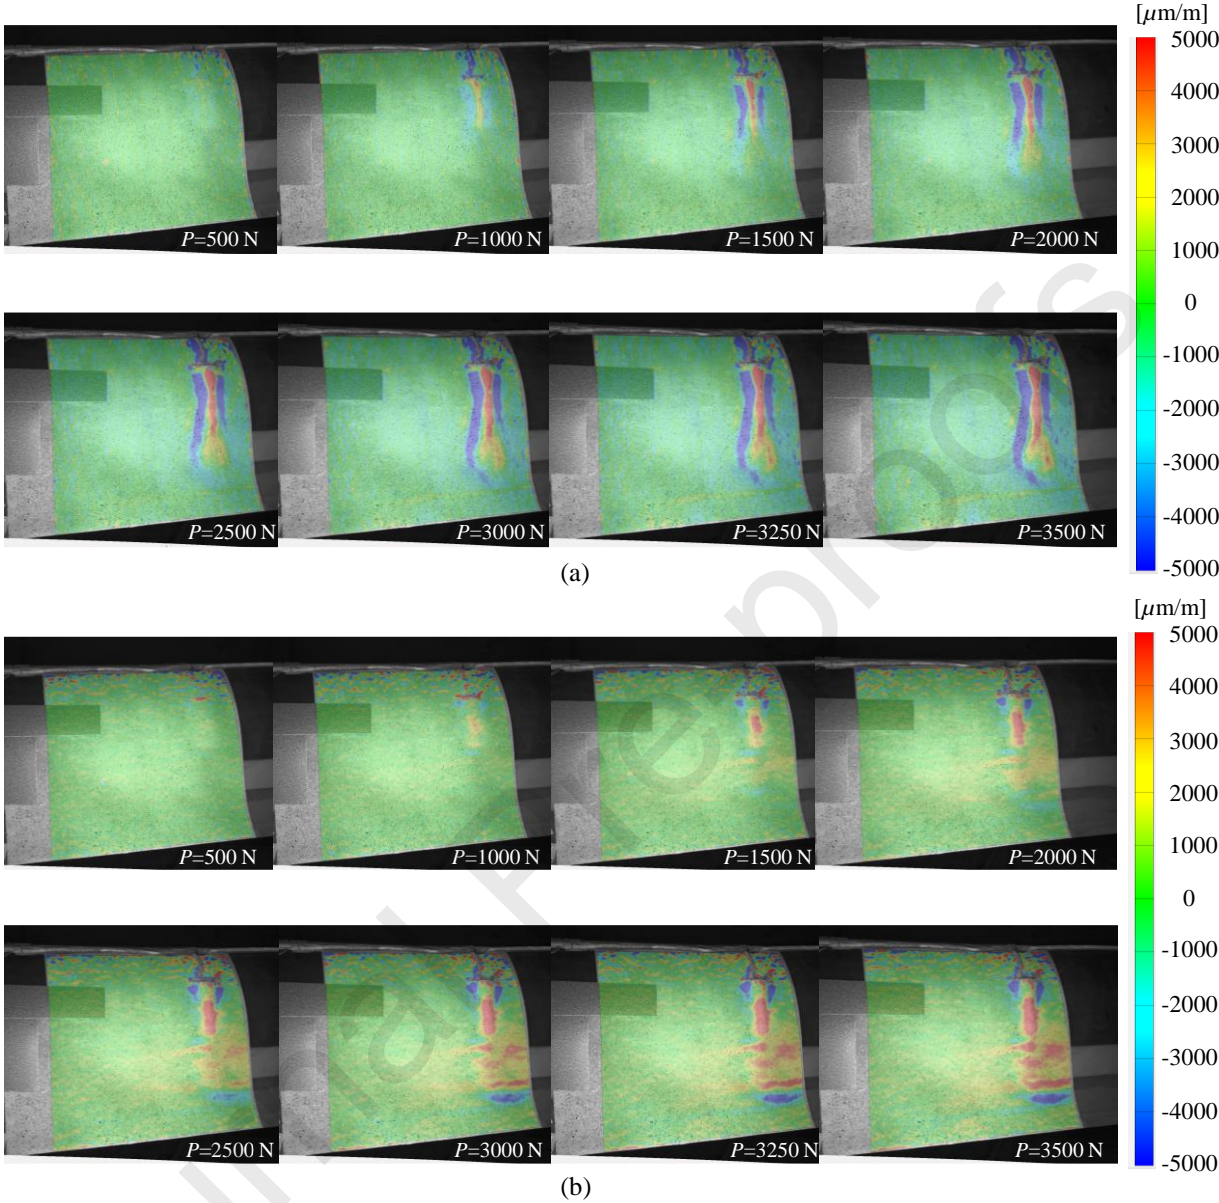
Figure 15

In order to investigate what happened underneath the painted spar cap region at 8.3 m, DIC measurements are carried out. First, it is decided to do DIC measurements under static loading due to a concern of structural collapse under fatigue loading; second, the loading saddle is removed so that the blade has a simple boundary condition as a cantilever beam fixed at the root on the test stand; and then, a static load is applied at the 13 m cross section using a crane that pulls the blade upward. The DIC system measures longitudinal strains along the blade axis direction and transverse strain along the chordwise direction. The DIC measurement results are shown in Fig. 15.

It can be seen that starting from a static load of around 1000 N, the region with the embedded wrinkle WK#2 shows a buckle wave in the spar cap, which is indicated by both compressive longitudinal strains shown in blue and tensile longitudinal strains shown in red in Fig. 15(a). In addition, the discontinuity of strain contour at the top of the wrinkle region indicates a surface crack there. Note that the buckle covers beyond the spar cap, meaning that the damage has propagated into sandwich panels adjacent to the spar cap.

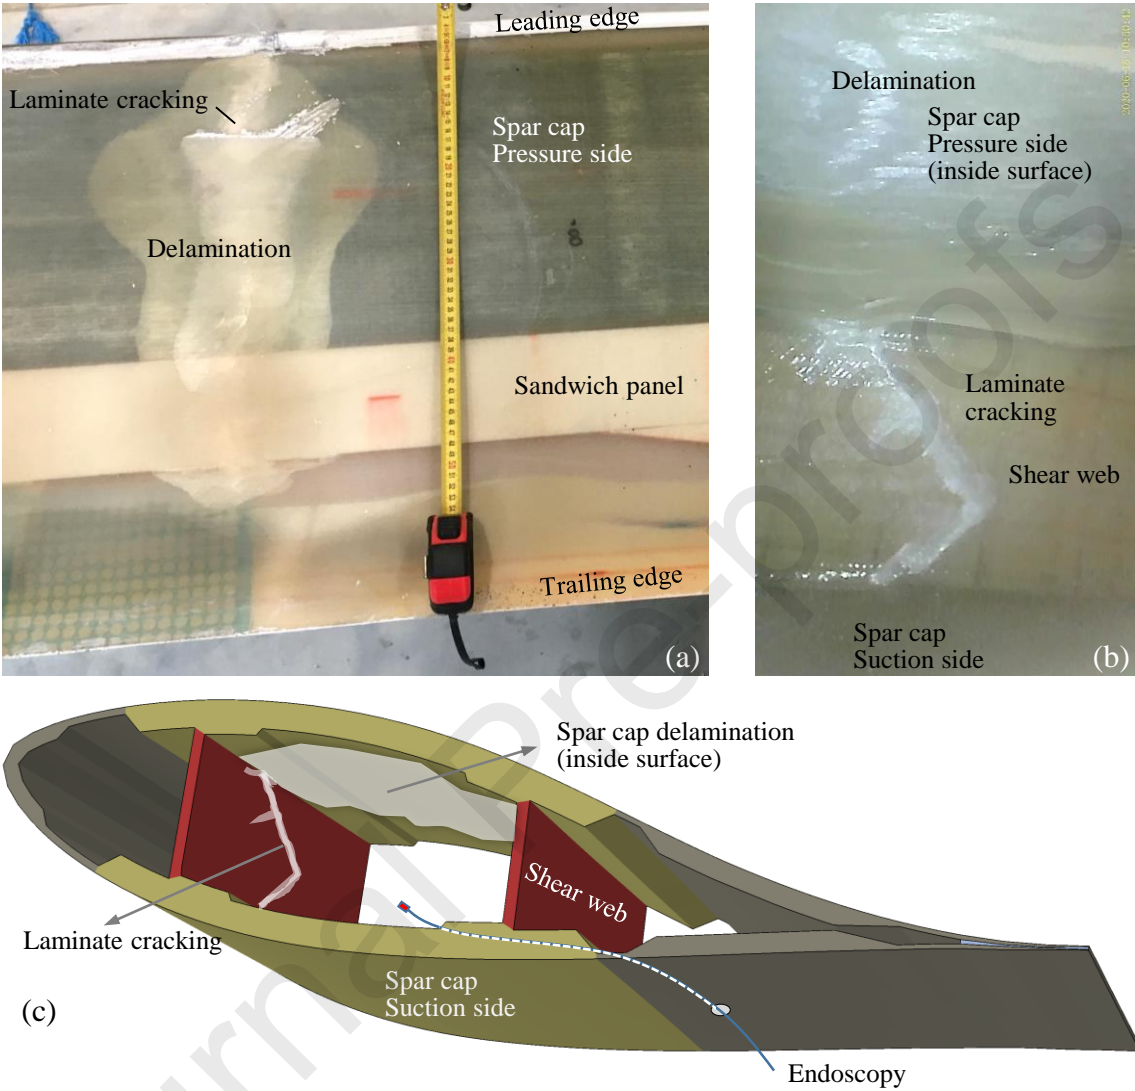
Figure 16

To verify the findings from the DIC measurements, the paint is removed and the delamination damage at this location is now visible, see Fig. 16(a). Indeed, the spar cap laminate is significantly damaged by delamination as well as surface cracking. The delamination exists not only in the spar cap but also in the sandwich panels. An endoscope (Teslong TSMS450D8L5 with dual lens) is used to inspect the internal damage of this cross section as shown in Fig. 16 (b). It is shown that the delamination of the inside surface of the spar cap as well as laminate cracking in the shear web. Fig. 16 (c) summarized the internal damage found by the endoscope.

*Fig. 16. Fatigue failure at the 8.3m section due to an embedded wrinkle in the spar cap laminate. The observation is made after removing the paint with speckle patterns. (a) Delamination and laminate cracking at the spar cap viewed from the outside surface. (b) Delamination of the spar cap and laminate cracking of the shear web with a view taken from the inside. (c) A schematic illustration of internal damage inspection using an endoscopy through a hole drilled in the aft sandwich panel and the rear shear web.*

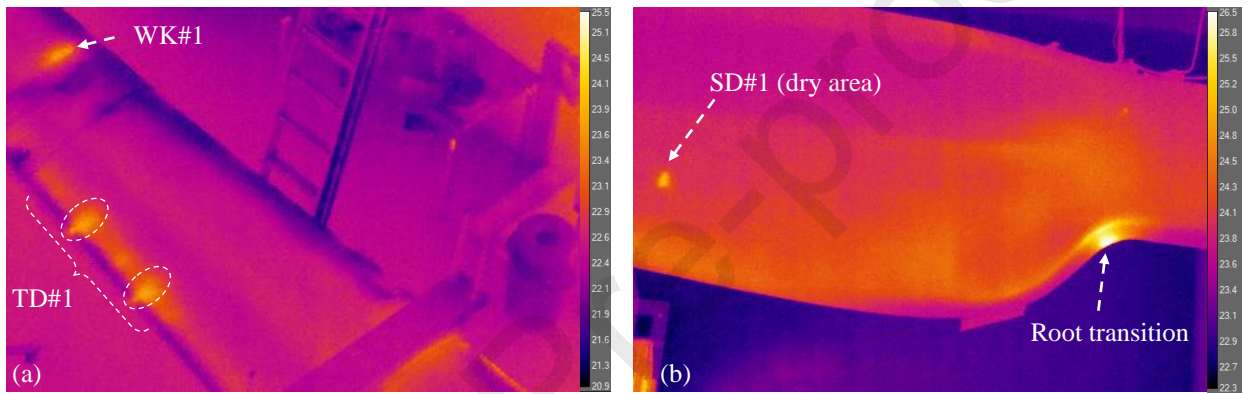
Figure 17

*Fig. 17. Thermal footprints of damages when the blade is subject to edgewise fatigue loading. (a) Thermal footprints of a wrinkle WK#1 and a trailing edge adhesive debond TD#1. Note that the length of the debond region is longer than the distance between two hot spots marked with cycles within the debond region. (b) Significant thermal abnormality is observed in the dry area of the sandwich debonding SD#1 and in the root transition region. All images are taken when the blade is under fatigue loading.*

After the flapwise fatigue test, the spar cap on the pressure side of the blade has significant delamination damages around the 8.3 m location. Before starting the edgewise fatigue test, tapered scarf repair with wet layup techniques was carried out, see Supplementary material. Thermal images of the blade under edgewise fatigue loading are shown in Fig. 17. The thermal footprint of the wrinkle WK#1 can be seen from Fig. 17(a) although it is not as significant as it was when the blade is under flapwise fatigue. Remarkably, two hot spots are observed *within* the trailing edge debond region TD#1, which will be further examined in the next section. The inboard region of the blade shows thermal footprints of dry areas of skin laminates in the sandwich debond SD#1 as well as the root transition region due to stress concentration, see Fig. 17(b).

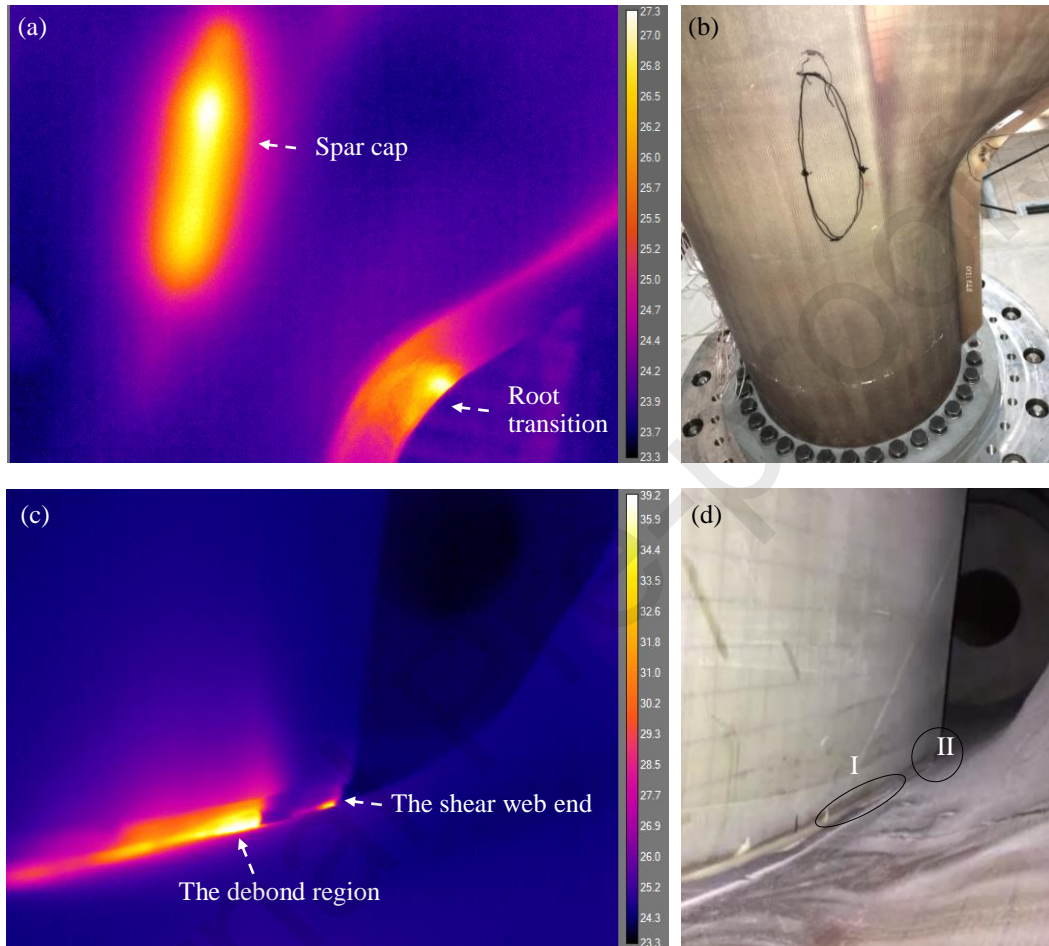
Figure 18

A few close-up thermal images are taken. Fig. 18(a) shows the thermal features in the inboard region where significant heat up in the suction side spar cap and the root transition region is observed. Visual inspection of these two regions as shown in Fig. 18(b) finds delamination in the root transition region but no damage in the spar cap. It is then decided to take a thermal image from the inside of the blade as shown in Fig. 18(c). It is found out that the thermal feature observed from the spar cap is caused by the thermal activities at the debond in the adhesive bondline between the rear shear web and the suction side spar cap. The thermal activities are due to material rubbing and abrasion in the debond region as shown in Fig. 19. The heat generated in the debonding is so substantial with a detected maximum temperature of 39 °C in comparison to a surrounding temperature of about 25 °C that it can be detected from the outside of the blade in the spar cap. This finding shows that it is possible to detect adhesive joint debond underneath the thick spar cap laminate in full-scale blade using thermography without using external heating sources, leading to a new opportunity of using thermography to detect such damages in wind turbine blades while they are in operation.

*Fig. 18. Thermal footprints of the shear web debond and the root transition region when the blade is subject to edgewise fatigue loading. (a) A thermal image taken from the suction side of the blade close to the blade root shows two heated regions. One region is the root transition region and the other is the suction side spar cap. (b) An image taken by a regular RGB camera shows two regions with thermal abnormalities. Delamination is found in the root transition region but no damage is found in the suction side spar cap. (c) A thermal image taken inside of the blade shows significant heat-up regions in the adhesive joint between the rear shear web and the suction side spar cap. (d) An RGB camera image shows the bondline under concern. Significant tapping and*

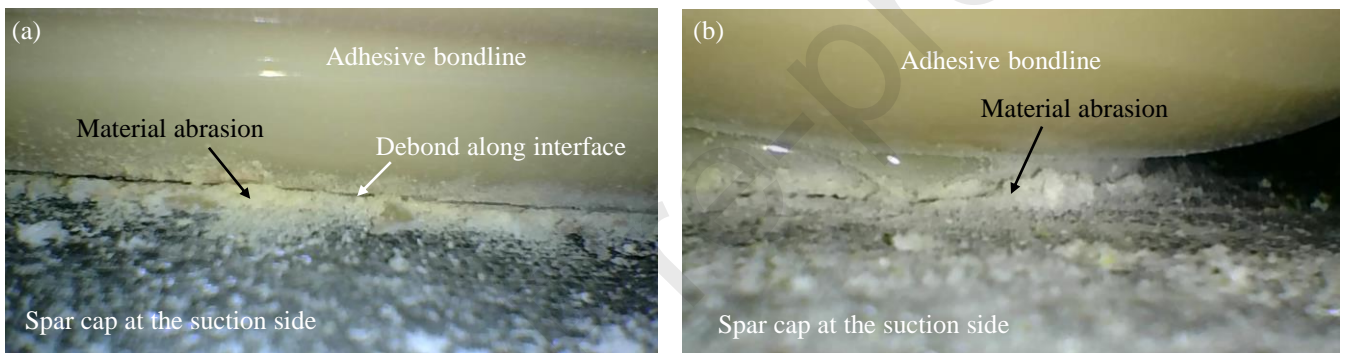
Figure 19

*Fig. 19. Significant material abrasion is found in the thermal heat-up locations in the adhesive bondline. (a) This image shows location I as indicated in Fig. 18(d). (b) Location II, i.e., the shear web end, as indicated in Fig. 18(d). The images are taken using the endoscope when the cracks are most visible during fatigue loading.*

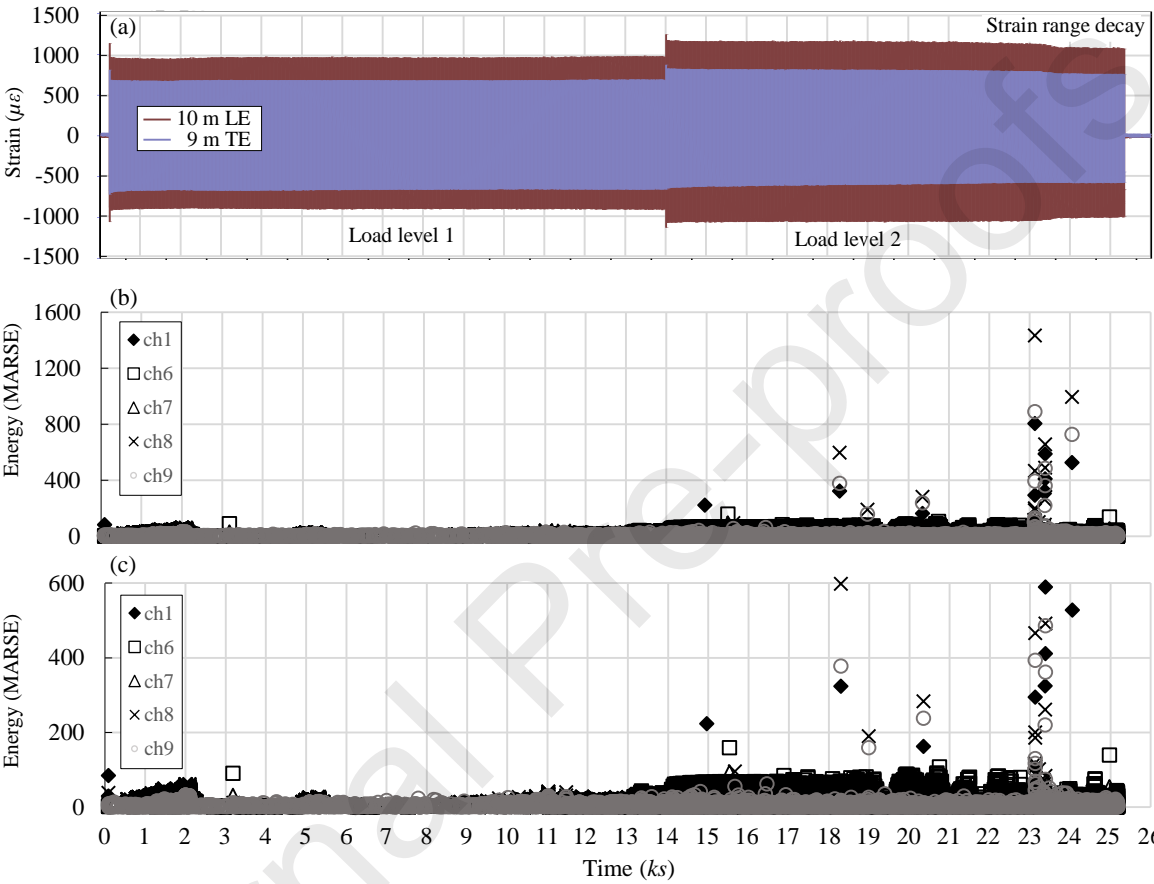
Figure 23

*Fig. 23. Scatter plots of AE energy show detected activities during the edgewise fatigue loading with two loading levels matching the strain gauge trace. (a) Time history records of strains at 9 m trailing edge (TE) and 10 m leading edge (LE). A high load level loading starts at 14000 s and a strain range decay starts around 23000 s. (b) The overview of AE energy shows considerable AE activities under a high load level particularly in channel #1, #8 and #9. The boom of AE energy activities occurs when the strain range decay starts to appear. (c) A close-up zoom view of (b) with AE energy activities below 600 MARSE.*
