## The STRYDE limb lengthening nail is susceptible to mechanically assisted crevice corrosion: an analysis of 23 retrieved implants

*Published in:*  
Acta Orthopaedica

*Publication date:*  
2021

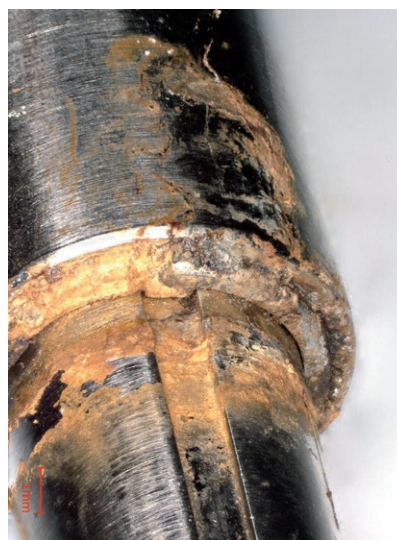
Figure 4. Digital microscopy of the junctional discoloration, i.e., corrosion products.

2 surgeons observed “oozing” of a brown substance from the telescopic nail junction during hardware removal in addition to the observation of junctional discoloration (Figure 4).

Macroscopic inspection and photo documentation revealed discoloration at the telescoping junction in 20/23 implants (Figure 4) and 20/23 had corrosion at the locking screw holes

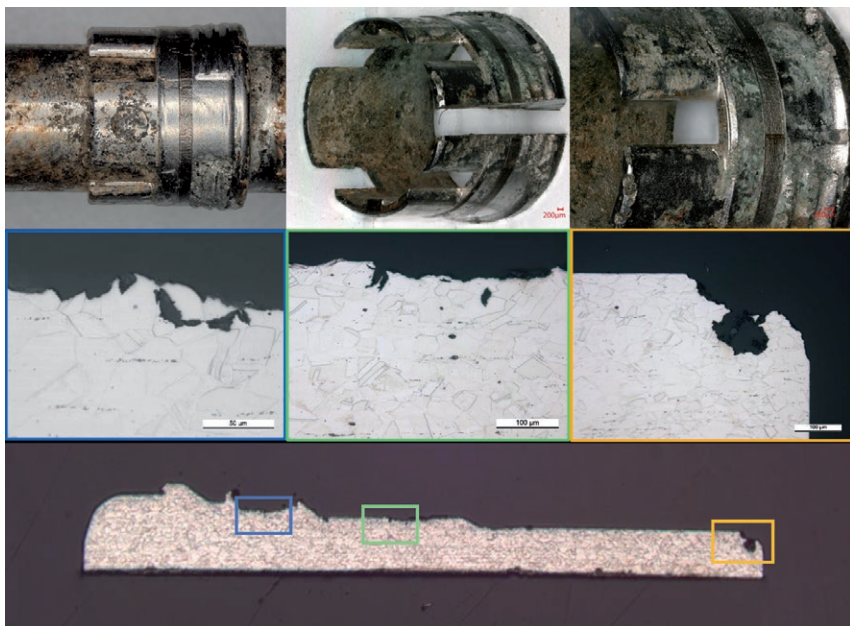
Figure 9. Corrosion attack at the bushing/crown. Digital microscopy (upper panels) and microscopy of the microstructure (middle and lower panels).

Microscopic inspection verified the mechanical damage and local corrosion of the microstructure both at the bushing (Figure 9) and at the screw and screw holes (Figure 10).

A possible explanation for corrosion near the telescopic junction is that corrosion initiates at the interfaces of the bushing where small-amplitude movements can produce disruption of the passive film causing metal degradation and crevice formation. As the environment in the crevice becomes more aggressive it leads to further degradation of the bushing and other parts of the telescopic junction.

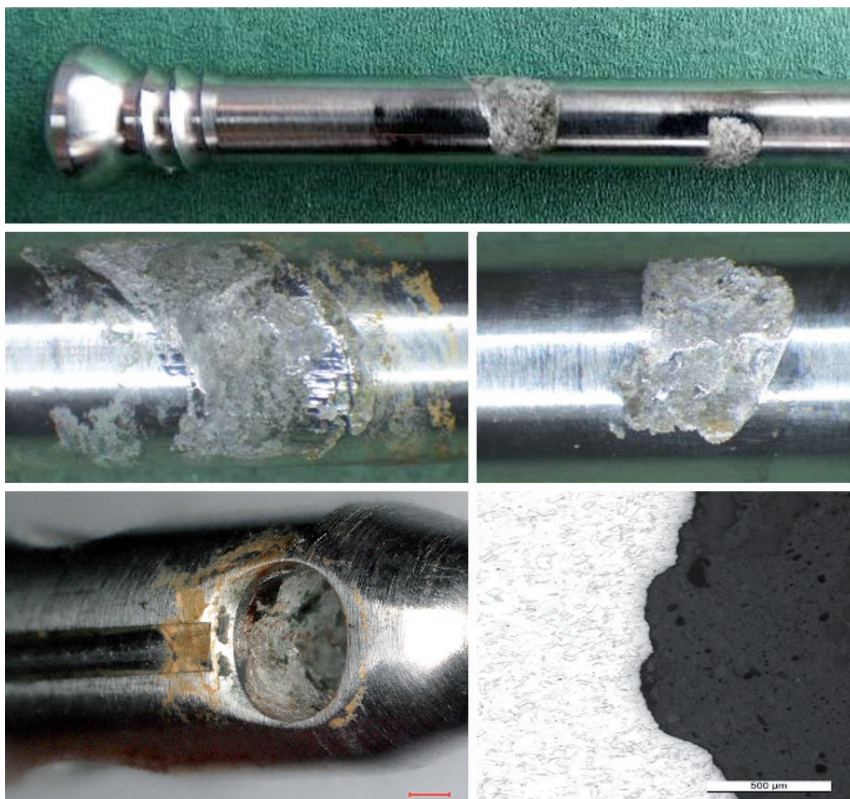
Figure 10. Mechanically assisted crevice corrosion/fretting and crevice corrosion at a locking screw, screw hole including microscopic image of the corrosion-attacked microstructure. For SEM imaging see Figures 12 and 13 in Supplementary data.

Mechanically assisted crevice corrosion may also explain the material degradation inside the screw holes. Weight-bearing may initiate this process by causing small-amplitude movements between the screw and screw hole, initiating fretting. Subsequently, a larger crevice is formed where the distraction rod inside the screw hole is attacked due to increased aggressivity of the environment inside the crevice between screw and screw hole. Moreover, galvanic corrosion could be ruled out, because the housing, bushing, and screw were made from the same metal, i.e., Biodur 108.
