## Decisive parameters for moisture safe internal insulation of masonry – Long time monitoring in inhabited dwellings

*Published in:*  
Energy and Buildings

*Publication date:*  
2024

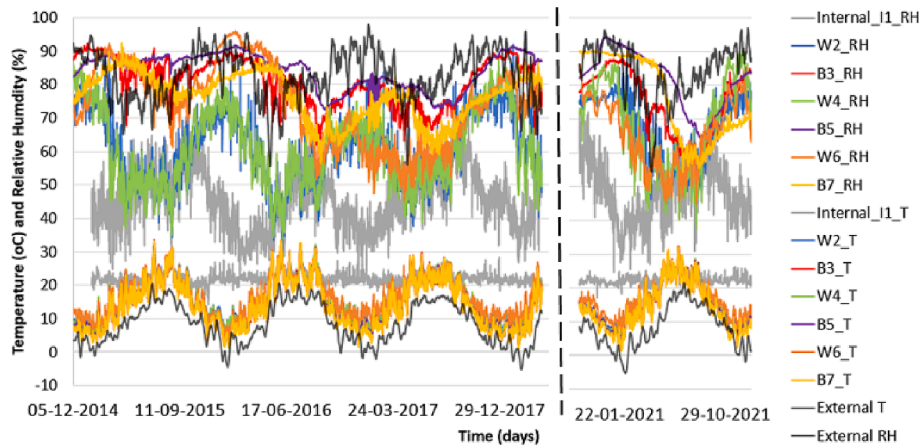
Fig. 4. Case M: Measured relative humidity and temperature in S (B3, W2) and SW (B5, B7, W4, W6) facade. Grey lines: indoor (sensor I1). Black lines: external weather conditions, obtained from DMI (Danish Meteorological Institute).

Fig. 4 show the relative humidity and temperature measurements for case M for two time periods (2014–2018 before hydrophobization and 2020–2022 after hydrophobization) as hourly averages generated from minutely data. The external climate (T and RH) is running averages every two weeks for better readability. There is a gap of 2.5 years with no measurements. Prior to hydrophobization, sensors W2 and W4 (S oriented in the intersection) barely recorded relative humidity levels above 80 %, in contrast to W6 (SW oriented in the intersection), which peaked at 95 % during the second winter after insulation. The lowest humidity level at the beam ends was recorded in the post-hydrophobization period from July through September. The sensor at the interfaces with the highest relative humidity after hydrophobization was W4. Relative humidity is typically observed to be higher during the second measuring period compared to the first.

Except sensor W6, which had a 2–3 °C rise in winter temperature during the first three months after hydrophobization, all sensors’ values for the temperature conditions in both periods are very similar and exhibit typical seasonal variation. In all cases, the temperature at the wall interface is higher than the beam ends, despite the thermal bridge. After hydrophobization, the interior temperature (sensor I1) gradually rises over the course of the year (by max. 4 °C). The external climate data (both T and RH) seem to follow the normal seasonal fluctuations. The humidity class of this case is calculated to be class 2 (dwellings with normal occupancy and ventilation).

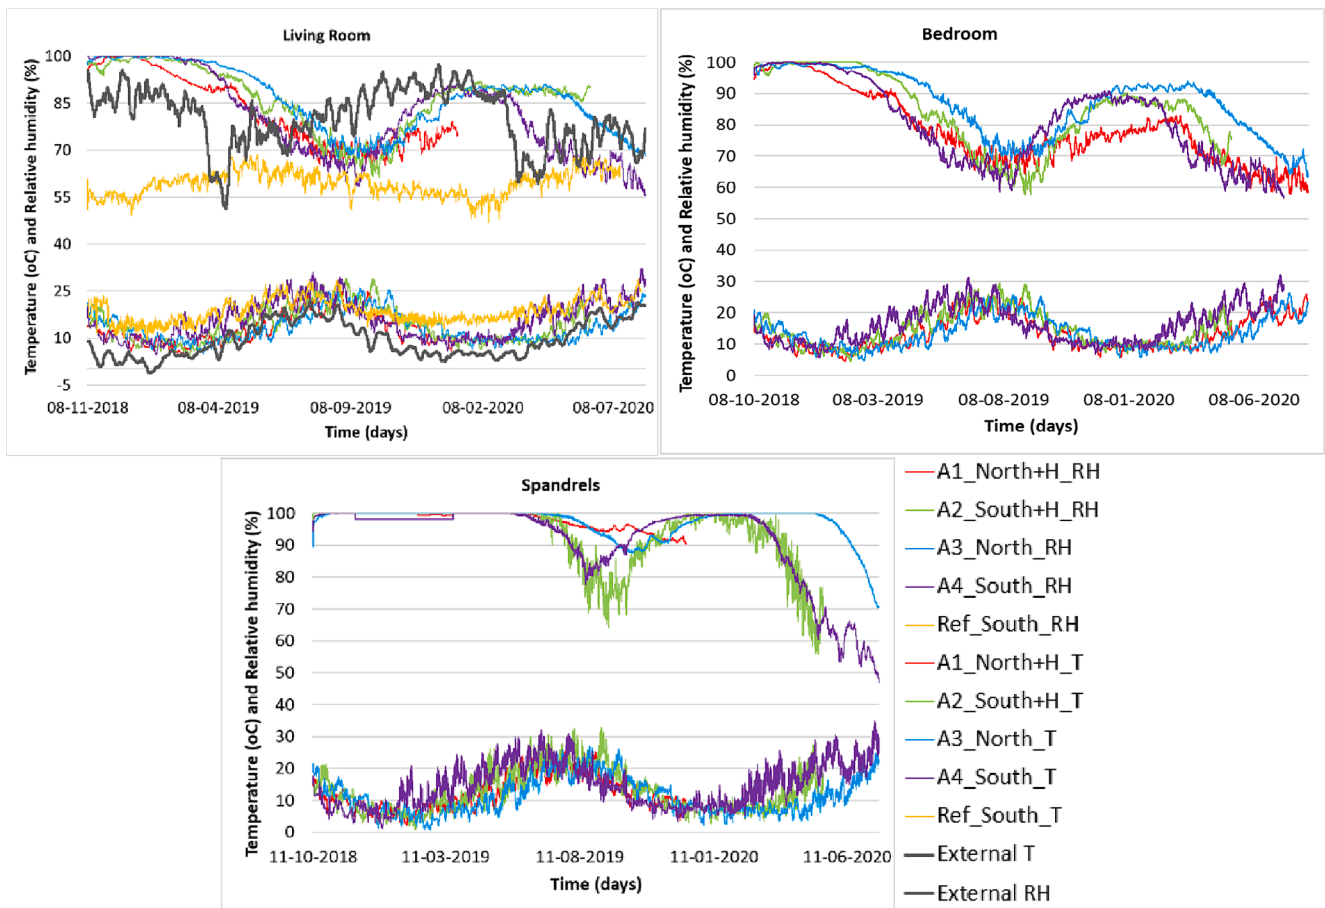
Fig. 5. Case B: Measurement data from a) living room + external climate (black lines), obtained from DMI (Danish Meteorological Institute), b) bedroom and c) spandrels for all four apartments.

Fig. 5 displays the results of the measurements for relative humidity and temperature in the intersection between the original wall and the insulation for the living room, bedroom, and spandrels of case B. The

drying out period had various offsets, since the systems were not installed simultaneously [32]. Additionally, since the (yellow) sensor is mounted on the living room wall, these measurements should be regarded as interior climate measurements (Ref. = Indoor climate). Some measurements stopped earlier than others due to sensor malfunction. The external climate (T and RH) is running averages every two weeks for better readability. Winter 2019–2020 showed relative humidity up to 100 %. A1 sensors (north, hydrophobized) in the bedroom and living room showed the lowest relative humidity, whereas A3

sensors (north, non-hydrophobized) in the living room and bedroom consistently displayed the highest relative humidity. Relative humidity in all wall sensors generally drops after the first few months to 90 % the following winter.

Spandrels appear to be an exception, as the minimum relative humidity during warm months was approximately 70 % and the maximum was 100 % for the first nine months. Additionally, A2 sensors (south, hydrophobized) at the spandrels displayed significantly larger relative humidity fluctuations. The external climate data (both T and RH) seem

Case B, is the only case where there are measurements from the spandrels, where the wall thickness is smaller. In that case, the spandrels' exceptionally high relative humidity may be caused by a combination of the thick insulation, which decreases the wall's temperature, and the thinner wall, which increases the risk of water penetration. Thus, the moisture risk in the spandrels is higher than in the regular walls. The results demonstrate that the mold risk is relatively high in the spandrels, and, therefore, they cannot be characterized as moisture-safe.

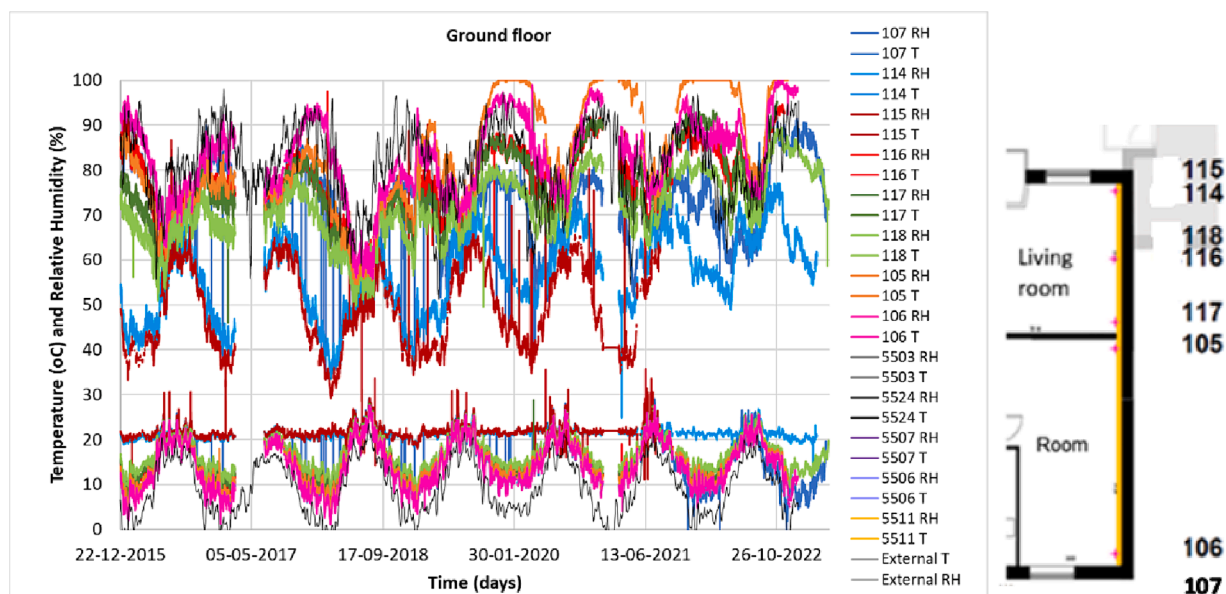
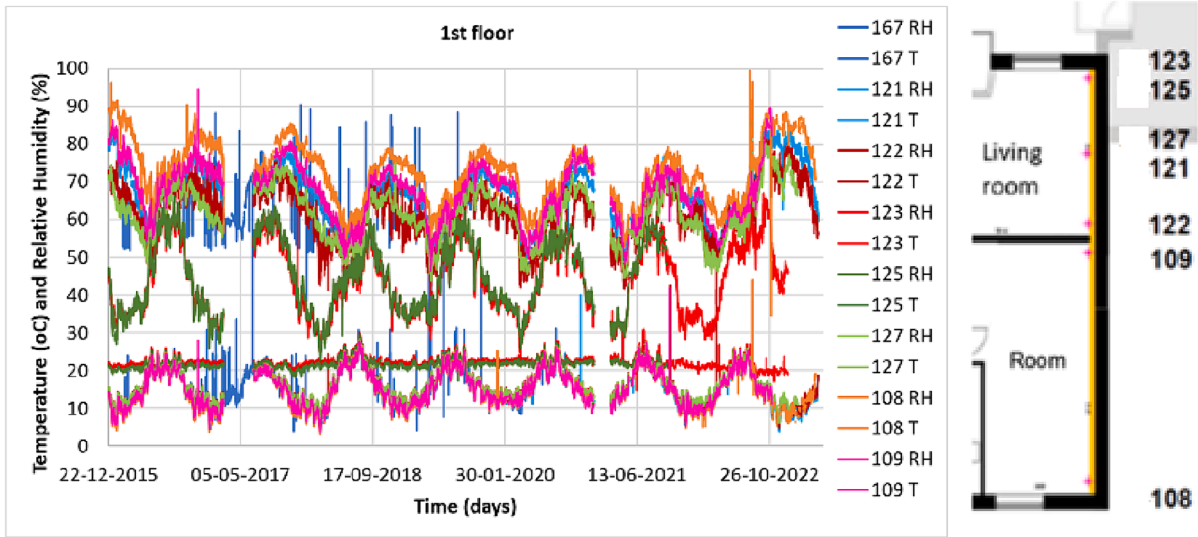
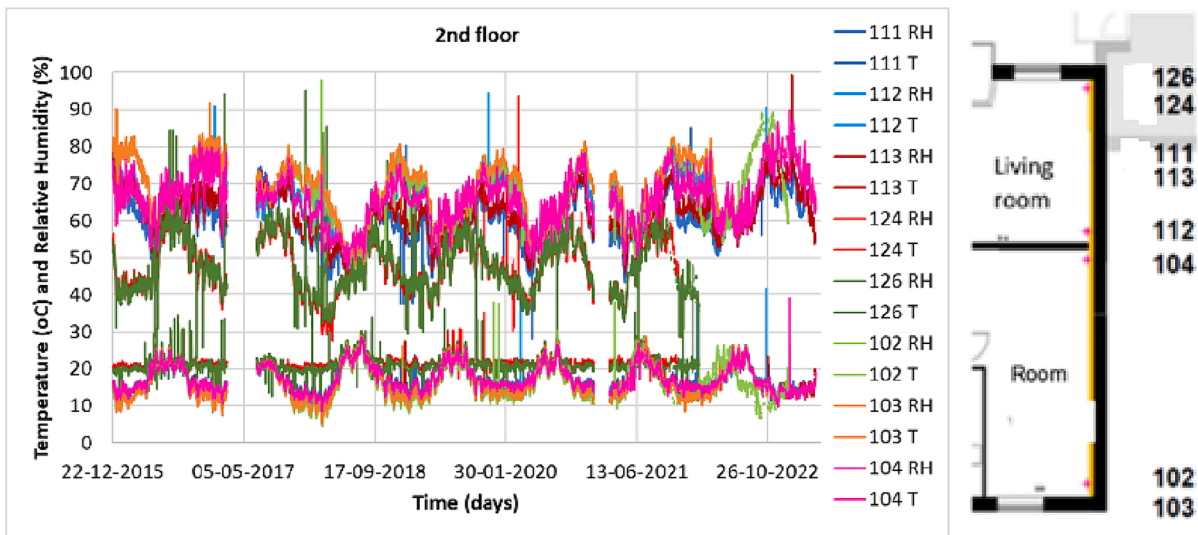
Fig. 6, Fig. 7 and Fig. 8 display the measurement results for case D. The measurements were interrupted for three months in 2017 because of sensor malfunction [24]. The wall is regarded as internal in the places where the gable is joined to the neighboring building; therefore, the sensors there roughly measured the indoor climate conditions (sensors 115, 114, 123, 125, 126 and 124), as presented in the graphs [24]. However, there were dedicated sensors (5503, 5524, 5507, 5506 and 5511) for measuring the indoor climate, but these sensors measured only for the period March 1016–July 2017 (see Fig. 6). The external climate (T and RH) is running averages every two weeks for better readability. The measurements in the interface between insulation and the existing wall were generally lower than 80 %. Measurements taken from the ground floor differed from those above; in the eastern bedroom, sensors 105 and 106 displayed higher values than those taken from the other measuring points. This increasing tendency started at winter 2019 and continued until 2022 when the measurements stopped. Relative humidity in the interface was above 90 % at this time, and one sensor (105) reached 100 % every winter before it decreased during spring times. These sensors' temperature measurements also indicated lower temperatures; in particular, sensor 106 showed a reduction in temperature up to 5 °C during the colder months. Additionally, relative humidity in the ground floor apartment seems to be higher from the beginning and keeps rising over the years while 1st and 2nd floor's RH stayed lower and only the last 1–2 years started to increase. The external climate data (both T and RH) seem to follow the normal seasonal fluctuations. The humidity class of this case is calculated to be class 2 (dwellings with normal occupancy and ventilation).

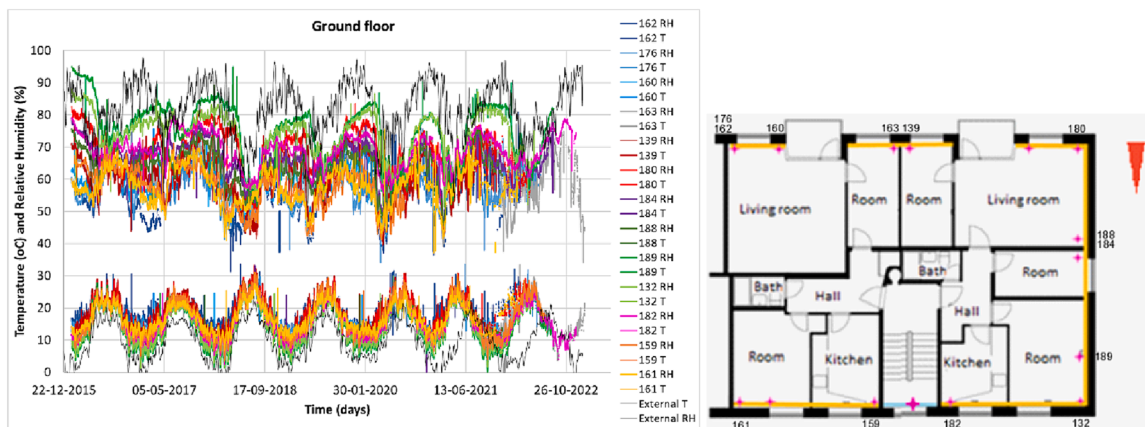
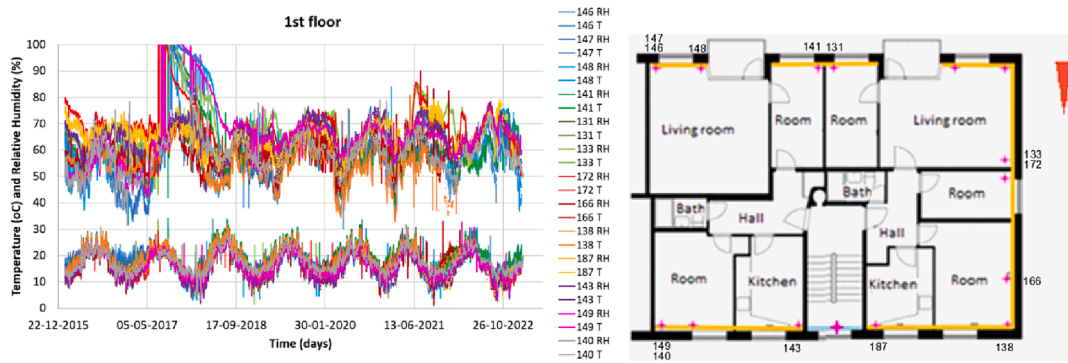
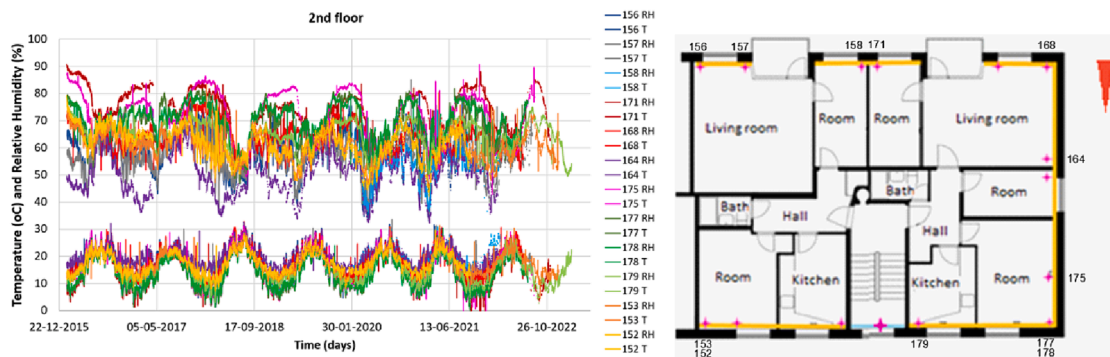
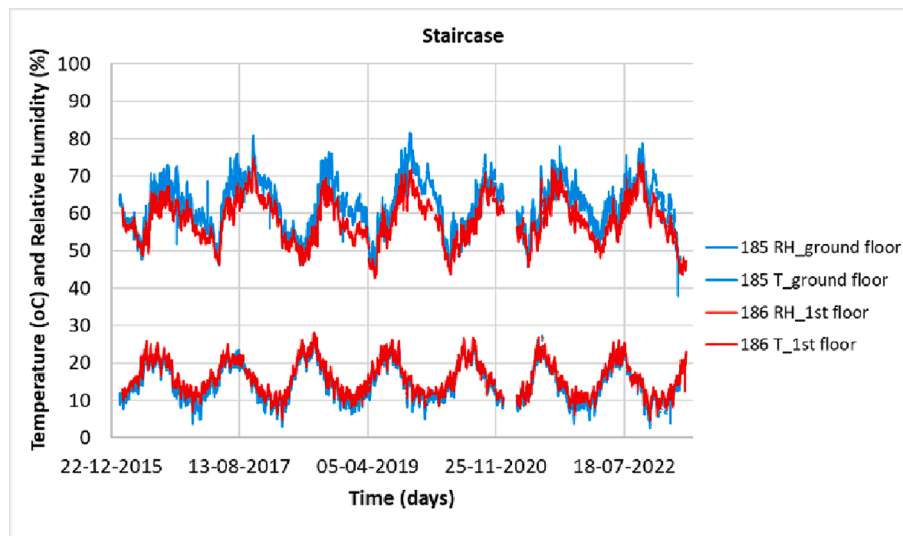
The hygrothermal measurements of case F are presented in Fig. 9, Fig. 10, Fig. 11, and Fig. 12. There are separate graphs for each floor and the staircase results. Some sensors stopped functioning after a short period, leaving 48 active sensors. In this case, there are no indoor climate sensors for measuring the indoor climate conditions. The insulation in the first-floor apartments was removed and re-established during summer 2017. As a result, measurements showed a sharp rise

in relative humidity due to the wet adhesive mortar; thus the peaks in the graphs are disregarded and not further commented on. The external climate (T and RH) is running averages every two weeks for better readability.

On the ground floor, sensor 132 and 189, which displayed up to 85 % RH during the winter, are the sensors with the highest relative humidity values. On the 1st floor, sensors 133 and 172 displayed relative humidity values up to 85 % and slightly lower temperatures during winter 2021. However, for the remaining time, these measurements resembled the measurements of the other sensors. The seasonal variation on the 1st floor was similar to the ground floor. On the 2nd floor, sensors 177 and 178 diverge, reaching 80 % RH during winter periods. These sensors also measured lower temperatures. Sensors 171 showed up to 85 % RH in the first winters, and gradually increases over the next winters above 80 %. The deviation could be explained by the lower temperature measured in this sensor. Living room sensor 164 registers an expected seasonal range of 35–70 % RH and a minimum temperature of 15 °C. On the contrary, sensor 175 peaks at 85 %. However, during summer, the relative humidity falls below 70 %.

In the staircase (north facing), measurements have been made in the interface on the ground and 1st floor. The results revealed similar findings for the two floors. Relative humidity is shown to be higher in the ground floor sensor than the 1st floor, while temperature is the opposite. The external climate data (both T and RH) seem to follow the normal seasonal fluctuations. The humidity class of this case is calculated to be class 2 (offices, dwellings with normal occupancy and ventilation), with the staircase being class 1 (unoccupied buildings, storage of dry goods).

In Case F, the relative humidity at sensor 132 and 189 (ground floor) peaked during winter at 85 % RH, so they deviate from the other data. Additionally, this sensor registers lower temperatures, which results in higher relative humidity. The bedroom's corner, which is next to the gable, registers relatively low temperature. However, the results demonstrate that the conditions at the interface are influenced by user behavior and the interior climate, as the sensor on the 1st floor in the same place registers higher temperature and lower relative humidity.

ground floor registers somewhat higher relative humidity and slightly lower temperatures. However, that sensor was closer to the front door, which often opens during the day, fact that explains this.

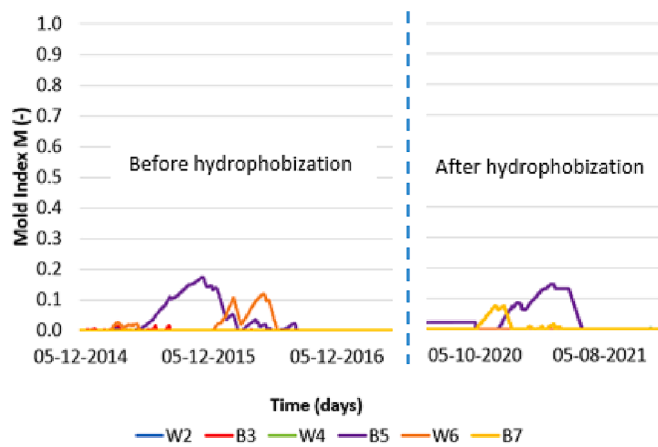
Fig. 13. Mold Index of case M, for interface and beam ends sensors as a function of time.

Fig. 13 displays the risk of mold growth for Case M. Both measuring times—before and after hydrophobization—are shown in the graph. The mold growth index was practically zero and consistently below 1 in both periods. Only sensors B5 and W6 showed some mold growth initiation for the observed values prior to hydrophobization, although they never reached Mold Index 1. For sensors B5 and B7, the mold growth initiates during the post-hydrophobization phase. Furthermore, for all 3 sensors (W6, B5, and B7), the mold index, which had initially been somewhat above zero, quickly decreased to zero. In measurements made before hydrophobization, the Mold Index was found above zero both in the interface and the beam ends, however, after hydrophobization, this was

only found at the beam ends.

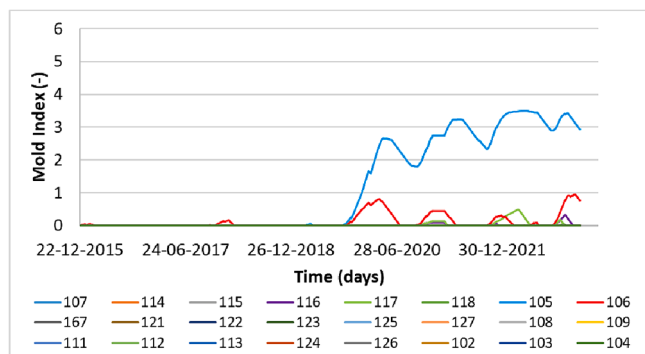
Fig. 15. Mold index of case D of all sensors as a function of time.

Fig. 15 presents the mold growth risk for case D. Winter 2019 was the first time when mold risk appeared specifically on the 1st floor. Two bedroom sensors, showed values above zero; sensor 105 displayed the

maximum Mold Index of 3.5, while sensor 106 gave a value of less than 1. The assessed mold risk was practically equivalent to 0 for the other locations.

Except for the room on the ground floor, the mold model predicted no mold growth risk behind the insulation. This one sensor that recorded 100 % relative humidity during the most recent winter season reached a Mold Index of 3.5 before decreasing along with the relative humidity. This high moisture level can only be explained by a high interior moisture load during the last period of the measurements, when residents' behavior might have changed, e.g. very low ventilation rates or/and high moisture production.

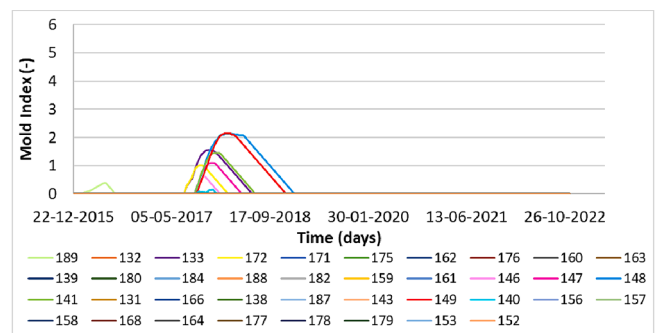
Fig. 16. Mold index of case F as a function of time.

Fig. 16 shows the mold growth risk for case F. As a result of the re-installation of the insulation, there was initial built-in moisture, and several sensors indicated risk of mold growth with a maximum of almost 2, but it rapidly decreased. In the remaining time, sensors displayed lower mold index values with no risk of mold initiation.

In case F, despite the relatively high relative humidity measured, there is no increased risk for mold growth. None of the measurements achieved mold index higher than 2. Furthermore, the two locations with the highest mold index, reached these values only because of the built-in moisture (re-establishment of internal insulation). The result of the mold testing when the insulation was removed in the 2nd floor apartment confirmed that after 2 years there was none or very little mold at the intersection (low mycometer values). Thus, the mold risk calculation and the mold testing agree and they both show that there is no risk of mold growth in that case.
