Investigation and Retrofitting Proposal for a Panbo Type House in Sisimiut, Greenland

Qu, Jing; Vladyková, Petra; Villumsen, Arne

Publication date:
2012

Qu, J., Vladyková, P., & Villumsen, A. (2012). *Investigation and Retrofitting Proposal for a Panbo Type House in Sisimiut, Greenland*. Paper presented at Artek Event , Sisimiut, Greenland.

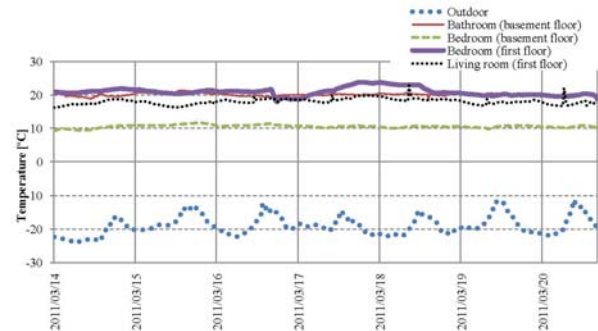
Figure 8: Measured temperature in the coldest week of 2011

The figures show that in the summer the house does not have a problem of overheating. In the winter the bedroom in the basement is probably not used because the temperature of the bedroom is around 10°C. But in the warmest week of 2011 the measure relative humidity often reaches 100% and it might show a malfunction of the sensors. In addition, there are also some problems with where the sensors are placed. The sensors are placed too close to the floor. However ideal position should be between 1m and 2m on the wall. Therefore the results of the TinyTags measurement could be taken for reference but in the future the sensors should be replaced and more precise results would be used to analyze the indoor climate.

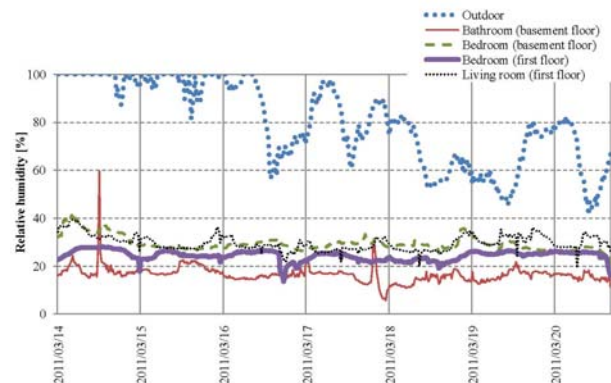
Figure 9: Measured relative humidity in the coldest week of 2011

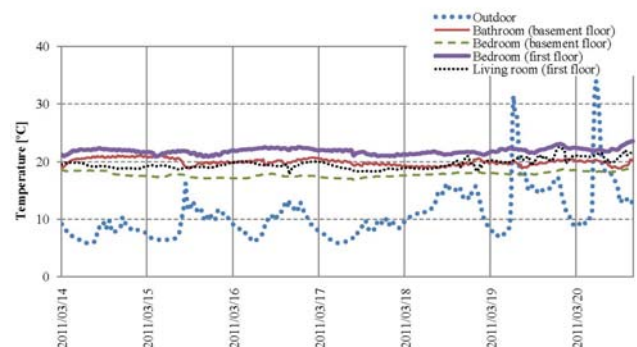
Figure 10: Measured temperature in the warmest week of 2011

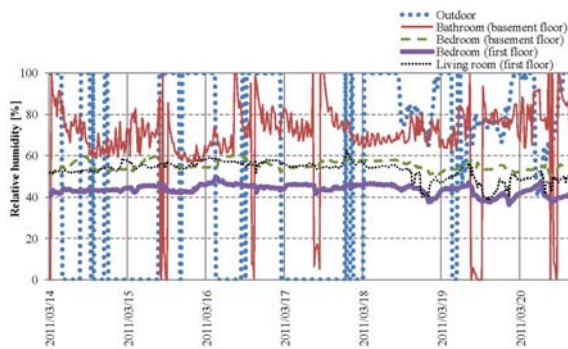
Figure 11: Measured relative humidity in the warmest week of 2011

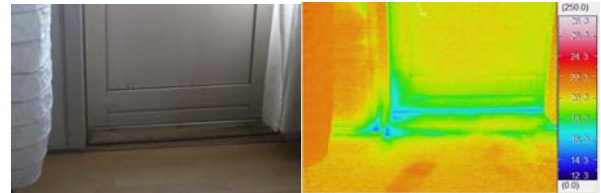
The thermography tests show that there are some problems with the building envelope, such as leaky windows, doors and building component joints. Some pictures are taken as examples to see the problems. (Figure 12, 13 and 14)

Figure 12: The leaking balcony door in the living room

According to the result of the investigation, the retrofitting work mainly consists of applying extra paper insulation layer and new climate shield, replacement of windows and doors, levelling up the living room floor and installation of mechanical ventilation system.

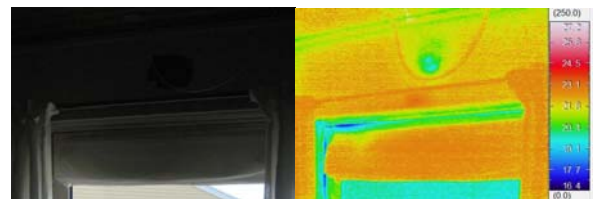
Figure 13: Untight window, natural vent and joints between the wall and the ceiling
