Investigation and Retrofitting Proposal for a Panbo Type House in Sisimiut, Greenland

Qu, Jing; Vladyková, Petra; Villumsen, Arne

Publication date:
2012

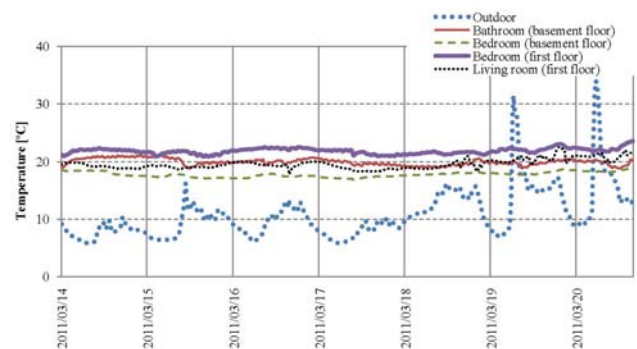
Figure 10: Measured temperature in the warmest week of 2011

The figures show that in the summer the house does not have a problem of overheating. In the winter the bedroom in the basement is probably not used because the temperature of the bedroom is around 10°C. But in the warmest week of 2011 the measure relative humidity often reaches 100% and it might show a malfunction of the sensors. In addition, there are also some problems with where the sensors are placed. The sensors are placed too close to the floor. However ideal position should be between 1m and 2m on the wall. Therefore the results of the TinyTags measurement could be taken for reference but in the future the sensors should be replaced and more precise results would be used to analyze the indoor climate.
