# Valuation of the 12 year old Concrete in the Ulkebugt Bridge, Sisimiut, Greenland

Published in: Nordic Concrete Research

Publication date: 2011

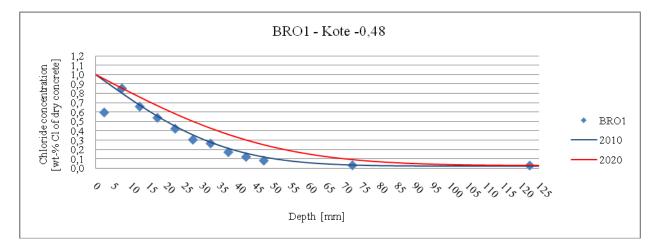
*Figure 2 – Chloride profile of the concrete in the splash-zone. Year 2010 (blue) and 2020 (red). Measurement results are marked.*

The lifetime of the concrete is limited by the chloride ingress. Corrosion of the reinforcement will initiate once the chloride level reaches 0.1 wt-% of the dry concrete. To make an estimated lifetime, it is important to know the thickness of the cover over the reinforcement. The requirement for the cover in the pillar in the splash-zone is 70 mm. Figure 2 shows that the critical chloride level at the depth of 70 mm will be reached in approximately 10 years.

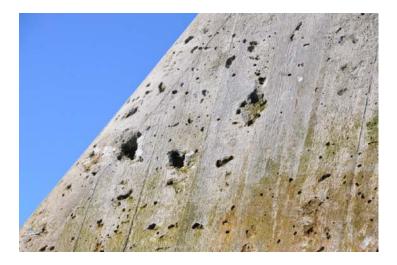
However the concrete surface of the pillar shows in some areas signs (smaller and larger holes in the surface) which could indicate freeze-thaw damages. These holes are probably smaller and larger agglomerates of air voids, probably caused by an improper compaction of the fresh concrete in relation with a "closed" design of the formwork, which leads to a high amount of entrapped air voids (equal to agglomerates of air voids) along the form side. In places with larger holes, the seawater is allowed to enter far into the holes from start, making the concrete and reinforcement more vulnerable to chloride initiated corrosion. The result of insufficient compaction of the concrete is many deep holes in the concrete, which is contributing to the overall state of the concrete pillar.

*Figure 3 – Deep holes into the concrete surface.*

The concrete surface of the pillar shows in some areas signs in form of smaller and larger holes in the surface which could indicate freeze-thaw damages. These holes are probably smaller and larger agglomerates of air voids, probably caused by an improper compaction of the fresh concrete in relation with a "closed" design of the formwork, which leads to a high amount of entrapped air voids along the form side. The seawater is allowed to enter far into the holes from start, making the concrete and reinforcement more vulnerable to chloride initiated corrosion.
