Challenges in risk assessment Insidious erosion of safety margins over time

Challenges in risk assessment

Insidious erosion of safety margins over time

Alaska Airlines flight 261

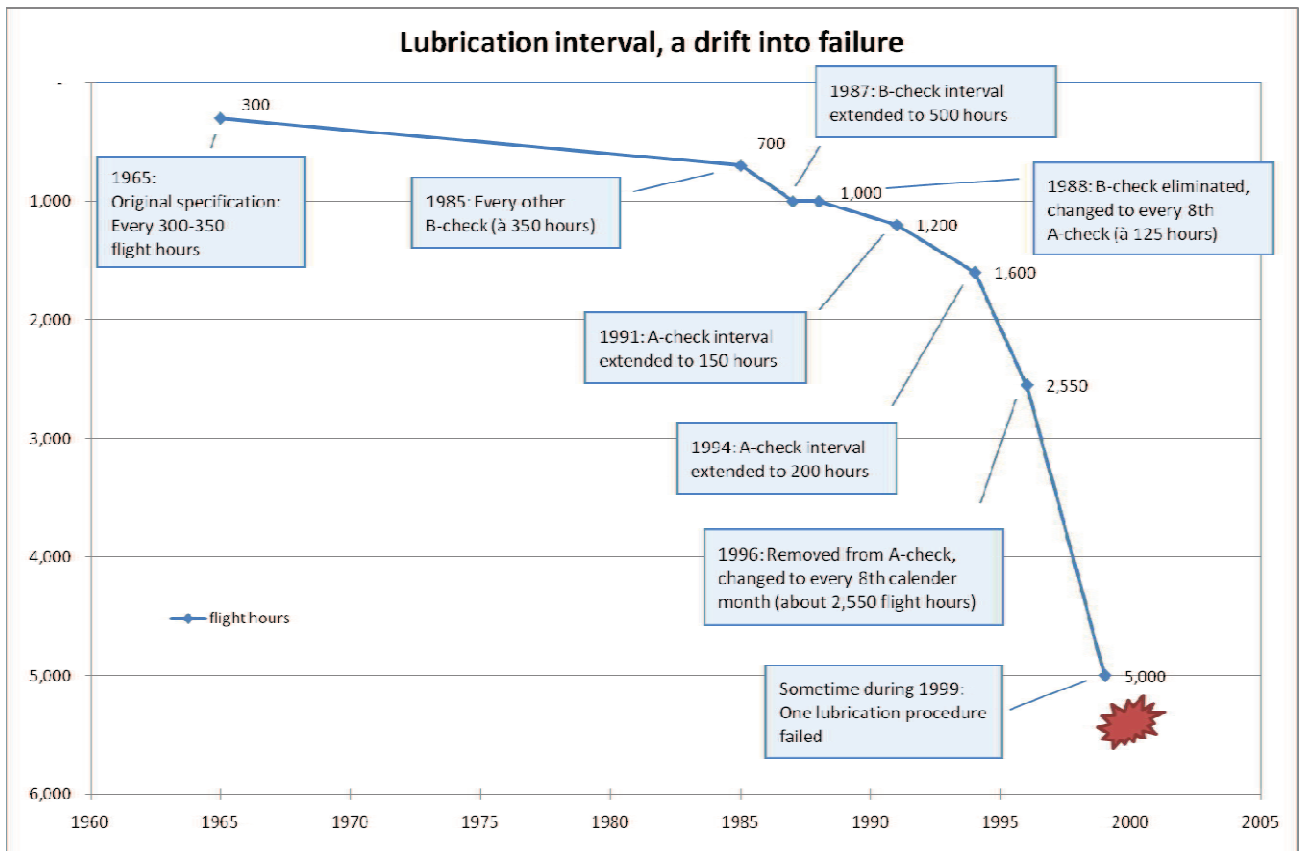
The immediate technical cause for this crash relates to inadequate lubrication of a critical component in the tail section of the jet. The graph below shows how processes of drift hollowed out the margins of safety originally engineered into the system, to the extreme point where a single failed lubrication procedure, in this case caused by a careless mechanic, would lead to catastrophic failure.

Multiple organizations were involved and all changes were concurred by the aircraft manufacturer and the regulatory oversight agency. What is particularly notable in this case is that while each of the changes, assessed individually, would be insignificant, the sum of the many steps, all in the wrong direction, turned out to be fatal.

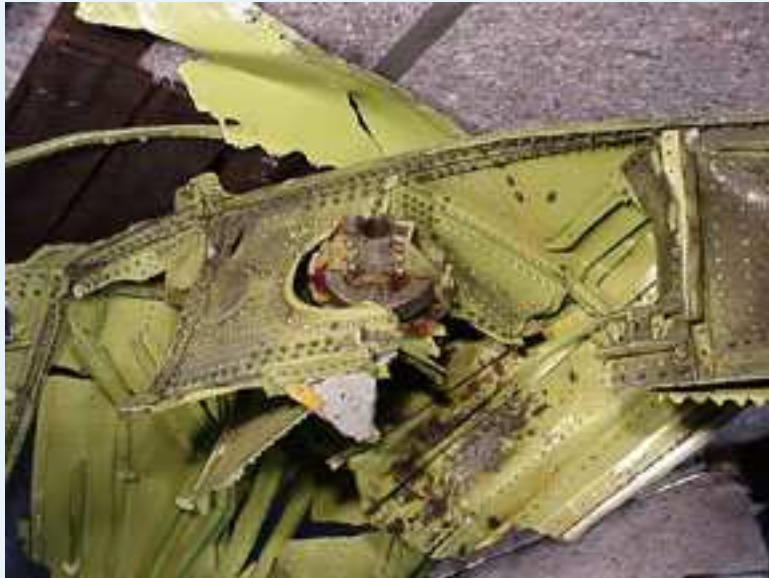
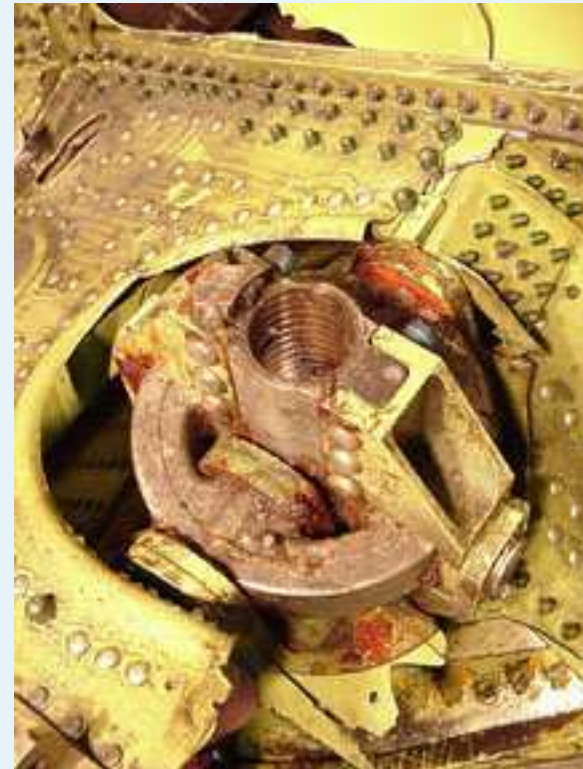
Gimbal nut from Alaska Airlines flight 261, shown below as attached to front spar of stabilizer from the aircraft's tail, and in close-up

Acme nut severely worn

Approximately 90 percent of the thread thickness had worn away before the remainder of the threads sheared off.

Cause of excessive wear: Lubrication failure

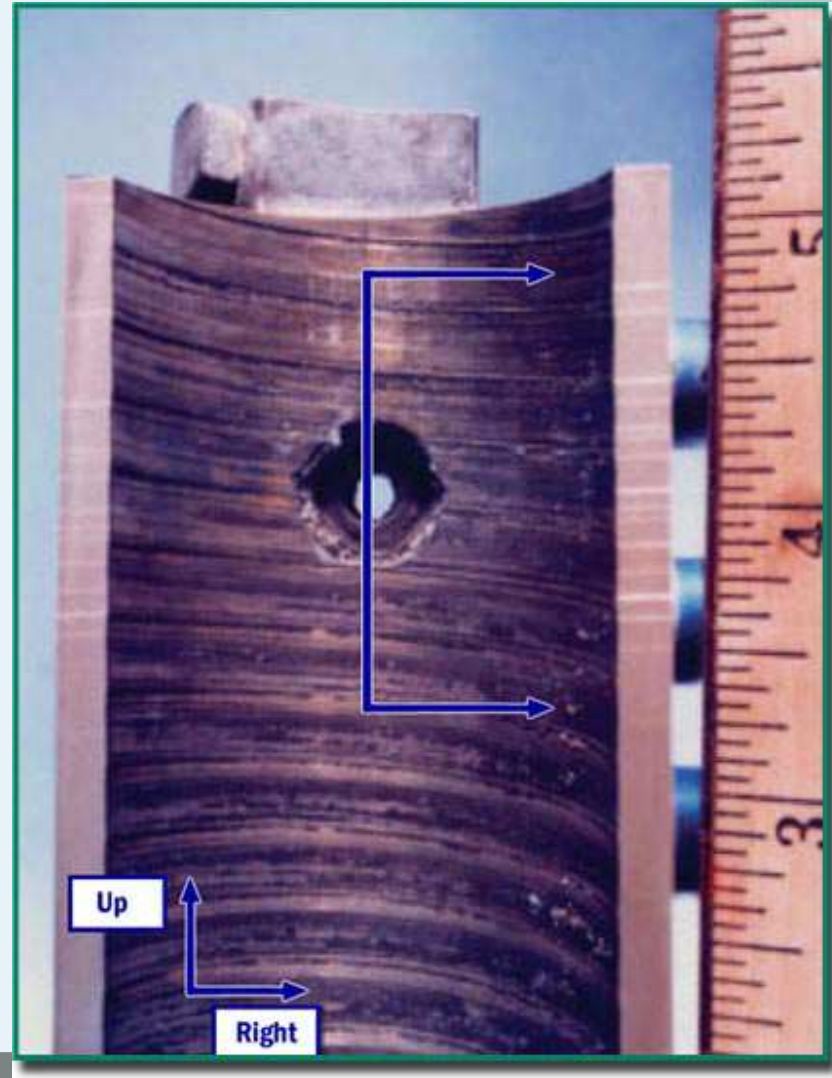
Jackscrew with metal shavings

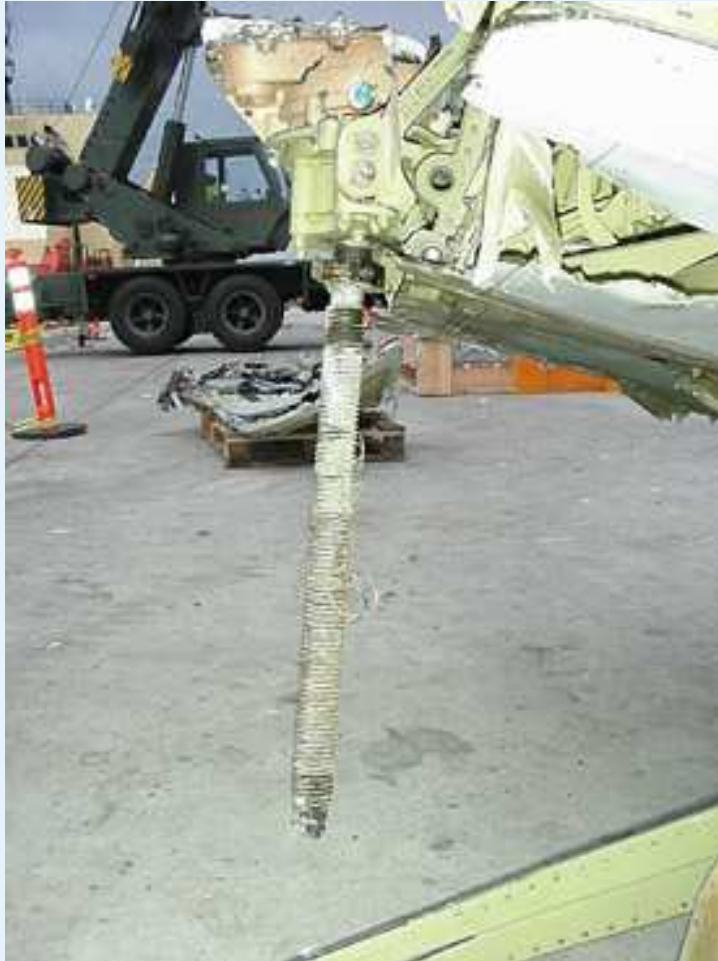
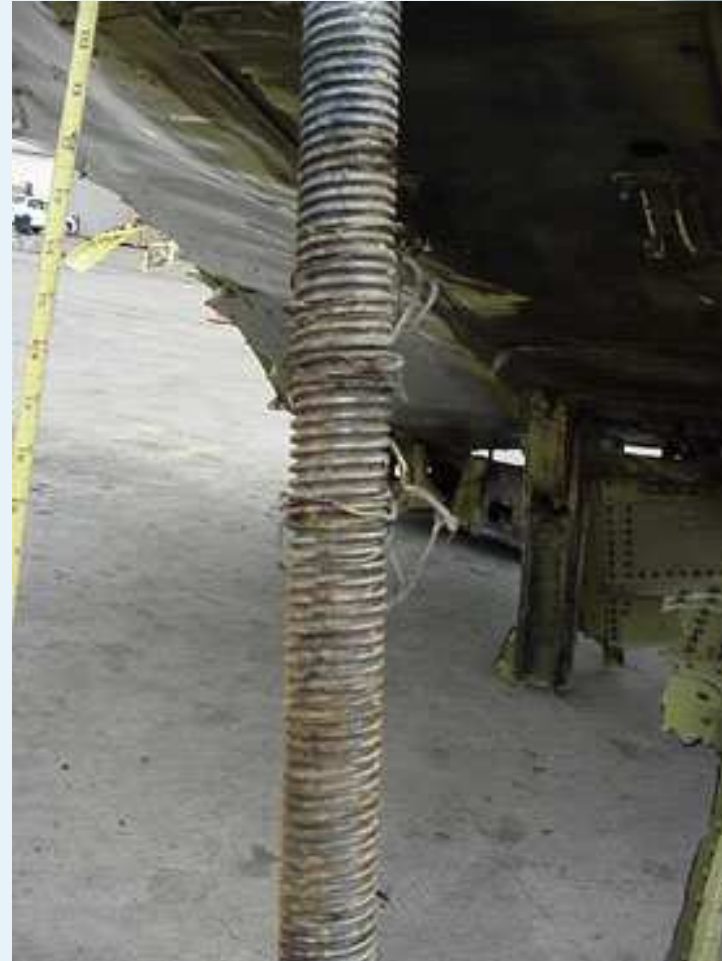
Jackscrew from horizontal stabilizer of Alaska Airlines flight 261, recovered from the wreckage

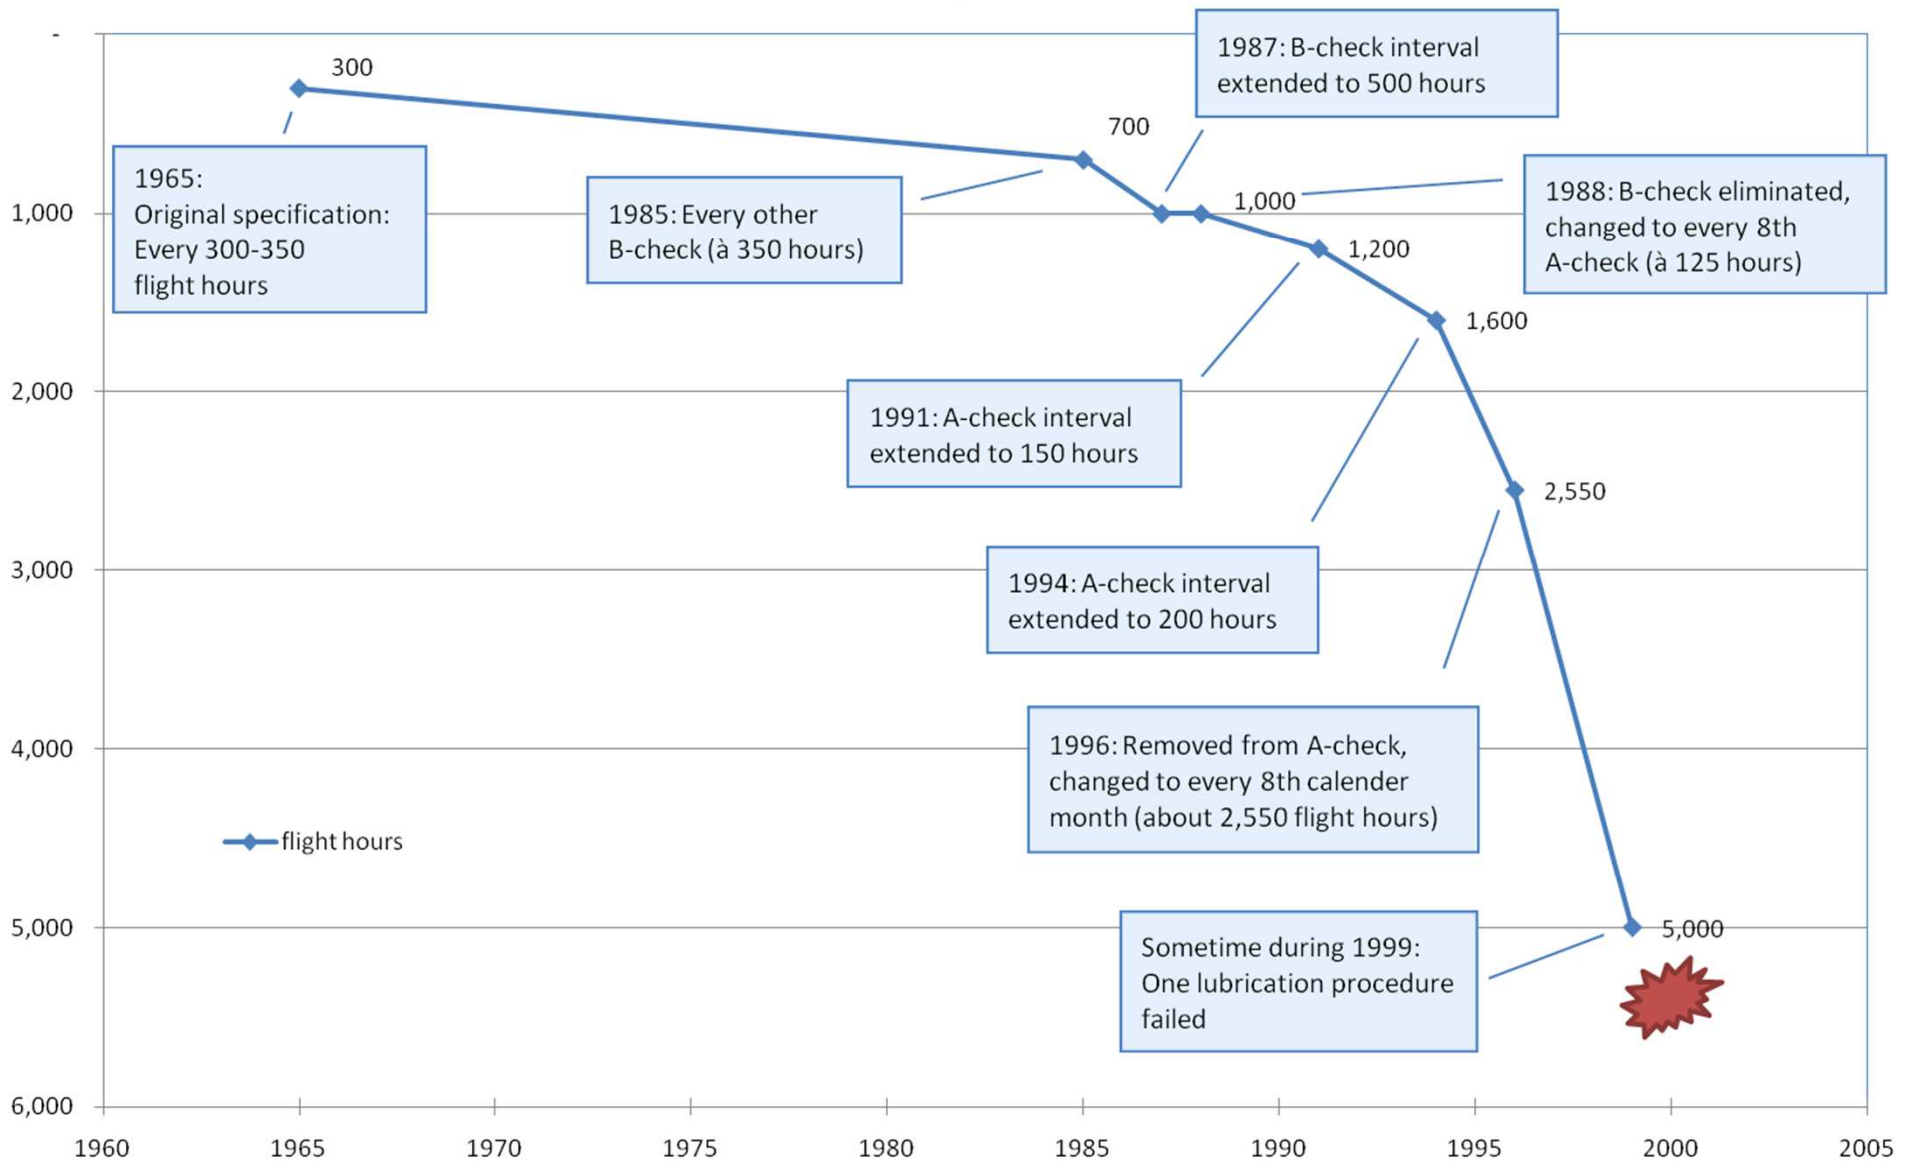
Lubrication interval, a drift into failure

- Preventive measure:
- Alaska Airlines, with FAA approval, increased the **lubrication interval** from 500 flight hours to every eight calendar months. (wear is a function of aircraft usage, not calendar time). (decreases the tolerance for missed or inadequate lubrication).
- Risk control measure:
- The **thread wear check** to determine the airworthiness of the jackscrew assembly was required at every other C check. However, the C check interval was extended.

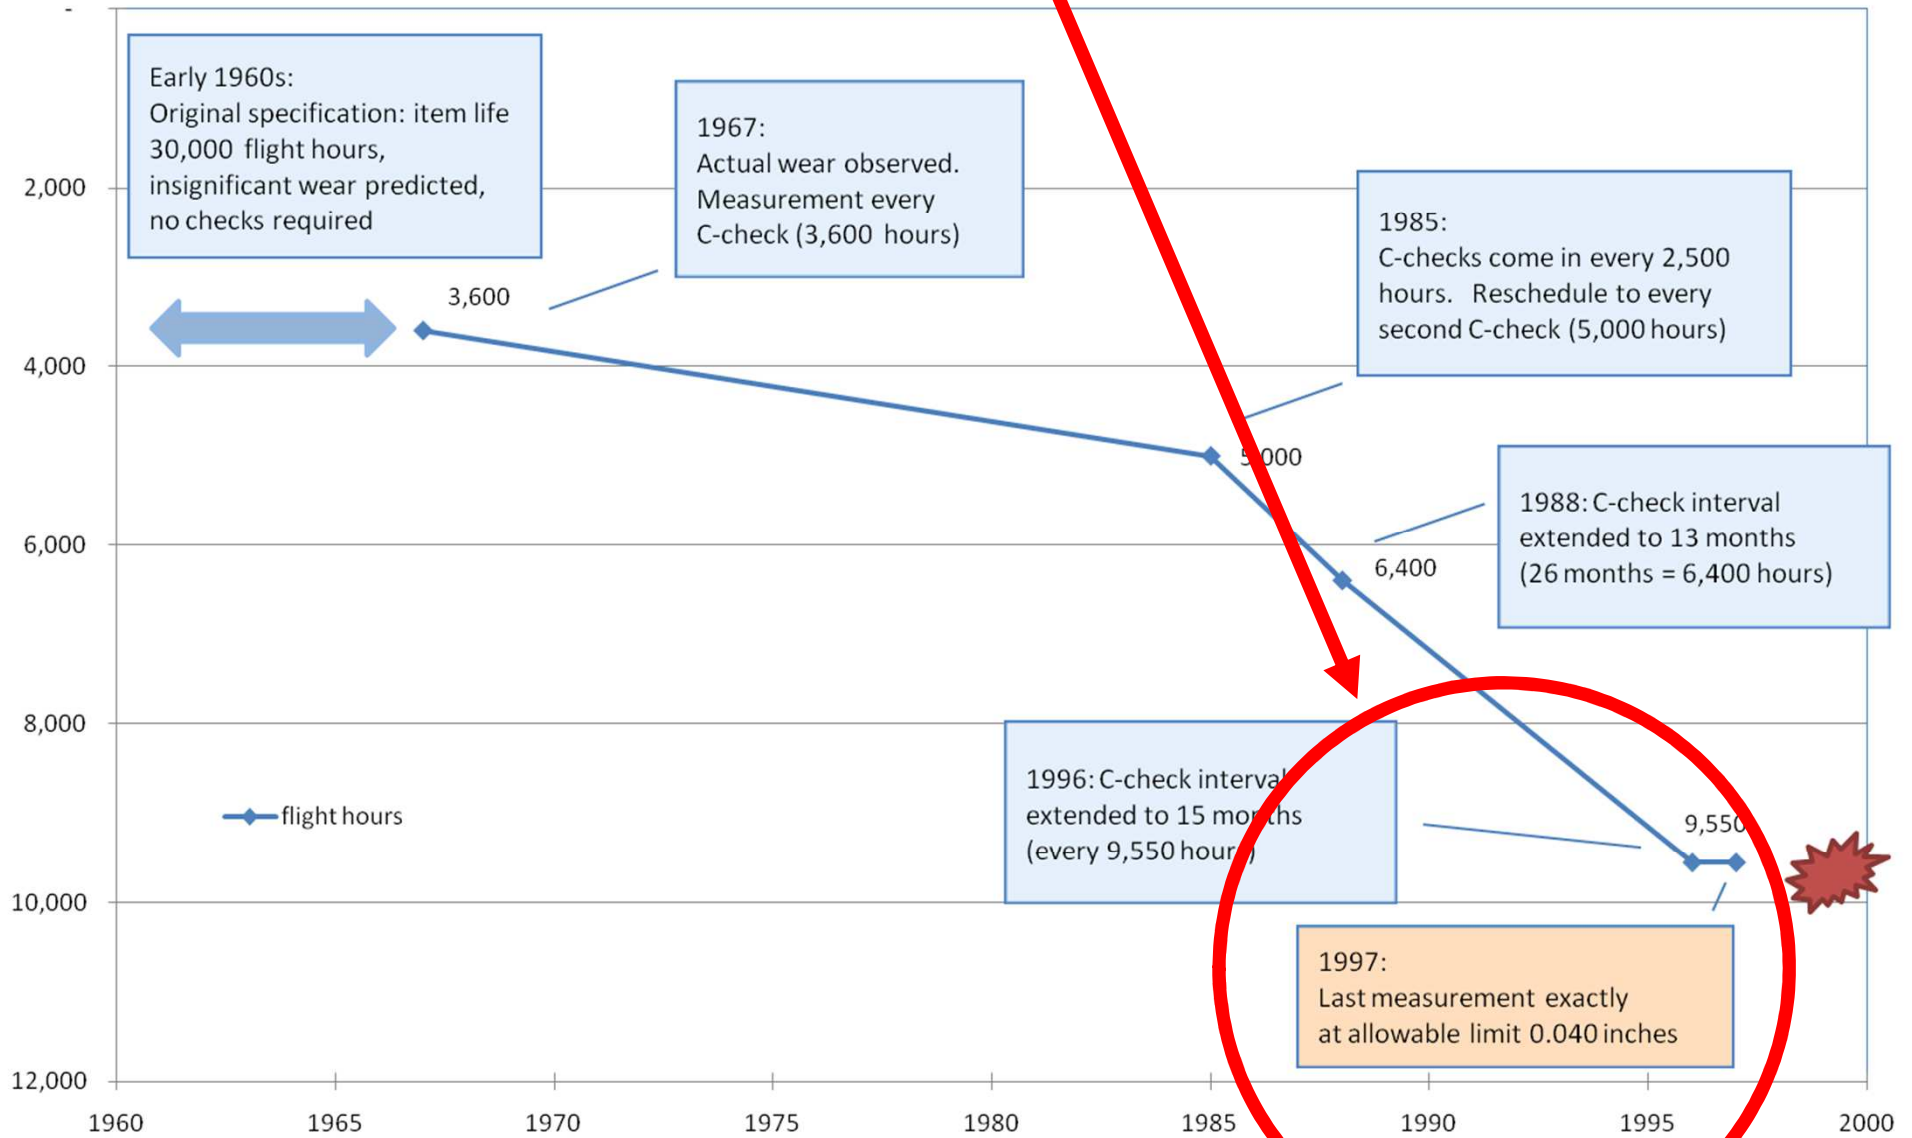
The last thread wear measurement

Accident airplane's last thread wear check - 1997

"Horizontal Stab - acme screw and nut has maximum allowable end play limit (.040 in.)." The planned action box, which was filled out by the day-shift lead mechanic and inspector, stated, **"Replace nut and perform E.O. 8-55-10-01."**

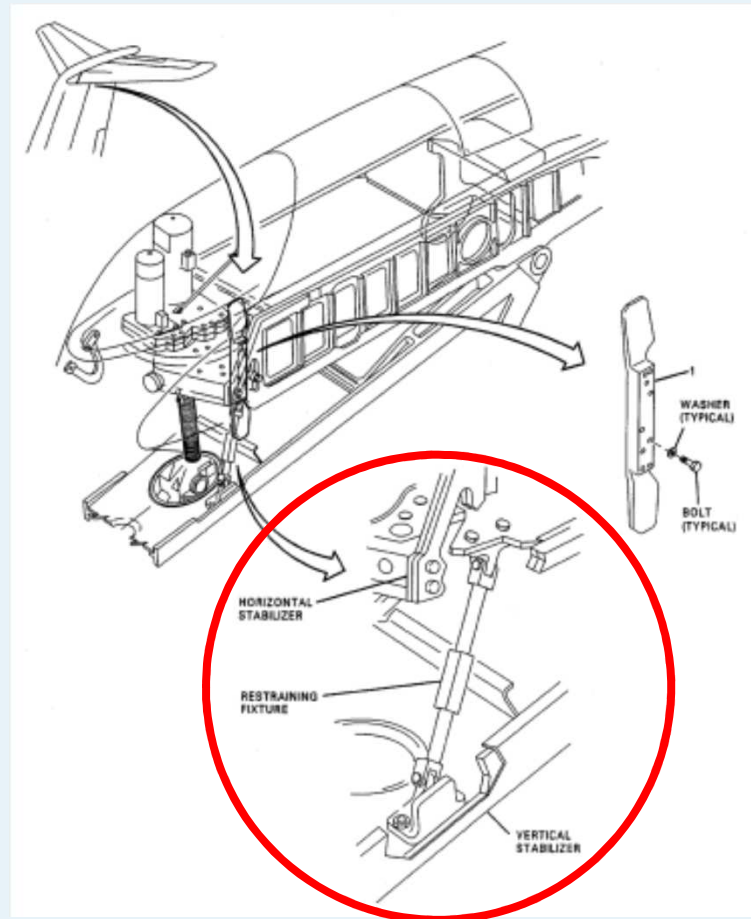
Measuring nut thread wear - using a "restraining fixture"

To allow operators to monitor acme nut wear without removing the jackscrew assembly from the airplane, Douglas developed the on-wing end play check procedure. The procedure calls for pulling down on the horizontal stabilizer by applying a specified amount of torque to a tool known as a restraining fixture to change the load on the acme screw from tension to compression

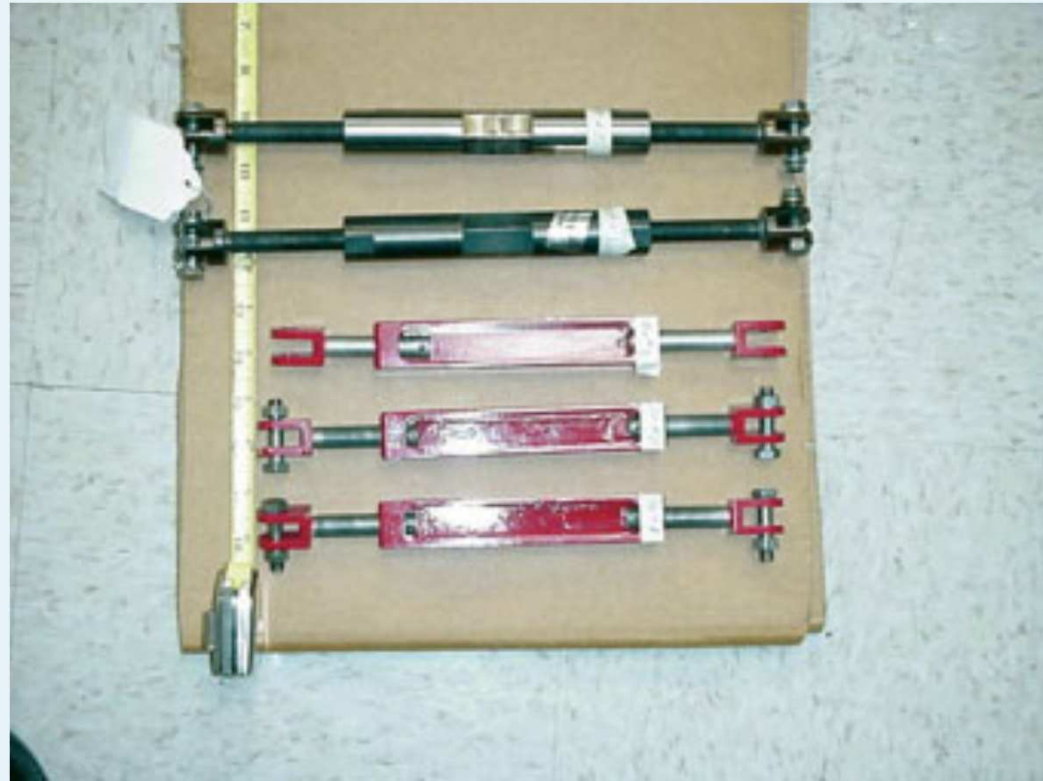
Fixture manufactured in-house

- Up until the time of the accident, Alaska Airlines had only one restraining fixture in its inventory. The fixture was manufactured in-house...
- During several of these tests, the in-house restraining fixtures yielded lower end play measurements ...

Two Alaska Airlines-fabricated restraining fixtures and three Boeing manufactured fixtures

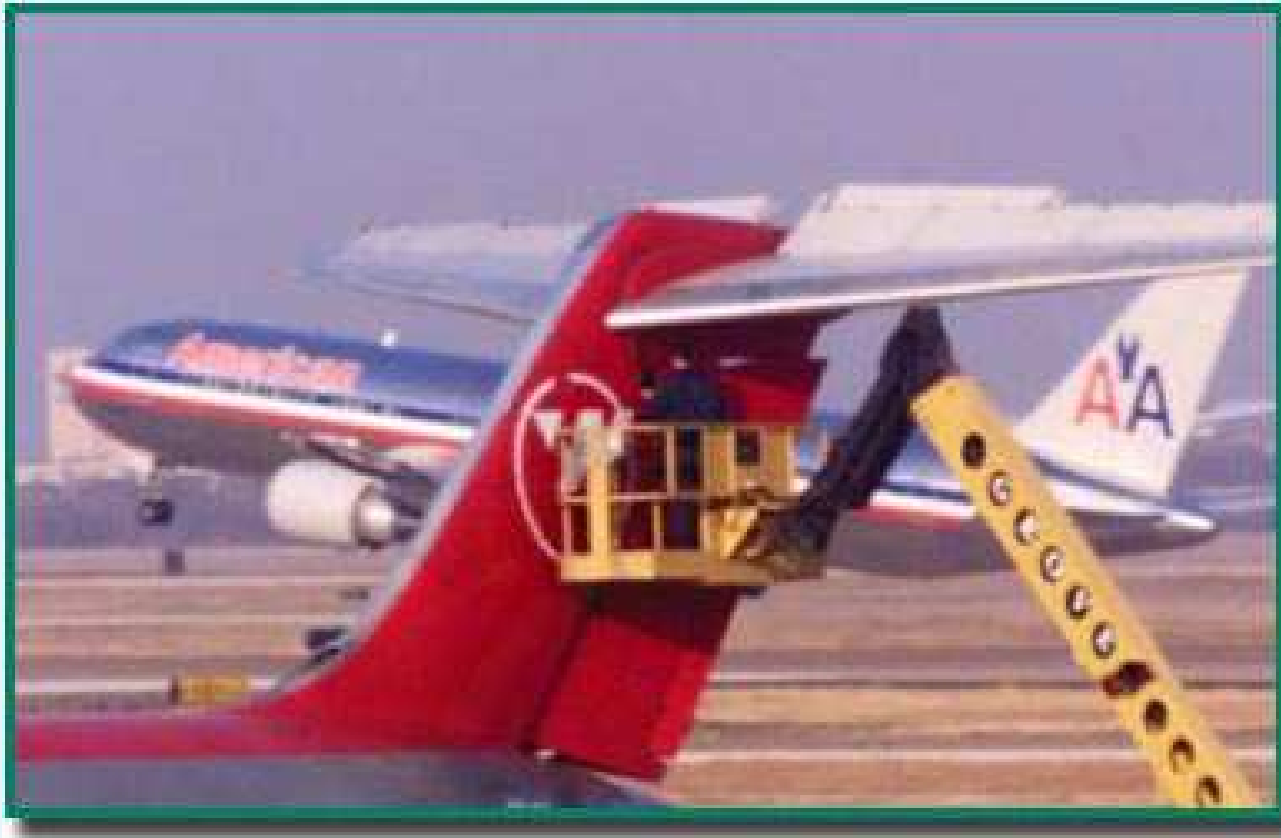
Lubrication maintenance access

Photograph showing maintenance on the horizontal stabilizer of a Northwest Airlines MD-83 aircraft. An American Airlines aircraft is in the background

Recommendation: Increase the size of the access panel to accomplish the lubrication procedures.
