Explosion of lithium-thionyl-chloride battery due to presence of lithium nitride

Published in:
Journal of Failure Analysis and Prevention

Explosion of lithium-thionyl- chloride battery due to presence of lithium nitride

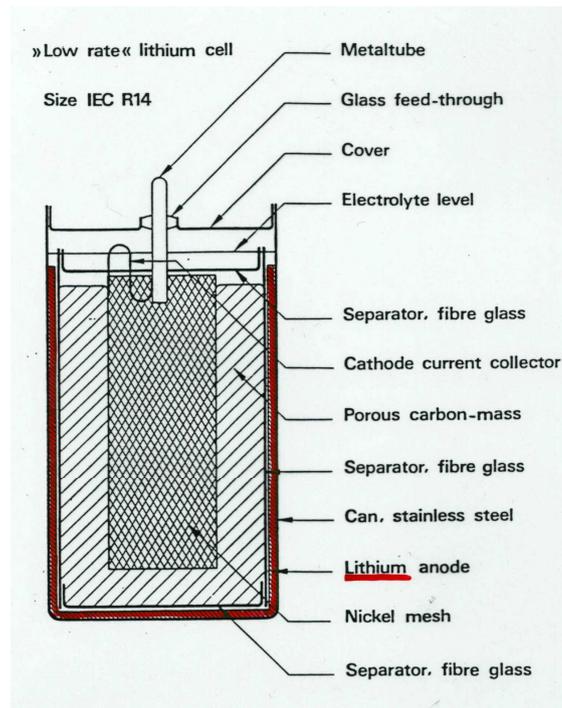
The accident cell was a R14 stainless steel (type 304) container with metallic lithium foil as anode, thionyl chloride as cathode, compressed powdered carbon and nickel mesh as current collector and a glass fibre nonwoven separator (**Figure 1**). The lithium foil thickness was 1.4 mm. The electrolyte was prepared adding AlCl₃ and LiCl salts to anhydrous SOCl₂ to yield a solution of 1.73M LiAlCl₄, about 300 g/l. Henceforth, the article will refer to this solution as the thionyl chloride electrolyte, or simply the electrolyte.

Figure 1 Schematic construction of accident R14 cell
