## Large Steel Tank Fails and Rockets to Height of 30 meters - Rupture Disc Installed Incorrectly

**Vertical cylindrical 90 m<sup>3</sup>  
steel tank operated at  
"slight overpressure"  
rockets to height of 30 m –  
rupture disc overpressure  
relief device inoperative,  
installed upside down**

At a brewery, the base plate-to-shell weld seam of a 90 m<sup>3</sup> vertical cylindrical steel tank failed catastrophically. Leaving the contents behind, the 4 ton tank “took off” like a rocket and landed on a van, crushing it. The top of the tank reached a height of 30 m. The internal overpressure responsible for the failure is estimated at 60 kPa. A rupture disc rated at less than 50 kPa provided overpressure protection and thus prevented the tank from being covered by the European Pressure Equipment Directive. This safeguard failed and it was later found that the rupture disc had been installed upside down. The organizational root cause of this incident may be a fundamental lack of appreciation of the hazards of large volumes of low-pressure compressed air/gas. A contributing factor may be that the standard P&ID symbol for a rupture disc may confuse and lead to incorrect installat

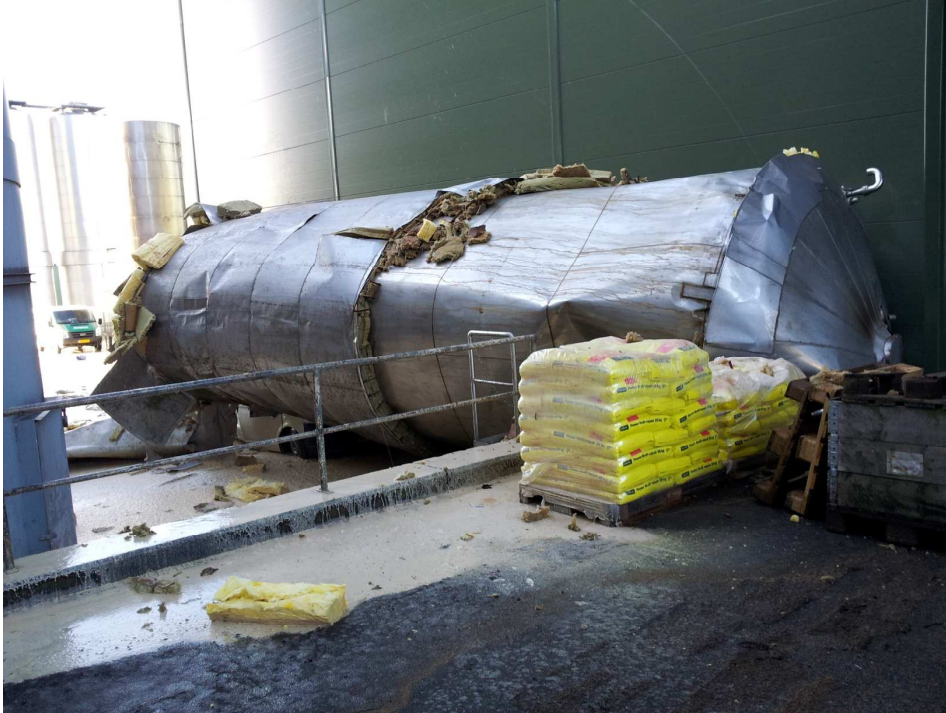
Shortly before the tank failure, two refrigeration technicians employed by an external contractor arrived to service a large ammonia-cooling unit located on the roof of the adjacent building. They parked their van next to the outdoor yeast storage tank, entered the building and climbed the stairs to the roof. Immediately after passing through a doorway in a 3 m tall noise protection wall on the roof they heard a sudden dull *poof* sound. They turned around and saw the storage tank rising vertically up in the air. The base of the tank clearly rose above the roof of the adjacent tall green building, then fell back to the ground landing on their van. They rushed back down and saw that the van had been crushed (Figure 2, Figure 3).

*Figure 2 The van is visible under the tank. Tank contents washed up on elevated platform.  
(Photo courtesy of the company)*

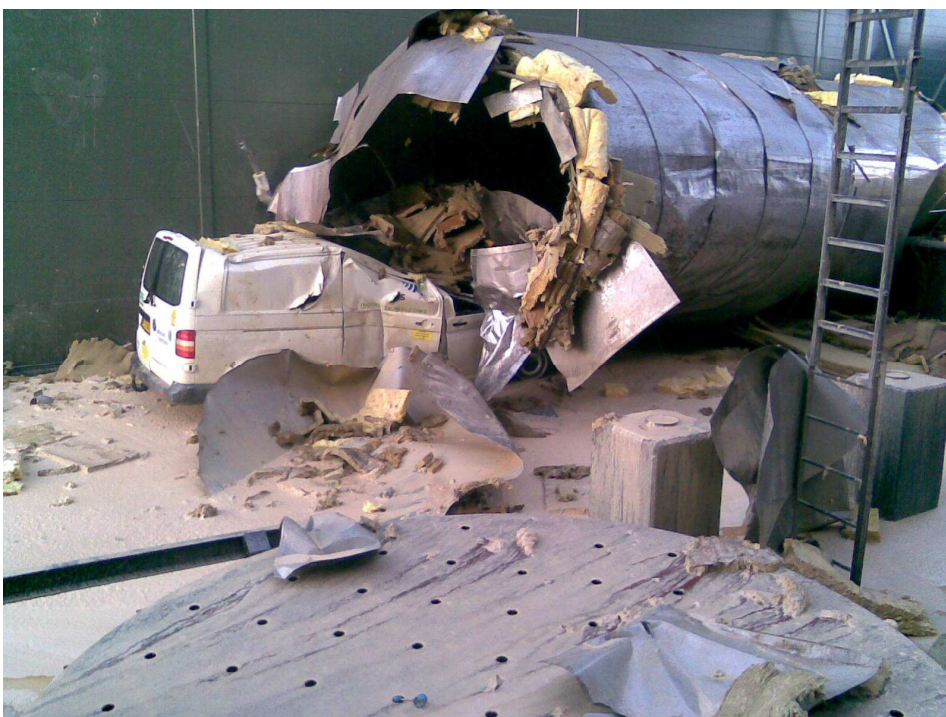
*Figure 3 Tank landed on van, crushing it. The tank's original position (the sloping support structure for the tank floor plate) seen in foreground. The tank floor plate is seen center left. (Photo courtesy I.W. Michaelsen)*

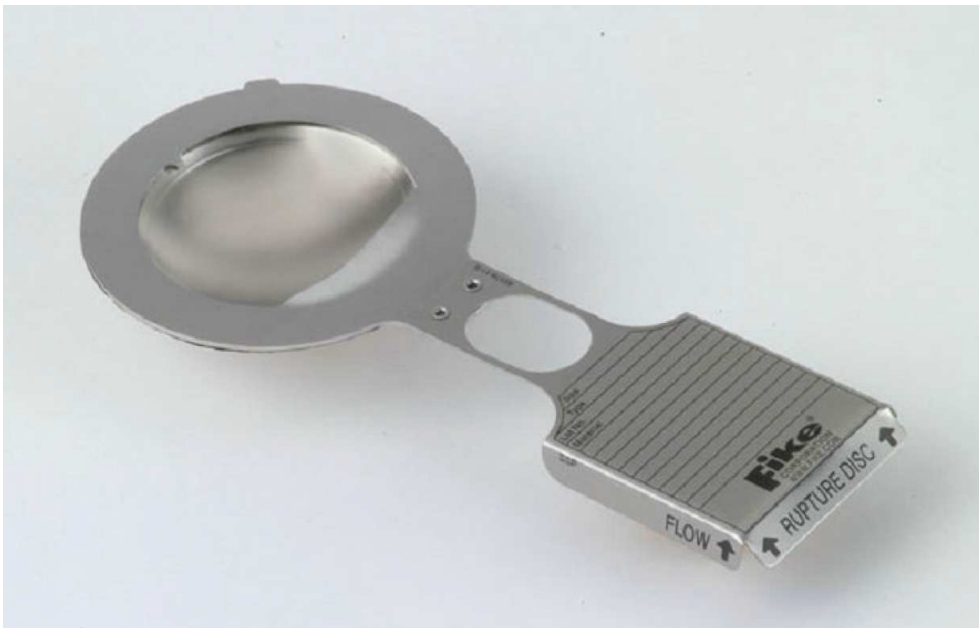
The rupture disc was intact. It was a reverse buckling type device that had been installed upside down (i.e. with the dome facing away from the tank). The vendor stated when asked, that the

rupture disc likely could withstand an overpressure of at least three times the stamped pressure (i.e. 150 kPa or more) before bursting, if installed upside down.

To guide correct installation, arrow marks printed on the nameplate indicate the direction of pressure relief (Figure 6). However, the dome itself can point either way depending on the type of design and gives no reliable indication of the correct direction of installation.

*Figure 5 Reverse buckling type rupture disc (dome points towards the fluid pressure) similar to the one installed on the incident storage tank. Proper flow direction of pressure release is marked on the nameplate (Photo courtesy: Fike®)*

- The P&ID symbols in use for rupture discs may be a possible source of confusion during installation of reverse buckling type discs.
- The nameplate of a rupture discs clearly indicates the flow direction and allows simple visual verification of correct installation without interruption of production. Such inspections should be included in safety audits.
- The rupture disc seems to have been installed only to avoid being covered by the European Pressure Equipment Directive's arbitrary limit of 50 kPa(g). Had the tank failed at a slightly lower pressure than 50 kPa, the consequences would still have been dramatic. The burst pressure of the rupture disc could easily have been specified at a lower value for the tank in question, significantly reducing the hazard (provided that it had been correctly installed).

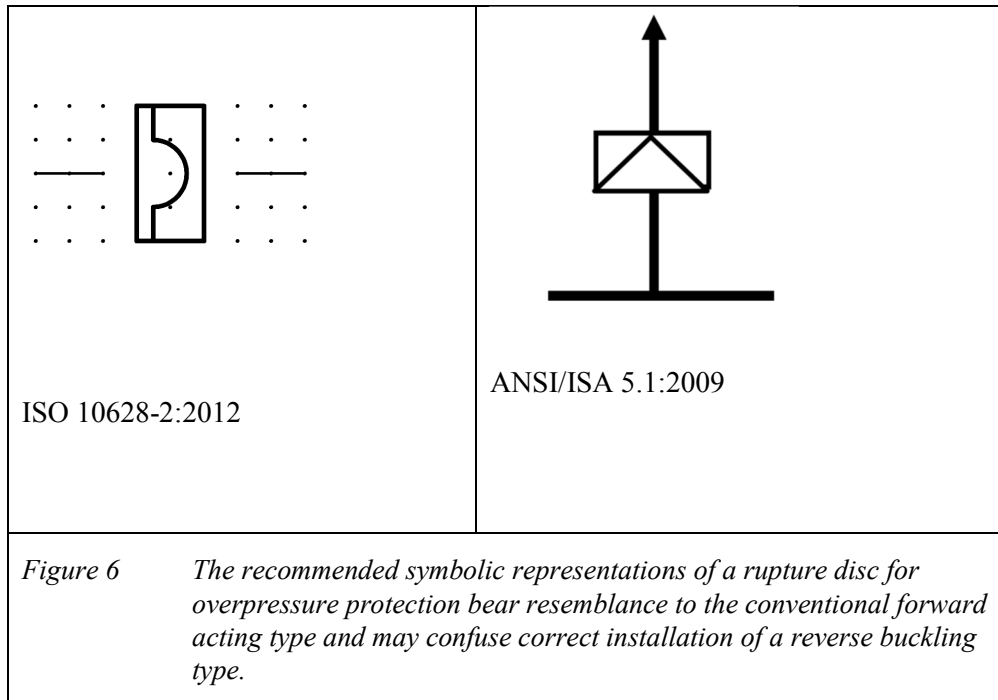
Figure 6 shows the symbolic representation of a rupture disc for piping and instrumentation diagrams (P&IDs) recommended by the ISO 10628 standard [16] and the ANSI/ISA 5.1 standard [17]. Assuming a conventional left-to-right reading direction, the ISO symbol clearly depicts a forward acting disc type and the ISA rectangle symbol may easily be interpreted to do so as well. The installation of a rupture disc requires no specialized training and it may be speculated that the symbols might mislead a less experienced pipe fitter to believe the dome should be installed facing away from the tank. This would result in an upside down installation of a reverse buckling type disc.

As mentioned above the rupture disc on the outdoor storage tank that was installed upside down was precisely a reverse buckling type disc.
