**Hedlund, Frank Huess; Astad, John; Nichols, Jeffrey**

# **Inherent hazards, poor reporting and limited learning in the solid biomass energy sector: a case study of a wheel loader igniting wood dust, leading to fatal explosion at wood pellet manufacturer**

Project No.  
Document no. Aars 2010  
Version 20  
Date of issue April 4, 2014

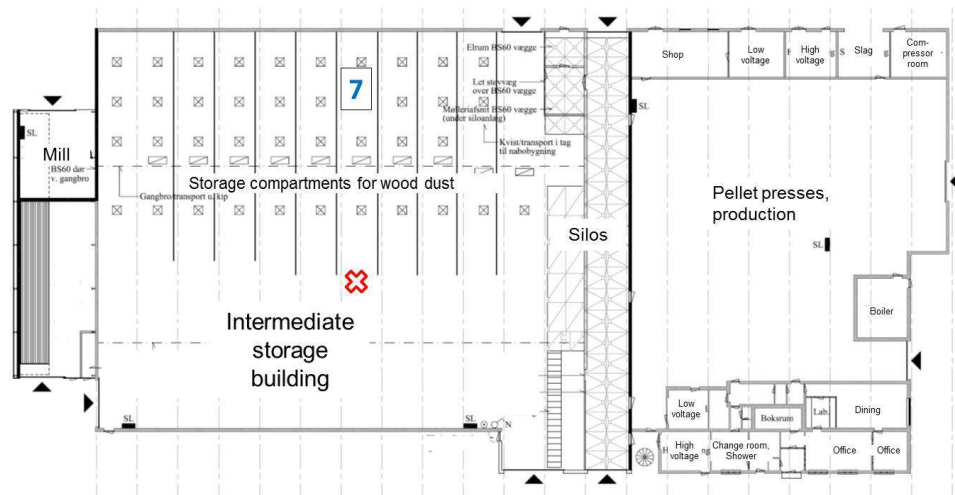
The intermediate storage in building II (40m x 50m) comprised 9 storage compartments for wood dust (Figure 2). Each compartment was about 25 m long and wide enough for a wheel loader to enter, shovel up material and bring it to the dust mixing pit. Wood dust was dumped into the cells from a band conveyor connected to a wide flexible hose that extended down to the floor to limit dust generation. A sensor would raise the hose as the pile grew in size. This area was designated ATEX zone 22 (dusts): defined as an explosive atmosphere not likely to occur in normal operation and if it does occur, it will exist only for a short time. Safety engineering control measures included extensive mechanical local exhaust ventilation, magnetic separation of tramp iron upstream from the mill with spark, fire detection and sprinkler system downstream the mill. At the end of each shift the wheel loaders were cleaned with compressed air to prevent accumulations of dust.

Figure 2 Layout of Building II showing wood dust storage hall, production hall and hopper arrangement in between. Accident compartment seven is marked. Fat black line shows A60 firewalls. Source: Company application for environmental permit, dated Jan 28, 2010)

immediately process wood dust from the mill into pellets, eliminating the intermediate storage. This would eliminate the hazard, a 500 t buffer storage of combustible dust, i.e. primary prevention. From an organizational perspective [24], [25], the root cause would be a failure to address principles of inherent safety at the design stage; other contributing factors such as the usage of wheels loaders would be derived secondary unsafe practices.

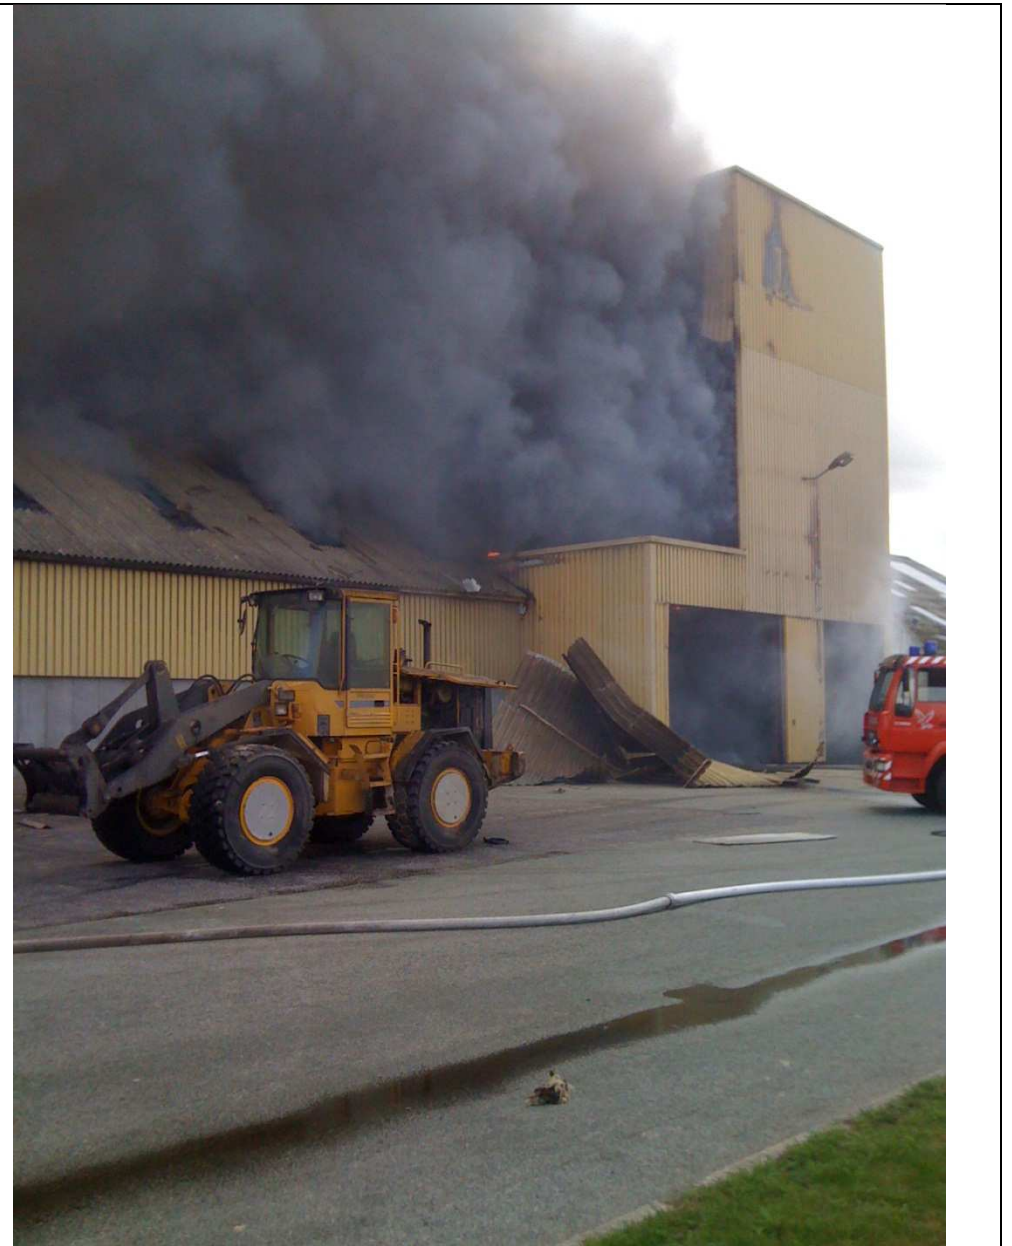
Within seconds the whole floor in compartment #7 was on fire and the flames then instantly expanded to fill the entire compartment. There was a large bang and he ran back and threw himself under his own wheel loader seeking protection from fiber cement roofing sheets and other debris that came down.

*Figure 3 Photo taken one hour after the explosion. The wheel loader is similar to the accident wheel loader, note blown out wall panels. Picture taken from north. Photo courtesy: Beredskab Vesthimmerland (the local fire and rescue services) photo kindly provided by official of the county Vesthimmerland Kommune.*

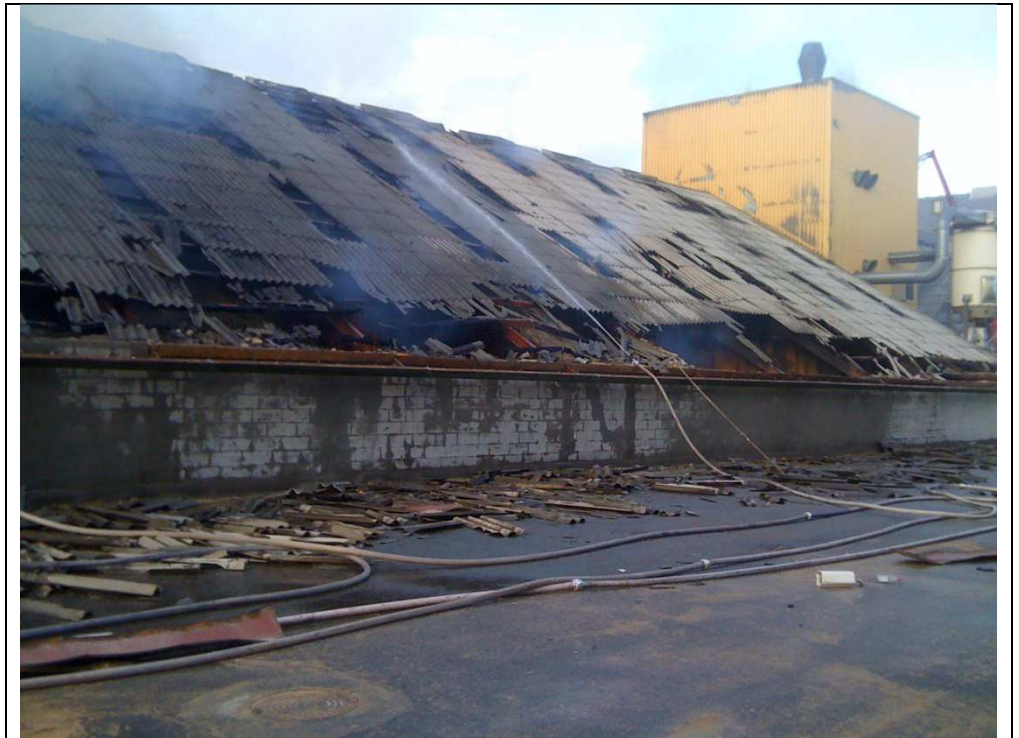
*Figure 4 The many light fibre cement roofing panels that remained in place indicate that the explosion overpressure was modest. Note that the wall made of lightweight porous concrete blocks shows no blast damage. Wood dust compartment wall dividers are visible inside building. Photo taken from south. Photo courtesy: Beredskab Vesthimmerland (the local fire and rescue services) photo kindly provided by official of the county Vesthimmerland Kommune.*

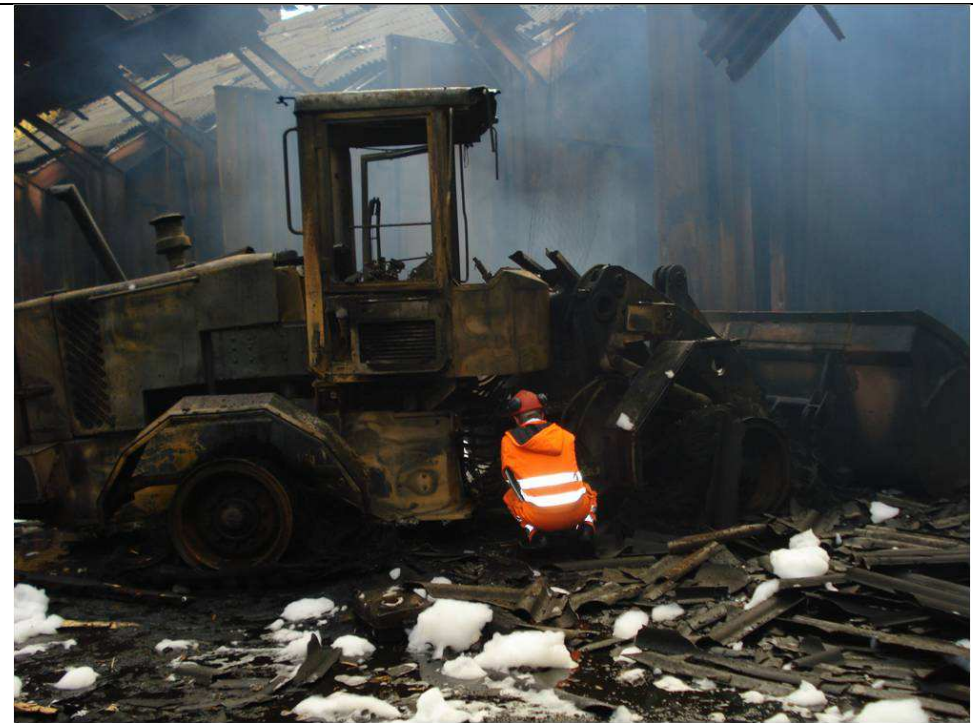
The wheel loader, a Volvo L70D, year 2000, was examined by a police vehicle inspector the next day (Figure 5). This model is pivot controlled; articulation of the center hinge provides improved maneuverability for tight job sites. The examination revealed that the universal joint shaft (in Europe known as a cardan joint shaft) that provides power transmission to the front axle was missing. It was concluded that the transmission shaft had failed mechanically, damaging the numerous electrical cables that were routed underneath the chassis resulting in arcing and sparking, which had ignited the dust (Figure 6). The joint and shaft were later discovered under the bucket. There were small signs that the shaft had been weakened by fractures near the weld zone. These findings concluded the police investigation as there was no indication of wrongdoing, only of bad luck.

In 2013, we managed to locate a highly competent and helpful mechanic at the local Volvo Service Centre, who had seen the accident vehicle. He suggested that the hollow transmission shaft could have failed due to an internal explosion. The parking brake on some of the older Volvo loaders is mounted directly on the shaft. If the driver forgets to release the parking brake, the system rapidly overheats and fails. He had repaired many loaders with this failure. The mechanic suggested that water had somehow entered the hollow transmission shaft and an internal steam explosion could explain the ripped open and torn shaft.

*Figure 5 Examination of the wheel loader revealed that the universal (cardan) joint and shaft was missing. Windows in the driver's cabin melted in the intense heat. Tires are burned away. Source: Police investigation, photo in useful quality kindly provided by an official from The Danish Working Environment Authority.*

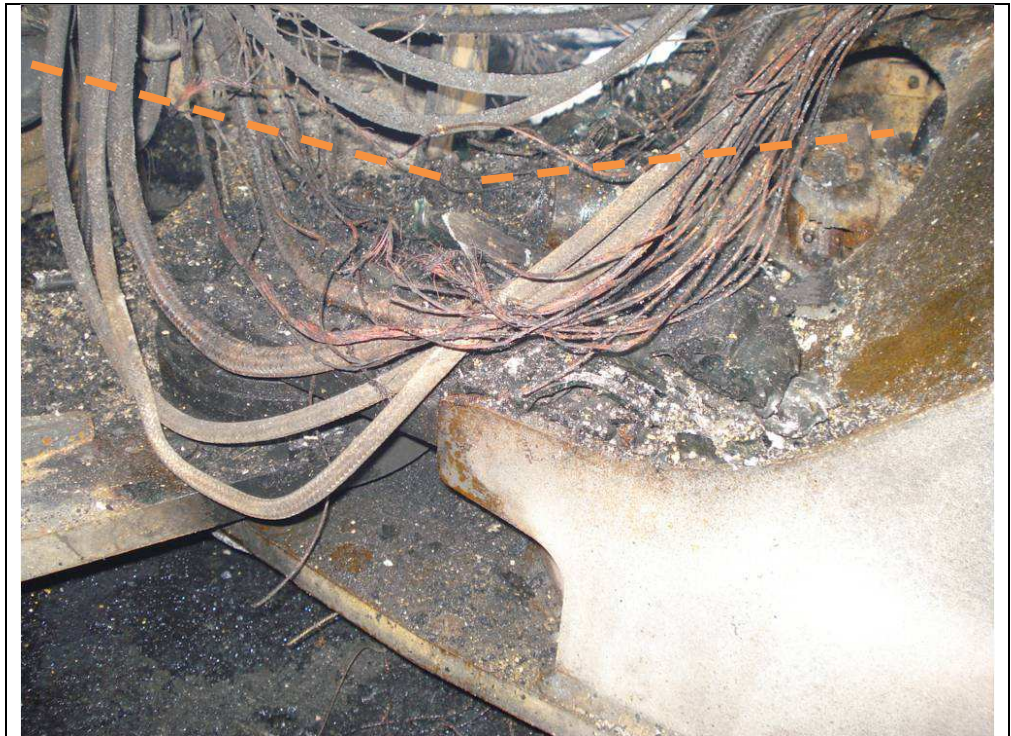
On Sep 17, the police released a statement to mass media that the cause of the explosion was identified. Due to weld failure a mechanical component broke loose under the vehicle and damaged electrical cables, causing a combustible dust explosion. The manager of the facility expressed emotion and disbelief, as the facility was in full compliance with the most recent norms and guidelines; this explosion should not be possible.

*Figure 6 Torn electrical cables and fire damaged hydraulic hoses. Dotted line shows approximate position of missing universal (cardan) joint shaft. Hydraulic hoses appear intact.  
Source: Police investigation, photo in useful quality kindly provided by an official from The Danish Working Environment Authority*

- 4 Spontaneous mechanical failure of the transmission shaft damages the many electrical cables that run nearby, causing short circuits and sparks that ignite wood dust (the official finding)
- 5 Parking brake not released, water inside the overheated and weakened transmission shaft produces a steam explosion, the mechanical failure damages electrical cables which ignite wood dust
- 6 Parking brake not released, pyrolysis gases from wood dust trapped inside the overheated and weakened transmission shaft explodes, the mechanical failure damages electrical cables which ignite wood dust
- 7 Parking brake not released, hot surfaces on brake drum and transmission shaft ignite dust, later collision impact with steel wall overloads the weakened shaft which fails and tears cables.

We consider option 4) the most probable and option 1) the least probable immediate accident cause. The conclusion has major implications for accident prevention efforts because it suggests that this type of wheel loader is entirely unsuitable for locations where potentially explosive atmospheres of combustible dust or flammable vapors can be present. We argue that the accident has broad learning potential because of the widespread usage of front loaders in combustible dust environments, the innocent nature of the human error and the severity of the consequence.
