## Post-mortem study on structural failure of a wind farm impacted by super typhoon Usagi

*Citation (APA):*  
Chen, X., Li, C. F., & Xu, J. Z. (2015). *Post-mortem study on structural failure of a wind farm impacted by super typhoon Usagi*. Paper presented at EWEA Annual Conference and Exhibition 2015 , Paris, France.

Xiao Chen<sup>\*1</sup>, Chuan Feng Li, Jian Zhong Xu

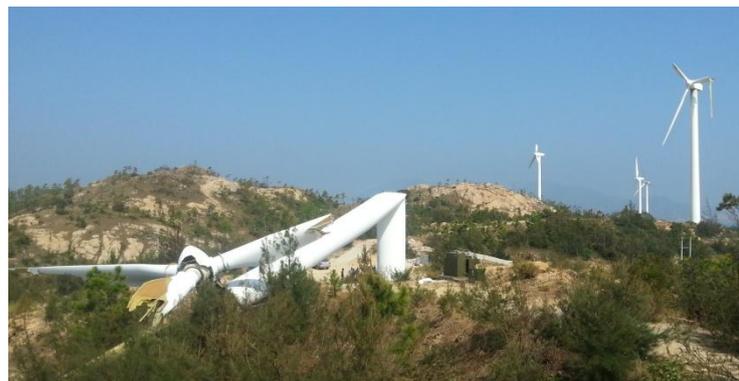
Field investigation on the wind farm was conducted after Usagi impact. Representatively, an overview of structural failure is shown in Figure 3. Failure statistics showed that eight out of twenty-five towers collapsed, three out of twenty-five turbines were burned and eleven out of seventy-five blades fractured. For the latter, the number of the fractured blades would be thirty-five if the blades installed on the collapsed towers were taken into account, leading to 46.7% blades failed in the wind farm.

Figure 3 An overview of structural failure of the wind farm (with turbine manufacturer's logo removed)

It was found that all tubular steel towers failed due to local buckling and the collapsing direction was SW or SSW, suggesting the dominating wind load coming from NE or NNE. The composite blades fractured at a location ranging from the inboard to the middle span, where the load-carrying box-beams inside the blades were totally fractured. Severe cracks were also found at sandwich shells of the blades which did not break off.

Interestingly, the distribution of structural failure over the wind farm appeared to be strongly relevant to the terrain characteristics. Six out of eight collapsed towers were found on the flat valley floor while most towers located on ridges with higher elevations remained intact. On the contrary, most blade breakage

occurred at the turbines located on ridges rather than on the valley floor.
