Investigation and Retrofitting Proposal for a Panbo Type House in Sisimiut, Greenland

Qu, Jing; Vladyková, Petra; Villumsen, Arne

The 'Blue House' is a standard family detached house built by Panbo Huse A/S in 1985 in Sisimiut, Greenland. As an old building, it has many problems such as poor thermal comfort and high energy consumption, and therefore, the house has a potential to be retrofitted. The investigation of the 'Blue House' was carried out in August 2011, including collection of original documentation, visual inspection, blower-door test, thermography test, the indoor climate monitoring, questionnaire and interview with the occupants. The indoor climate, including temperature and relative humidity, has been recorded since December 2010. The results of the investigation show that the house has some serious problems influencing proper functions, such as thermal bridges, poor thermal comfort and high energy consumption. A retrofitting plan, including having an additional paper insulation layer and exterior climate shield, has been proposed and will be carried out in 2012. Although the blower-door test shows that comparing with the considerably large number of houses built in

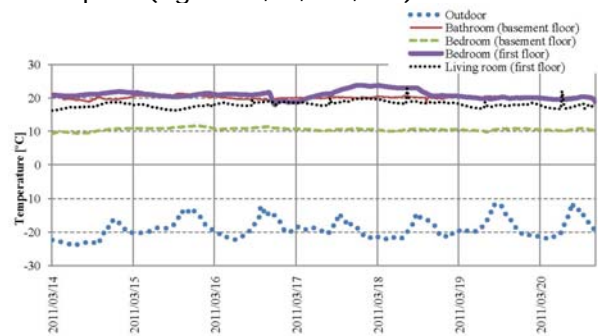
Figure 8: Measured temperature in the coldest week of 2011

The figures show that in the summer the house does not have a problem of overheating. In the winter the bedroom in the basement is probably not used because the temperature of the bedroom is around 10°C. But in the warmest week of 2011 the measure relative humidity often reaches 100% and it might show a malfunction of the sensors. In addition, there are also some problems with where the sensors are placed. The sensors are placed too close to the floor. However ideal position should be between 1m and 2m on the wall. Therefore the results of the TinyTags measurement could be taken for reference but in the future the sensors should be replaced and more precise results would be used to analyze the indoor climate.

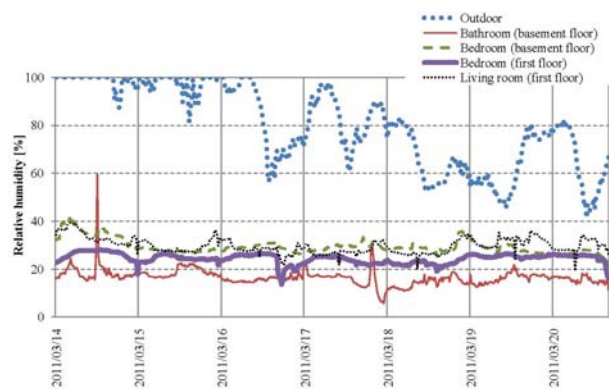
Figure 9: Measured relative humidity in the coldest week of 2011

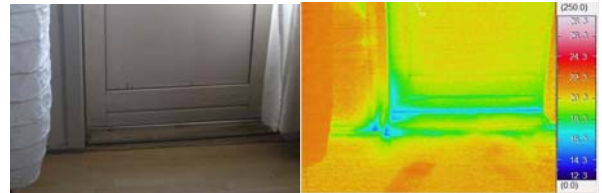
The thermography tests show that there are some problems with the building envelope, such as leaky windows, doors and building component joints. Some pictures are taken as examples to see the problems. (Figure 12, 13 and 14)

Figure 12: The leaking balcony door in the living room

According to the result of the investigation, the retrofitting work mainly consists of applying extra paper insulation layer and new climate shield, replacement of windows and doors, levelling up the living room floor and installation of mechanical ventilation system.

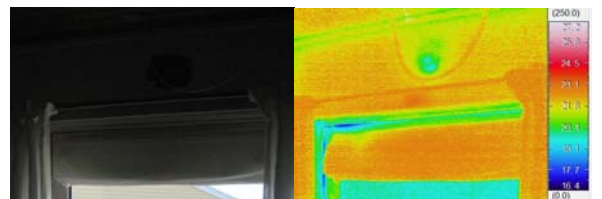
Figure 13: Untight window, natural vent and joints between the wall and the ceiling
