Investigation and Retrofitting Proposal for a Panbo Type House in Sisimiut, Greenland

Qu, Jing; Vladyková, Petra; Villumsen, Arne

Publication date:
2012

Qu, J., Vladyková, P., & Villumsen, A. (2012). *Investigation and Retrofitting Proposal for a Panbo Type House in Sisimiut, Greenland*. Paper presented at Artek Event , Sisimiut, Greenland.

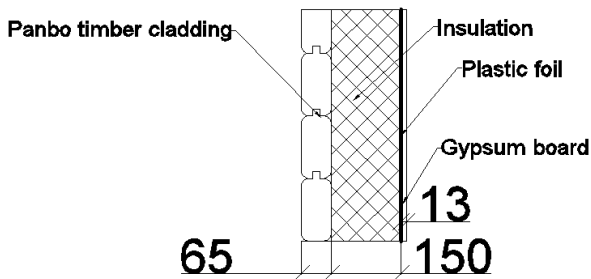
The construction of the exterior walls of the ground floor is wooden structure with 150mm mineral wool insulation inside.

13mm gypsum board is used on the interior side (figure 6). The construction of the ground floor is wooden structure with 200mm mineral wool insulation. The exterior walls of the basement consists of 250mm concrete, 80mm insulation, air gap and 1-2 layers of gypsum board. The total thickness is 370mm. The basement floor is built with concrete with interior insulation. Self-carrying roof structure with 200mm mineral wool insulation is used for the pitched roof, which has an inclination of 20°.

Figure 6: The construction of the exterior wall (ground floor)

'Thermal Bridge Breaker (TBB)' will be used to fix the new wind barrier and climate shield, at the meantime it will make room for the paper insulation (figure 15). TBB 80mm height will be mounted every 450mm vertical and horizontal. To the exterior Cembritt windstopper 9mm, additional wooden board and new climate shield will be used. 105mm Paper insulation for the wooden walls and 120mm for the concrete walls will be blown behind the windstopper through a pipe. To protect the paper insulation from the moisture, 100mm EPS board will be installed at the lower part of the outer walls where the walls touch the ground. Except for the outer walls, the attic and the basement floor will also be insulated with additional paper insulation.

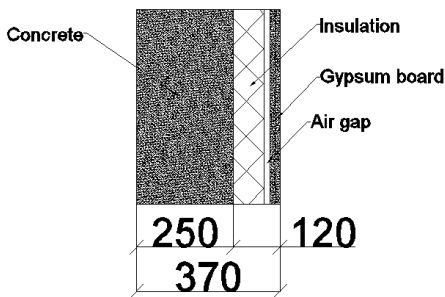
Figure 7: The construction of the exterior wall (basement)

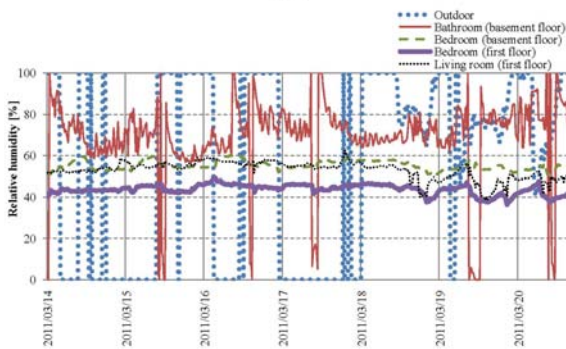
Figure 11: Measured relative humidity in the warmest week of 2011

The figures show that in the summer the house does not have a problem of overheating. In the winter the bedroom in the basement is probably not used because the temperature of the bedroom is around 10°C. But in the warmest week of 2011 the measure relative humidity often reaches 100% and it might show a malfunction of the sensors. In addition, there are also some problems with where the sensors are placed. The sensors are placed too close to the floor. However ideal position should be between 1m and 2m on the wall. Therefore the results of the TinyTags measurement could be taken for reference but in the future the sensors should be replaced and more precise results would be used to analyze the indoor climate.

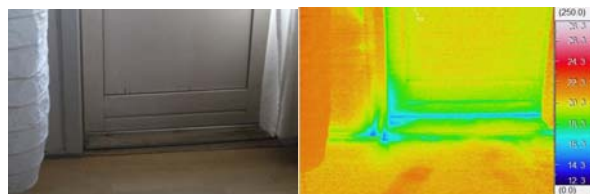
The thermography tests show that there are some problems with the building envelope, such as leaky windows, doors and building component joints. Some pictures are taken as examples to see the problems. (Figure 12, 13 and 14)

Figure 12: The leaking balcony door in the living room

From the thermography tests it can be seen that although the building envelope of the blue house is rather tight, the house has many weak points. Except for the problematic windows, doors, natural vents and some joints between building components, the heat loss through the building envelope of the ground floor (wood) differs from heat lost through the envelope of the basement (concrete). The result of the testing reveals that heat loss through the thermally weak parts could be quite high. It means in the retrofitting, improvement of the wind barrier and continualization of the whole building envelope must be considered.

According to the result of the investigation, the retrofitting work mainly consists of applying extra paper insulation layer and new climate shield, replacement of windows and doors, levelling up the living room floor and installation of mechanical ventilation system.

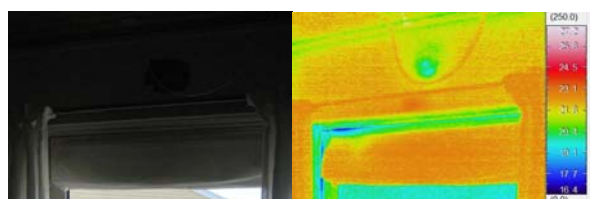
Figure 13: Untight window, natural vent and joints between the wall and the ceiling
