## A performance test of wood-plastic parquet flooring

A PERFORMANCE TEST OF WOOD-PLASTIC  
PARQUET FLOORING

Klaus Singer and Arne Vinther

August 1972

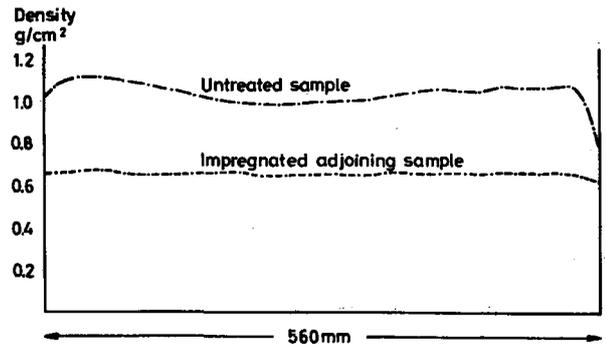
Fig. 2. Depletion of polymer from the ends of the sticks as seen in variation of density.
