Published in: Wear

3D characterization of rolling contact fatigue crack networks

Casey Jessop^a, Johan Ahlström^a, Lars Hammar^a, Søren Fæster^b, Hilmar K. Danielsen^b

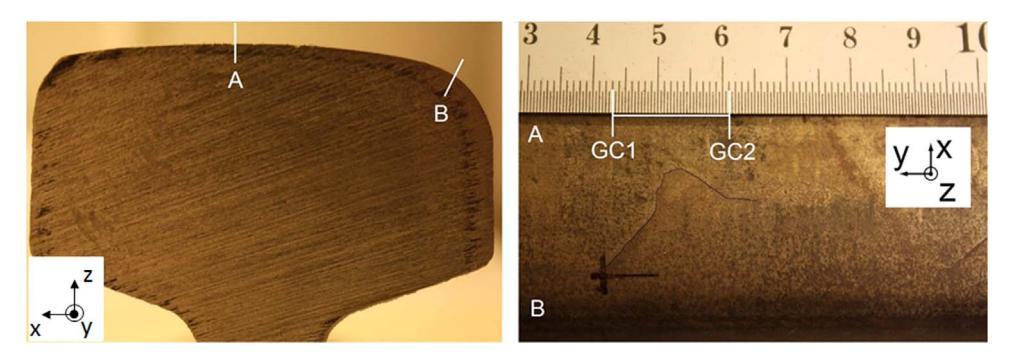
Fig. 1. Squat with gold cross marks (GC1, GC2) and scale (the V-shaped surface-breaking crack has been traced to be more visible).

Squats are surface-initiated defects, characterized by their V-shaped surface-breaking crack and two-lobe darkened surface [6], and are classified within three classes: A (light), B (moderate), and C (severe), according to [8,9]. Fig. 1 shows a Category B squat. The initiation of squats is thought to originate due to local plastic deformation of the surface from rolling contact fatigue (RCF) loading, including dynamic wheel-rail contact forces [1]. When local thermal damage on the rail surface is believed to affect the initiation mechanism, the defect is rather referred to as a stud [1,7]. In this work we have not determined the cause of initiation due to limited background information, and have chosen to use the name 'squat' for the defects studied.

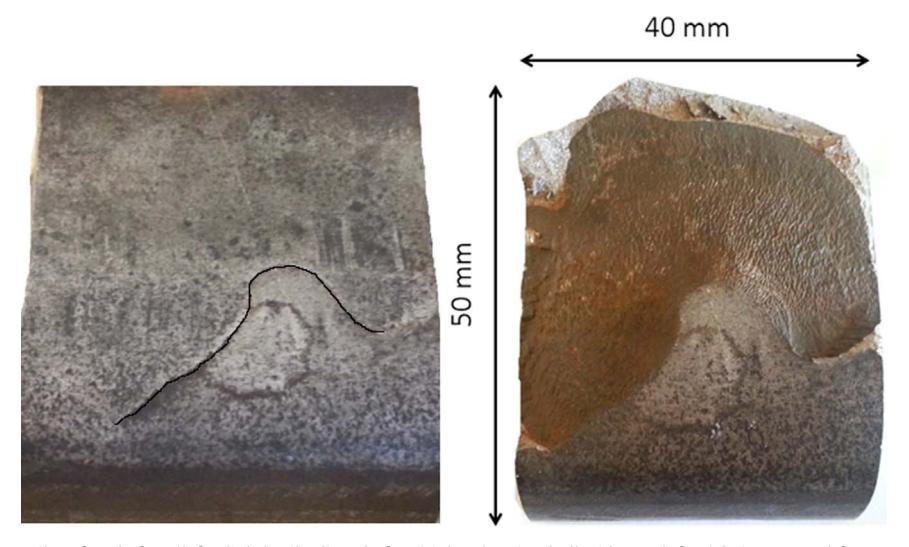
Fig. 4. Category B squat rail surface before (left, slightly tilted) and after (right, showing bulk-side crack face) being opened for topography measurements.

An investigation of the topography of the squat on a macro scale was done using stereomicroscopy and stylus profilometry. The fatigue crack path can clearly be followed from the origin to the outside edges, as shown in Fig. 4. Stereomicroscopy images of the same crack are shown in Figs. 11 and 12 shows the mapping from the topography method. A closer examination of the surface (Fig. 11b) shows ridges, very pronounced in certain areas as described by the 3D surface profile in Fig. 13, and occasional beach marks. The mappings obtained, clearly show the texture and roughness of the squat surface, also visible by the X-ray tomography, which are not captured by radiography through the entire rail head nor can be clearly imaged using metallographic sectioning since only one perpendicular plane is imaged.

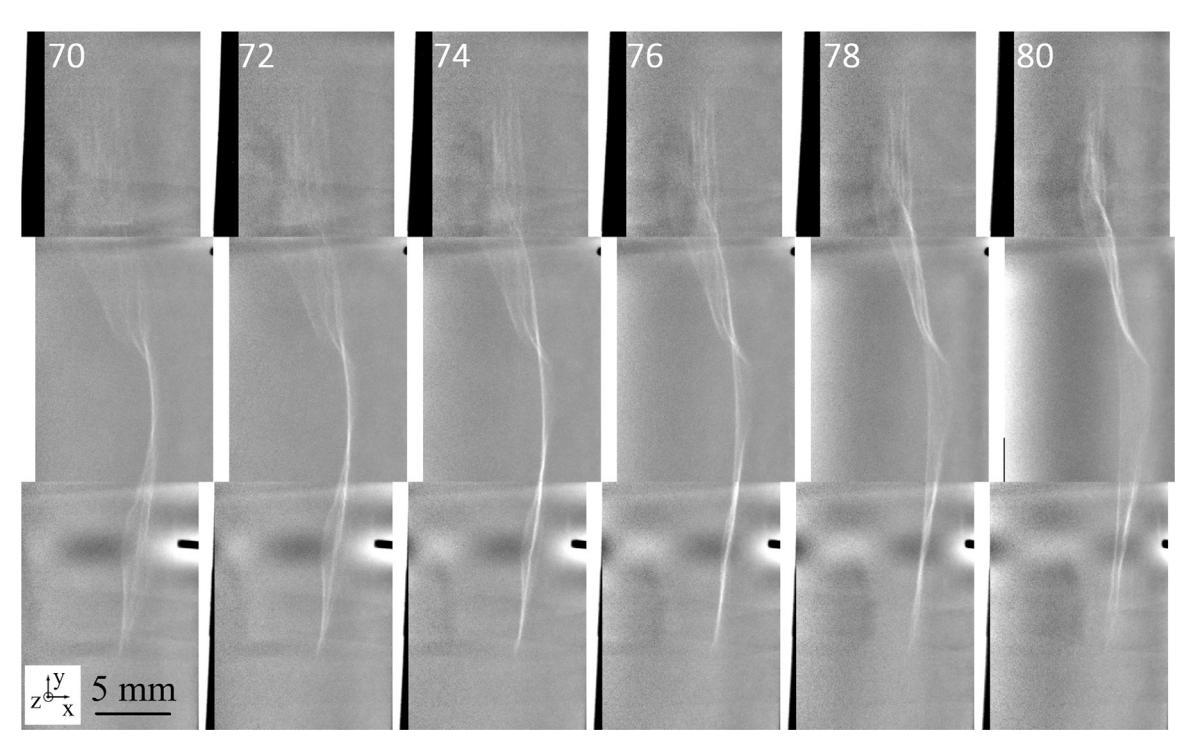
Fig. 5. Superposed X-ray image sequences of squat, ranging from 70° to 80°.

The radiographic images obtained after corrections and enhancement allow observation of a given area of the squat crack network, without tampering. Fig. 5 shows a compiled sequence of images from the squat between the angles of +70 and $+80^{\circ}$, with 2° intervals, according to the previously described radiography set-up (Fig. 2). It can clearly be observed how the intensity increases as the crack normal becomes perpendicular to the incoming X-ray beams. Artefacts are caused by joining images to cover the entire length of the crack, as well as from the necessary mathematical treatment of images. These artefacts currently hinder a fully automated interpretation of images.

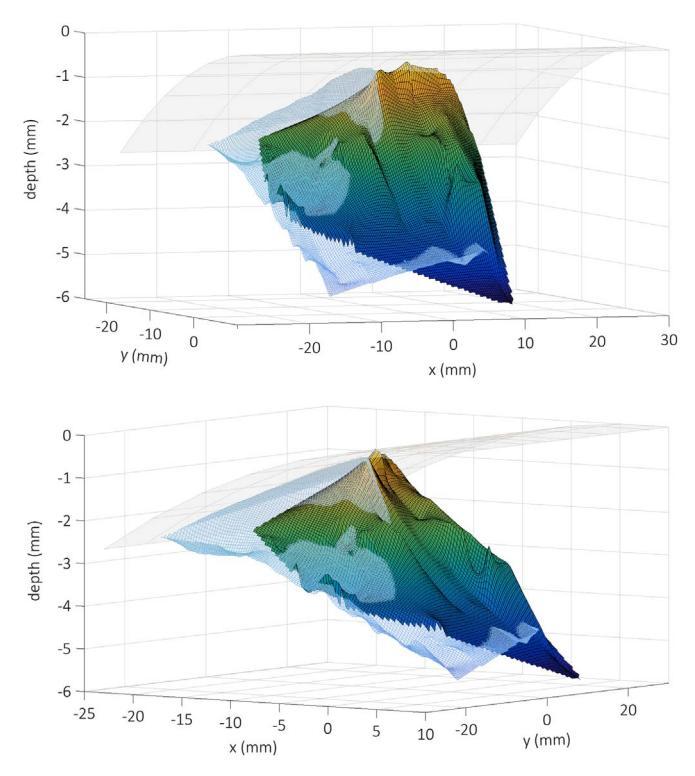
Fig. 6. 3D plots with surfaces obtained from both 3D reconstruction (colored) and metallography (mesh). The crack network is showed relative to the rail surface (gray). Note that the scaling in z-direction is exaggerated to better show the shape of the crack. (For interpretation of the references to color in this figure legend, the reader is referred to the web version of this article.)

The result of the 3D geometrical reconstruction is shown in Fig. 6, demonstrating a section of the squat network which is similar to that reported in literature [21].

also be observed that the reconstructed crack geometry does not extend to y-positions beyond the surface-breaking part of the crack, represented in Fig. 6. That is, the peripheral parts of the squat which lie entirely below the surface cannot be detected unless it extends to the surface, due to the tight closure which exists.

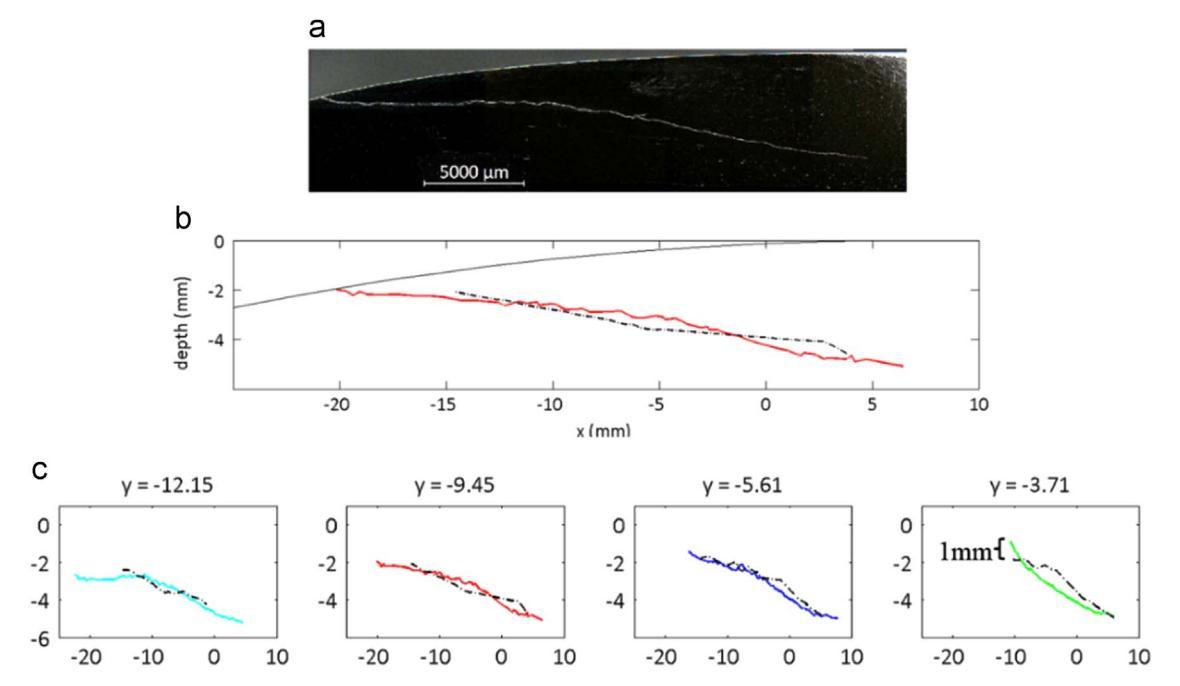
Fig. 7. (a) Transverse cross-section of the squat, (b) from reconstruction (dash-dotted black line) and metallography (solid red line). (c) Reconstruction (dotted lines) and metallography (solid lines) comparisons. It should be noted that the depth is exaggerated in (b) and (c). (For interpretation of the references to color in this figure legend, the reader is referred to the web version of this article.)

crack obtained through metallographic sectioning. Similarly, the surface-breaking section of the crack was not always present in the 3D reconstruction, since planes were plotted assuming piecewise parallelism, there is a limit to the degree of curvature that can be interpreted. The method, however, was found to give a reliable description of the geometry of the crack on medium depths; that is, each curve measured from the metallographic cross-section follows well the interpolated curve from the reconstructed surface, as shown in Fig. 7c.

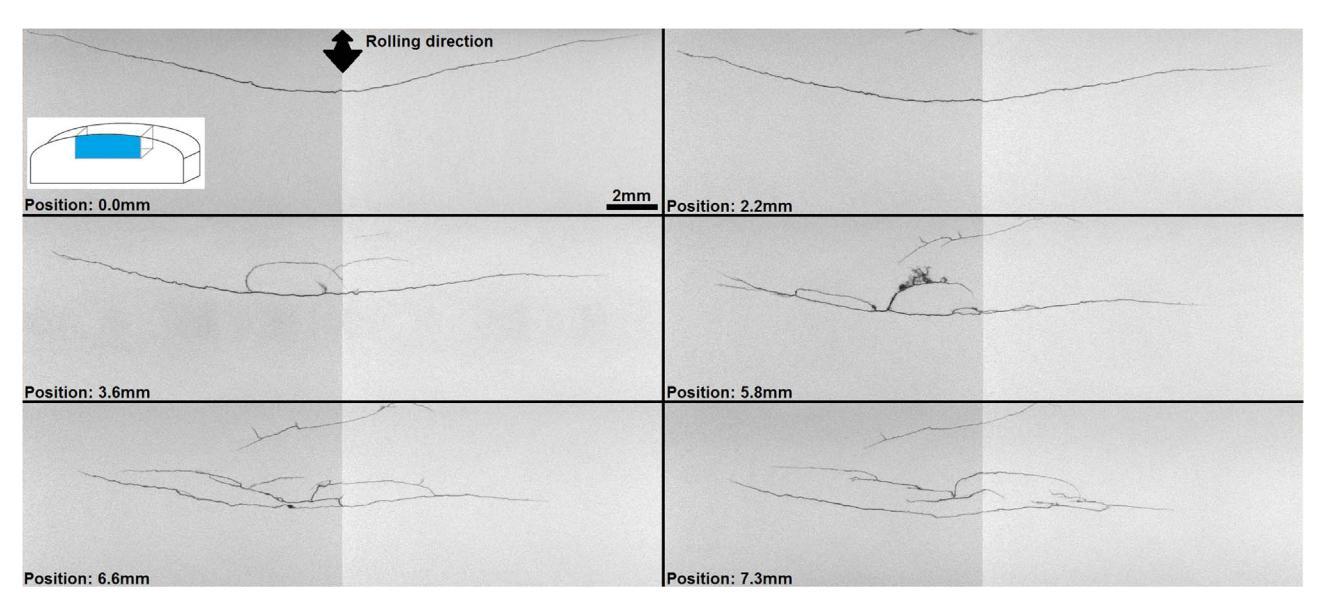
Fig. 8. A series of sections through the reconstructed volume containing part of a squat. The position of the sections is given along the rolling direction. The surface of the rail is approximately 400 μ m above the top of each section.

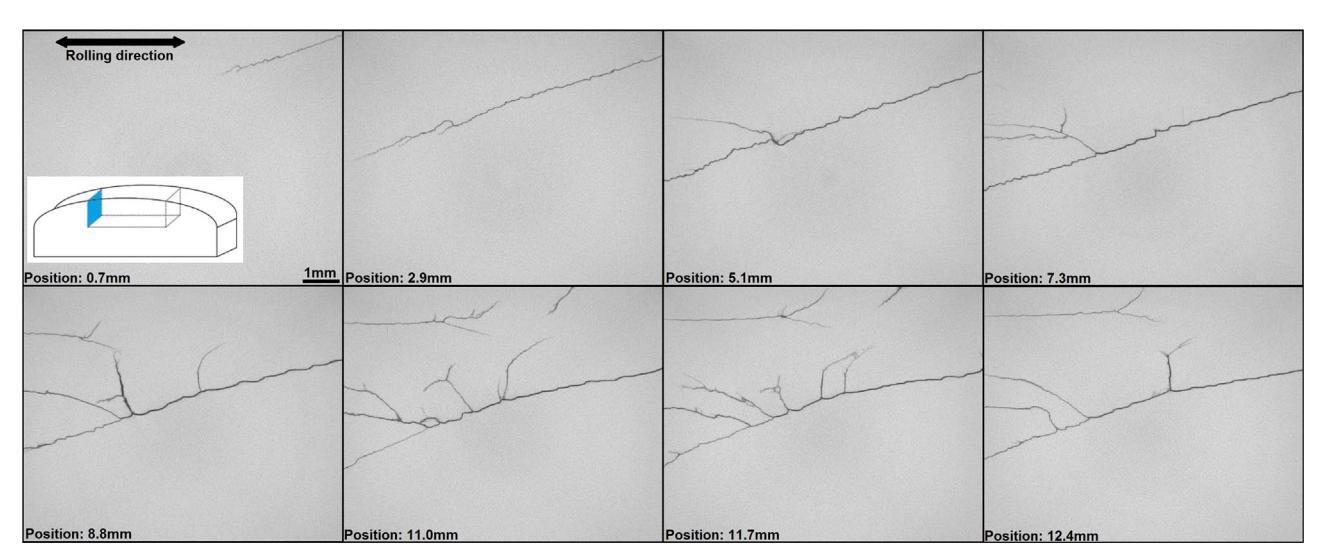
Fig. 9. A series of sections through half of the reconstructed volume of a part of a squat. The position of the sections is given transverse to the rolling direction. The surface of the rail is approximately 400 μ m above the top of each section a. (For interpretation of the references to color in this figure, the reader is referred to the web version of this article.)

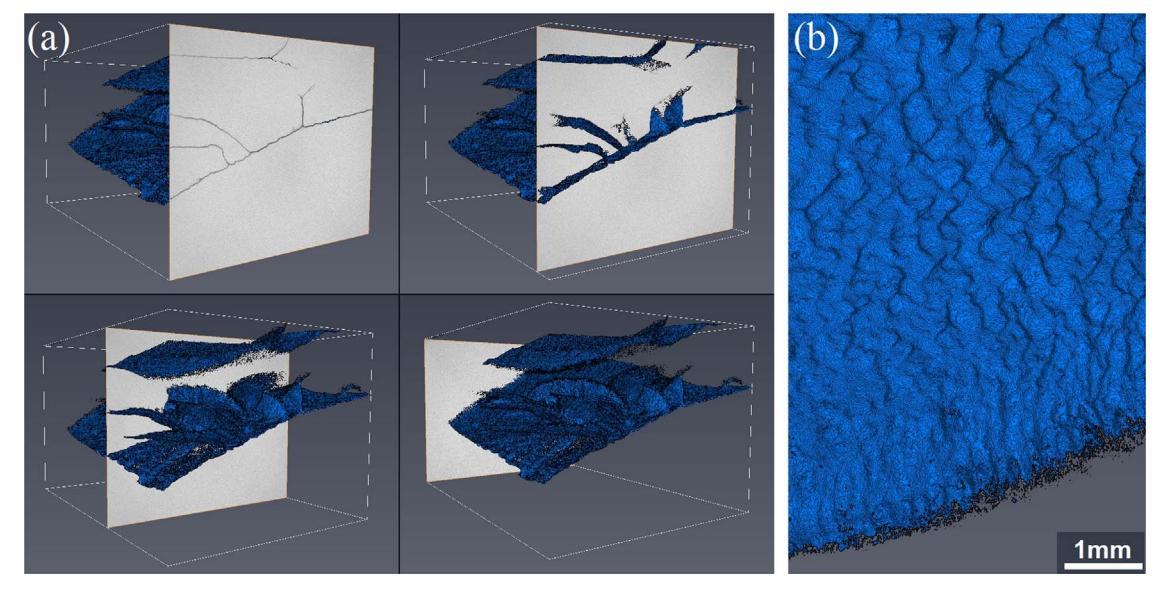
Fig. 10. (a) 3D representation of the crack network in blue from the same volume shown in Fig. 9. Four sections through the reconstructed volume illustrate how the images in Fig. 9 are taken. (b) Overhead view showing crack ridges. (For interpretation of the references to color in this figure legend, the reader is referred to the web version of this article.)

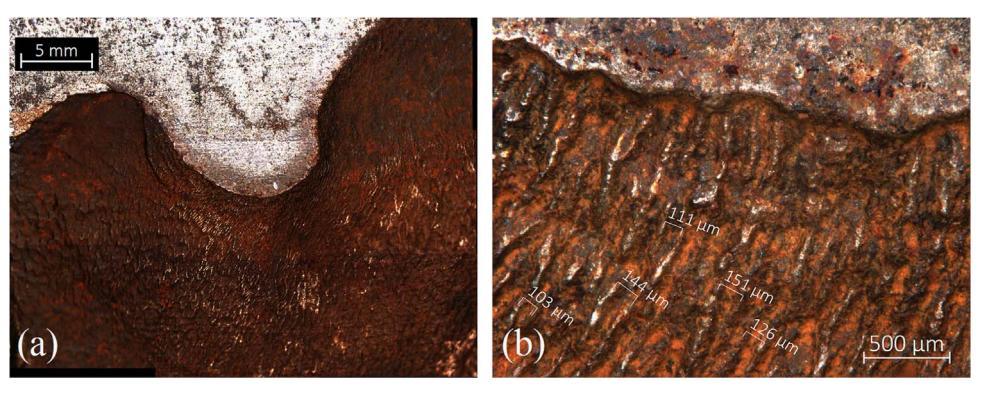
Fig. 11. Images from stereomicroscopy of (a) squat surface, and (b) detail of squat surface close to the tip of the v.

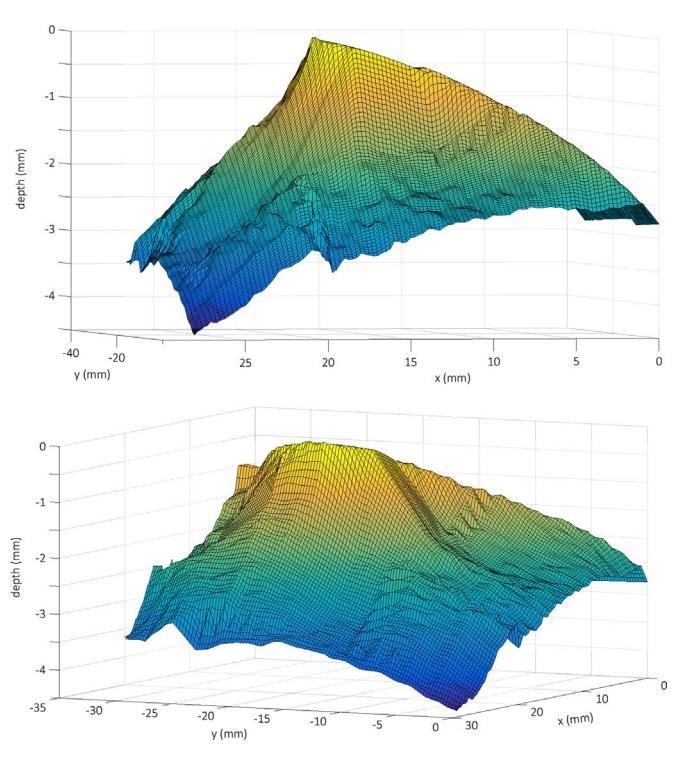
Fig. 12. Mapping of overall squat geometry, 1 mm step size.

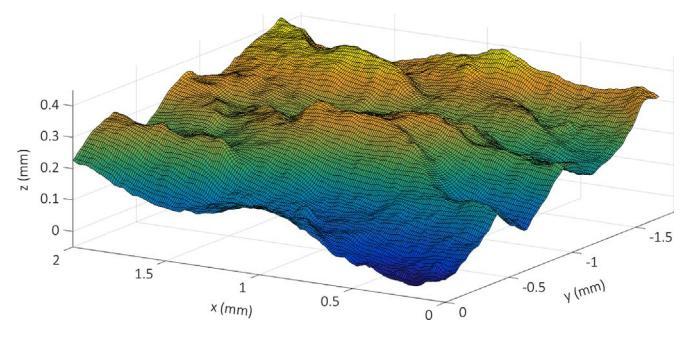
Fig. 13. Mapping from topography showing ridges, 50 um step size.

A squat was broken open, and the bulk-side face of the crack network was investigated for topography. The 3D mapping showed a highly textured surface on different scales: pronounced ridges, some beach marks, and variations in surface roughness. These features are not apparent in the reconstruction nor the metallographic sectioning, adding an extra dimension to the complex squat crack network geometry. A careful investigation of the fatigue surface was not done in this study, but it should be noted that the presence of ridges signifies a relative movement between the crack faces only in the direction of the ridges. In other areas, varying sliding direction between the crack faces generates a smooth surface due to plastic deformation and wear.
