A CASE OF PEELING

Anders Nielsen⁽¹⁾

Abstract

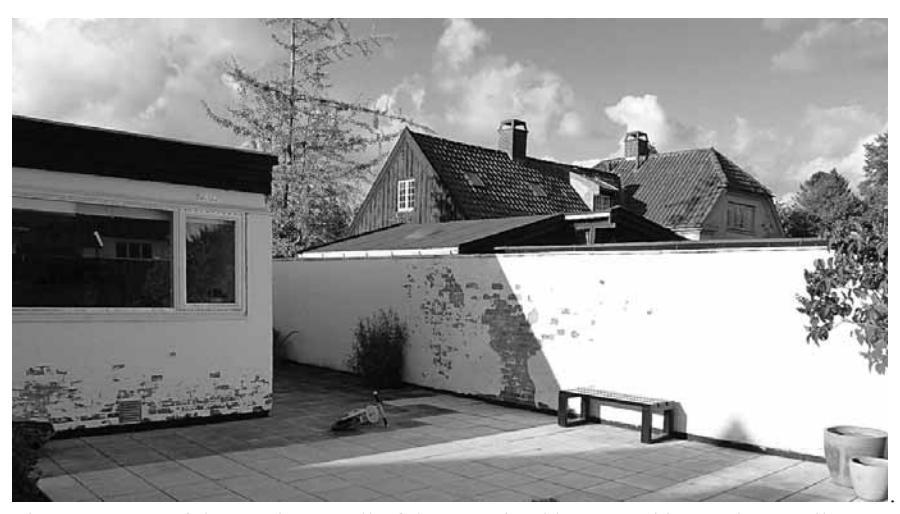
Figure 1. Part of the southern wall of the examined house and its gardens walls. May 27, 2015, 18.28 o'clock.

The peeling occurs on a villa situated in Nordsjælland north of Copenhagen. It was build in 1960's with facades and garden masonry walls of red tile. Around 1995 the walls were painted with polymer paint. Before the painting the walls were smoothened with cement plaster with thicknesses up to 4 mm. The plaster consists of fine sand and cement as binder. In 2011, before a sale of the villa, the walls were painted again. At that occasion the gardens walls got another layer of plaster, before the painting. In the winter 2011- 2012 the peeling began and is still going on. I had the opportunity to examine the walls in 2015 in connection with a trial about payment of the repair.

- The correct repair in this case will be to remove all plaster and paint, and treat the walls with air lime mortar and lime wash, as should have been done from the beginning.

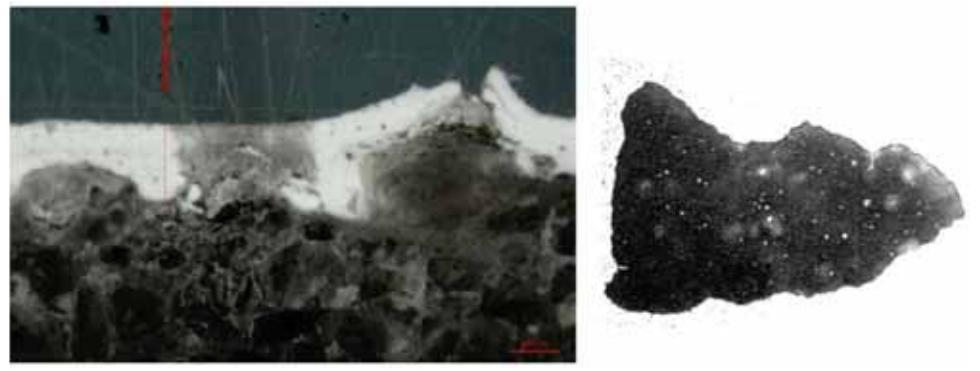
The specimens were examined on polished sections, Figure 2. The thickness of the inner layer were measured to 0,185 - 0,359 mm, and of the outer layer to 0,066 - 0,350 mm. Further it was observed that the paint contained inorganic material, probably kaolin.

Figure 2, left: Micro photo of cross section of the treatment on the south facade of the house. Lowest the cement plaster (grey and black), above the two white paint layers. The paint layer is broken over a protruding stone. The breath of the picture is equal to 2,5 mm. Photo DTI. Figure 2, right: A piece of the paint layer in transmitted light. A lot of pinholes are seen. The breath of the picture is equal to 11 mm. Photo AN.

Firstly, the application to the rough surface of the cement plaster gives a paint layer, which in no way is "a homogeneous layer". The paint film is punctured over the protruding sand particles from the plaster, because the capillary forces in the fluid paint draw the film away from the top of the particles, cf. Figure 2.

The cement plaster used for the smoothening of the masonry is very dense and strong. I have not got any numbers for the properties, but on polished sections it can be seen that the plaster is very dense, cf. Figure 2. The strength is illustrated from the fact that it is not possible to break small pieces with the fingers.

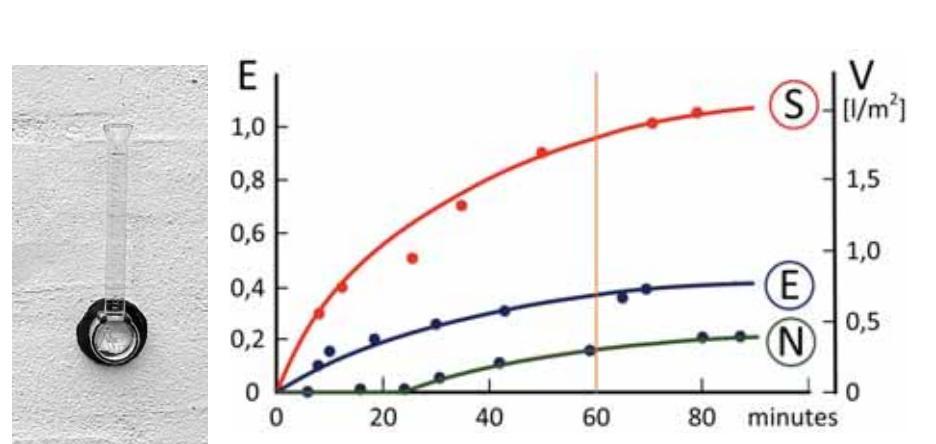
Figure 3. Karsten tube measurements. The glass tube at the device, left, is divided in units, E, which are transformed to suction, V l/m^2 . The height of the tube is 15 cm.

The capability of the surface treatment to suck up water was measured on three different walls by means of the so-called Karsten tube, cf. Figure 3. The measurements were taken in May 2015, i.e. four years after the painting. Measurement S was taken at the South faced façade, which is the most exposed. The suction here is around 1.8 l/m^2 after 1 hour. Measurement E is from the East faced façade, which is less exposed. Here the suction is 0.7 l/m^2 after 1 hour. Measurement N was taken on the North faced façade. Here it is seen that nothing happens in the first 24 minutes, hereafter the suction starts. This seems to correspond to the information about the high amount of kaolin in the paint: When the kaolin has expanded due to the water up-take, the paint layer has been opened so much that the water penetration can begin.

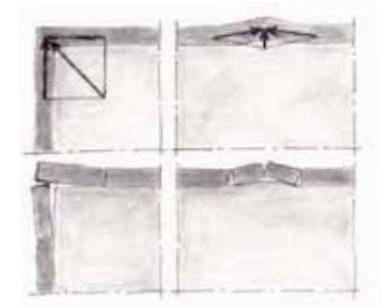
From the literature, e.g. [1], it is known that the thermal expansion of masonry lies in the interval from $5 - 8 \times 10^{-6} \, {}^{\circ}C^{-1}$ dependent on the type of mortar used. The thermal expansion of cement mortar lies in the interval $8 - 14 \times 10^{-6} \, {}^{\circ}C^{-1}$ depended on the amount of cement. So, the cement mortar will contract or expand nearly twice as much as the masonry for the same temperature change. Furthermore, at temperature changes the plaster layer is cooled or heated first in relation to the tile. This means that the plaster will try to contract or expand much more than the tile, which again means that contracting or compression forces are created in the plaster. During cooling the contraction may create cracks in the plaster. During heating the compression forces interact around corners and irregularities, giving outward directed

Figure 4. The compression forces in the surface layer cooperate at corners and unevenness's in resultants, which exceed the adhesion, thus causing peeling.

forces exceeding the adhesion; thus the plaster will peel of, cf. Figure 4. For this reason the peeling most often starts at the corners.

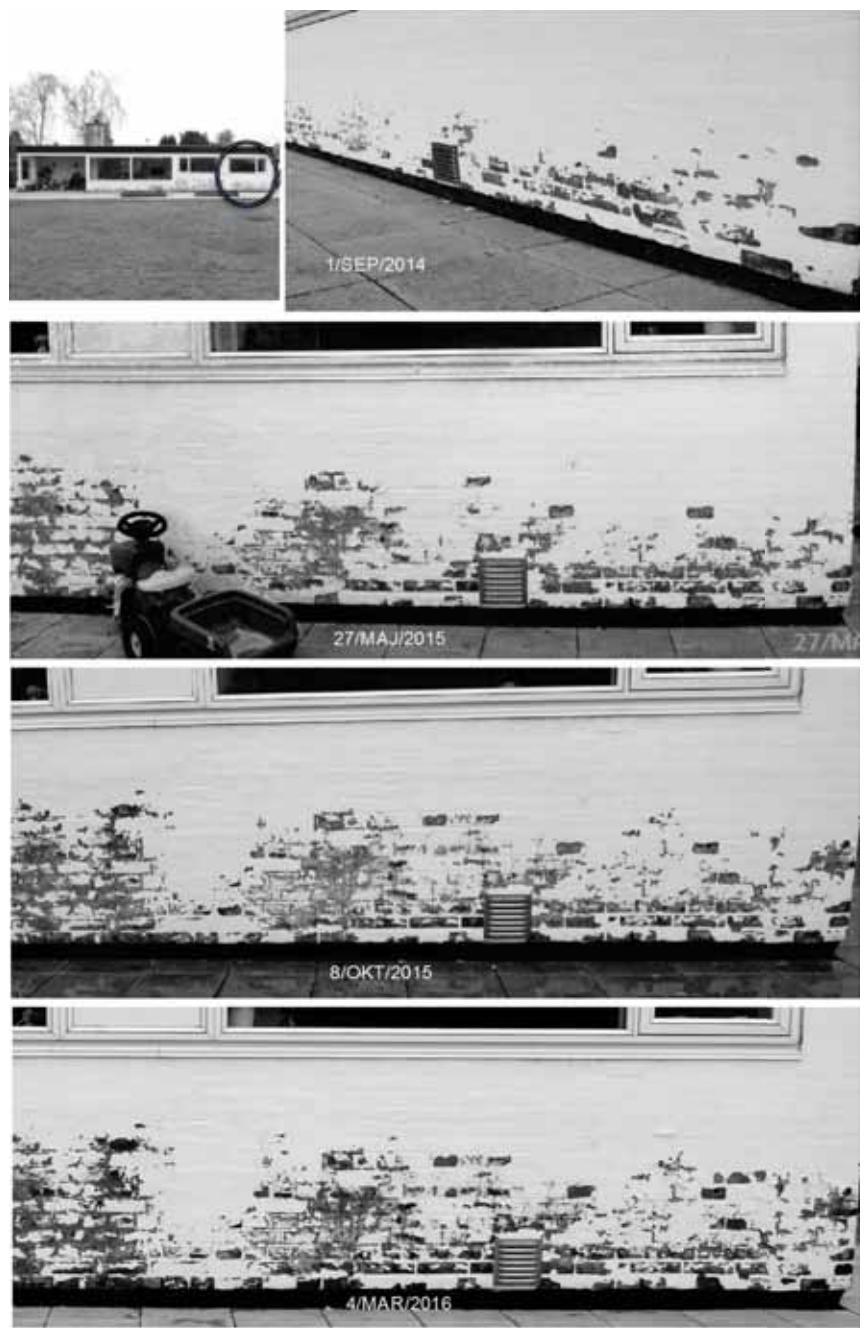
The damage does not start at day one. It is necessary with a number of temperature changes where small cracks are developed before the visible peeling starts. But first started, the phenomenon will occur all the year round, because temperature differences occur both summer and winter. This is in opposition to the generally accepted view that the peeling occurs in winter caused by freezing. The pictures on Figure 5 shows that the peeling takes place all the year round. The peeled-of pieces consist of plaster in the whole thickness, leaving the tile exposed.

Figure 5. Development of the peeling from September 1, 2014 to March 4, 2016.

The main cause of the peeling seems to be the difference in thermal expansion between the masonry and the cement plaster. The peeling occurs all the year round.
