# 2D and 3D characterization of rolling contact fatigue cracks in manganese steel wing rails from a crossing

*Published in:* Wear

Publication date: 2019

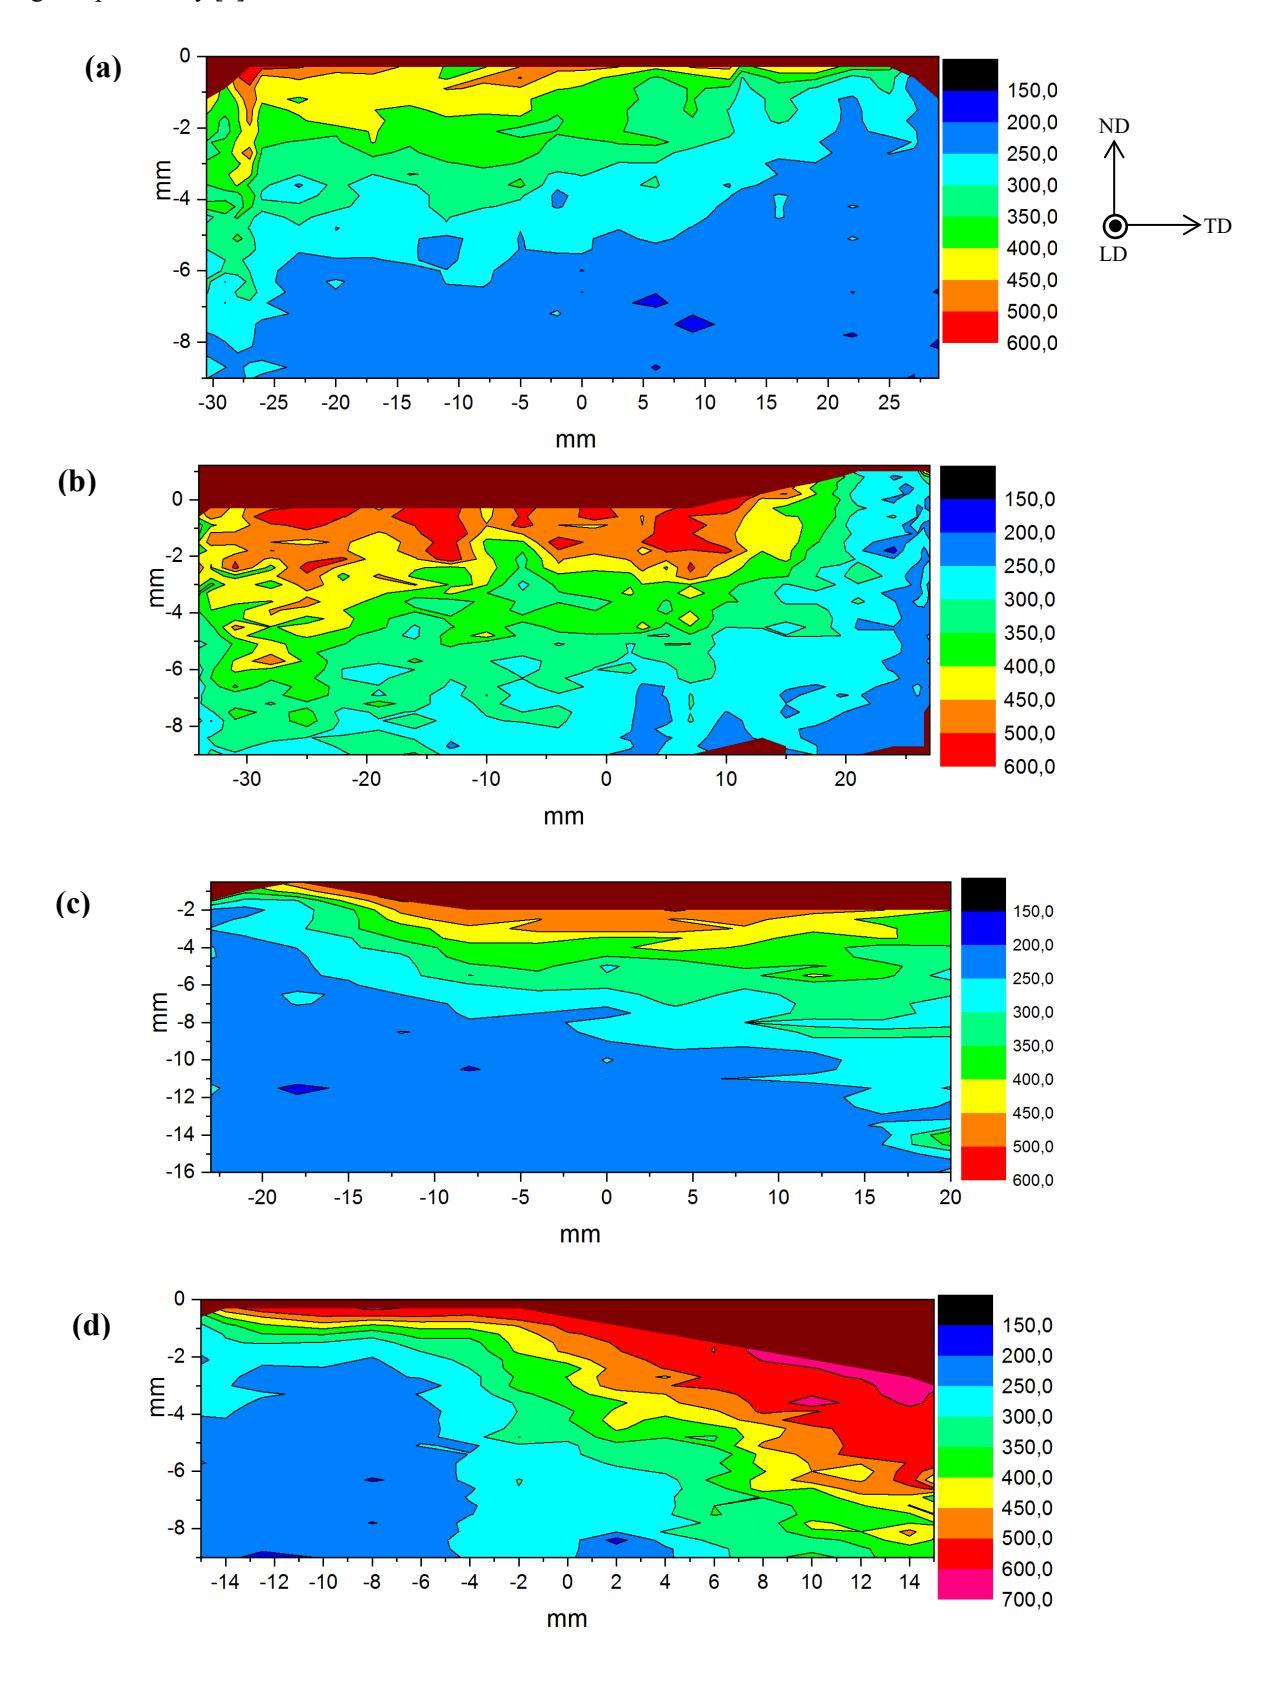
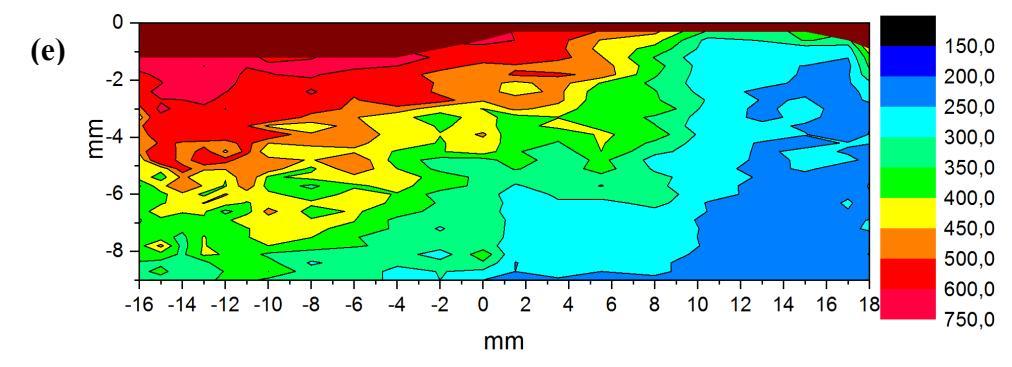
Figure 2 shows the hardness maps of the two wing rails at different locations. The positions (i), (iii) and (iv) belong to wing rail 1 and (ii) and (v) to wing rail 2, which had been repair welded. As shown, the hardness measurements were made on wing rail 2 at locations away from the weld. The figures show that the hardness gradient is different at different locations, due to the difference in rail wheel contact at those places. In positions (ii), (iv) and (v), the deformation hardening is most severe at the top layer showing a high hardness of more than 600 Hv. The hardness maps from locations (i) and (iii) show that these locations are comparatively less deformed. The extent of deformation varies due to the difference in the direction of traffic (diverging track or straight track). Below the wheel running surface the hardness values decrease, indicating less deformation at larger depths, with the undeformed region having a base hardness of around 220 Hv. Cracks were found at region (ii), although the hardness as well as depth of hardening are higher at region (iv) and (v). No cracks were found in these very hard regions; (iv) and (v).

Region (i) has the least deformation and maintains the original rail profile shape, whereas in the other cases, the rail profile changes with deformation. With increased deformation, the depression of the surface profile (as in Figure 2b, 2d and 2e) compared to the original profile gets more severe. The work hardened layer is observed to extend to 10 mm below the surface. This depth of the deformation in the investigated wing rails is found to be nearly the same as found in case of the manganese nose rail studied previously [9]. Although the previously studied crossing was fairly a new one (5 years in service) compared to the crossing in the present study (13 years in service), the yearly traffic density through both the switches was approximately the same (14MGT). The depth of hardening was the same in both cases. Similar depth of hardening is reported for manganese crossing experiencing 130 MGT loads during service in another study [10]. Depth of hardening by other deformation mechanisms like explosion hardening can be much higher up to 25 mm from the surface [11]. The depth of hardening from wheel/rail contact is significantly higher in manganese grade crossings compared to normal pearlite grade. In literature it has been reported that in pearlitic grade the depth of hardening extends to only 3-5 mm from the wheel running surface [12-13].

**Figure 2:** Hardness contour maps of the wing rails at different locations: (a) Wing rail 1 position i, (b) Wing rail 2 position ii, (c) Wing rail 1 position iii, (d) Wing rail 1 position iv and (e) Wing rail 2 position v. The axes only indicate the scale. The zero points are chosen arbitarily.

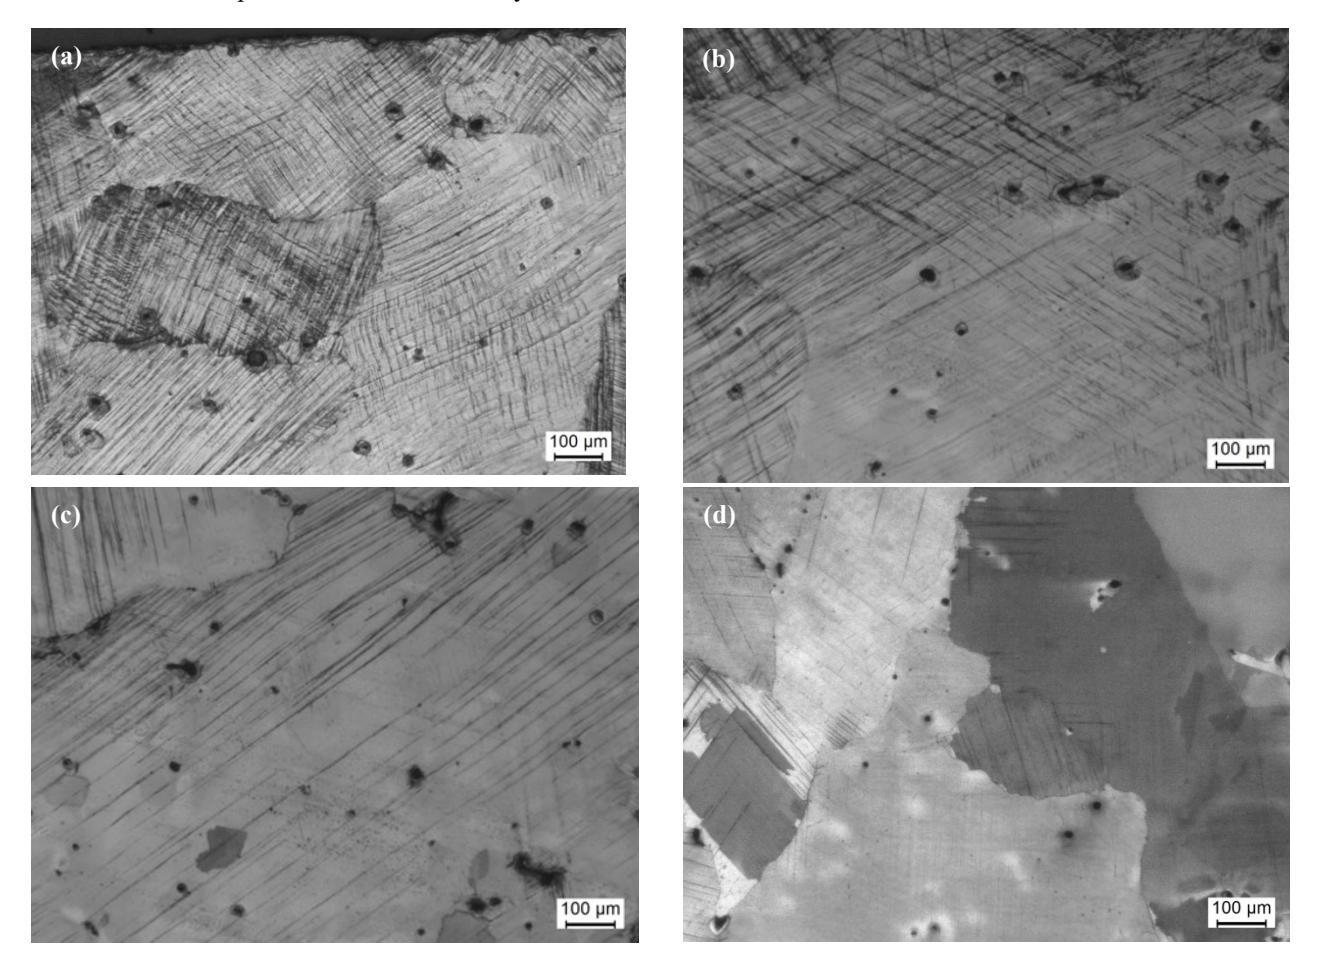
The microstructure is austenitic in manganese steel. The grain size is coarse, ranging up to 500  $\mu$ m, and the grains do not deform by shearing as in pearlitic rails. Figure 3(a-d) shows optical micrographs of the deformed wing rail at different depths from the wheel running surface. At the rolling contact surface, Figure 3a, a large number of bands can be seen crossing each other within the grains. The deformation in manganese steels is manifested in the form of these bands and not by the usual elongation of grains as seen in pearlite. The surface receives the maximum deformation and hence the density of the bands is higher here and decreases with depth from the surface (Figures 3a-d). At around 12 mm in depth (Figure 3d) the microstructure is almost free from deformation bands. The deformation bands are inhomogeneously distributed with a wavy appearance and the direction of the bands varies from one grain to another. From optical microcopy it is not possible to reveal whether the deformation bands are mechanical twins or dislocation boundaries. The deformed microstructure in the wing rail was found to be similar to the manganese nose rail

**Figure 3:** Optical microscopy images of the transverse section (a) at the rolling contact surface, (b) at 6 mm depth from the surface, (c) at 10 mm from the surface, and (d) at 12 mm from the surface, where the base hardness has been reached.

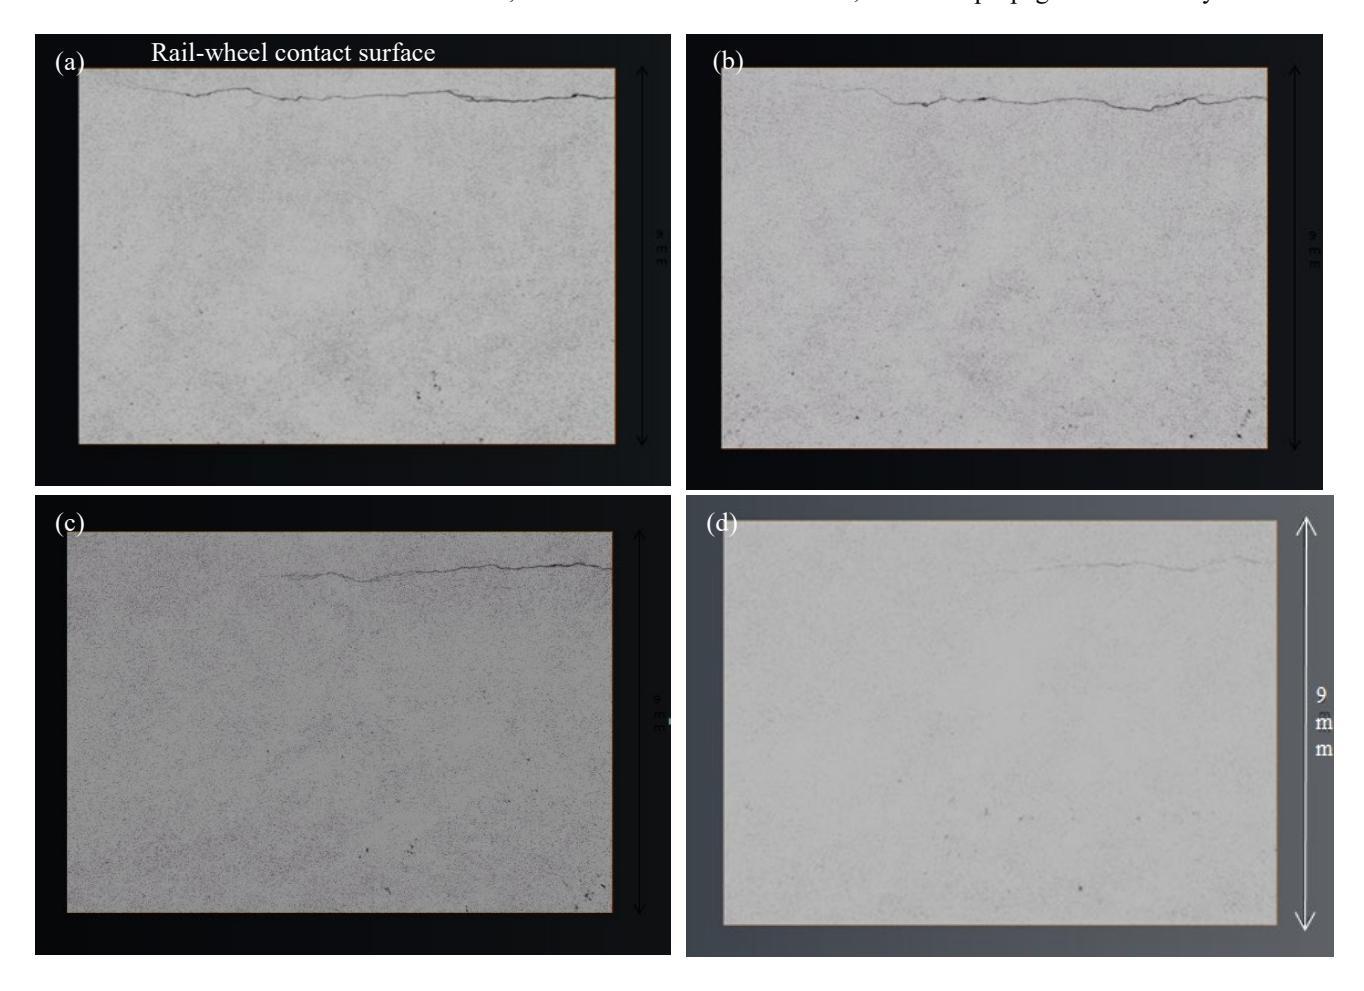
Two samples with size 10 mm by 10 mm by 40 mm from wing rail 2 (see Figure 1e) were characterized by X-ray tomography. Figure 4(a-d) shows 2D slices from one of the 3D tomographic reconstructions. Tomographical reconstructions are 3D density maps, which allow detection of even small cracks due to differences in density, thereby identifying cracks in 3D giving a detailed overview of the entire crack surface. Figure 4 shows a very long subsurface crack parallel to the running surface across the entire cross section of the specimen. However, the full 3D reconstruction also reveals the presence of cracks in contact with the surface. While most of the cracks run parallel to the running

surface, the crack network is extensive and continuous.

**Figure 4:** 2D slices showing the crack network within the wing rail at different locations along the longitudinal direction (a) at the trasverse cut (0 mm), (b) 10 mm from the transverse cut, (c) 18 mm from the transverse cut and (d) 29 mm from transverse cut.

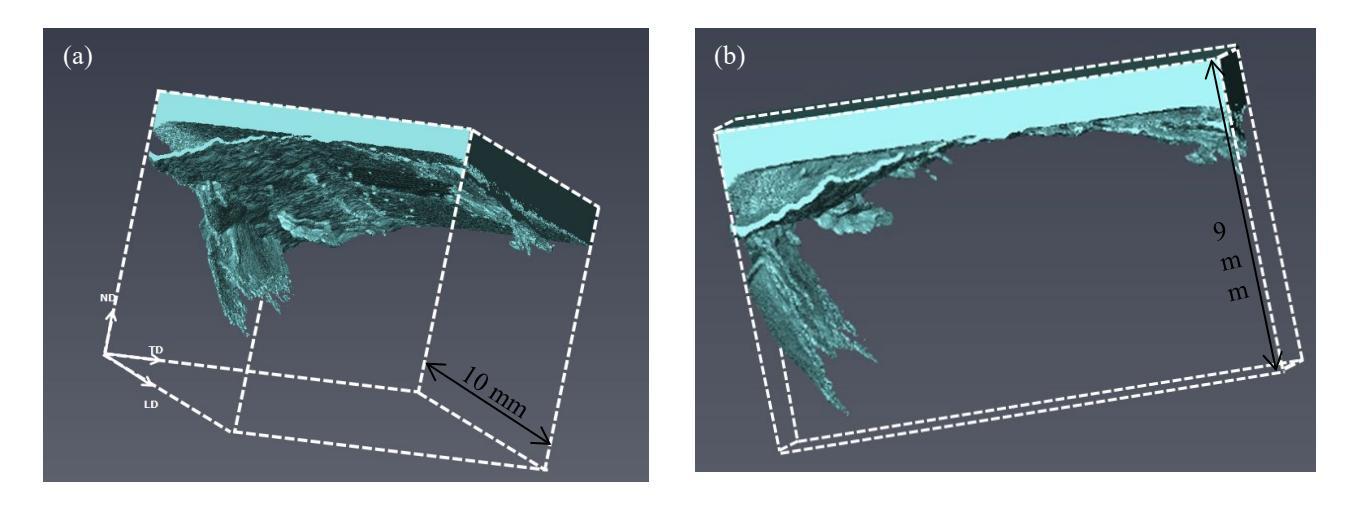
Figure 5 shows the 3D reconstructions of another crack network in sample 2. In this figure, the steel is represented as transparent and the blue colored areas represent air, including air inside the cracks, thereby making the crack network and running surface visible. The white box represents the volume of the wing rail which has been scanned. The interior crack surface has a rough and wavy appearance with ridges which are quite similar to the failure surfaces often seen in rolling contact fatigue. Figure 5 also reveals that the crack network is spreading quite deep into the rail, with seemingly random crack propagation. Most of the cracks move parallel to the running surface, as apparent from Figure 4, but there are also some diverging downward branching cracks which could cause rail break in the long run. The wing rail contains both surface and sub surface cracks, where some are interconnected, and some propagate individually.

**Figure 5:** (a and b) 3-D tomographic representations of the crack network within the wing rail of a manganese crossing seen from different directions. The steel is represented as transparent and the blue coloured area represent air, making the crack network and running surface visible.

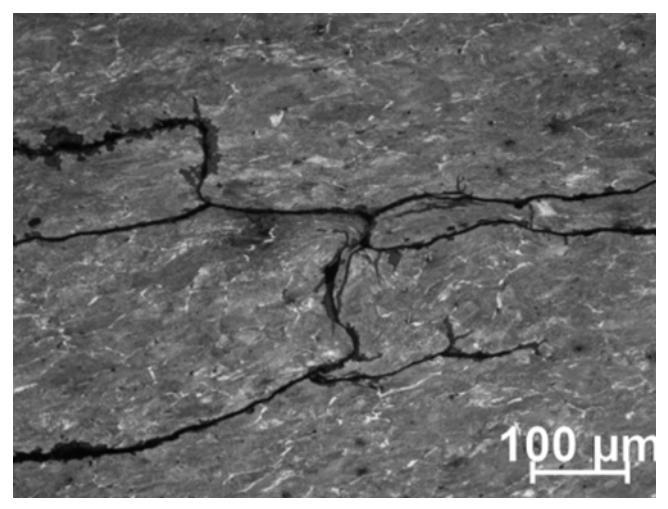
The two-phase microstructure in a pearlite grade material, consisting of ferrite and cementite, affects the deformation mechanism and eventually the crack initiation and propagation [14], where cracks tend to propagate through the softer ferrite phase, resulting in a wavy appearance. Figure 6 shows a rolling contact fatigue crack in pearlite grade steel from a straight track with a wavy crack propagation that passes through several grains. Figure 7 shows an optical micrograph of a subsurface crack in the wing rail of the manganese steel crossing investigated in this work having the same wavy appearance intersecting several grains with several crack branches and a seemingly random crack propagation. This is in correspondence to the cracks found in a manganese steel crossing nose studied previously in [9], where a more detailed study showed the cracks avoided the twinned regions (harder areas of the matrix) and were mostly transgranular giving the wavy appearance by following the weakest link in the microstructure. Therefore, although the plastic deformation is caused by slip in pearlitic grade without twinning, and for manganese steel deformation is from both dislocation motion as well as twinning, the crack networks have a similar appearance for pearlitic steel straight tracks and manganese steel crossings irrespective of the very different loading conditions in the two cases.

**Figure 6:** Optical micrograph of a rolling contact fatigue crack in a rail from straight track of pearlitic steel [15].

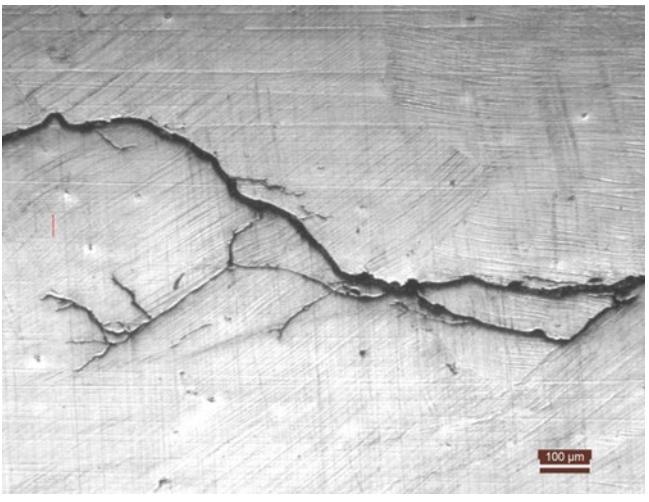
cracks found in pearlitic grade steel used in normal straight tracks. The cracks tend to be concentrated mostly within the plastically deformed layer and have a wavy surface appearance which is common for rolling contact fatigue cracks.

**Figure 7:** Optical micrograph of a rolling contact fatigue crack in the wing rail of manganese steel crossing.
