Fatigue testing of a 14.3 m composite blade embedded with artificial defects – damage growth and structural health monitoring

Published in: Composites Part A: Applied Science and Manufacturing

Publication date: 2021

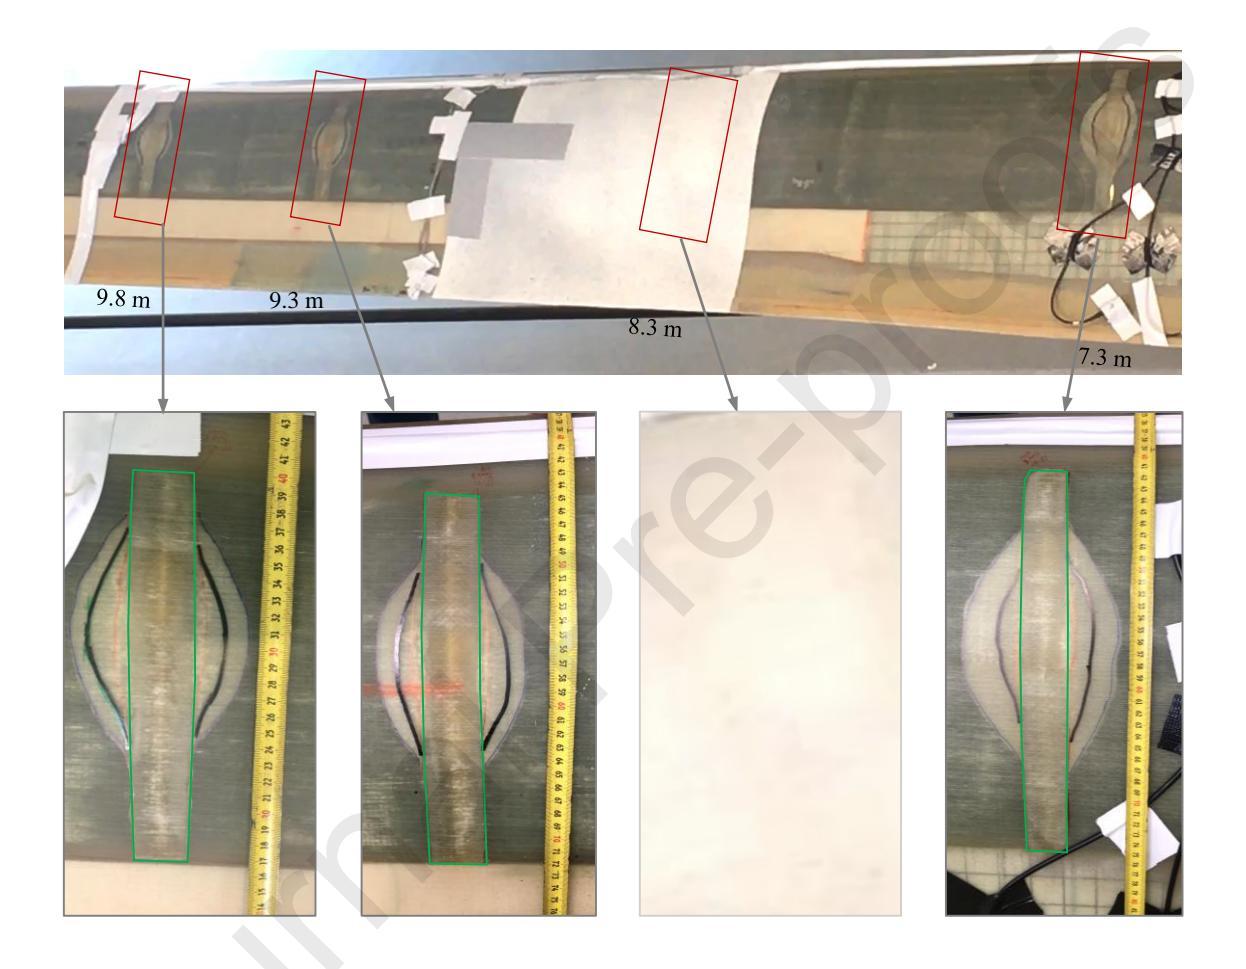
Figure 8

During the flapwise fatigue test, several damages initiate and progress from artificial defects. The most significant is the delamination originated from laminate wrinkles embedded in the spar cap. Fig. 8 shows three locations at 7.3 m, 9.3 m, and 9.8 m which have visible delamination growth with the increase of the fatigue cycle number. It is visual as the blade is not painted in these regions. It can be seen that the delamination regions at these three locations exhibit a similar belly shape at both sides of the embedded wrinkles. The center regions show maximum delamination growths as they are subject to higher cyclic strains due to the curvature of the spar cap in the transverse direction, i.e., meaning that the central regions are furthest away from the neutral axis of the cross sections when the blade is under flapwise fatigue loading. Different stages of delamination growth are marked with the increase of fatigue cycle numbers up to 38000 cycles under high-load fatigue. Note that the delamination at 8.3 m is not visible due to the paint for DIC measurements.

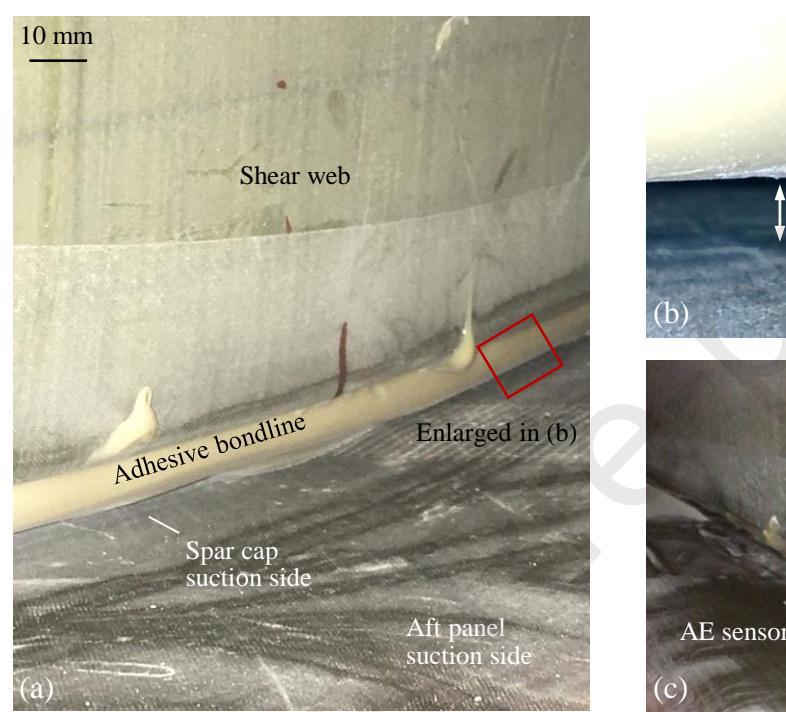
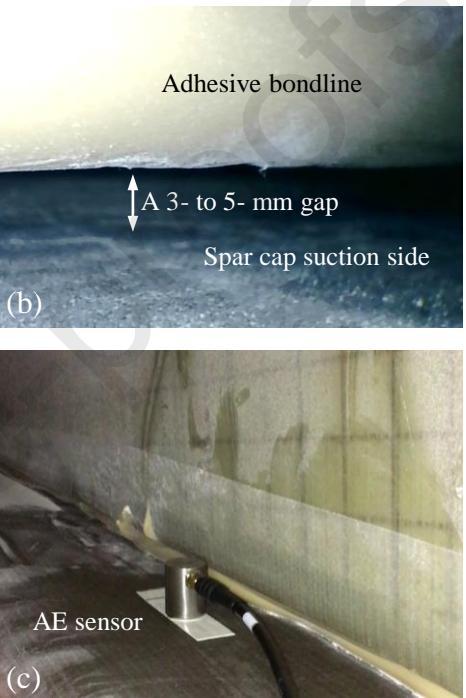
Figure 14

Note that channel #8 and #9 have been active during the fatigue test but they only generate low AE energy per hit with average values of 9.5 and 6.7 MARSE/hit, respectively. In comparison, ch #1, #6 and #7 generate 215.8, 37.0, and 150.5 MARSE/hit, respectively. Visual inspection reveals that the low AE energy activities in ch #8 and #9 are caused by the tapping, or cyclic contact, between the shear web and the spar cap on the blade suction side shell due to the adhesive joint debond when the blade is under fatigue, see Fig. 14 and Supplementary video S1.

Fig. 14. Manufacturing-induced debonds between the shear web and the spar cap at the suction side of the blade. The initial debond is approximately 65cm long and starts 0.5 m from the shear web end, i.e., the debond spans from 1.00 m to 1.65 m along the blade axis. (a) An overview of the adhesive bondline between the shear web and the spar cap. (b) The debond region where a 3- to 5- mm gap exists. (c) An acoustic emission sensor ch #8 is installed close to the crack tip at a 1.65 m blade spanwise location.

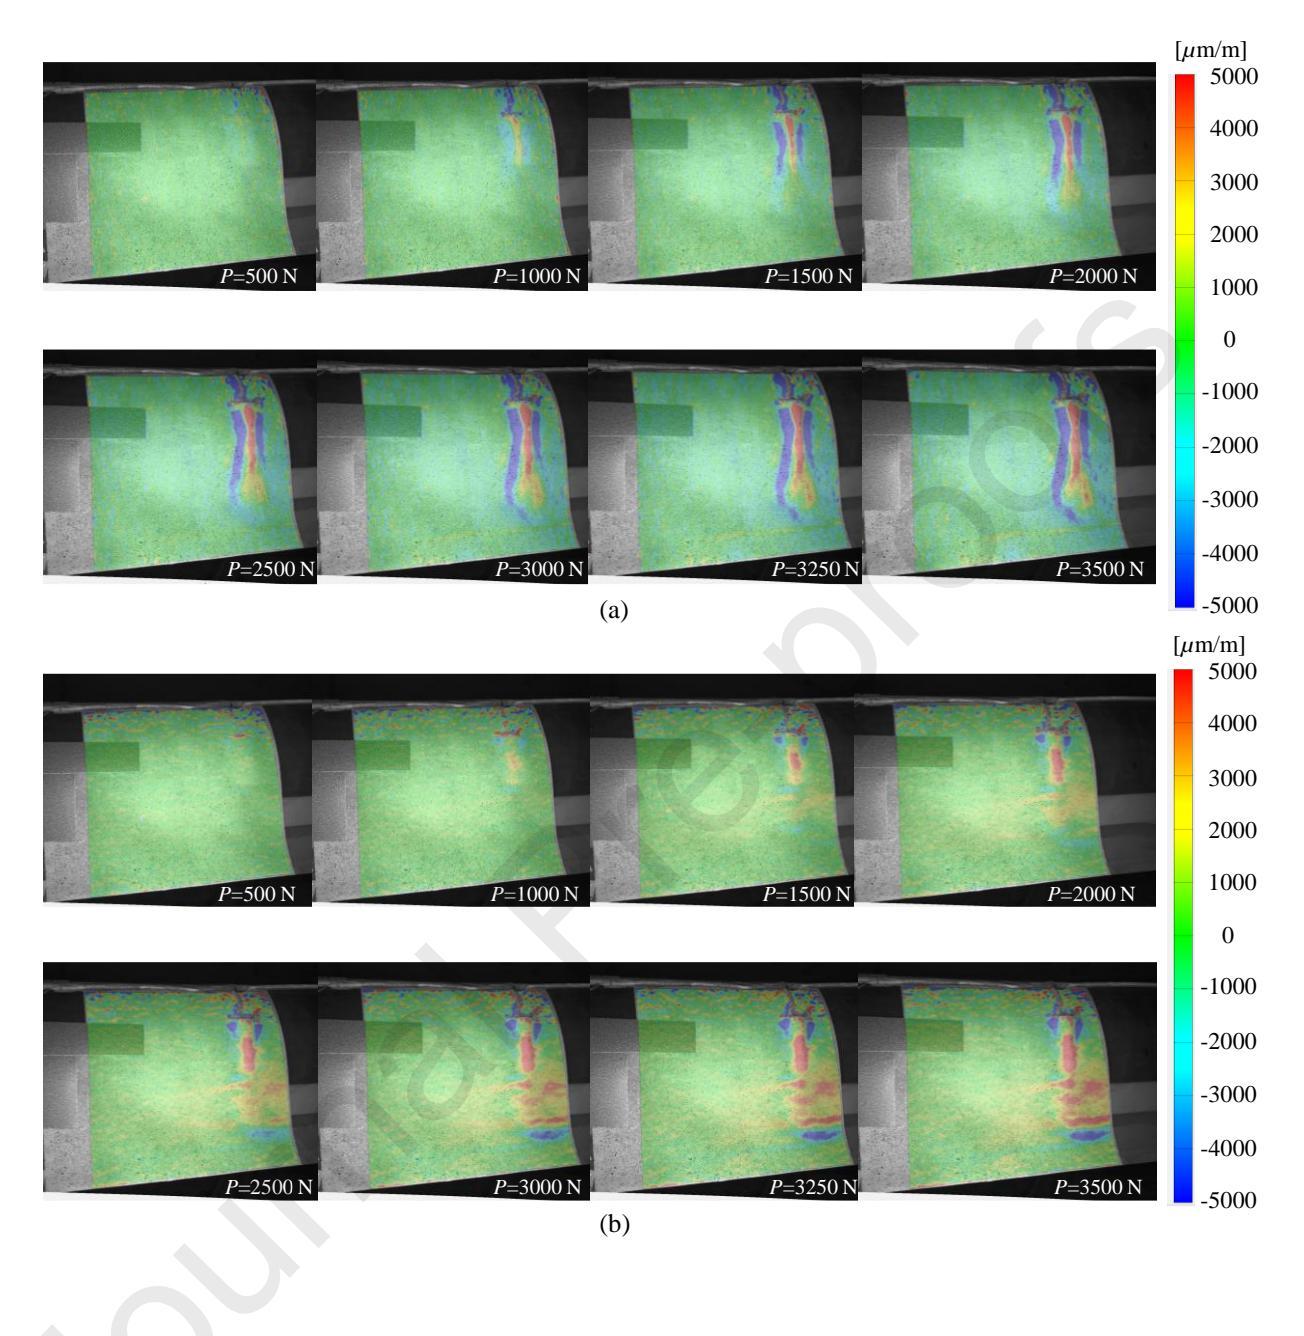
Figure 15

In order to investigate what happened underneath the painted spar cap region at 8.3 m, DIC measurements are carried out. First, it is decided to do DIC measurements under static loading due to a concern of structural collapse under fatigue loading; second, the loading saddle is removed so that the blade has a simple boundary condition as a cantilever beam fixed at the root on the test stand; and then, a static load is applied at the 13 m cross section using a crane that pulls the blade upward. The DIC system measures longitudinal strains along the blade axis direction and transverse strain along the chordwise direction. The DIC measurement results are shown in Fig. 15.

It can be seen that starting from a static load of around 1000 N, the region with the embedded wrinkle WK#2 shows a buckle wave in the spar cap, which is indicated by both compressive longitudinal strains shown in blue and tensile longitudinal strains shown in red in Fig. 15(a). In addition, the discontinuity of strain contour at the top of the winkle region indicates a surface crack there. Note that the buckle covers beyond the spar cap, meaning that the damage has propagated into sandwich panels adjacent to the spar cap.

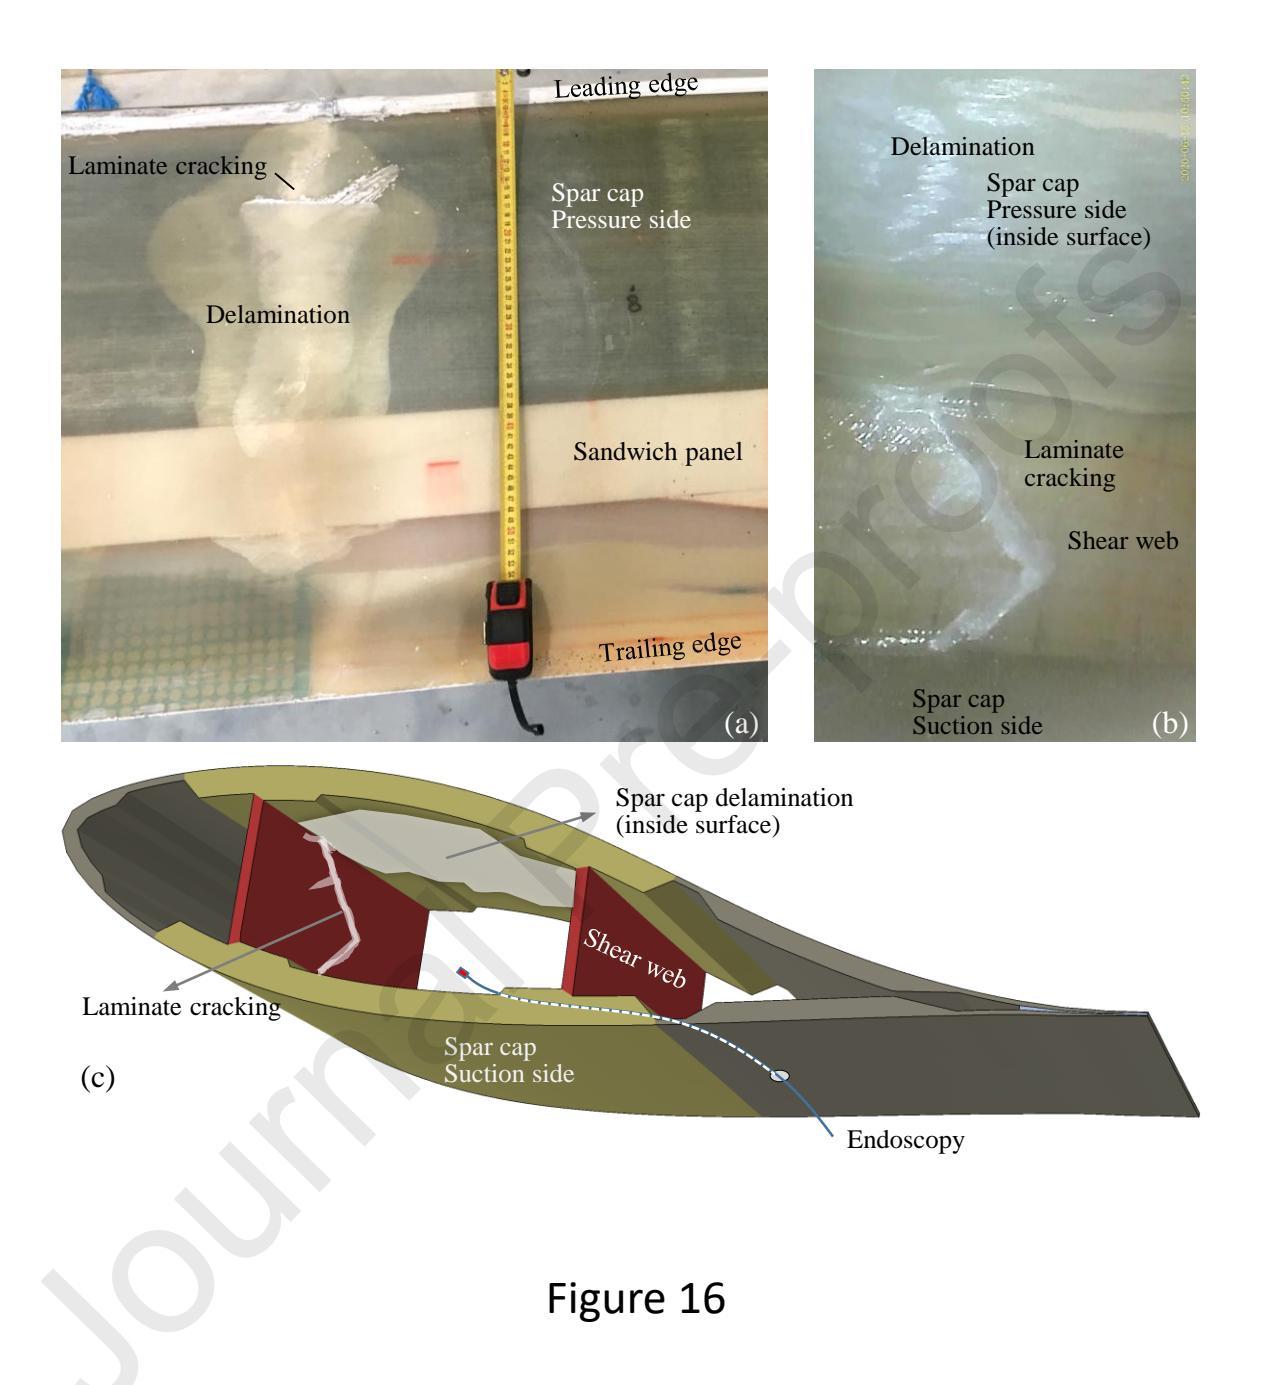
To verify the findings from the DIC measurements, the paint is removed and the delamination damage at this location is now visible, see Fig. 16(a). Indeed, the spar cap laminate is significantly damaged by delamination as well as surface cracking. The delamination exists not only in the spar cap but also in the sandwich panels. An endoscope (Teslong TSMS450D8L5 with dual lens) is used to inspect the internal damage of this cross section as shown in Fig. 16 (b). It is shown that the delamination of the inside surface of the spar cap as well as laminate cracking in the shear web. Fig. 16 (c) summarized the internal damage found by the endoscope.

Fig. 16. Fatigue failure at the 8.3m section due to an embedded wrinkle in the spar cap laminate. The observation is made after removing the paint with speckle patterns. (a) Delamination and laminate cracking at the spar cap viewed from the outside surface. (b) Delamination of the spar cap and laminate cracking of the shear web with a view taken from the inside. (c) A schematic illustration of internal damage inspection using an endoscopy through a hole drilled in the aft sandwich panel and the rear shear web.

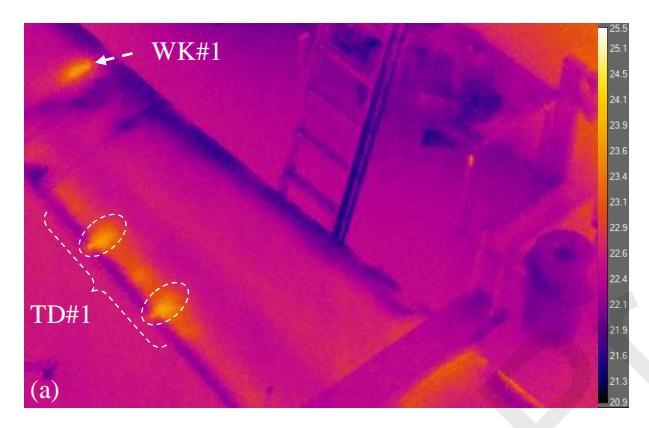
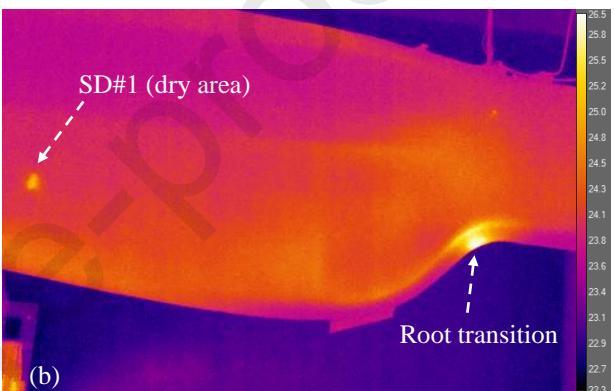
Figure 17

After the flapwise fatigue test, the spar cap on the pressure side of the blade has significant delamination damages around the 8.3 m location. Before starting the edgewise fatigue test, tapered scarf repair with wet layup techniques was carried out, see Supplementary material. Thermal images of the blade under edgewise fatigue loading are shown in Fig. 17. The thermal footprint of the wrinkle WK#1 can be seen from Fig. 17(a) although it is not as significant as it was when the blade is under flapwise fatigue. Remarkably, two hot spots are observed *within* the trailing edge debond region TD#1, which will be further examined in the next section. The inboard region of the blade shows thermal footprints of dry areas of skin laminates in the sandwich debond SD#1 as well as the root transition region due to stress concentration, see Fig. 17(b).

Fig. 17. Thermal footprints of damages when the blade is subject to edgewise fatigue loading. (a) Thermal footprints of a wrinkle WK#1 and a trailing edge adhesive debond TD#1. Note that the length of the debond region is longer than the distance between two hot spots marked with cycles within the debond region. (b) Significant thermal abnormity is observed in the dry area of the sandwich debonding SD#1 and in the root transition region. All images are taken when the blade is under fatigue loading.

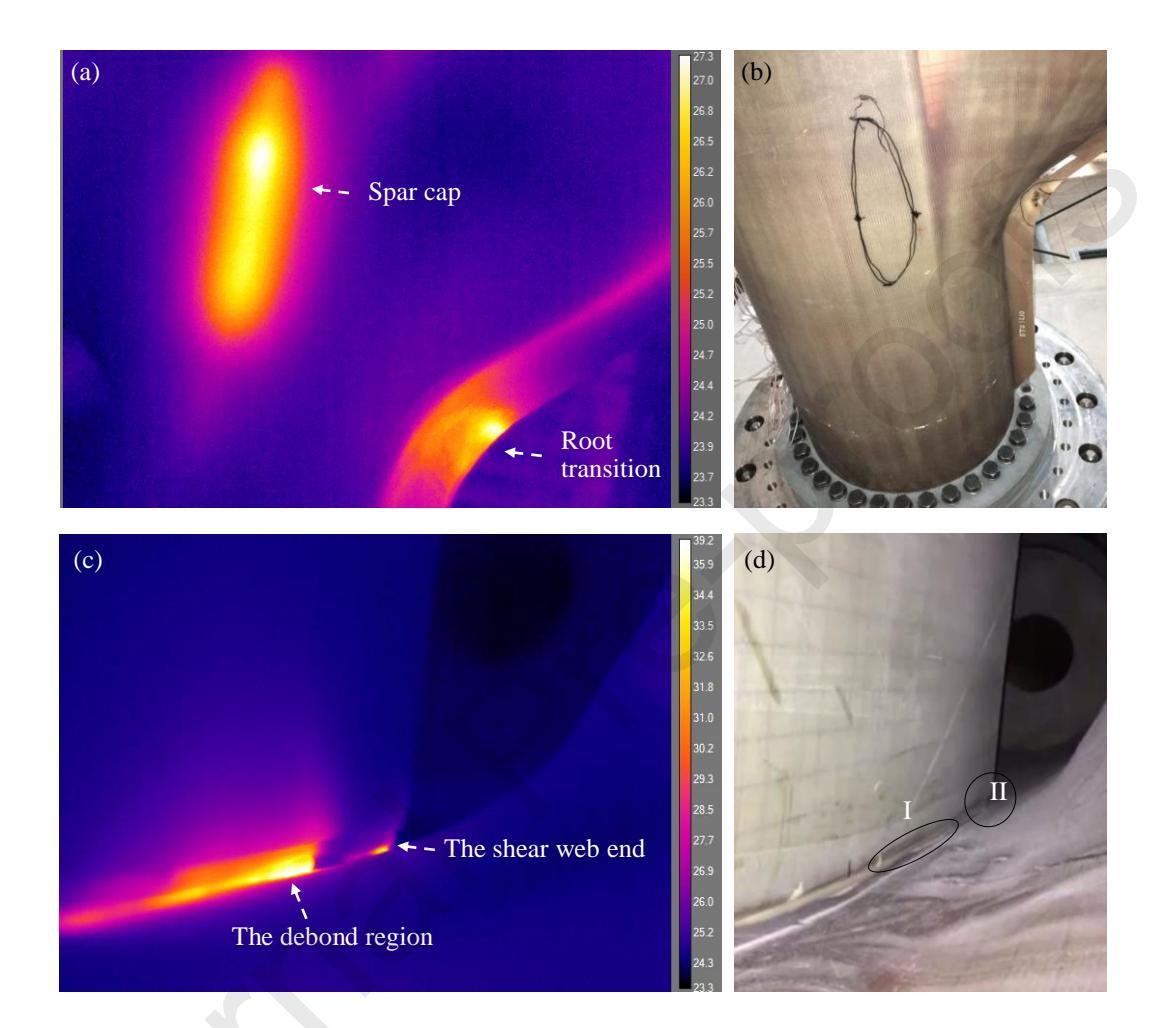
Figure 18

A few close-up thermal images are taken. Fig. 18(a) shows the thermal features in the inboard region where significant heat up in the suction side spar cap and the root transition region is observed. Visual inspection of these two regions as shown in Fig. 18(b) finds delamination in the root transition region but no damage in the spar cap. It is then decided to take a thermal image from the inside of the blade as shown in Fig. 18(c). It is found out that the thermal feature observed from the spar cap is caused by the thermal activities at the debond in the adhesive bondline between the rear shear web and the suction side spar cap. The thermal activities are due to material rubbing and abrasion in the debond region as shown in Fig. 19. The heat generated in the debonding is so substantial with a detected maximum temperature of 39 °C in comparison to a surrounding temperature of about 25 °C that it can be detected from the outside of the blade in the spar cap. This finding shows that it is possible to detect adhesive joint debond underneath the thick spar cap laminate in full-scale blade using thermography without using external heating sources, leading to a new opportunity of using thermography to detect such damages in wind turbine blades while they are in operation.

Fig. 18. Thermal footprints of the shear web debond and the root transition region when the blade is subject to edgewise fatigue loading. (a) A thermal image taken from the suction side of the blade close to the blade root shows two heated regions. One region is the root transition region and the other is the suction side spar cap. (b) An image taken by a regular RGB camera shows two regions with thermal abnormalities. Delamination is found in the root transition region but no damage is found in the suction side spar cap. (c) A thermal image taken inside of the blade shows significant heat-up regions in the adhesive joint between the rear shear web and the suction side spar cap. (d) An RGB camera image shows the bondline under concern. Significant tapping and

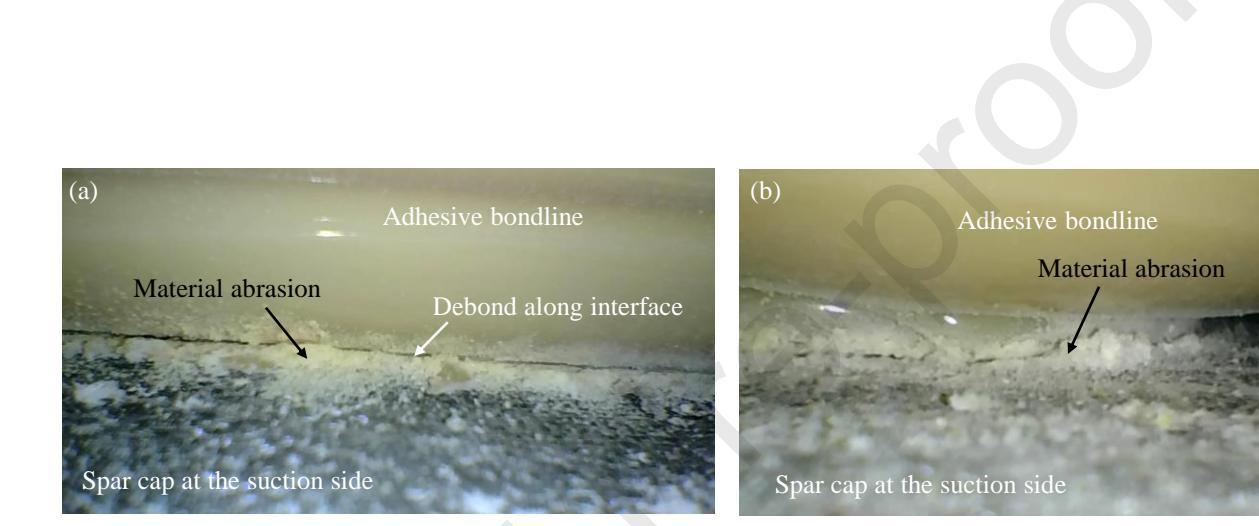
Figure 19

Fig. 19. Significant material abrasion is found in the thermal heat-up locations in the adhesive bondline. (a) This image shows location I as indicated in Fig. 18(d). (b) Location II, i.e., the shear web end, as indicated in Fig. 18(d). The images are taken using the endoscope when the cracks are most visible during fatigue loading.
