APISSEQ Sisimiut – Greenland

-1st winter survey 2011-

Report nr. SR 11-01 DTU BYG March 2011

This report summarizes the very first survey of the engineering dormitory Apisseq in Sisimiut, Greenland. The dormitory was inaugurated in August 2010 and the survey was performed in March 2011. The experienced problems and their possible causes are explained in the report. Furthermore possible solutions are suggested.

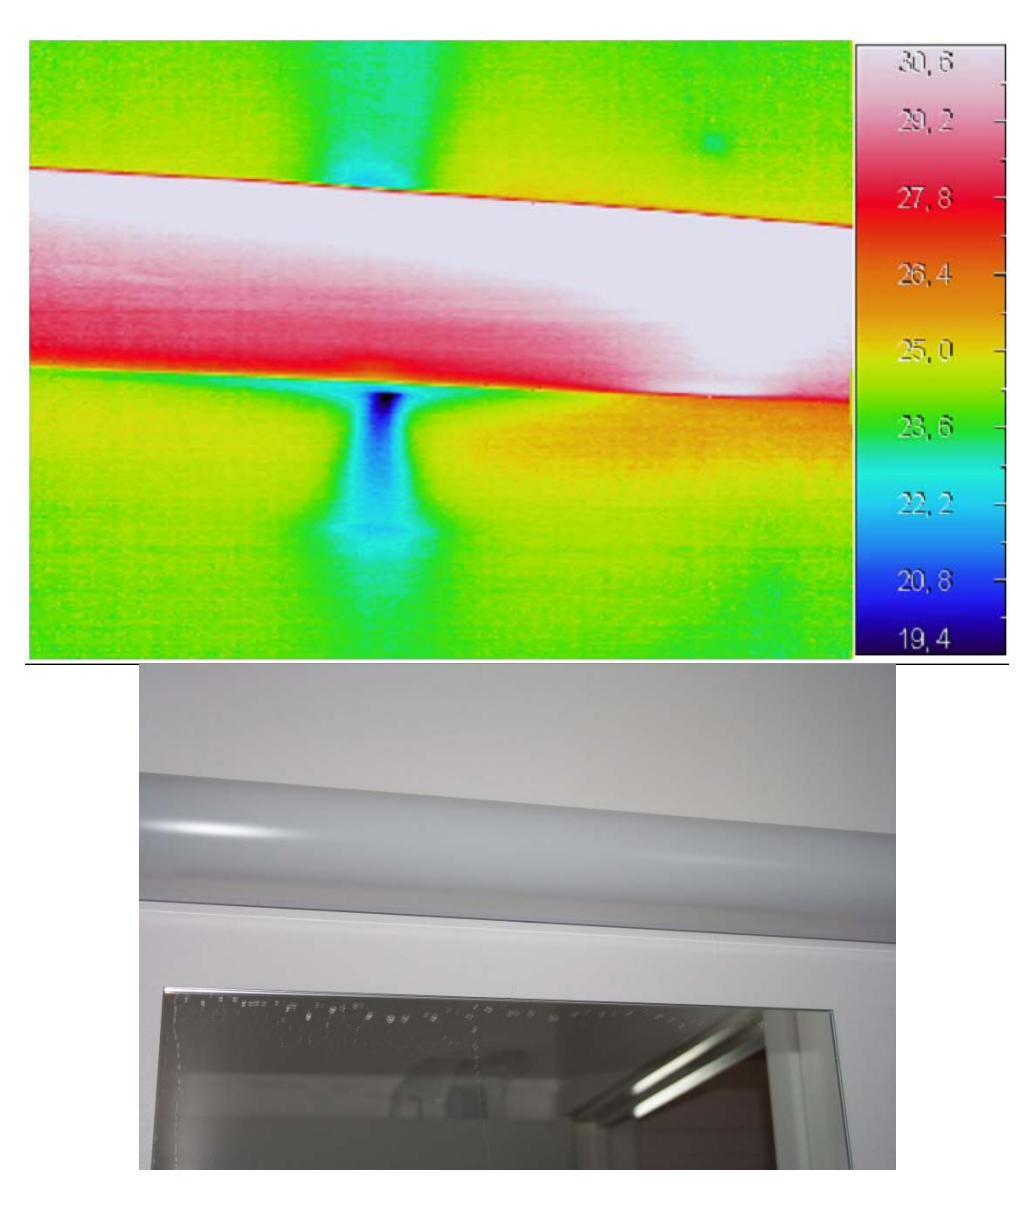
Figure 5 - Air leakage from behind the light in the bath room

In the Figure 5 the leakage from behind the wall-mounted light, shows most likely the penetration of the vapour barrier by the electricity cable, or mounting screw.

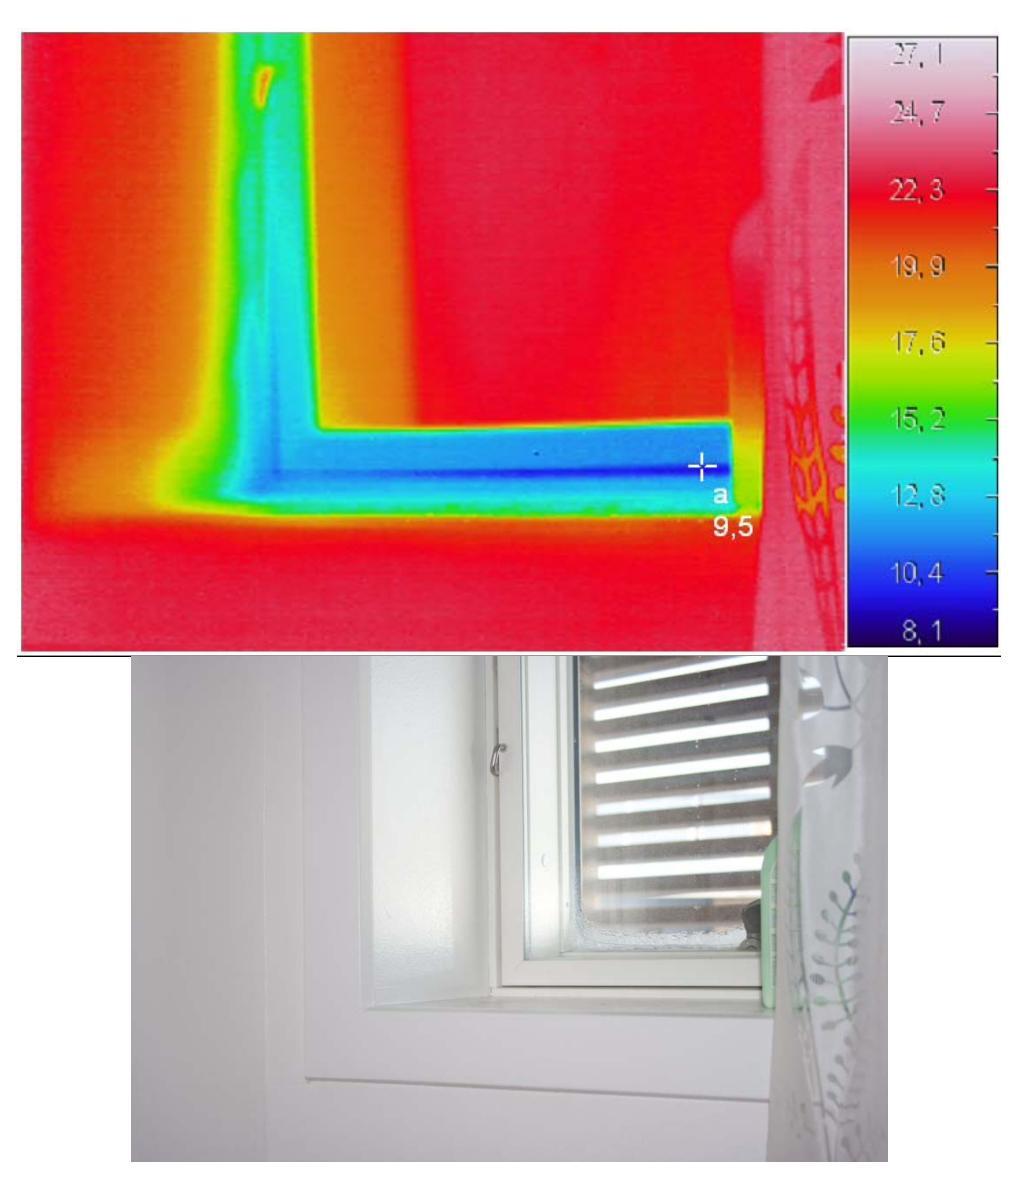
Figure 6 - Leakage around the bath room window

Figure 6 displays the insufficient sealing of the crack between the third removable glass pane and the window frame. This untightness also causes penetration of the moisture from bathroom to the window gap and its condensation and freezing on the middle glass pane (see Figure 7).

The third removable glass panes should be sealed and attached to the frames properly so the exfiltration of the air from the space to the window gap will be avoided.

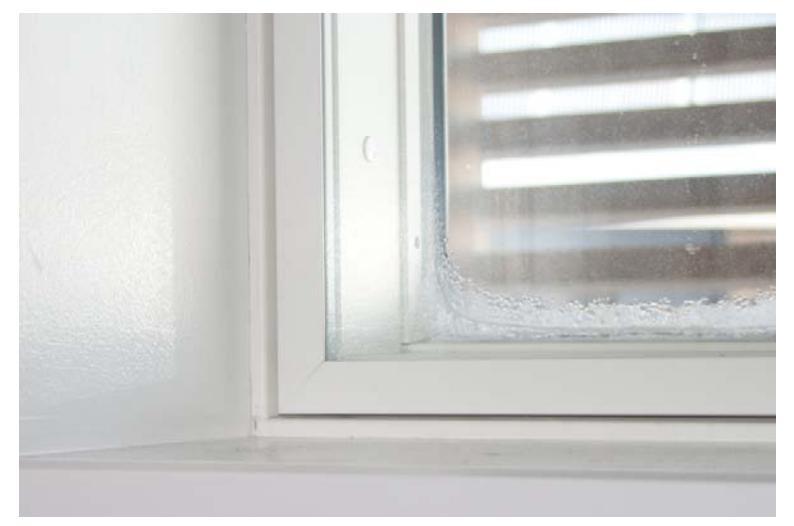
Figure 7 - Condensation and frost formation on the window pane in the bath room

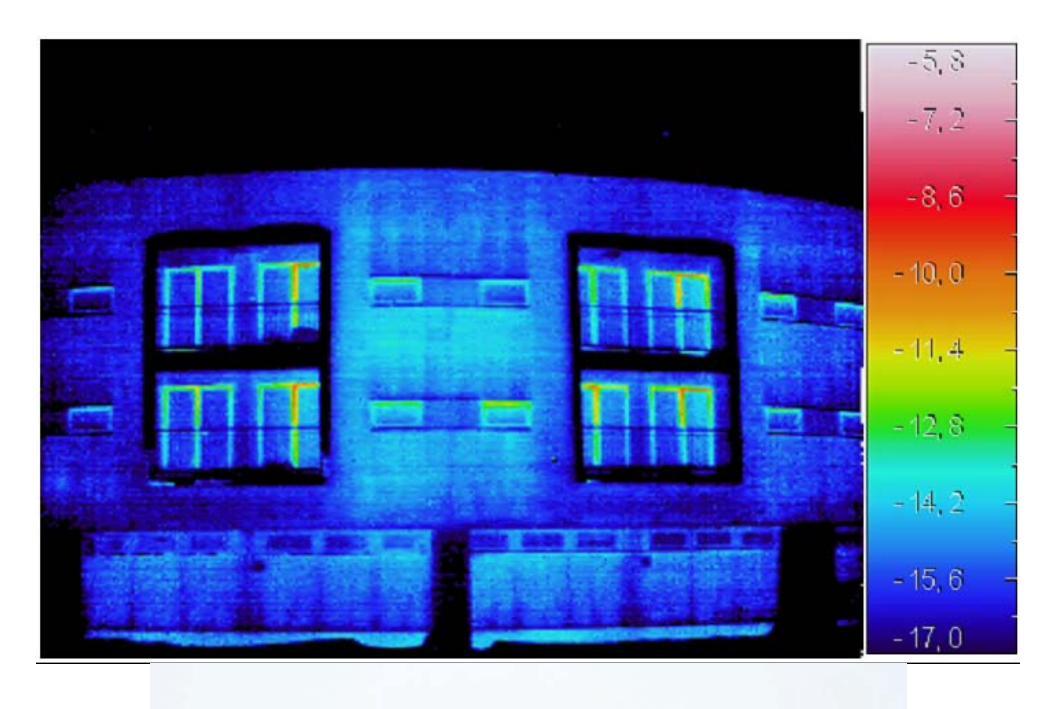
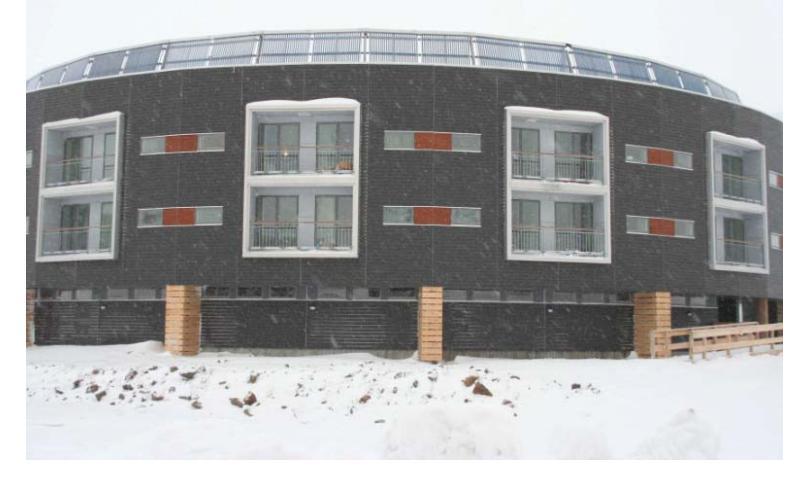
Figure 8 – South-western facade

The pictures of the facade show, that the significant thermal bridges are created mainly by the window frames of the large windows/balcony doors. They are larger in case of balcony doors compare to the fixed windows (see Figure 8 and Figure 9).

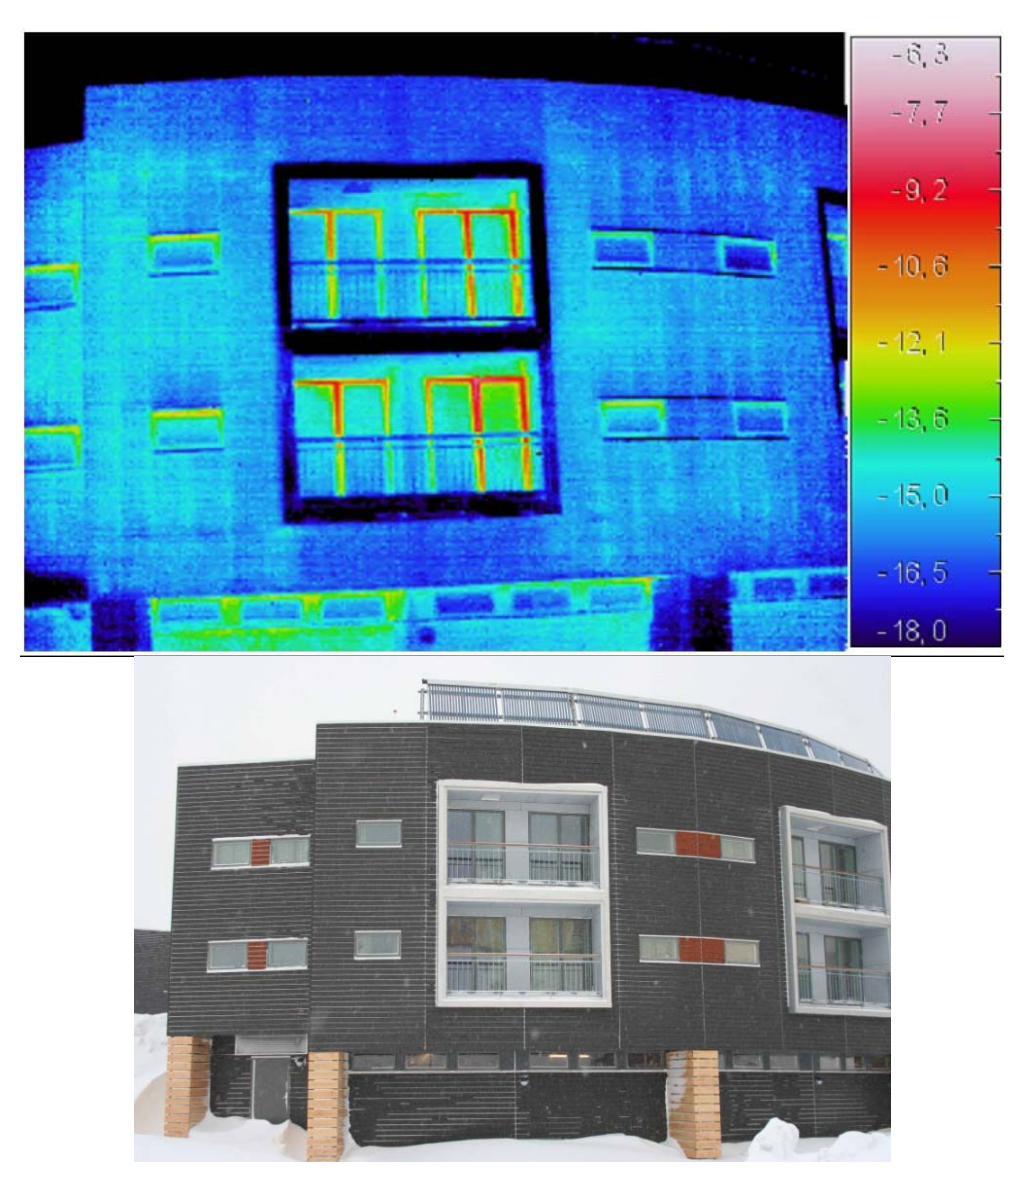
Figure 9 – Western facade

In Figure 9 it is possible to see the warmer facade (meaning higher heat loss) from the technical room (down left) with the ventilation unit. It is caused by the lack of insulation of this room and insufficiently insulated ventilation ducts in that room. The heat loss from the ducts heats up the room. Higher room temperature then increases the heat loss through the uninsulated facade. As a result of this phenomenon the fresh supply air which was heated in the ventilation unit is being cooled before it is delivered to the space.

The technical rooms with ventilation units should be additionally insulated to avoid extra heat losses.

The ducts in the technical (unheated) rooms should be insulated with at least 100 mm of thermal insulation to avoid heat losses and the air supplied to the rooms should have a temperature of 20 $^{\circ}C$

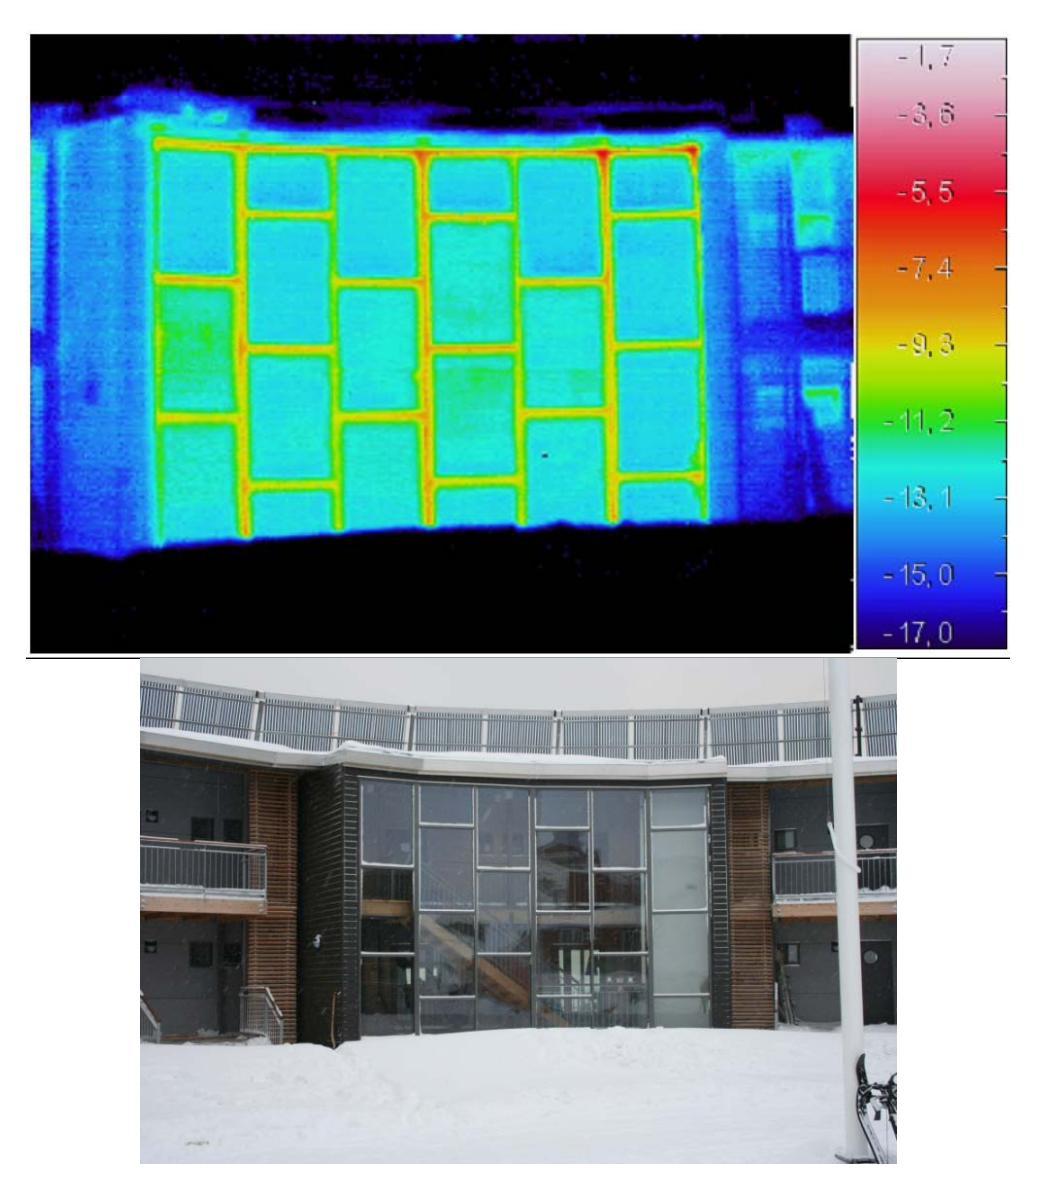
In section 3.1 the heat loss from the glazed part of the atrium was estimated. From Figure 10 it is obvious that the actual heat loss will be even higher due to thermal bridges of the window frames.

Figure 10 - Glazed atrium facing north

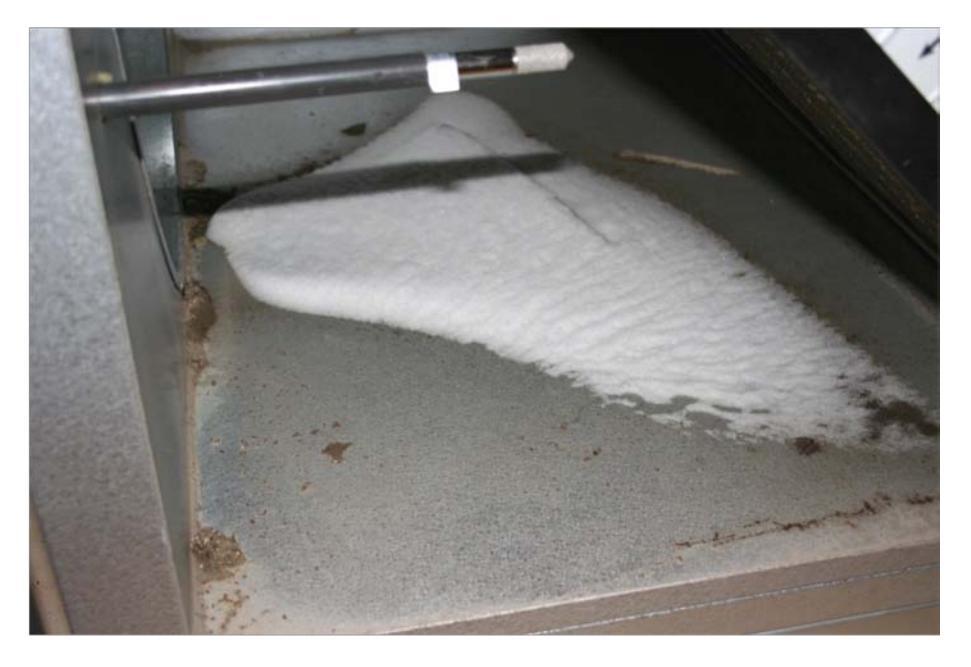
In the Figure 11 and Figure 12 the identical chamber could be seen before it started snowing and after 24 hours of light snowing outside. Significant amount of snow was sucked with the supply air into the unit during that period.

Figure 11 - Ventilation unit - snow accumulation in the supply air chamber – before it started snowing

The intake on the facade should be better protected from the snow and the drainage of the melted snow from the unit should be enabled.

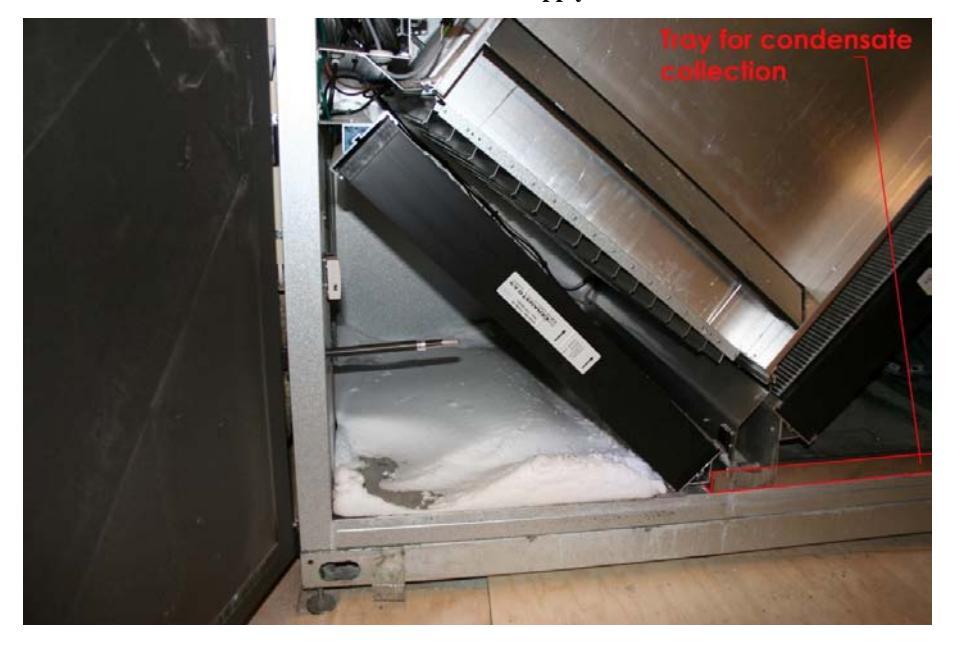
Figure 12 - Ventilation unit - snow accumulation in the supply air chamber – after 1 day of light snowing (10 cm of snow/day)

There is a risk that in case of long lasting snowing the chamber will be filled with snow which may affect the air flows or in the worst case put the unit out of order until the snow melts. The other risk is the water accumulation inside the chamber after the snow melts. The unit has a metal tray for collecting the liquid condensate and draining it out of the unit, but it is only placed under the exhaust chamber (see Figure 12). After the snow in the tight supply chamber melts, the water will create a small lake where the bacteria could start to grow.

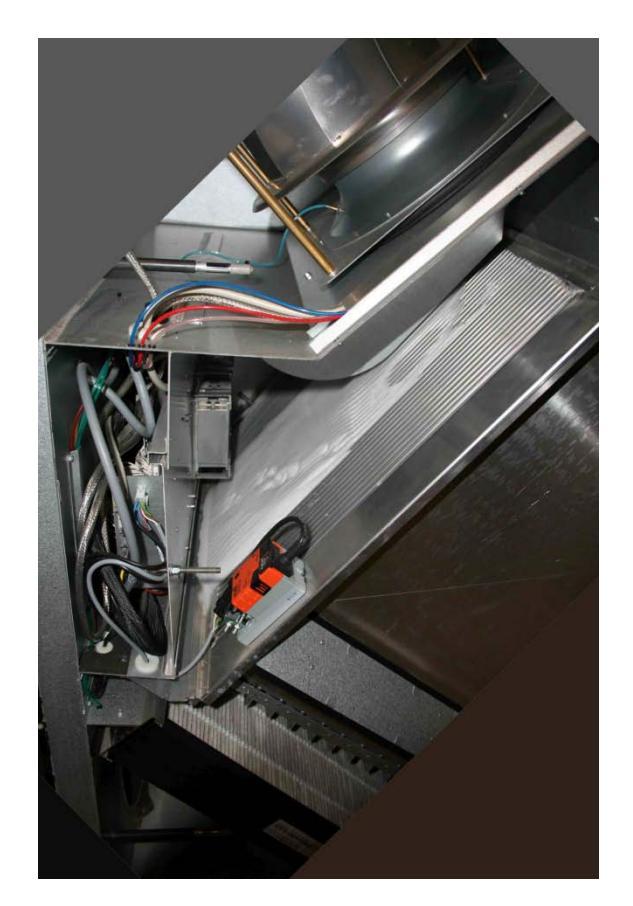
The units are equipped with the by-pass of the cold supply air in cases that freezing appears. The by-pass damper however doesn't take any action even in cases where the frost formation is obvious (see Figure 13). It is probably caused by the wrong setup of the unit.

Figure 13 - Cross flow heat exchanger with frost formation

The defrosting strategy of the heat exchangers should be checked and adjusted so the by-pass damper opens when it is suppose to. It should be controlled by the pressure loss of the heat exchanger possibly in combination with the outdoor temperature. In case that the temperature of the incoming air is below freezing point and the pressure loss increases without increase of the air flow, the frost is most likely blocking parts of the heat exchanger. It means, that the defrosting function should be activated.
