Corrosion in electronics: Overview of failures and countermeasures

Published in:
Proceedings of EuroCorr 2014

Summary

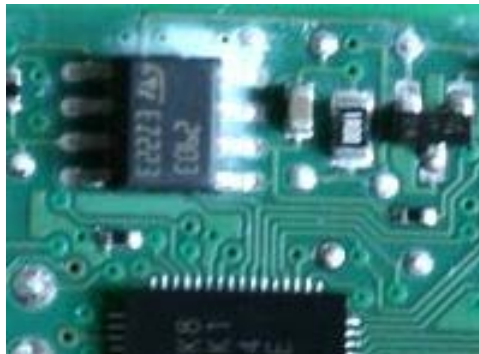
An example of a field failure return showing white residues is given in figure 3. The white coloration can be due to various reactions of the flux residue rosin e.g. oxidation or hydration.

Figure 3 Field failure returned PCBA showing white residues near integrated circuit chip component.

As such the white residues are not necessarily harmful for the electronic circuit, but if active acid residues are present it can cause unwanted leakage currents and corrosion. A Fourier transformation infrared spectroscopy (FTIR) analysis of a reference PCB laminate compared with the white residues shows correlation to succinic acid indicating that for this field failure there are active acid left in the residues. It is likely that humidity have reacted with the resin part of the reflow flux residue causing a release of the activator part.

Leakage current and corrosion is more likely to occur if active acid is present in an area on the PCBA that is populated with components having closely distanced biased lines e.g. integrated circuits as is the case shown in figure 3.

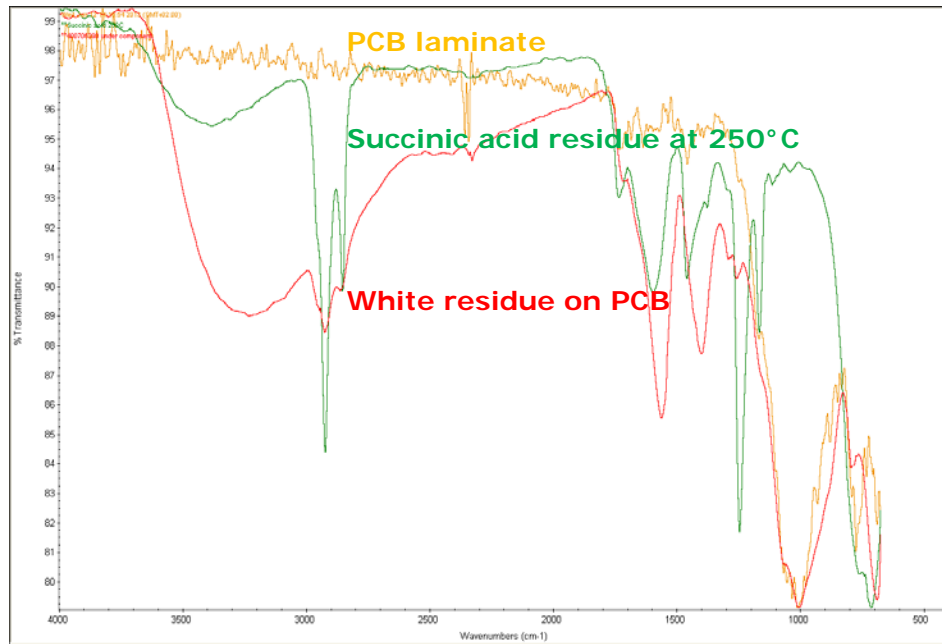
Figure 4 Fourier transformation infrared spectroscopy analysis of white residues shown in figure 3. The peaks seen for spectrum made in white residues area differ from spectrum made in a reference area on the same PCBA and these peaks corresponds to peaks found for succinic acid.

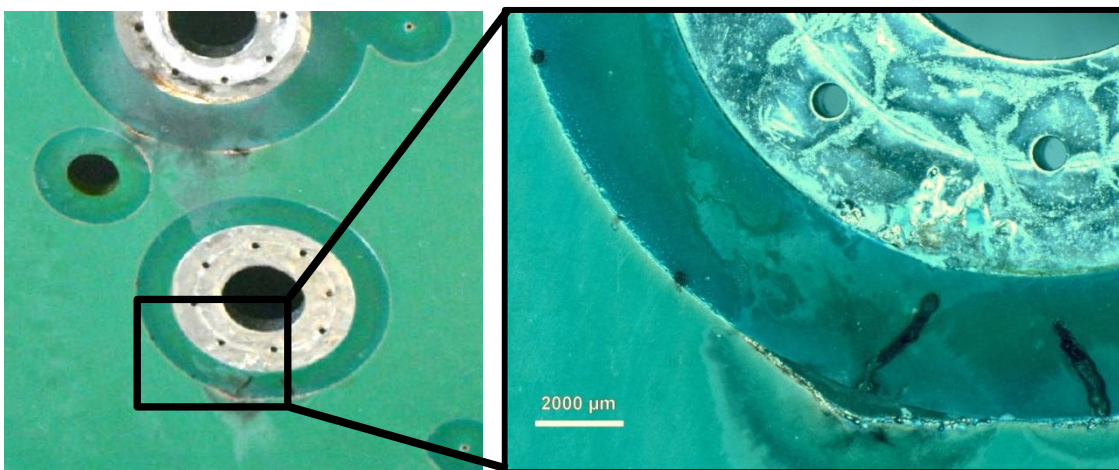
During change to lead free soldering a product was humidity tested in same manner as when the PCBA was lead containing soldered. Despite the soldermask not being intended to be used as an electrical insulator and water barrier for the PCBA it fulfilled this for the lead soldered PCBA. With the higher soldering temperature when going to lead free, more pinholes at the edges were seen in the soldermask (figure 5).

Figure 5 Condensation test of wave solder lead free high power PCBA showing electrical short circuiting due to solder mask pin holes. The black spots seen are due to corrosion of Cu under the pin holes in the solder mask.

High humidity and varying temperatures caused condensation and flash over between 400V biased points on the PCBA, one of them being the bare copper under a pinhole in solder mask.

Residues rat gel testing (figure 6) indicated flux and droplet formation on the PCBA surface so overall the combined effects of high bias, high humidity and pin holes in solder mask caused leakage current and finally short circuiting. One possible countermeasure could be to make a double solder mask in order to minimizing risk of pin holes, yet solder mask itself cannot be expected as a reliable water barrier layer, thus also measures for encapsulation in order to minimize the risk of condensation is needed.

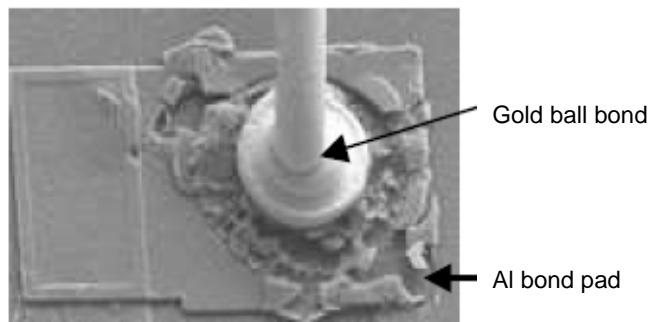
Another example of dissimilar metal contact is Al bond pad corrosion (figure 7), which occurs due to the high electrochemical potential difference between Al and Au.

Figure 7 Corrosion of Al bond pad in contact with Au ball bond

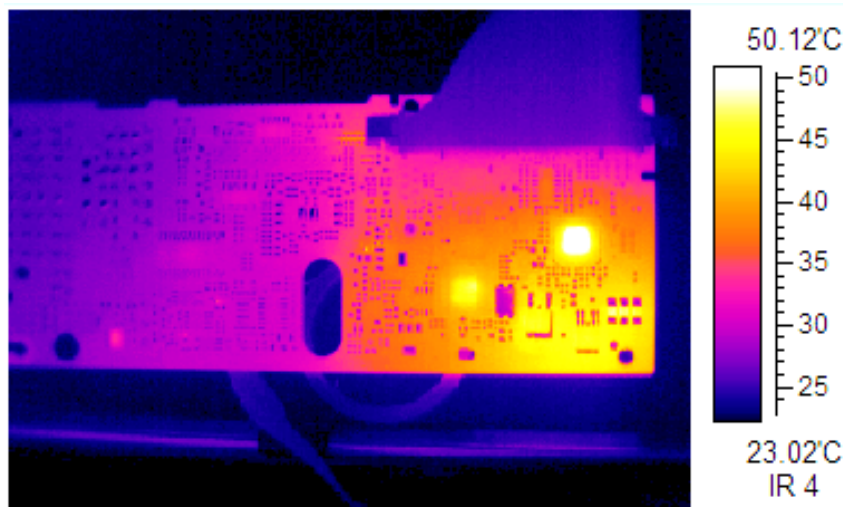
Temperature variation on a PCBA plays a major role in its reliability, especially when exposed to outside application environments. An Infrared (IR) image of a circuit board under biased condition is shown in figure 11. The temperature of the board varies from 25°C to 50°C. There are certain electronic components with high resistance, which dissipate heat more than other components like transistors or capacitors.

Figure 11 Thermal image of a PCBA under biased condition showing variation in temperature as 50°C maximum to 25°C minimum.

From a corrosion point of view, the local temperature variation can change the way humidity interact with the PCBA surface. There is a significant possibility for more interaction of humidity (water layer formation, slow drying etc.) in the colder part of the boards depending on the outside temperature and level of humidity when a PCBA is exposed to the humid environment. Thus, maintaining uniform heat distribution throughout the board or placing the corrosion sensitive components near the hot zone of the board protects the circuit from condensation effects.

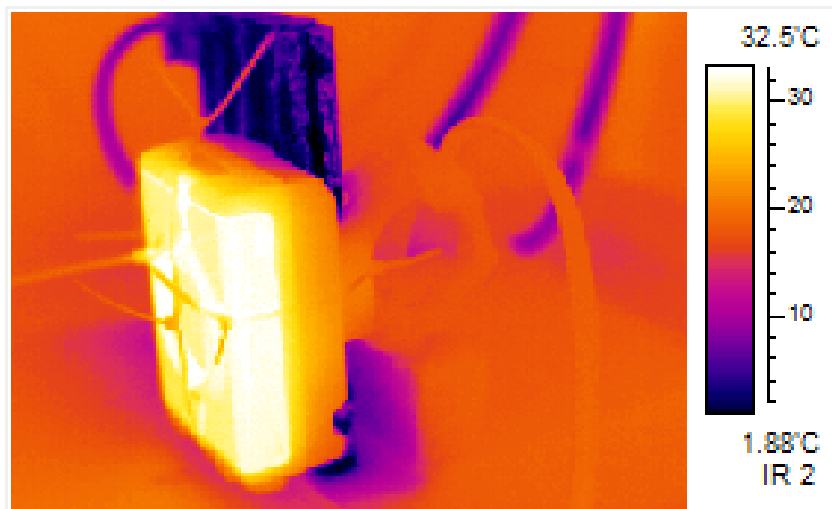
Figure 12 Thermal image of a biased electronic product exposed to condensation test in humid environment. The electronic encapsulation is placed on a water cooled metal block in order to promote condensation.

Another type of electronic product was investigated in a condensation test using thermal infrared camera (figure 12). For this product the self-heating when biased is distributed homogeneously and it was not possible to create condensation on the PCBA surface inside the encapsulation as long as the product is biased.
