In-situ Damage Characterisation of Natural Fibre Composites

In situ Damage Characterisation of Natural Fibre Composites

Presentation at CompTest 2011, Lausanne, EPFL

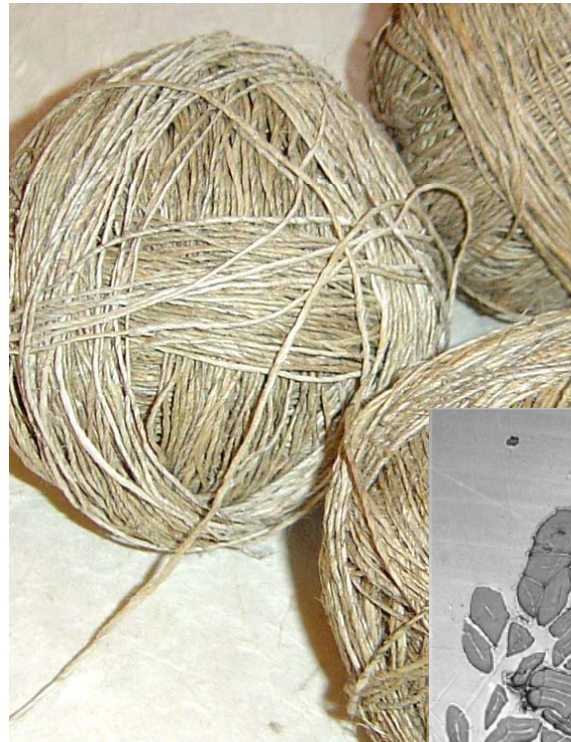
A piece of hemp yarn

- Yarn is spun from a large number of fibres
- Length of fibres
 - 50mm
- Diameter of yarn
 - 200-500 μ m
- Diameter of fiber
 - 5-15 μ m

Short fibres \rightarrow twisting
Fibres can form bundles

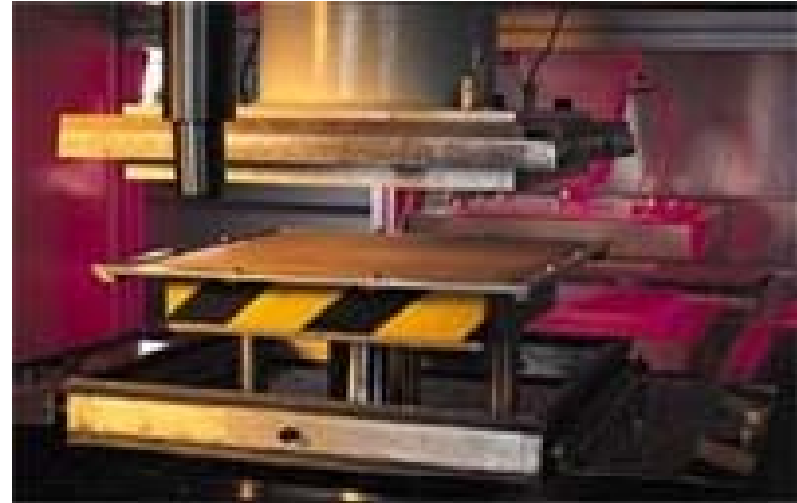
Press consolidation

- Small amount of porosities
- Short consolidation time

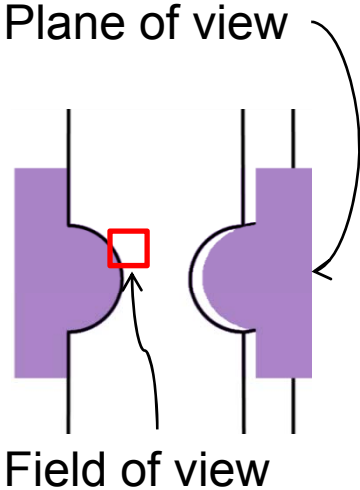
- Evolution of shear cracks
