## Energy retrofitting of a typical old Danish multi-family building to a “nearly-zero” energy building based on experiences from a test apartment

*Published in:*  
Energy and Buildings

**Energy retrofitting of a typical old Danish multi-family building to a “nearly-zero” energy building based on experiences from a test apartment**

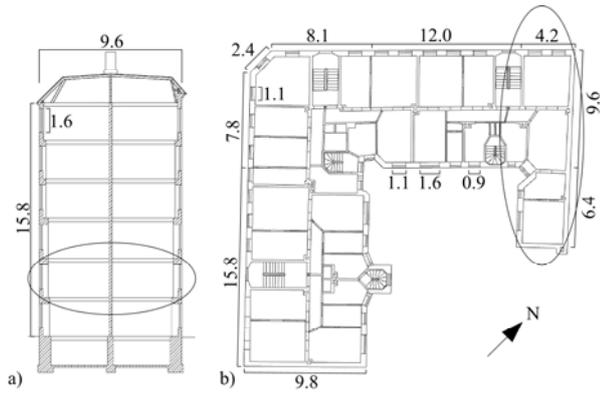
Fig. 1. a) Section and b) plan of the building. The test apartment is marked with a circle. Measurements in meters

The case building is located in Copenhagen, Denmark and is a multi-family building built in 1896 having six stories and a full height basement below ground level. The total gross heated floor area is 2717 m<sup>2</sup> which is divided amongst 30 apartments in three stairways (Fig. 1). The building faces an urban renewal that includes renovation of the windows, installation of outside insulation of the northeast facing end wall, and installation of mechanical ventilation in the apartments.

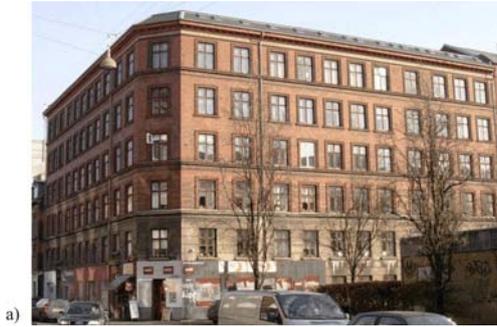
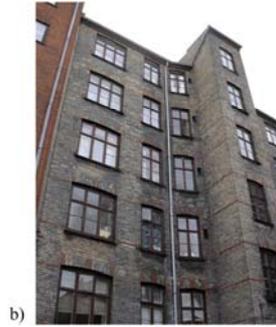
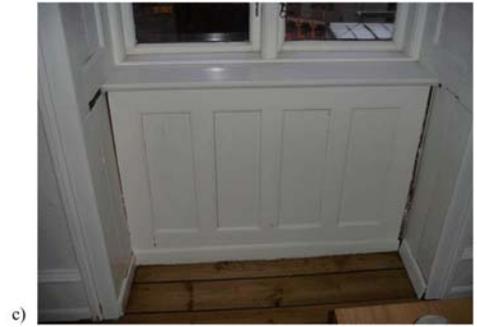
Fig. 2. a) Street facade, b) courtyard facade and c) spandrel seen from the apartment

The facades are built of solid brick masonry having a thickness from 360-720 mm; these have been considered by the municipality as being worthy of preservation. The spandrel was 240 mm thick and covered with wooden sheathing (Fig. 2). The northeast end wall was unattached to neighbour buildings and 360 mm thick.

The windows located on the street facade were predominantly single glazed 4-light windows having a secondary glazing. The windows facing the courtyard were single glazed windows that varied between 4-and 6-lights windows. The un-insulated roof was a typical roof as built in Copenhagen (Fig. 1a). The floor divisions were constructed with wooden beams and clay pugging and the floor divisions towards the unheated attic and basement were un-insulated. Table 1 provides the calculated U- and  $\Psi$ -values for the building envelope before and after retrofitting. The negative  $\Psi$ -values arise from the definition of the building envelope areas. In some instances the U-values include the linear thermal transmittance for the assembly; however, if the U-values include too large a heat loss through the assembly, this was then corrected by the negative  $\Psi$ -value.

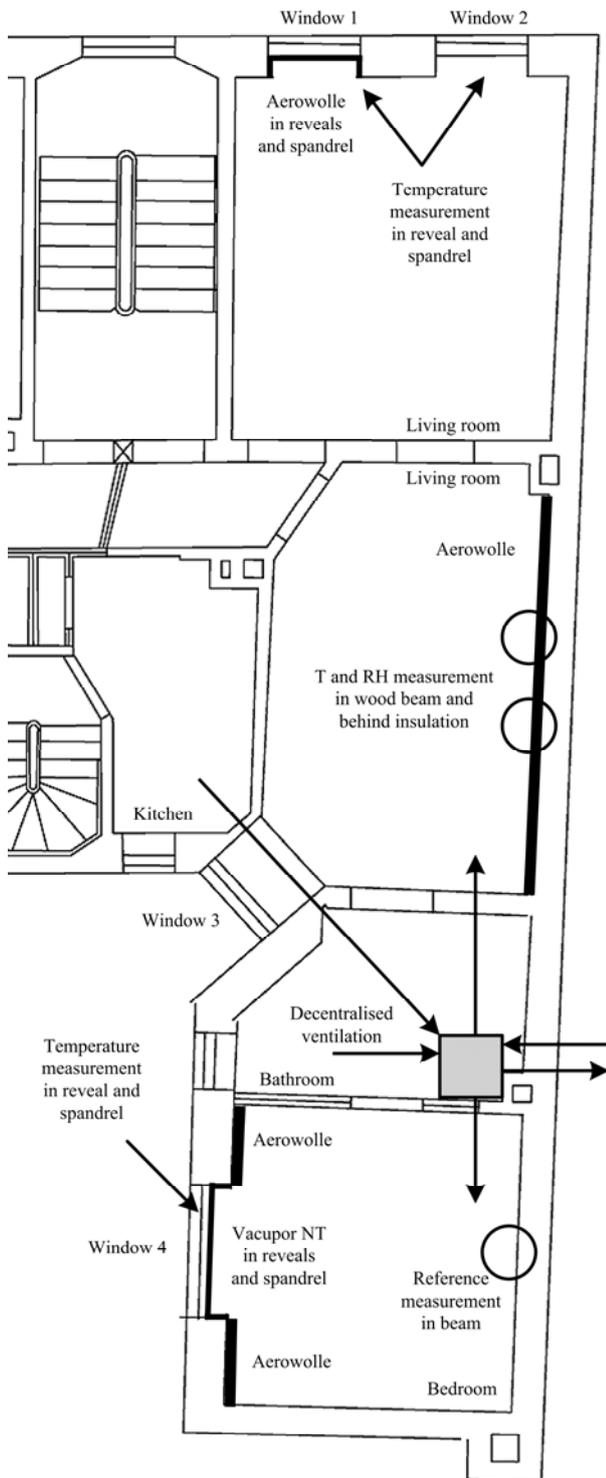
Fig. 3. Plan of test apartment and indication of retrofit measures

The first objective of the project was to evaluate different retrofit measures that had been implemented in the test apartment before determining the specific retrofit measures that would be implemented for the overall building retrofit program. The location of the test apartment in relation to the entire building is given in Fig. 1, and in Fig. 3 the retrofit measures are identified. These retrofit measures include two related to the installation of insulation materials, five measures focused on window retrofitting or replacement, and one measure related to the installation of a decentralised mechanical ventilation system incorporating heat recovery. Four of the five retrofit measures undertaken on windows are shown in Fig. 3 as one window was mounted at the ground floor level.

As is evident in Fig. 3, the Aerowolle product was applied on two wall sections to the interior portion of the exterior wall. This permitted measuring the development of the relative humidity and temperature in the wooden beams and behind the insulation installed on the inside of the 360 mm thick end wall; this is the same thickness as the wall where the most critical wooden beam is encastered (6<sup>th</sup> floor). The sensors for measuring the temperature and relative humidity at the beam end were placed into the end of the beam by boring a hole along the end of the beam to a depth that would place the sensors in proximity to the beam end. This was completed for one reference beam for which the wall had not been insulated and two other beams having an insulated wall above and below the beam. The sensors placed behind the insulation were milled into the existing wall, and placed approximately 1/3 and 2/3 up the height of the wall. For those temperature measurements taken at the reveals and spandrels, the sensors were placed in the middle of the surface in different layers of the structure. One window reveal was insulated with the Aerowolle product and one with the Vacupor NT product to permit a comparison between the performances of either of these two insulation products at the window reveal.

Although in the initial retrofit measures the inlet and outlet ventilation conduits went through the wall, ultimately these ventilation system conduits should go through the roof. In this apartment, the fresh air inlet was located in the bedroom and living room whereas exhaust ducts were located in the bathroom and kitchen (Fig. 3).

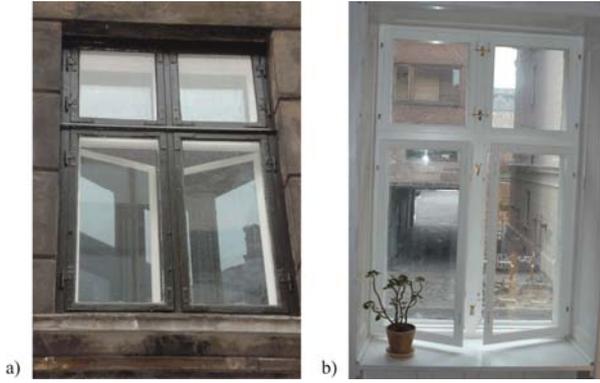
Fig. 4. Energy retrofitted 4-lite of type Window 2 with a secondary frame seen a) exterior of building and b) interior

Window 1 was a retrofitting measure of the existing single glazed window in which a secondary frame was applied as shown in Fig. 4b but having double glazing. In Fig. 5a a horizontal section of the frame and casement illustrates the

Window 2 as shown in Fig. 4 was a retrofitting of the existing window in which a traditional secondary frame with a Low-E coated glazing was applied. The design for Window 2 was similar to that of Window 1 but did not include a third pane as shown in Fig. 5a.

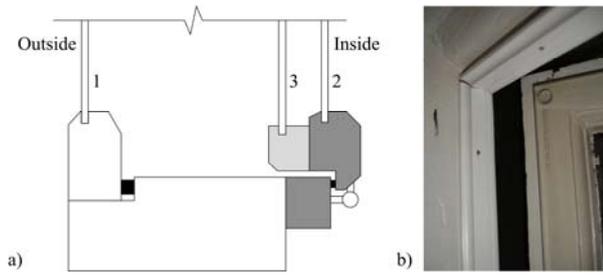
Fig. 5. a) Horizontal principal section of the frame and casement of Window 1. b) Window 3 with installed sash

assembly for Window 1 and in which the original window frame is marked with white whereas the secondary frame is the dark grey area, which was installed onto the original frame. However, on the secondary frame an extra glazing was installed (light grey) at a minimum distance of 20 mm between the two glazing surfaces (pane 2 and 3 in Fig. 5a); hence, the two panes in the secondary frame function as a glazing unit. The outer glazing (1) was a normal pane and the two inner panes (2 and 3) both had Low-E coatings towards the outside. This window can also be equipped with an insulating and reflective curtain in the cavity between the original frame and the secondary frame which could improve the energy saving potential given that 75% of the heating degree-days in Denmark are in darkness.

Window 3 was renovated but instead of a secondary frame a sash with a 4 mm tempered low-E coated glazing (Optoglas) was installed directly on the casement using a special fitting. Fig. 5b shows the corner of the casement with the installed glazing. The difference between this window and the previously described windows was that the newly installed glazing would always be fixed to the casement and thereby make up for a glazing unit that was air tight whereas the secondary frames would open to the inside and make the cavity more greatly exposed to humid room air entering the cavity and pose a risk of mould growth and condensation.

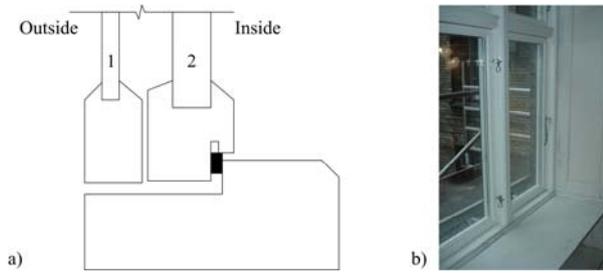
Fig. 6. a) Horizontal principal section of the frame and casement of Window 4 and 5. b) The new Window 4 seen from the apartment

Window 4 was a newly installed coupled window with a single pane and a glazing unit whereas Window 5 was a new coupled window with two single panes. The design of the window structures are shown in Fig. 6a where pane 2 was either a glazing unit or single pane for Window 4 or Window 5, respectively, and in Fig. 6b is shown the newly installed window 4 seen from the interior.

Window 4 had a krypton-filled glazing unit where the inner pane was with a low-E coating as was the single outer pane. Window 5 was a new window where the manufacture tried to imitate the details of the original window for which the inner pane had a low-E coating.

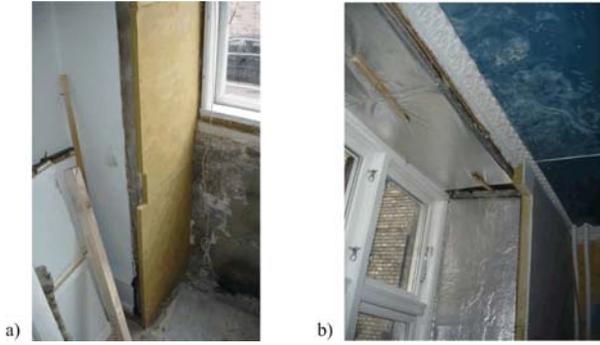
Fig. 7. Insulation applied in the window reveals where a) is Aerowolle and b) is Vacupor NT

The window reveals were insulated with 20 mm deep Aerowolle (Fig. 7a) or Vacupor NT (Fig. 7b). It was found that the gap behind the reveal panel did not fit the 20 mm insulation material and the size of the window opening was thus reduced. This also influenced the spandrel panel which as a consequence had to be adjusted to the new window size. The Vacupor NT insulation product constitutes a vapour barrier itself but to install the Vacupor NT to the window and the inside Aerowolle insulation an additional vapour barrier was installed to complete the vapour tight layer.

In comparison to the Aerowolle product, which was easy to work with given that it could be cut to size on site and affixed to the wall with an adhesive, the Vacupor NT product was a challenge to work with. Specifically, the Vacupor NT product needed to be ordered in specific sizes given that no on site changes could be made if incorrect sizes were delivered. In this case the measurements of the panel size were made before dismantling the reveals which involved too small Vacupor NT panels. Secondly, the material needed special care as the panels were easily punctured thereby losing their insulation value. Given both these factors, the installation of the Vacupor NT panel products was difficult in particular in the upper reveals (Fig. 7b).

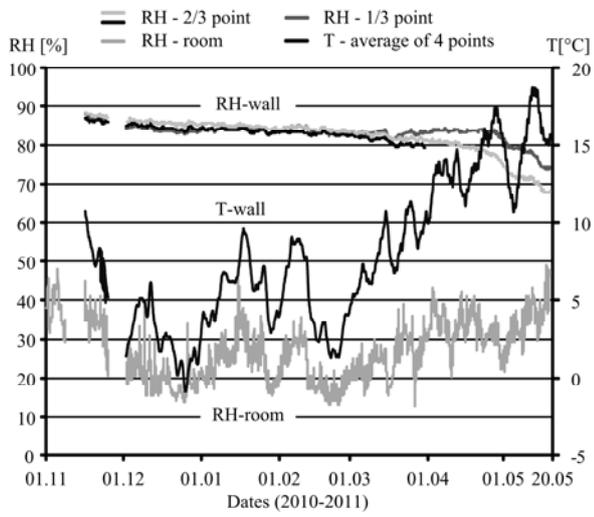
Fig. 8. Temperature and relative humidity behind inside insulation and relative humidity in room

Provided in Fig. 8 are the values for the temperature and RH measurements behind the inside insulation and in the room as of November 1, 2010 to May 20, 2011. Notably, in the period between November and May, the RH in the room ranged from 40% to 55% RH; this was slightly lower than the typical values for the interior of Danish homes of this type of construction as given in [23] and similar to the values obtained by measurements in 115 Danish dwellings [24].

In respect to the RH, it is evident from Fig. 8 that an initial value of 85% RH was recorded and that subsequently the RH decreased to 80%; it is also evident that when the temperature increased the RH dropped below 75%. It must be noted that one measurement point located 1/3 up the height of the wall remained constant at 95%; this RH value was determined to be an error in measurement and has not been included in Fig. 8. The high RH values at the beginning could be due to built in moisture from mounting the sensors. The mould growth depends on several factors where the most important are temperature, RH and exposure time. Based on the Isopleths information provided in [25] a risk for mould growth could be present when the temperature is around 10°C and the RH is 85%; in such instances under these conditions the germination time is about 2 days. However, there were no visible signs of mould growth on the wall after dismantling the Aerowolle product, which was also documented through Mycometer surface test for mould growth. Nonetheless, in the ground floor apartment located at street level and in which the Aerowolle product was installed directly onto wallpaper, the results of a Mycometer surface test indicated extensive mould growth.

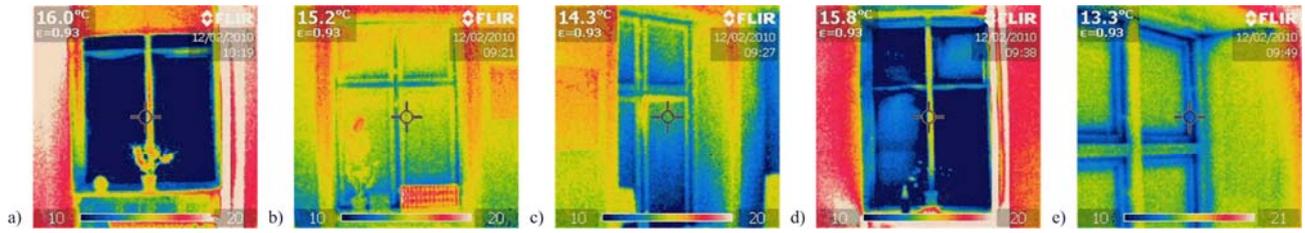
Fig. 9. Thermal imaging of the a) single pane reference window and b-e) the four investigated Windows 1-4

The surface temperatures of the windows were measured using thermographs shown in Fig. 9. Window 1 and 4 had the highest surface temperature as was expected given that their respective U-values had the same magnitude. Window 2 (U=1.62W/m<sup>2</sup>K) and Window 3 (U=1.76W/m<sup>2</sup>K) also had comparable U-values but the surface temperatures were very different where Window 2 performed better but had also a lower U-value. The surface temperature of Window 3 was almost the same as for the single glazed reference window.

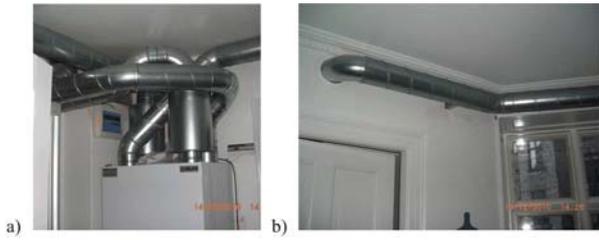
Fig. 10. Ventilation ducts in apartment. a) Inlet and outlet from the air handling unit; b) duct located in rooms

The first issue was the installation of the ducts in the test apartment that was built in 1896 and evidently not designed for accommodating mechanical ventilation. Furthermore the space under the ceiling was limited even though the room height was ca. 2.5 m; however, the top of the windows were about 20 cm below the ceiling. In Fig. 10 is shown how the final installation was carried out as the initial installation of the 125 mm diameter ducts was not deemed acceptable and therefore was reinstalled.

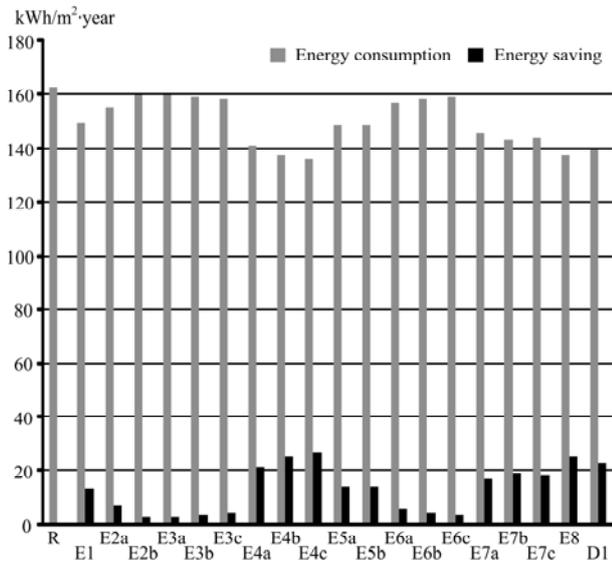
Fig. 11. Energy use and savings for building envelope measures

- R: Existing building
- E1: End wal, 250 mm outside insulation
- E2a: Ceiling to attic, injection of 100 mm insulation
- E2b: New insulated roof construction, average insulation 350 mm

- E3a: Floor to the basement, 50 mm mineral wool
- E3b: Floor to the basement, 100 mm mineral wool
- E3c: Floor to the basement, 150 mm mineral wool
- E4a: Window, retrofitted as window 2

- E7c: Wall, 40 mm inside Aerowolle
- E8: Wall, spandrel and window reveal, Aerowolle combination
- D1: Roof dwellings, 350 mm insulation and increased heated floor area

mechanical ventilation system, these measures are provided in Fig. 11 for the building envelope and Fig. 12 for the mechanical equipment. In Fig. 11 and Fig. 12 are shown the theoretical calculated energy savings that could be obtained for the respective proposed retrofit measures and the theoretical energy use of the building after implementation of the different measures.

In respect to retrofit measures to be made to the building envelope, it was seen from a review of the information, that the most effective measures were new window installation, the installation of insulation on the walls, and a new highly insulated roof structure (incorporating 350 mm insulation). In the project it was planned replace the existing roof with a new roof and convert the previously unheated attic to dwellings, thus the heat loss to the attic was eliminated and the heated floor area increased by 455 m<sup>2</sup>. If only a new highly insulated roof structure was installed the energy savings would not be significant as shown in Fig. 11 as measure E2B.

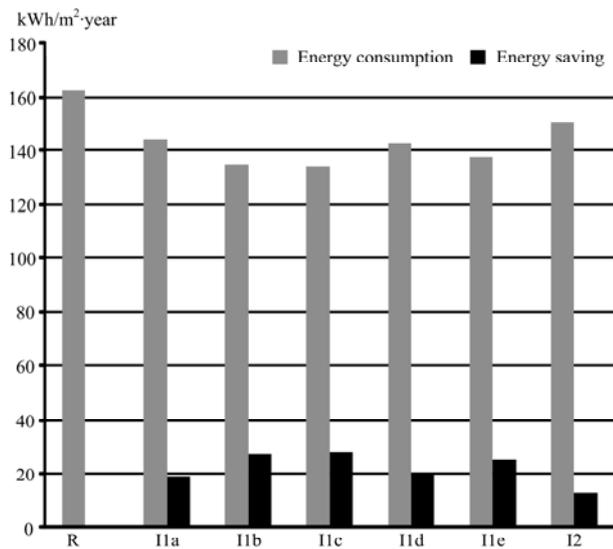
Fig. 12. Energy use and savings for mechanical equipment measures

- R: Reference building
- I1a: Centralised ventilation without DCV
- I1b: Centralised ventilation with DCV
- I1c: Decentralised ventilation with DCV
- I1d: Decentralised micro ventilation units
- I1e: Ventilations combination, I1a, b and c
- I2: Domestic hot water pipes, 40 mm insulation

Five ventilation retrofit measures were considered as part of the retrofit of the mechanical equipment. Two ventilation systems were considered: (i) centralised system, and; (ii) decentralised system. Either of these systems could be chosen with a DCV control. The largest energy savings were achieved with the DCV system. This was due to the reduced ventilation rate independent of the ventilation unit. A combination of three ventilation systems was also assessed; thus each stairway had one ventilation system. Two stairways were chosen to have centralised units with either DCV or not and one stairway had decentralised units with DCV.

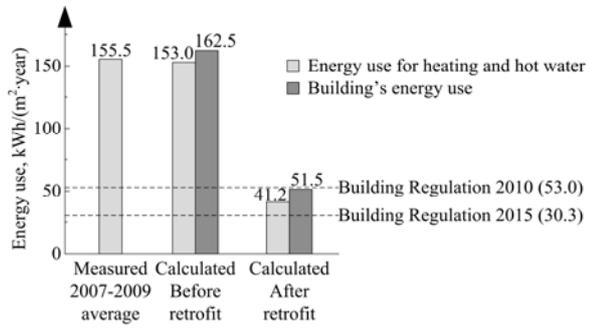
Fig. 13. Energy use before and after whole building retrofitting

The combination of energy saving measures reduced the theoretical energy use of the building to 51.5 kWh/(m<sup>2</sup> year). In Fig. 13 the calculated energy use for the building as well as heating and hot water is given but also that measured before retrofitting. The result meets the requirements for new residential buildings in 2010 but not the energy use requirements in 2015 for similar new buildings which is 30.3 kWh/(m<sup>2</sup> year). The theoretical energy savings obtained in the building with only passive measures was 68%.
