Twin stability in highly nanotwinned Cu under compression, torsion and tension

Published in:
Scripta Materialia

Publication date:
2012

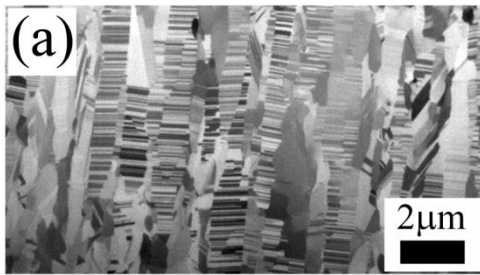
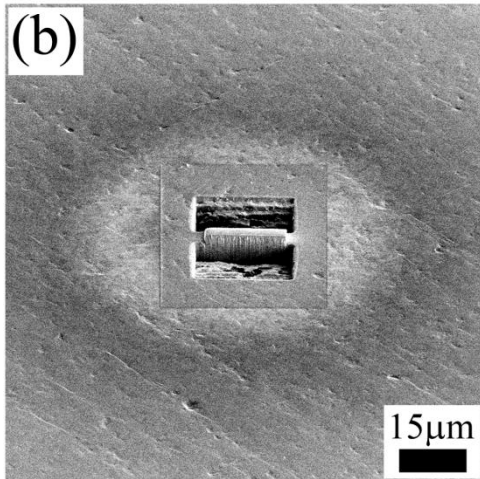
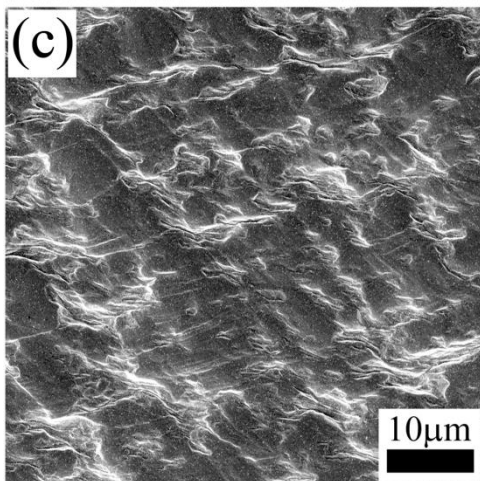
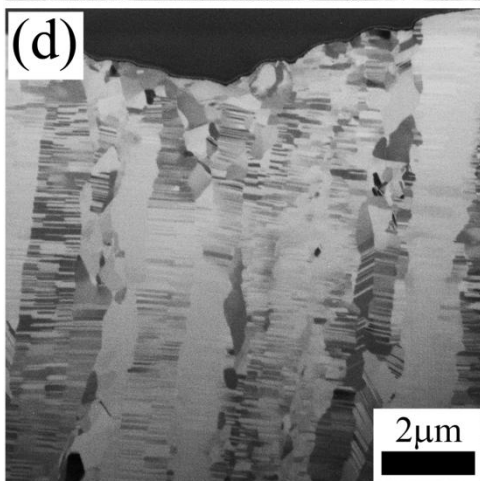
Figure 6

Figure 6. (a) Transverse cut of a nanotwinned Cu sample that has been fatigued to failure under a stress of 450 MPa. (Cut taken close to fracture site). (b) SEM image of surface of sample fatigued to failure at ~4000 cycles under a maximum stress of 550 MPa. Image is taken about 1 mm from the fracture site. Note the depression lines crossing the surface. (c) SEM of the surface of a sample fatigued to failure under a maximum stress of 405 MPa, showing apparent damage sites. Image is near the fracture site. (d) FIB image of a cut across a shear band in sample fatigued to failure under a maximum stress of 550 MPa, image taken near failure site. Note that the original nanotwinned structure has been lost in the region of the surface dip.

Deformation by tension-tension fatigue permits the study of accumulated strain on the nt microstructure. Stresses are applied in the same direction as in the case of the tension tests, but by cycling through several thousand cycles, the microstructure is subjected to a large accumulated strain, far greater than the fracture strain in a tension test. It is seen that fatiguing to failure in the low cycle regime produces a change in the nanotwinned microstructure (See refs [16, 17]). While most of the original twins remain, column boundaries are disturbed and within a number of columns, the original nanotwins have been replaced by other twins having different twin boundary spacing and orientation (**Fig. 6a**, see also Fig.3c in ref [16]). Damage originates at the surface, as is generally the case in fatigue failures. An SEM image (Fig. 6b) of the surface of a sample cycled between 550 and 55 MPa to failure at ~4000 cycles shows parallel depressions, crossing the surface at an angle of roughly 30° to the tensile stress direction. The image was taken about 1 mm away from the fracture site. These lines become more apparent as the fracture edge is approached. Closer to the fracture another set of parallel lines appears, slanted in the opposite direction (see Fig.7a in [17]). (This second set of lines might have been present but not apparent in Fig. 6b because of the tilt of the sample during imaging.) Surface cracks tend to appear at the intersection of two lines from the opposite sets (Fig 6c). A FIB image (Fig. 6d) of a cut made transverse to one of the lines near the fracture site in the sample fatigued between 550 and 55 MPa shows [some](#) loss of the original nanotwins near the surface, which has dipped below its original position. This loss of the original nanotwins at the surface

under a surface depression line is similar to the damage seen in the tensile test, Fig 4c.(See also Fig. 6 in [17]). In all of these figures the loss of original twinning is confined to a few μm at the surface.
