Coastal Erosion and Flooding Hazards on the North Sea Coast at Thyboron, Denmark

Publication date:
2016

COASTAL EROSION AND FLOODING HAZARDS ON THE NORTH SEA COAST AT THYBORON, DENMARK

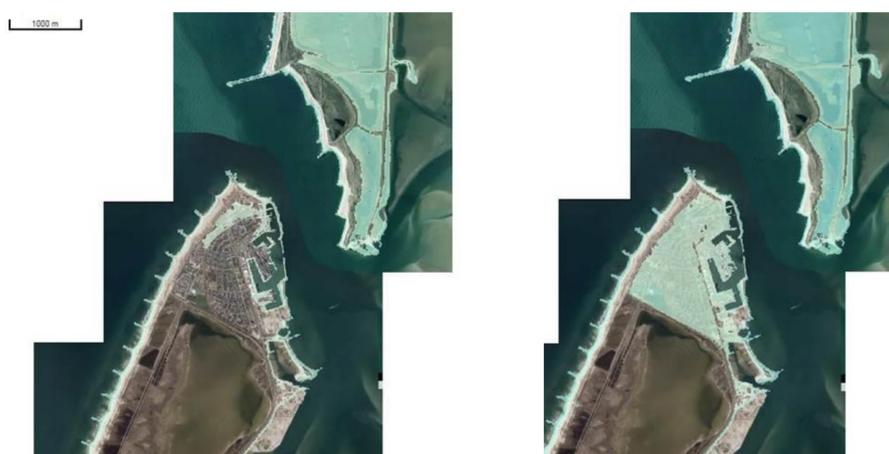
Figure 5. Potential flooding extent from a storm surge at Thyboron Harbor with a return period of 50 years in 2016 (left) and in 2060 including sea level rise and land subsidence.

The cross-sectional area of the channel is out of equilibrium with the tidal prism and increases; leading to more extreme storm surge levels inside the fiord, Figure 4. Furthermore, the town of Thyboron experiences a differentiated net land subsidence of 2-8 mm/y. The increased cross-section, land subsidence and climate changes together will increase the future flood risk in Thyboron significantly, Figure 5.
