DURABILITY OF AIR LIME MORTAR

Anders Nielsen

Technical University of Denmark, Lyngby, Denmark

Abstract

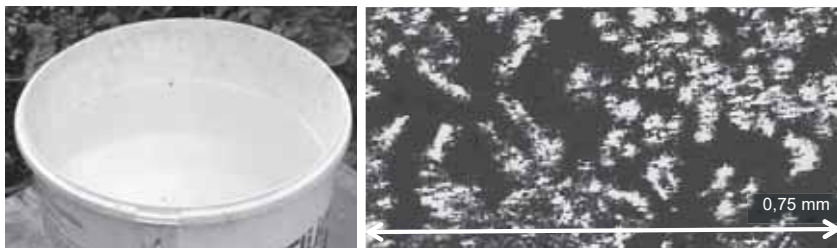
Figure 1. Carbonation on the surface of limewater. Crystals can be seen in the microscope.

When both calcium hydroxide and carbon dioxide are available, the carbonation process ($\text{Ca(OH)}_2 + \text{CO}_2 = \text{CaCO}_3 + \text{H}_2\text{O}$) is a relative fast process. This can be seen on the surface of freshly poured limewater in a bucket. In less than a quarter of an hour a grey layer has been created. It consists of very small crystals of calcium carbonate reflecting the light. The crystals can be seen in polarised light (Figure 1). During a week the crystal layer gets a thickness of 0.03 – 0.04 mm.
