Structural degradation of a large composite wind turbine blade in a full-scale fatigue test

Citation (APA):
Chen, X. (2017). *Structural degradation of a large composite wind turbine blade in a full-scale fatigue test*. Abstract from 2nd International Symposium on Multiscale Experimental Mechanics: Multiscale Fatigue , Lyngby, Denmark.

- 2nd International Symposium on Multiscale
Experimental Mechanics: Multiscale Fatigue

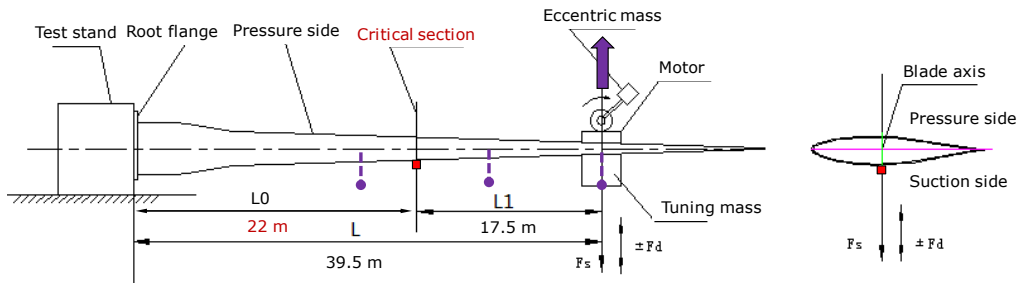
To answer, at least to a partial extent, these questions, this study conducts a full-scale fatigue test on a 47m composite rotor blade according to IEC 61400-23 (ed. 2014). A conventional single-axis mass resonance excitation (rotating mass) method is used as it is now still widely used for blade certification. The blade is tested in a flap-wise bending direction

with the suction side primarily under compressive stress and pressure side under tensile stress, see Fig. 1. The applied loads are increased to reduce the number of cycles to 2.0 million cycles. Bending stiffness of the blade is measured at different span-wise sections during the fatigue test in order to measure its possible degradation. Natural frequencies and damping ratios are measured both before and after fatigue test. Post-fatigue damage of the blade is examined throughout the blade.

Fig. 1 Fatigue test setup

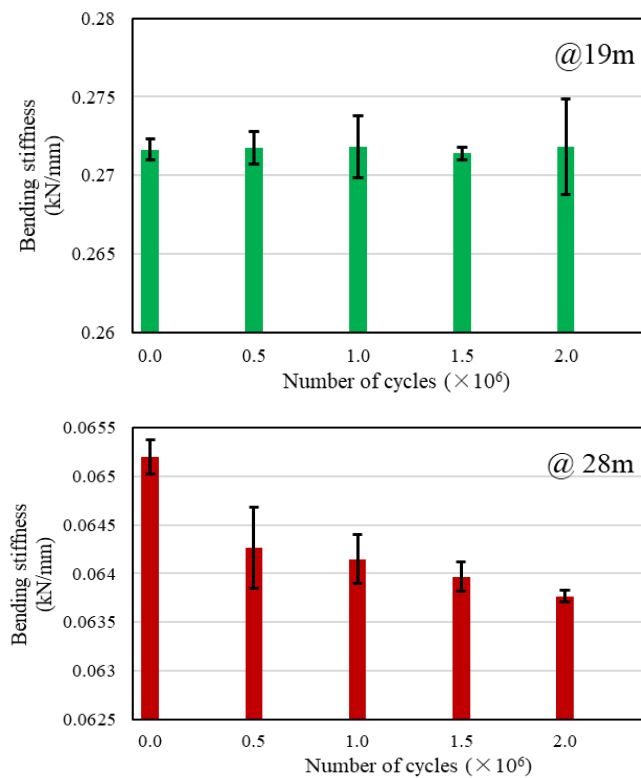
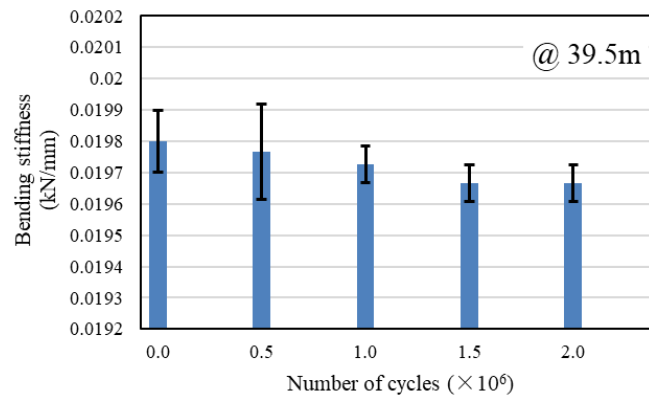
It is found that the blade exhibited different stiffness degradation patterns at different cross sections. As shown in Fig. 2, the bending stiffness of the blade from 0 to 19 m did not show obvious degradation during fatigue test. However, the bending stiffness of the blade from 0 to 28 m and that from 0 to 39.5 m showed very similar degradation pattern to composite materials, which is fast at the early stage and slow at the following stage. In addition, it is noted that the overall stiffness degradation is shown to be not significant.

Fig. 2 Degradation of bending stiffness at different blade sections

This trend may be explained by the stress/strain levels experienced by different sections. During the fatigue test, the blade was stressed most in the middle region approximately from 19 to 34 m where stiffness degradation is expected to be significant. This observation can be also verified by static load test as shown in Fig. 3.

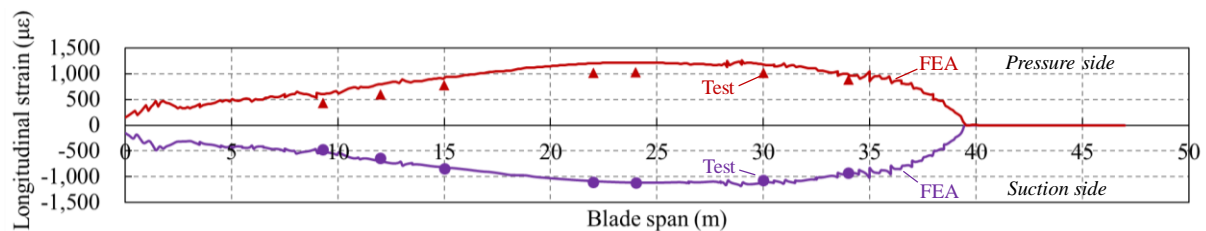
Fig. 3 Longitudinal strain distribution under static loads
