Investigation of Stone-hard-soil Formation from AC Corrosion of Cathodically Protected Pipeline

A stone-hard-soil structure was observed on a metallic pipeline under cathodic protection and subject to alternating current corrosion at a coating defect. Using x-ray diffraction, energy dispersive x-ray spectroscopy, ion-chromatography and inductively coupled plasma optical emission spectroscopy, the stone-hard-soil was characterised as being enriched in NaCl. Local alkalisation following the cathode reactions caused precipitation of calcite, believed to be partly responsible for the stability of the structure. Very close to the corrosion site at the

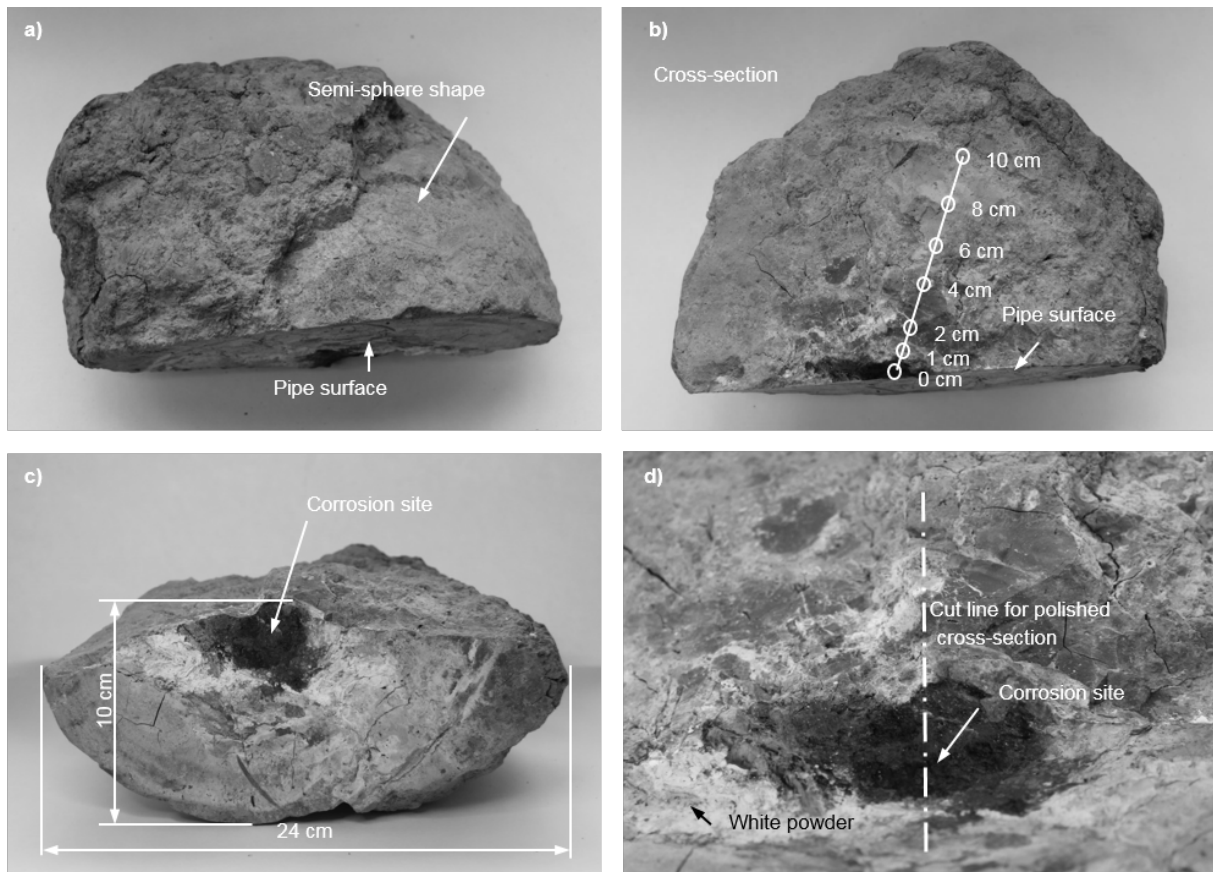
Figure 1. Stone-hard-soil semi-sphere from an AC corrosion case on a metallic pipeline. a) Cross-section with indications of sites for taking samples for further analysis. b) View of the outer surface of the sphere. c) View from the pipe surface with the corrosion site clearly visible and dimensions as shown. d) Close up of corrosion site surrounded by a white powder. The cut line for making a polished cross-section is indicated.

The stone-hard-soil sample investigated in this study is shown in Figure 1. It is half of the semi spherical structure that develops at a coating defect on a pipeline subject to cathodic protection and an AC perturbation. The sample is split in the direction of the pipeline. It is clear that the structure is spherical around a corrosion site (Figure 1a-c) with a clearly altered appearance towards the corrosion site in Figure 1d.

Powder samples from the stone-hard-soil were extracted using a $\varnothing 6$ mm drill along a straight line at distances of 0, 1, 2, 4, 6, 8 and 10 cm from the corrosion site on the cross-section shown in Figure 1a, assuming approximately spherical uniformity in the stone-hard-soil. Additional two samples were taken from a reference soil (REF) excavated from nearby unaffected soil close to the pipeline.

were ground to a particle size $<45\ \mu\text{m}$ in an agate mortar prior to analysis. Furthermore, a scrape off of the white powdery phase shown in Figure 1d was analysed by XRD.

A cut cross-section of the stone-hard-soil (Figure 1d) from the 0-1 cm position was extracted for further analysis. This region was of special interest with regards to the interfacial reactions between the pipe and the soil. It contained both a black/brown corrosion product, a white powdery phase and the surrounding soil phase. After embedding in epoxy resin, a cross-section was prepared for analysis in SEM/EDS.

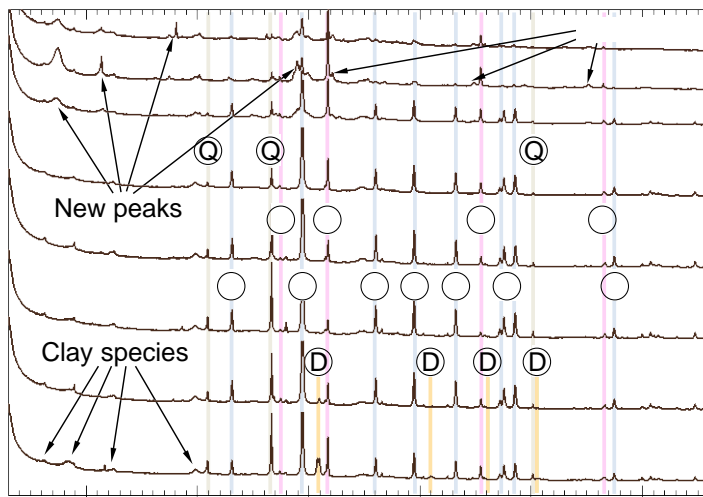
Figure 3. XRD (CuK α) spectra of the profile samples showing appearance of different species through the stone-hard-soil sample: (Q) Quartz SiO₂, (H) Halite NaCl, (C) Calcite CaCO₃, (D) Dolomite CaMg(CO₃)₂.

As expected, Fe concentrations are markedly increased in the close vicinity of the corrosion site (Figure 2a-b). The same is true for the alloying elements of the steel: Mn and V even though in very small quantities, verifying that this is indeed caused by steel corrosion. A general increase of both Na and Cl towards the corrosion site is observed, indicating a higher concentration of halite, NaCl (salt) in the stone-hard-soil compared to the reference soil. The concentration profiles of the earth alkaline ions Ca and Mg appear to be inverted, i.e. towards the corrosion site, Mg is high and Ca is low. At 1–2 cm Ca increases but Mg decreases. From 4–8 cm Mg is dominant and finally at 10 cm the relationship is again inverted. The proportions between Ca and Mg is not 1:1 as is clear from Table 1, but their inverse relationship is very interesting and will be elaborated on further in the discussion. Several of the elements show reduced concentrations close to the corrosion site (Na, Cl, Ca, Si, K, Ti, Al) but this may simply be caused by a displacement of the original soil by the corrosion products emerging from the coating defect. Figure 3 shows the results of the XRD analysis on the samples taken along the profile shown in Figure 1a. The characteristic peaks of a series of species can be seen throughout the sample, but the intensity varies. Since the profiles were made under identical conditions, this may be interpreted as variations in the concentration along the profile, but not with respect to peaks of other species. (Q) quartz; SiO₂, (C) calcite; CaCO₃ and (H) halite; NaCl is present throughout the sample and the reference soil, but the calcite and quartz signal is reduced towards the corrosion site. In the reference soil and the outer part of the stone-hard-soil a (D) dolomite; CaMg(CO₃)₂ phase is present. The XRD results support the findings of increased halite concentrations towards the corrosion site, especially in the 1–2 cm region in good correlation with the EDS and ICP-OES analysis in Figure 2. Close to the corrosion site in the 0–2 cm region, several new peaks emerge. Figure 4 shows an enhanced view of the 0–2 cm XRD spectra, and the new peaks are characterized as an aluminium substituted tobermorite: Ca₅Si₅AlO₁₇(OH)·5H₂O, pyroaurite:

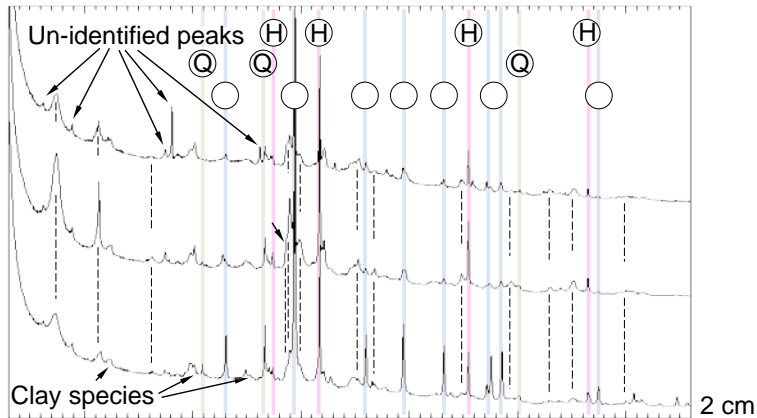
Figure 4. XRD ($\text{CuK}\alpha$) spectra of the 0-2 cm samples where the (C) calcite and (Q) quartz peaks are dramatically reduced and new peaks appear for an aluminium substituted (T) tobermorite $\text{Ca}_5\text{Si}_5\text{Al}(\text{OH})\text{O}_{17}\cdot 5\text{H}_2\text{O}$, (P) pyroaurite $\text{Mg}_6\text{Fe}_2(\text{OH})_{16}(\text{CO}_3)(\text{H}_2\text{O})_{4.5}$ and (V) calcium iron vanadium oxide (civo) $\text{Ca}_3\text{Fe}_{3.5}\text{V}_{1.5}\text{O}_{12}$. These new phases consume some of the dissolved Ca and Si, as well as Fe, Al and Mg. Vanadium is a minor alloying element in API 5L steels.

$\text{Mg}_6\text{Fe}_2(\text{OH})_{16}(\text{CO}_3)(\text{H}_2\text{O})_{4.5}$ and a calcium iron vanadium oxide (civo): $\text{Ca}_3\text{Fe}_{3.5}\text{V}_{1.5}\text{O}_{12}$. Some peaks, in the low 2θ angle region were still unidentified. Particularly the wider peaks are characteristic to clay species or phases with similar low crystallinity, and were generally consistent throughout the sample. Therefore they were not likely to have participated in the reactions and hence not of particular interest in this analysis. A markedly increased background signal in the 0–1 cm spectres caused by fluorescence with the $\text{CuK}\alpha$ X-ray radiation indicates a strong enhancement of iron in these samples. An XRD spectrum of the white powder in Figure 1d has not been included here, but it was shown to consist of mainly (B) brucite; $\text{Mg}(\text{OH})_2$, as well as calcite and halite.

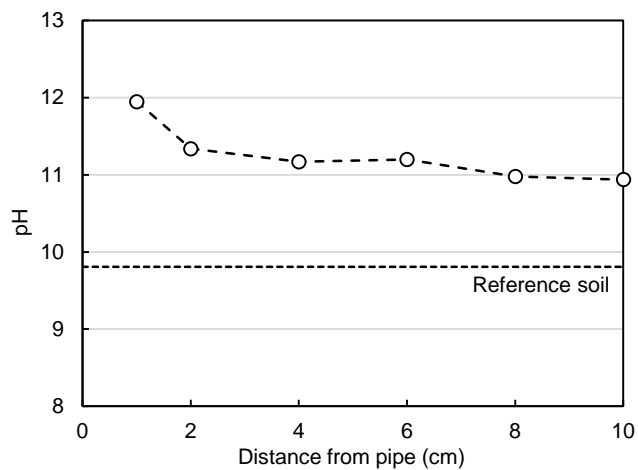
Figure 5. pH profile as a function of the distance from the pipe together with the reference soil pH level. The results clearly indicate alkalinisation of the stone-hard-soil, especially close to the cathodic pipe.

The obtained values are shown in Figure 5, giving a clear indication of alkalisiation of the stone-hard-soil compared to the reference soil pH. While the reference soil is already quite alkaline at $\text{pH} = 9.8$, the stone-hard-soil is as high as ~ 12 , 1 cm from the corrosion site. Given that the alkalinity is caused by the cathode reaction (1) at the coating defect, and observing the general increase in pH from 10 cm to 1 cm, it is anticipated that the pH at the 0 cm location may have been well beyond 12.

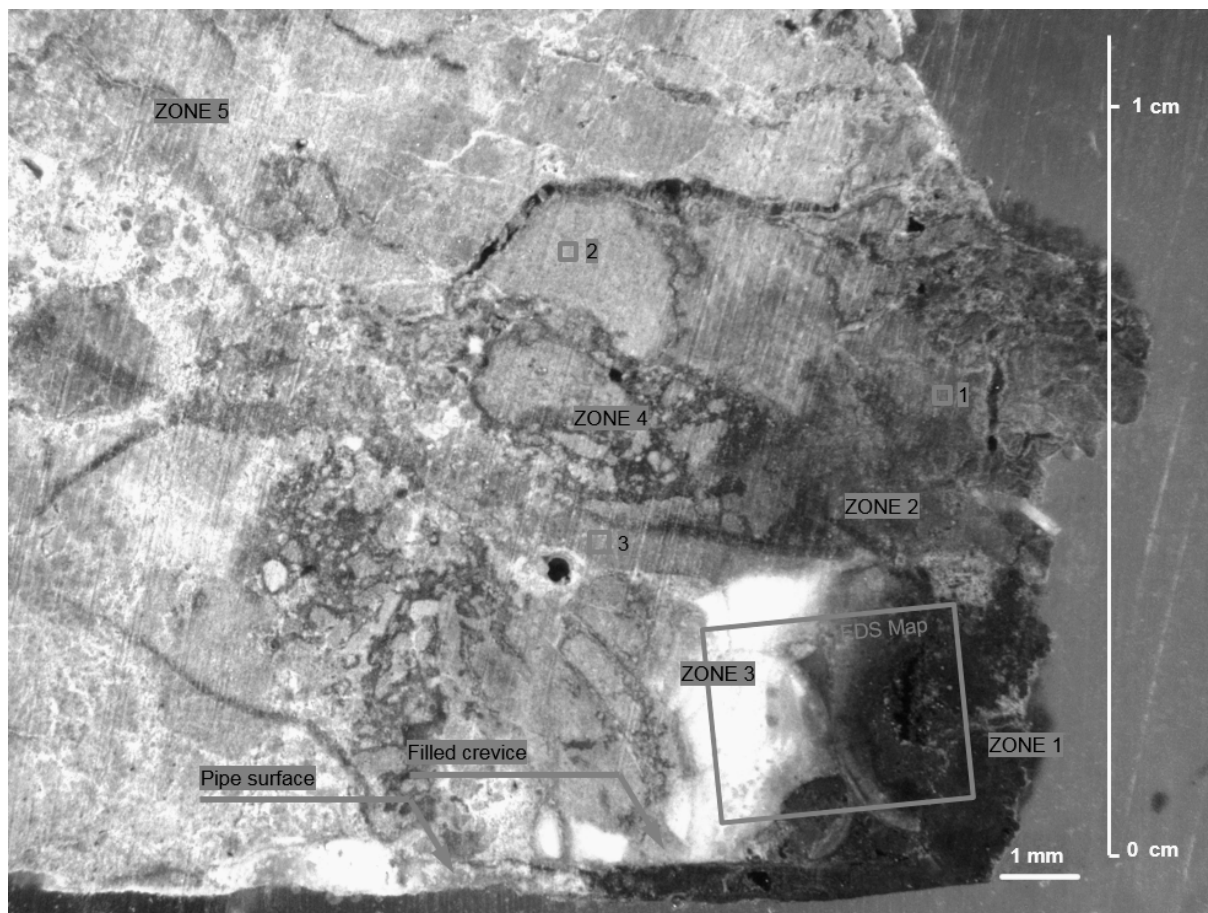
Figure 6. Cross-section of the stone-hard-soil close to the corrosion site in the lower right corner (0-1 cm), moulded in epoxy resin. Marked areas were investigated with EDS, see Figure 7 and Figure 8.

The low soil resistivity is attributed to the high salt content measured by EDS and ICP-OES. In Figure 6, a cross-sectional view of the stone-hard-soil within ~1 cm from the corrosion site is shown. The cut is made along the line indicated in Figure 1d. The cross-section clearly shows distinct phases in terms of visual appearance. A black/brown phase is visible at the corrosion site in the lower right corner (ZONE 1), surrounded by a more red/orange phase (ZONE 2). The colouration is assumed to be caused by dissolved iron and corrosion products. A white phase is present just left of the corrosion products and towards the pipe surface in the bottom of the image (ZONE 3). Then a concentric region of dark grey matter with numerous cracks is present (ZONE 4), and finally a bright beige region which extends to the rest of the stone-hard-soil in terms of appearance (ZONE 5). Towards the pipe surface in the bottom of the image a flat pattern indicates that the stone-hard-soil at some point detached partially from the pipe, and the resulting gap was filled with corrosion products and the white powdery phase identified as $\text{Mg}(\text{OH})_2$. This observation is supported by the circular pattern of the white phase observed in Figure 1c. Three areas within relatively homogeneous areas in the surrounding soil are marked (1-3) for chemical analysis by EDS. Furthermore a larger area across the black/brown, red and white region (ZONE 1-3) is chosen for element mapping by EDS.

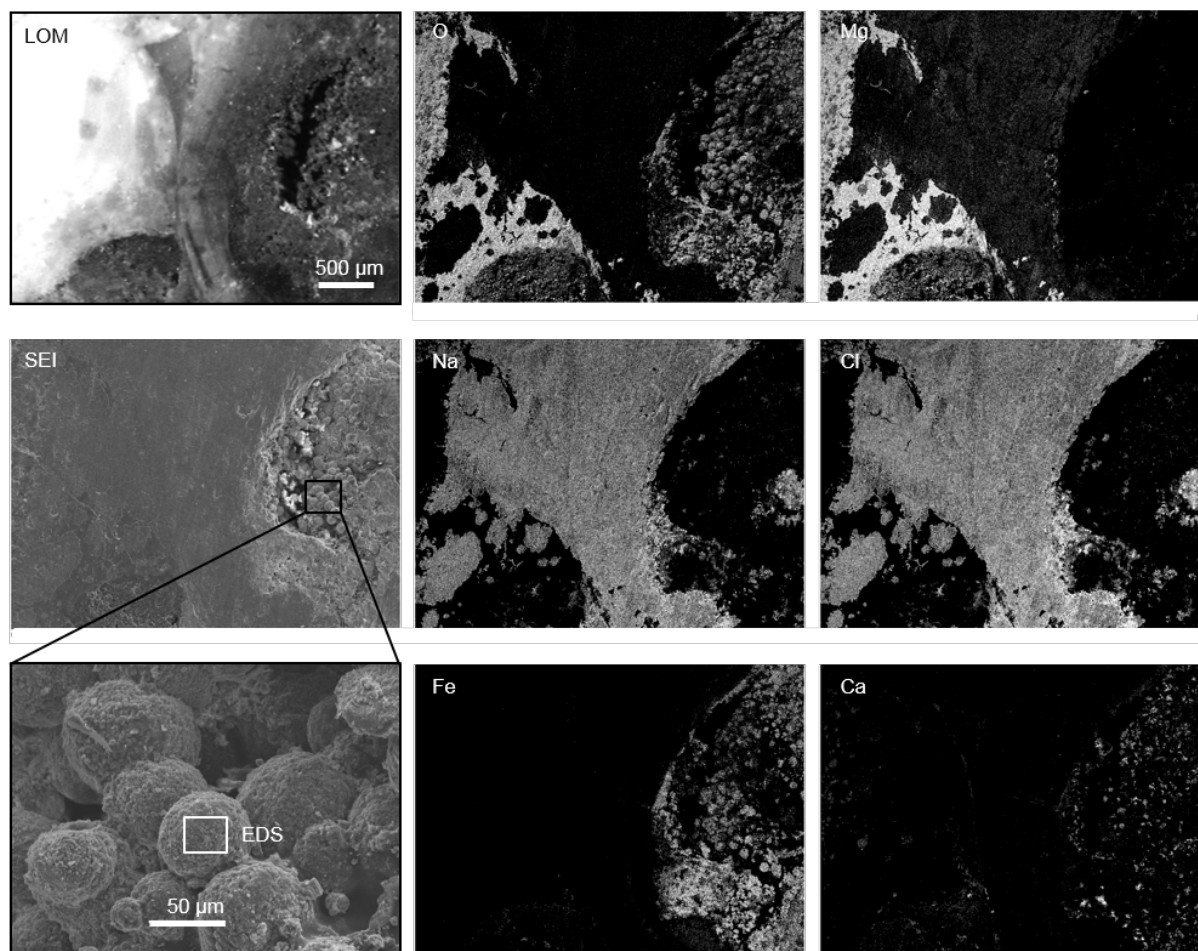
Figure 7. Close investigation of polished cross-section (Figure 6). Upper left: LOM image. Middle left: SEM image. Lower left: Close-up of corrosion products including area of detailed EDS analysis. Rest: EDS maps of the respective elements as indicated, showing distinct phases (Mg+O, Na+Cl, Fe+O, Ca+O) around the corrosion site.

EDS mapping of the marked area in Figure 6 can be seen in Figure 7 along with a closer look on some spherical structures observed in a cavity of the corrosion products, shown in secondary electron images (SEI). The EDS maps shows readings of the respective elements as white spots, that clearly maps out where the respective elements are present. The white phase clearly consists of mainly Mg and O in a 1:2 relationship read by a point EDS analysis,

corresponding to $\text{Mg}(\text{OH})_2$. Fe and O is present in the corrosion products. The spherulitic structure may be characteristic for siderite, FeCO_3 or magnetite, Fe_3O_4 . [17] Magnetite is a known corrosion product in AC corrosion cases, but the EDS investigation in the area marked on one sphere in Figure 7 suggested an Fe to O atomic ratio close to 1:3, thus suggesting FeCO_3 . The civo ($\text{Ca}_3\text{Fe}_{3.5}\text{V}_{1.5}\text{O}_{12}$) detected in the XRD spectra (Figure 4) may also be an option, since the mapping did show Ca present within the corrosion products, however the point analysis showed only minor Ca concentrations and no vanadium. Since no XRD verification of the corrosion product was possible, no conclusions could be made. Due to handling of the sample in aerated conditions and the likely oxidation of Fe(II) species as previously mentioned, a true characterization of the iron oxides formed under corrosion conditions is not possible.

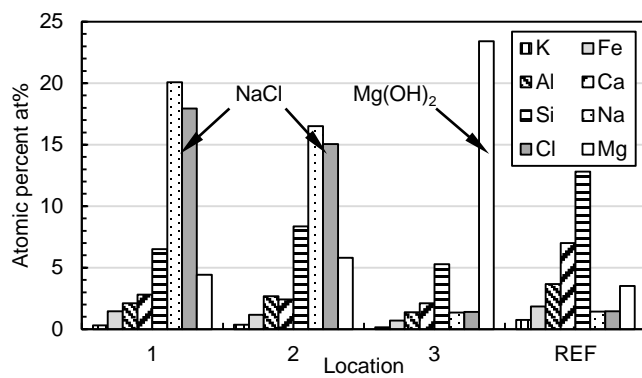
Figure 8. EDS results of locations 1-3 (Figure 6) and comparison to the reference soil.

Location 1 and 2 are strongly enriched with Halite, NaCl, while location 3 is enriched with Brucite, Mg(OH)₂.

The EDS measurements from locations 1-3 in Figure 6 i.e. in the vicinity of the corrosion site are shown in Figure 8. By comparison to the reference soil, it is evident that the concentration profiles of the species are matching (but suppressed due to the EDS results being relative), except for Na and Cl at location 1 and 2, and Mg in location 3. This is interpreted as enrichment of halite and brucite in these locations respectively, in line with the EDS mapping in Figure 7, however together with a clear trace of the original soil. These localised, but markedly different results within 0-1 cm from the corrosion site suggest that the chemical profile made by EDS and ICP-OES as well as XRD may be overly simplified, especially in this local region towards the coating defect. I.e. no brucite was detected along the XRD-profile in Figure 3, which may simply be explained by the fact that brucite appears locally, and was by chance not present in any of the profile samples in detectable amounts.

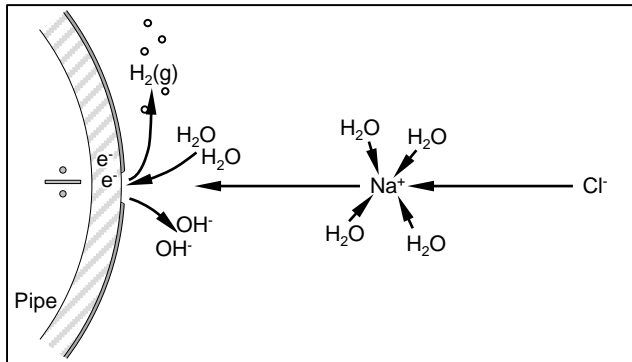
Figure 10. Simplified alkalisation and electro-osmosis illustration. Hydrated Na⁺ is attracted by the negatively charged pipe. At the surface, the cathode reaction (1) produces OH⁻. Cl⁻ ions follow the flow of Na⁺ to conserve local charge neutrality. The increase in ion concentration reduces the local soil resistivity and enhances the cathode reaction.

moisture content of the soil/steel interface in unsaturated soils. [24] The cathode will attract positive ions in solution, and thereby water by the process of electro-osmosis, since water molecules are attracted to the cations. [26] The reason for the enhanced NaCl concentration may be explained by this attraction of positively charged Na^+ ions in solution. This effect is illustrated in Figure 10. The negatively charged Cl^- ions should be repelled by the cathodic pipe, but may follow the migration of cations to ensure local charge neutrality or simply follow the water which will continuously migrate towards the coating defect where it will be consumed by the cathode reaction (1). The opposite observation for sulphate ions SO_4^{2-} may be explained by higher charge of this larger anion that enhances the influence of the electric field and slows down diffusion, making it unable to follow the cations towards the coating defect. The effect of an alternating voltage, and thus changing direction of the electric field, on the migration of an- and cations respectively is unknown, but the net direction of current, i.e. towards the cathode, is expected to govern the direction of the water migration, and as it has been discussed, the cathodic current is enhanced by AC by the process of faradaic rectification.

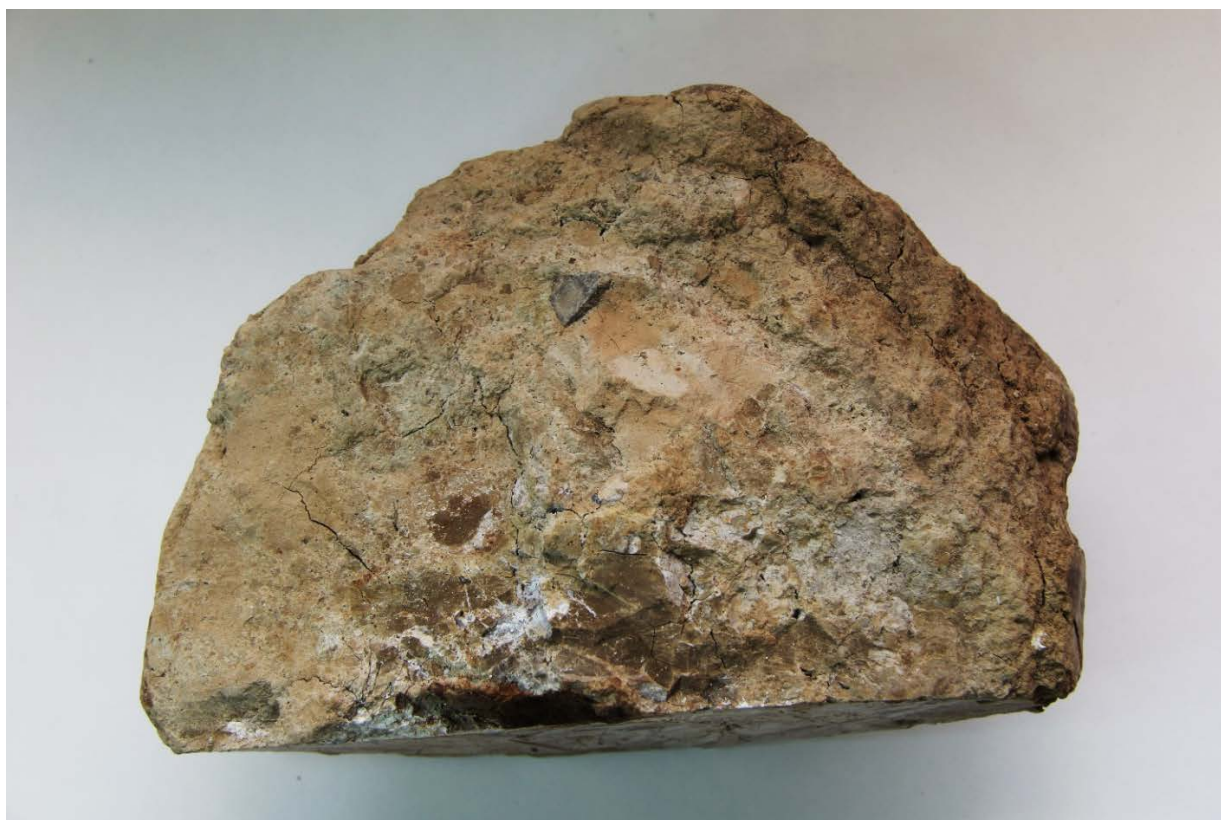
Graphical Abstract

A *stone-hard-soil* structure, characteristic for AC corrosion of pipelines is analysed. The pH of the stone-hard-soil was high from ~11 in the entire sample to >13 close to the corrosion site. Elevated concentrations of halite, NaCl, in the stone-hard-soil was found. This is suspected to create a low resistivity path for AC and DC currents. Hardening of the stone-hard-soil may be caused by precipitation of calcite and possibly electro-kinetic cementation. The soil resistivity was as low as 0.3 Ωm which is the main reason for AC corrosion due to high AC current densities even at mitigated AC voltage levels. Formation of cement-like minerals such as pyroaurite and tobermorite close to the coating defect is evidence of a very high pH.
