Energy Efficient Comfort in Older Apartment Blocks: Results and Experience

EUDP 2013-II: "ENERGY EFFICIENT COMFORT IN OLDER APARTMENT BLOCKS"

FINAL REPORT

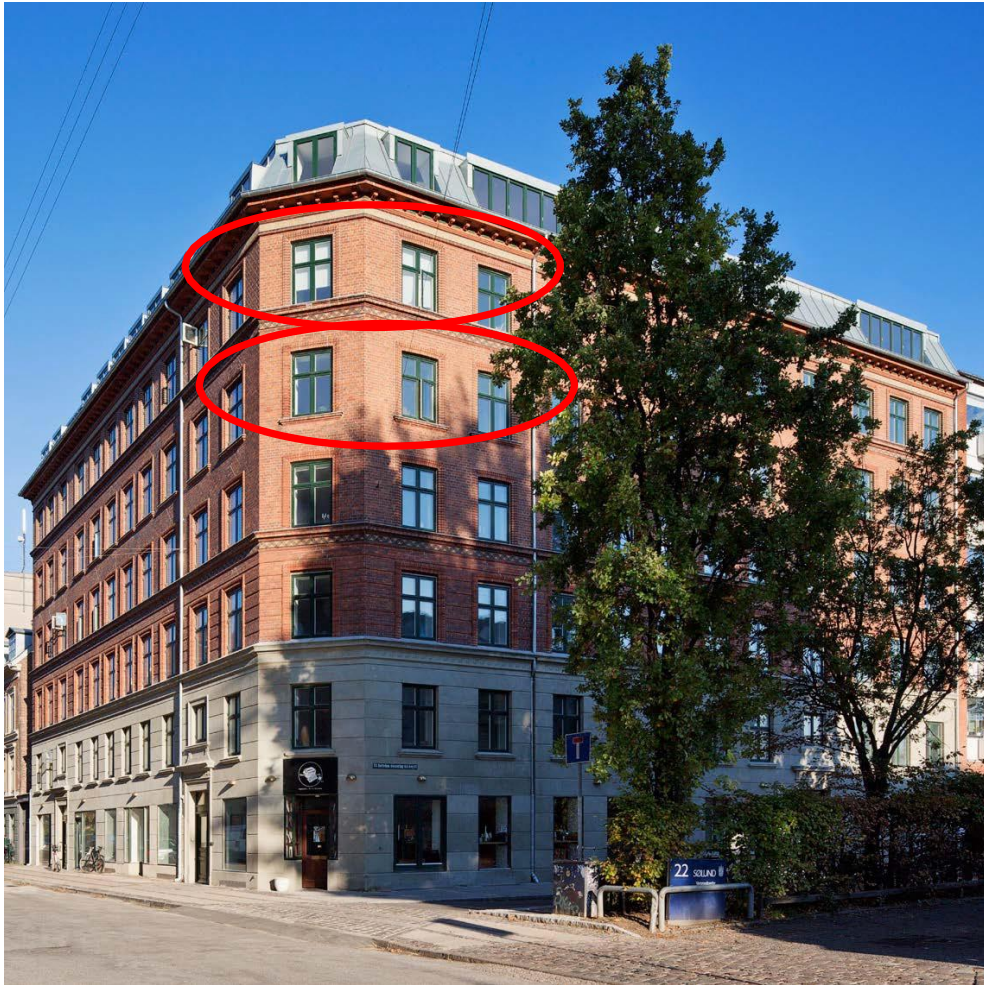
Figure 9: Measuring points from Ryegade 30.

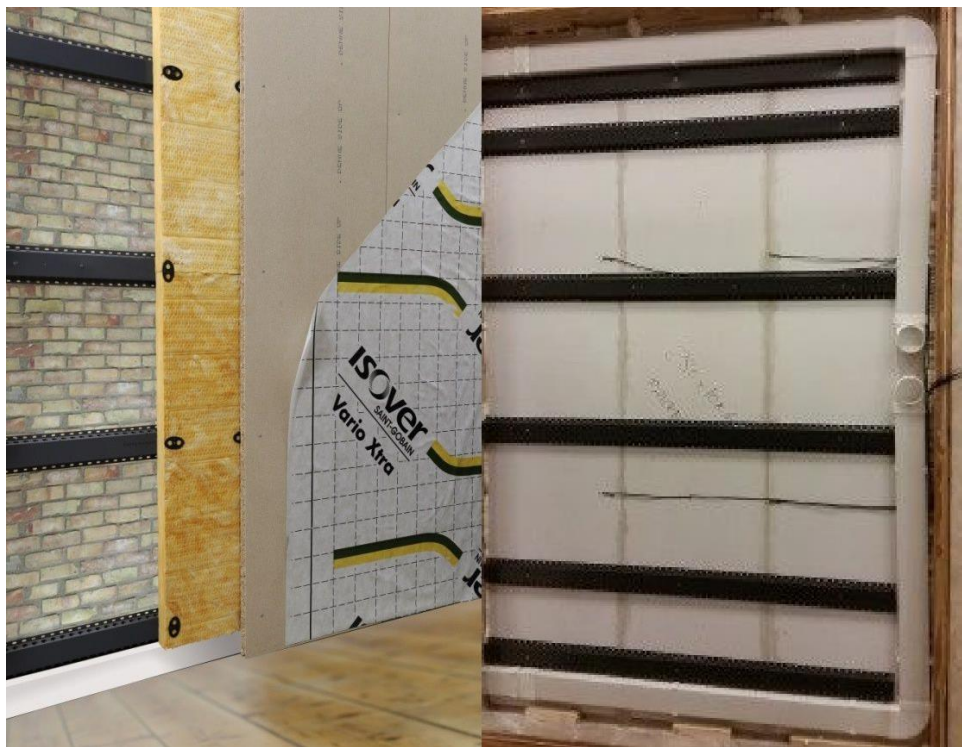
Figure 19: Isover RetroWall, left) showing all layers and right) the ducting

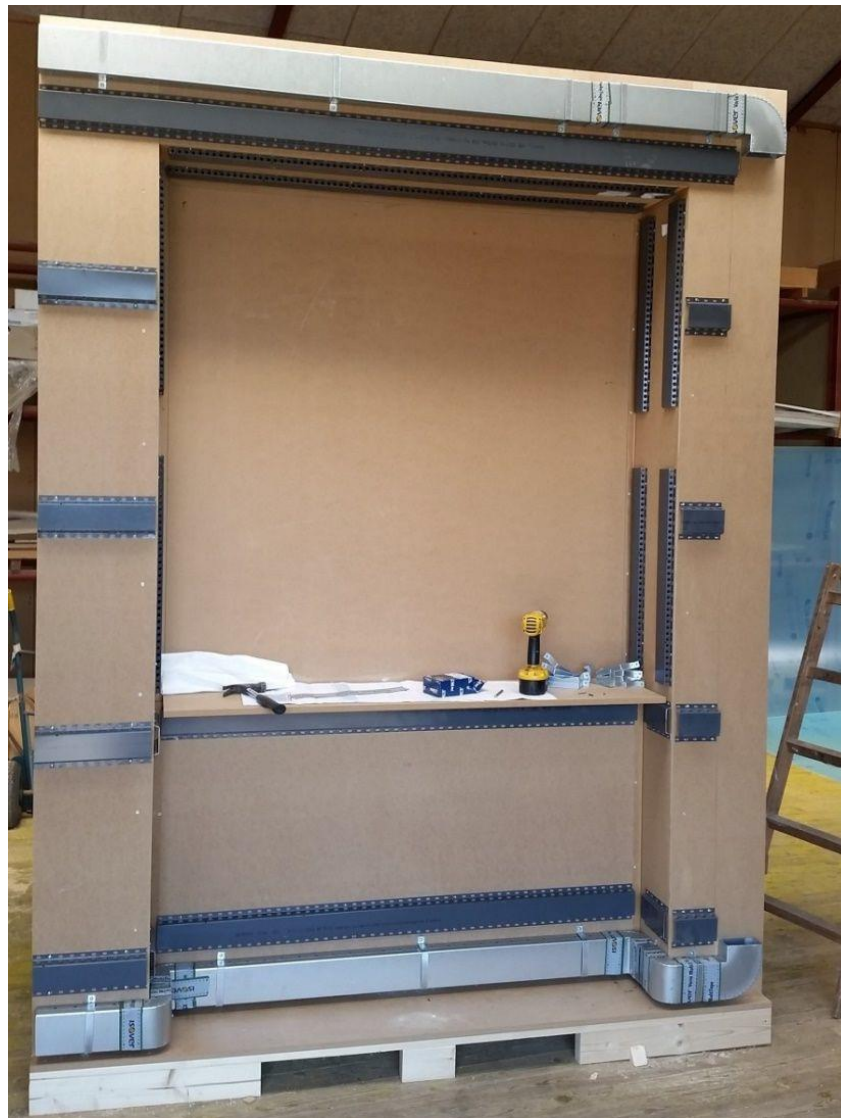
Figure 42: Mock-up test constructed by Isover

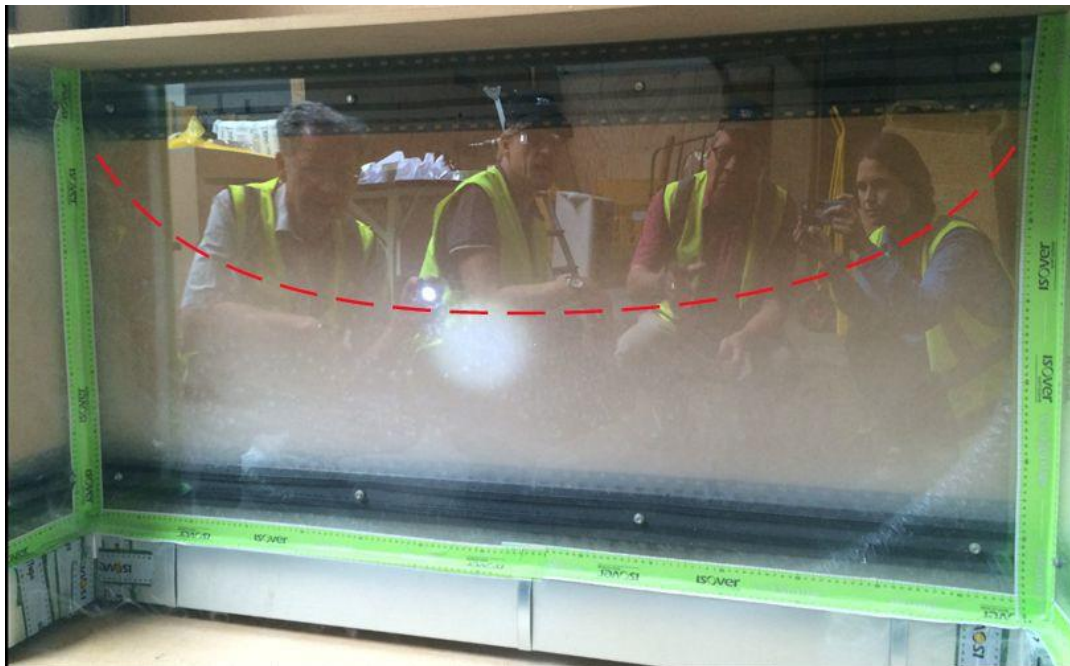
Figure 48: Movement of air beneath window visualized with smoke test
