Energy Efficient Comfort in Older Apartment Blocks: Results and Experience

EUDP 2013-II: "ENERGY EFFICIENT COMFORT IN OLDER APARTMENT BLOCKS"

FINAL REPORT

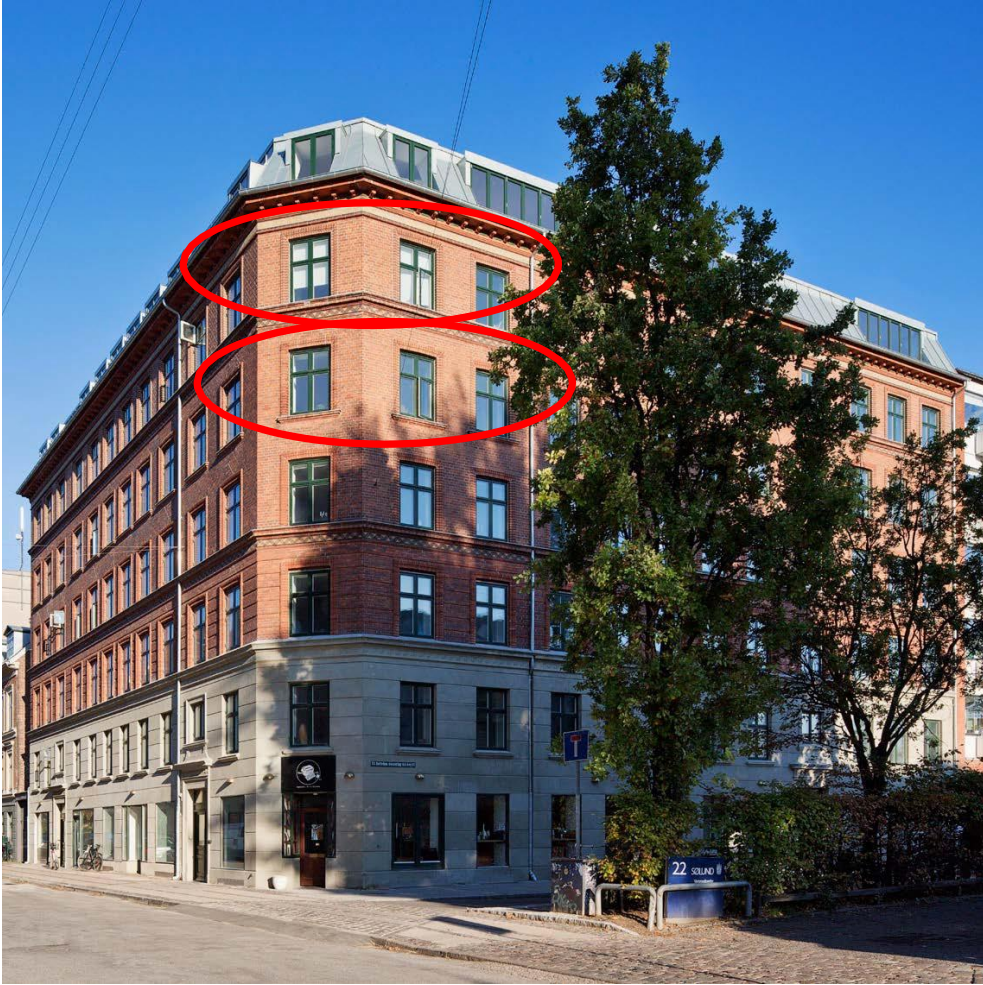
Figure 9: Measuring points from Rymsgade 30.

From the previous EUDP project: “1:1 demonstration af koncepter til renovering af ældre etagebygninger til lavenergiklasse 1”, measurements were carried out in Ryesgade on the 4th and the 5th floor in the corner apartments with orientation as seen in Figure 9. Also from Figure 9 the measuring points in both apartments can be seen. As seen the insulation is stopped 200mm above the floor construction in order to create a thermal bridge so that the beam ends have higher temperatures and thereby lower relative humidities. More details about the building can be found in the final report of the EUDP project: “1:1 demonstration af koncepter til renovering af ældre etagebygninger til lavenergiklasse 1”.

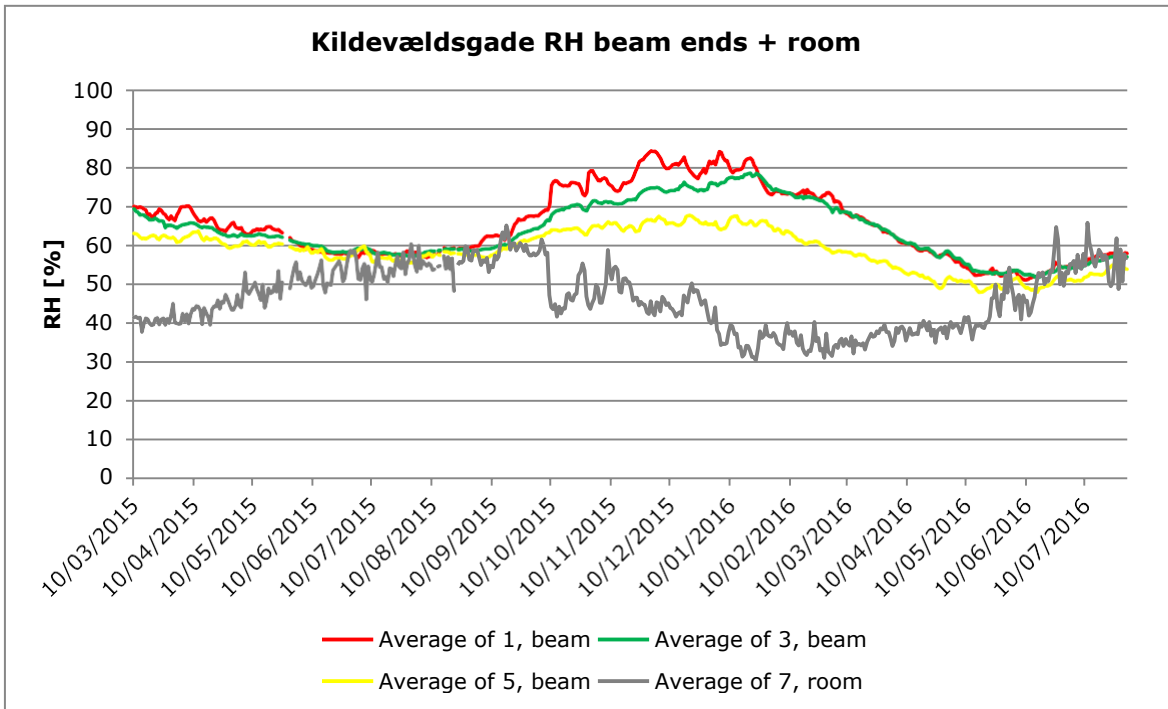
The relative humidity measured in beam ends at Kildevældsgade, seen in Figure 18, appear to be at acceptable levels during the measuring period from March 2015 - April 2016. The values generally vary seasonally between 50-80% - only sensor 1 exceeds 80 % slightly for short periods during winter. It is seen, that sensor 5 has the lowest relative humidity, and highest temperature, Figure 19, which again could be assumed to be caused by the hot water pipes. In this case, the temperatures in the beam appear to be slightly higher when compared to the wall-insulation interface. Despite the lower story not being insulated, the air gap installed may have the desired effect in this case.

Figure 18: Relative humidity measurements in Kildevældsgade, at beam ends, as well as room conditions

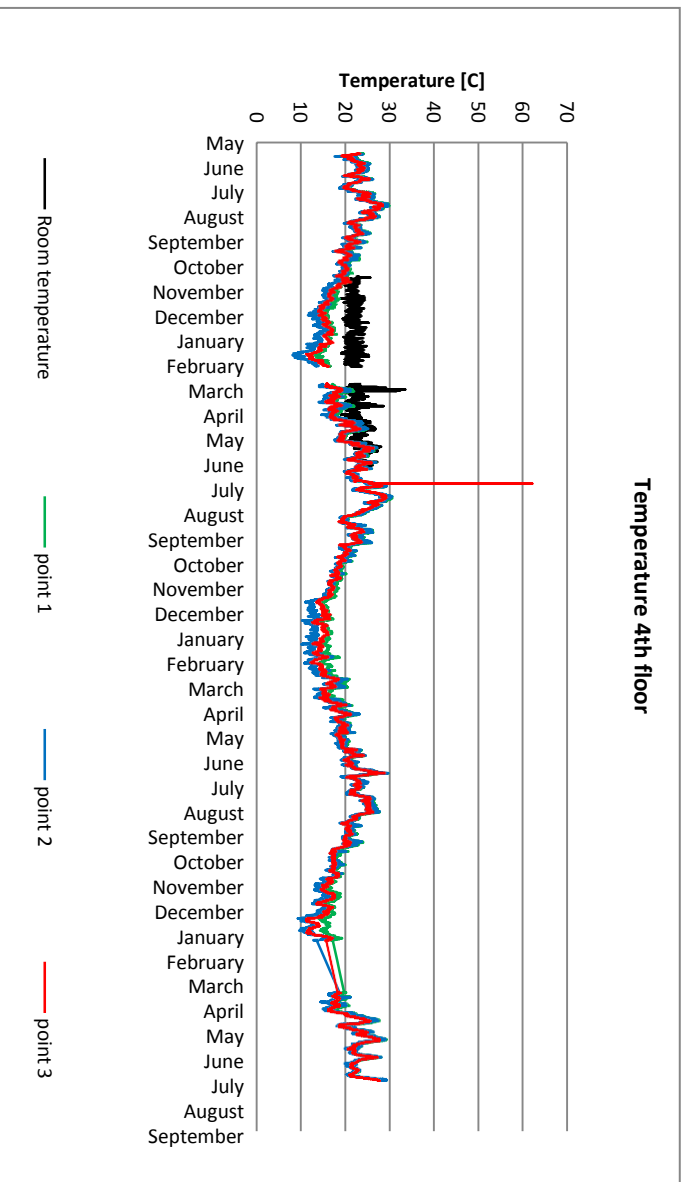
Figure 30: Temperature measurements on the 4th floor from Rymsgade 30 at beam ends.

Figure 30 and 31 show the temperature and relative humidity measurements on the 4th floor and figure 32 and 33 show the temperature and relative humidity measurements on the 5th floor.

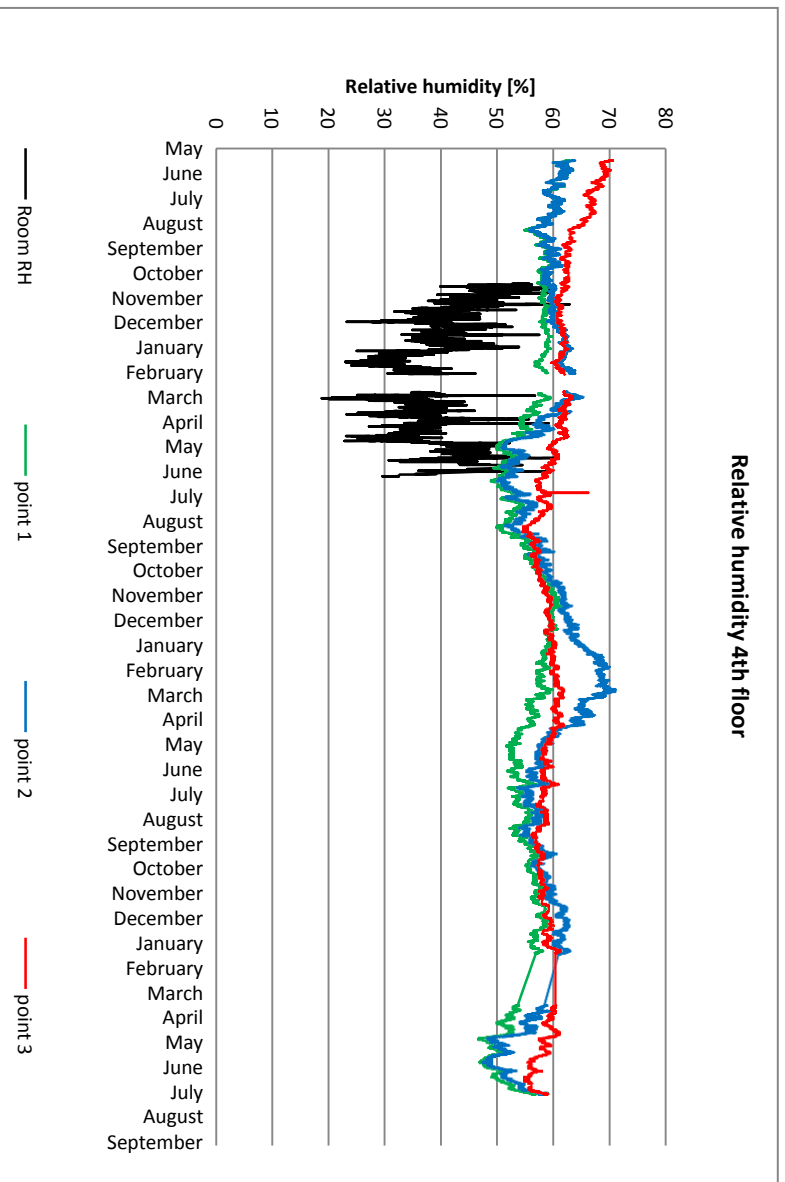
Figure 31.1: Relative humidity measurements on the 4th floor from Rymsgade 30 at beam ends.

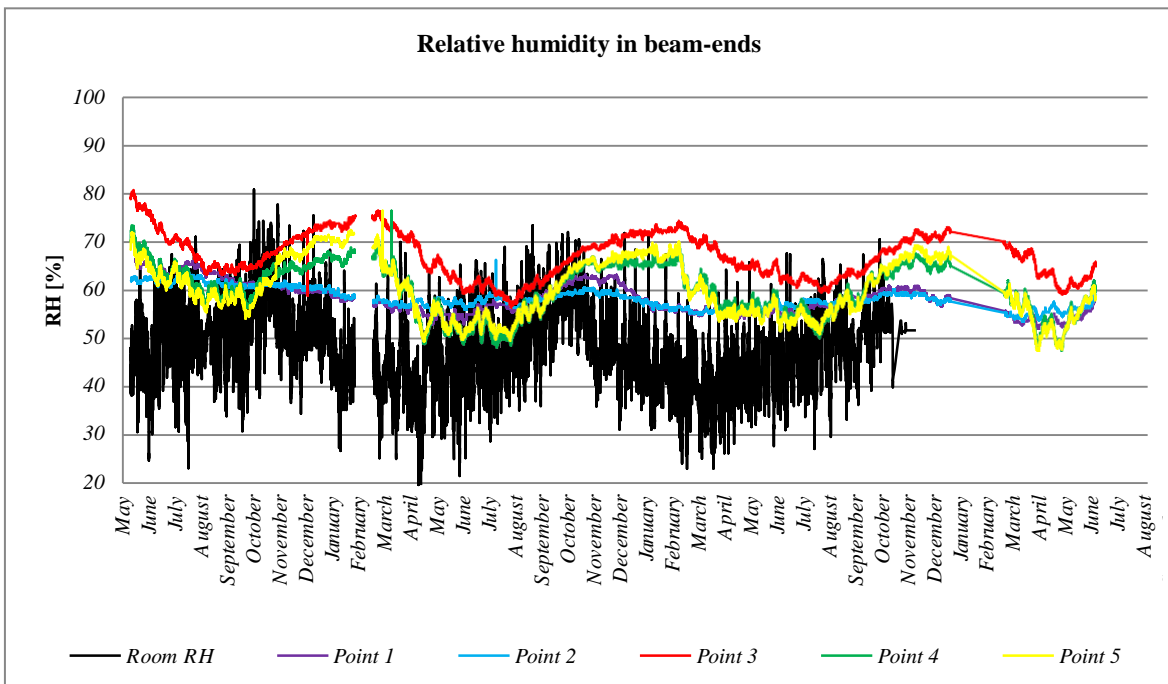
Figure 33: Relative humidity measurements on the 5th floor from Ryesgade 30 at beam ends.

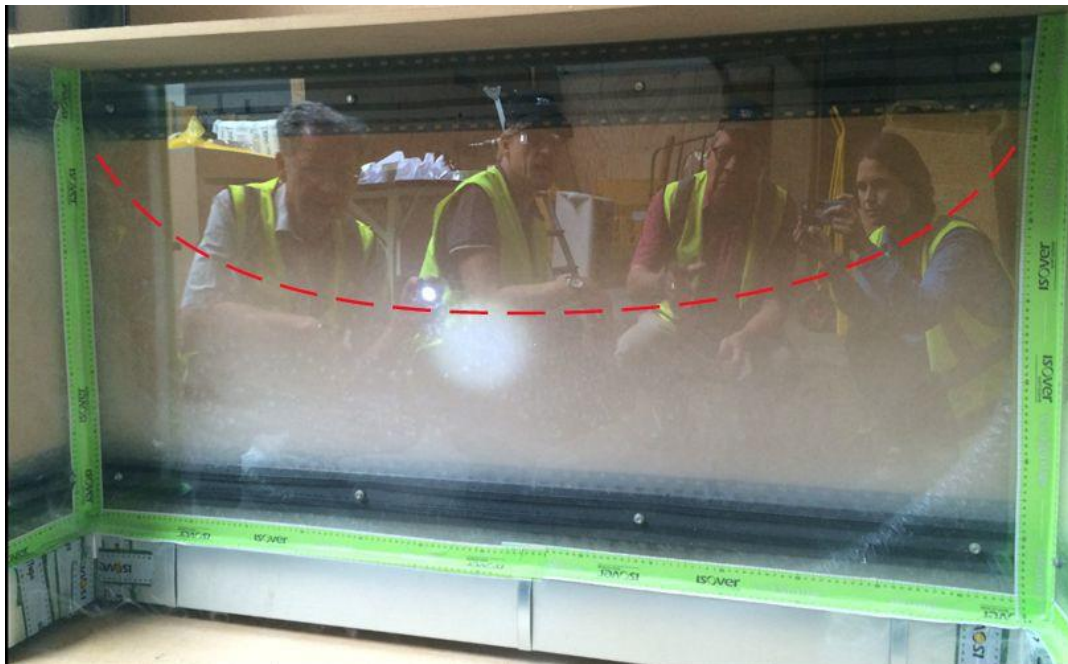
Figure 48: Movement of air beneath window visualized with smoke test

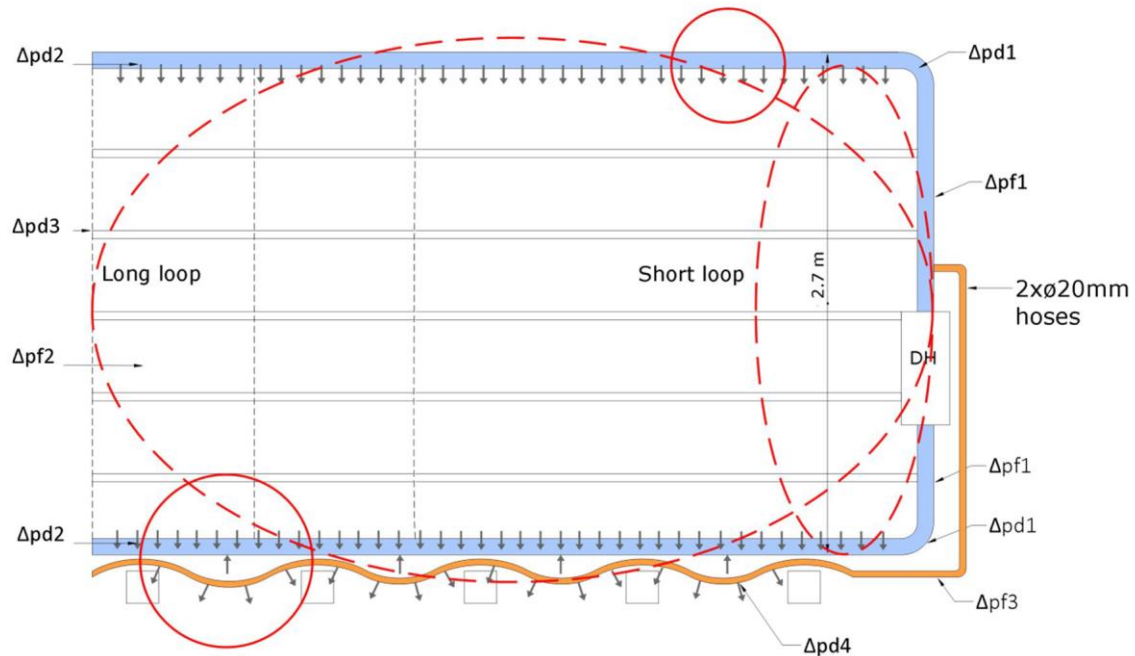
Figure 55: Ducting system 1 (Layout)

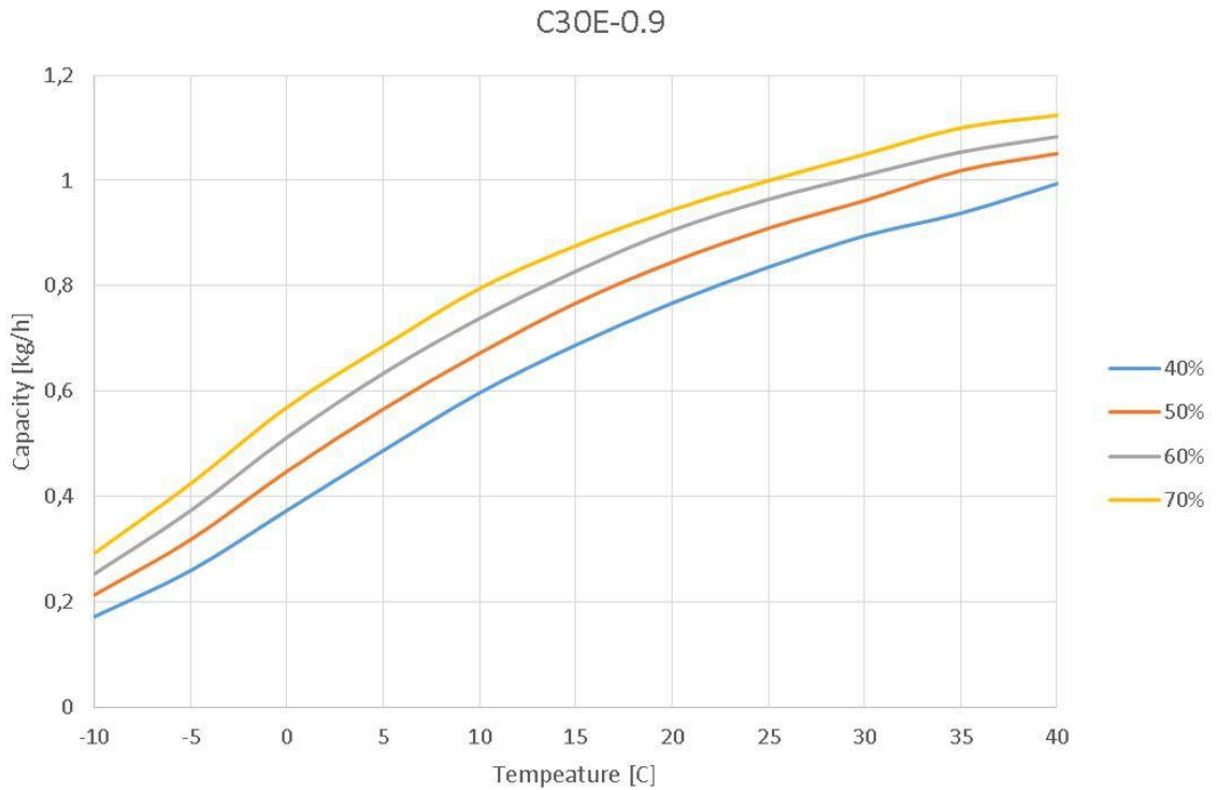
Figure 59: Drying capacity of the adsorption dehumidifier Cotes All-round C30E-09
