*Published in:*  
Journal of Physics: Conference Series

# Internal Insulation of Preservation Worthy Facades

**Abstract.** With international awareness of the need to decrease greenhouse gas emissions, the Danish government set a target to be fossil fuel-free by 2050. To achieve that, existing buildings will need to be retrofitted with energy-saving technologies such as improved thermal insulation. In Denmark, a larger mass of the building stock from around 1850 to the 1940s is preservation worthy. The construction is typically solid brick walls with wooden beams on the floors. This creates a challenge for energy retrofitting since the external facades cannot be altered. The application of internal insulation can influence the temperature and moisture profile of the wall. Moisture builds up in the interface between the original brick wall, and the insulation layer can create an environment where mould can grow. Previous research also demonstrated a risk of moisture build-up at the beam-ends when internal insulation is applied. Saint-Gobain ISOVER has, together with DTU, spent five years developing a new system, ISOVER RetroWall System, which addresses these problems. The presente

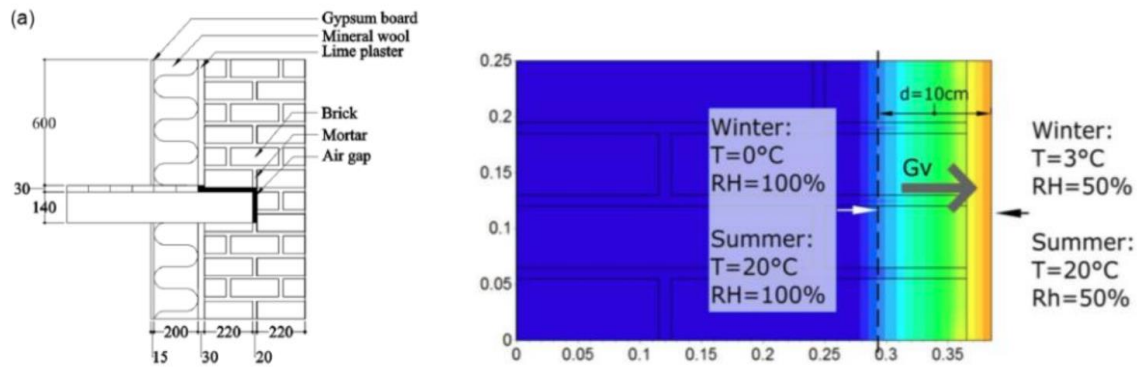
**Figure 1.** Cross section typical wall (left) and heat, air and mass conditions for summer/winter in the air cavity (right)

The Danish building stock ranging from the 1850s up to the 1940s has aesthetic value, and the facade needs to be preserved. To comply with government regulations for energy retrofitting, internal insulation is, therefore, the only option. Although it faces a technical problem, applying internal insulation and having the vapour barrier on the inside excludes the possibility of internal diffusion, and external drying by diffusion is the only option. Furthermore, the wooden beams lay within the brick wall. So longer periods with high relative humidity or condensation should be avoided in order to preserve its structural integrity. Previous studies done by Fosso [2] investigated the effect of wind-driven rain, capillary and added water content by diffusion into the air cavity Figure 1.

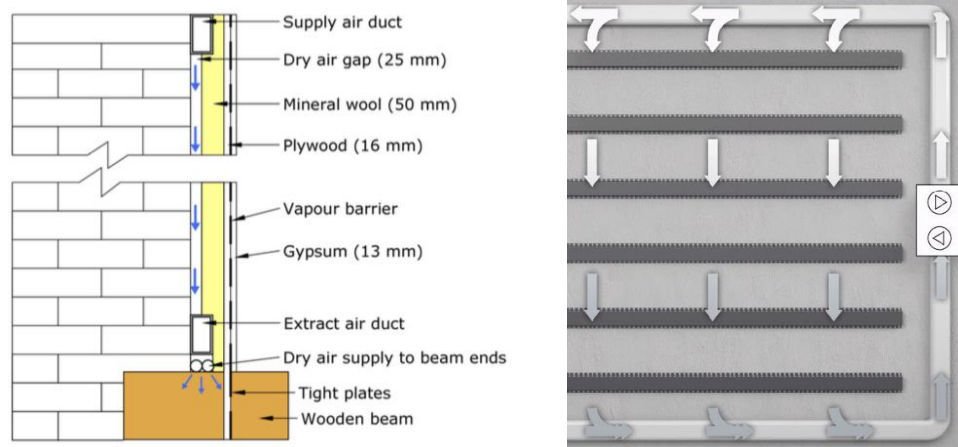
**Figure 2.** RetroWall Cross Section (left) and Airflow Layout (right)

The active dehumidification blows the air inside of a 25 mm air gap from the top of the wall. The air is collected on the bottom part of the wall and back to the dehumidifier. The system is composed of an air gap of 25 mm followed by 50 mm of insulation with mineral wool and a wall consisting of two 13 mm gypsum boards with a vapour barrier in between, as shown in Figure 2. The structure of the system is supported by horizontal steel brackets (25x110 mm), which have a 40% perforated area allowing the air to go through. The air supply and extraction are done on the top and bottom parts of the wall by steel ducts (54x100 mm).

RetroWall is a new concept for internal insulation for heritage buildings. The system tackles the problem by having active moisture control within the air cavity, between the internal wall and the insulation, and supplies air into the floor structure. The heat, mass and air balance to achieve the required airflow was prior investigated by Lucchesi [5], taking into account internal, external temperature, local climate and relative humidity.

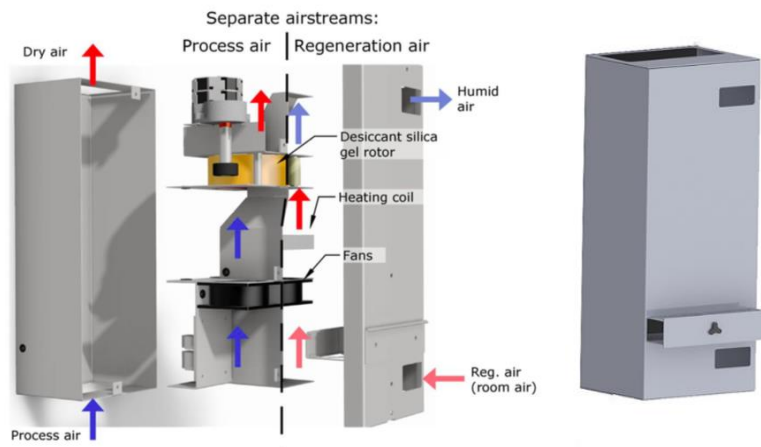
The dehumidifier is responsible for moisture control. In order to prevent moisture-related problems such as mould growth and wood decay, it keeps the relative humidity under 75%. The air collected is heated 10 degrees Celsius before returning into the cavity. The unit is split into two sections, process and regeneration airflows. The airflow within the air cavity is the process airflow, while the regeneration process is the airflow that dries the desiccant wheel with indoor air, see Figure 3. The moisture content exchanged indoors is very low, 30g/day while regular activities are 10kg/day.

**Figure 3.** Dehumidifier unit design

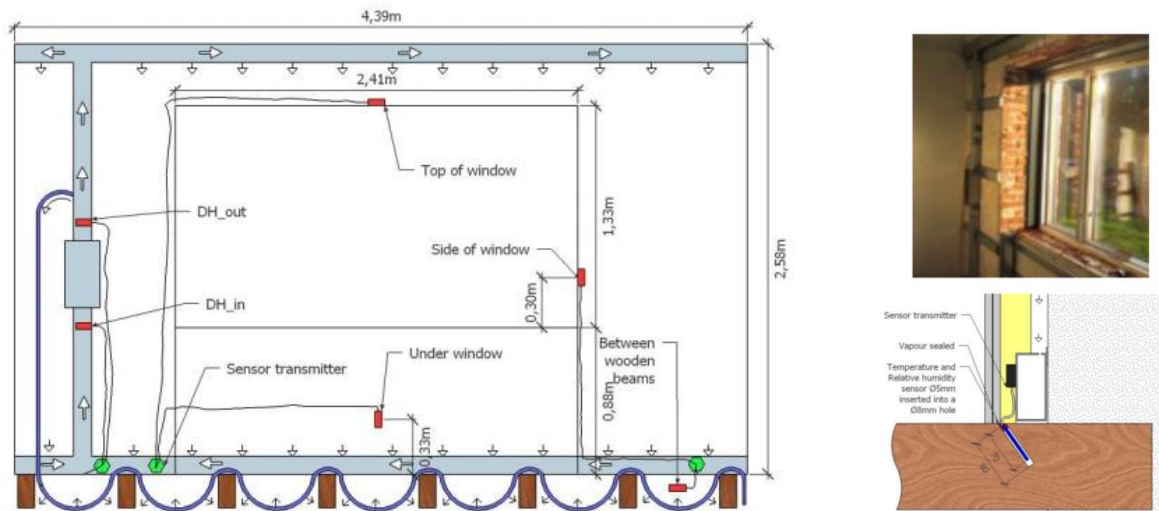
For one of the test cases, Ordrupvej, before installing the system, the wallpaper and paint were removed. Several sensors were placed within the wall in order to collect data while the system operates, as shown in Figure 4. In addition, the wooden beams got a dedicated hose to bring the dried air to remove moisture from beam ends.

**Figure 4.** Retrofit layout, the sensors for temperature and relative humidity are in red colour (left), installation (top right) and sensor in the wooden beams (bottom right) [1]

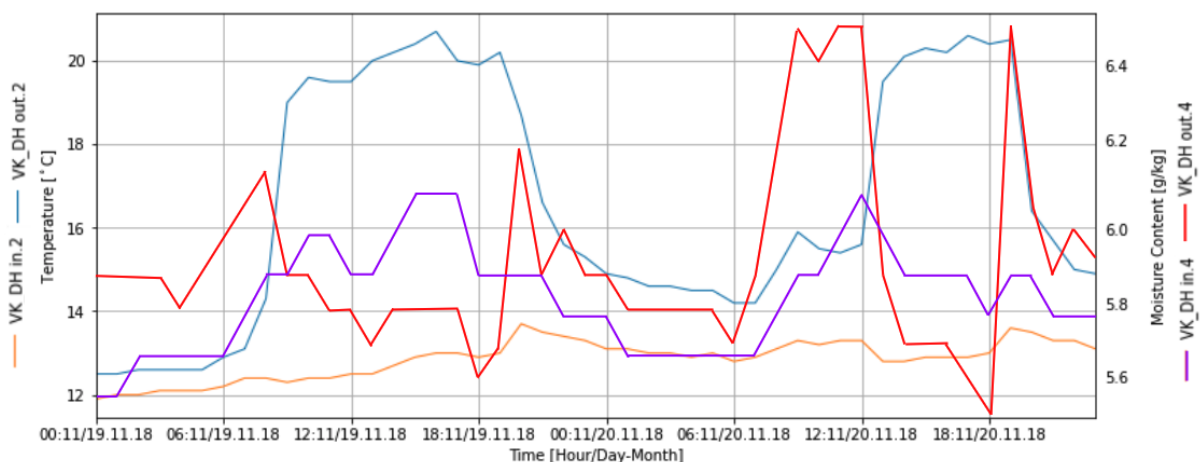
The Dehumidifier usually operates for 5 min every 2 hours to collect data on Relative Humidity. If RH is more than 65% it keeps running and we can capture the operations by the temperature difference from the inlet and outlet as in Figure 5. On the right, it can be seen that for the same period, Moisture Content in the outlet (DH Out) drops below the inlet (DH In) as soon as that operation starts, meaning it is drying the air.

**Figure 5.** VK - Dehumidifier DH inlet x DH outlet - Temperature (left) and Moisture content (right)

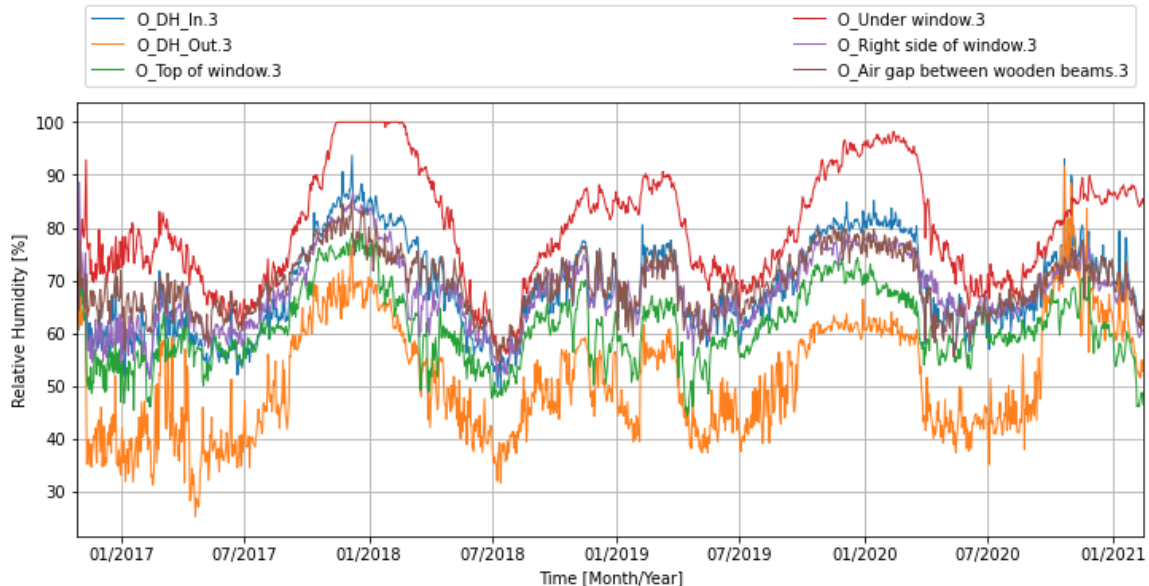
This site has a floor structure made over wooden beams that lay into the brick wall. This is a critical area as moisture can be driven by capillarity to the wood and start germination of mould and decay the element. For this reason, there is a hose supply airflow and sensors to capture the moisture, temperature and relative humidity. The RH was under 80% in this critical area during these five years, which proves the efficacy of the dedicated hose, see Figure 6. “Under window” is still the most critical due to the thickness of the wall and the difficulty to the airflow to get in that region.

Figure 6. OD - Relative Humidity - 2016-2021

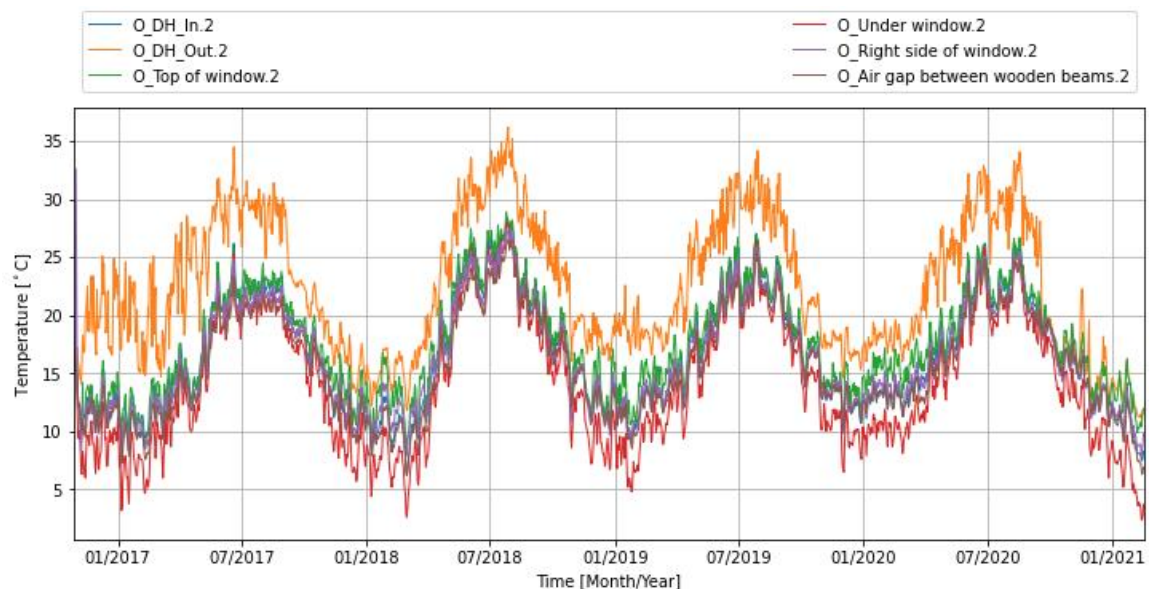
In Figure 7, the average temperatures for all sensors are shown and as expected, “under window” has the lowest, which corresponds to higher levels of humidity. Meanwhile, the temperature in between wooden beams was also low, but due to the extra air supply, relative humidity was kept at acceptable levels.

Figure 7. OD - Temperature - 2016-2021

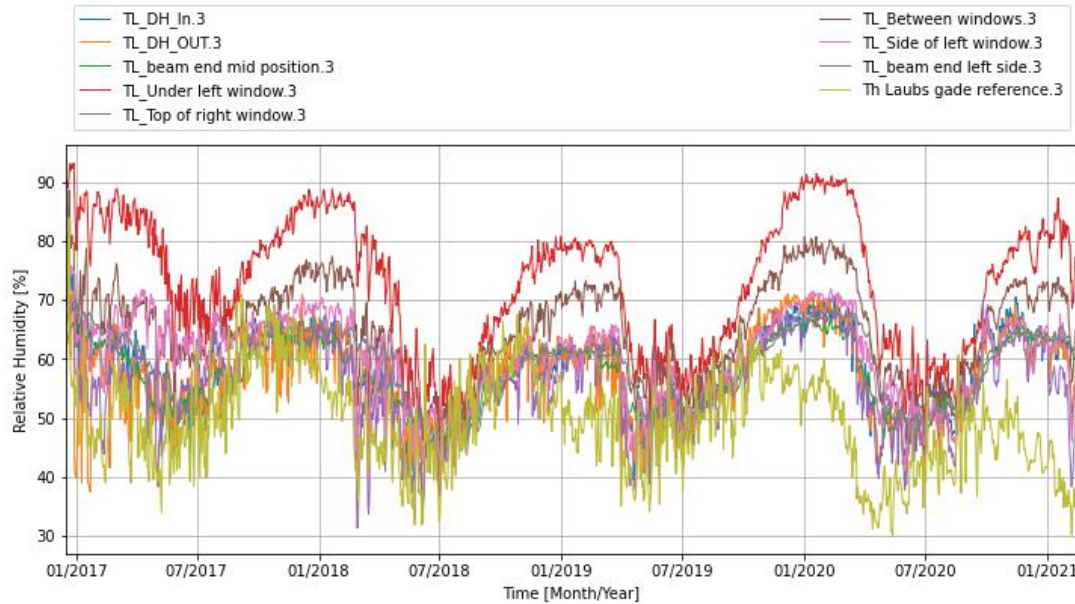
During the start of the system, Thomas Laubs Gade location had measurements of Relative Humidity under the window over 90%. The system showed to be able to remove moisture when switched on, but the occupant of the apartment kept switching off due to some noise issues. Figure 8 shows the data from the past five years, in which overall, the sensors show relative humidity was kept under 75%. “Under window” has a wall thickness 20% smaller, being the critical area that during winter and rainy days had some spikes. Beams end mid-position had results under 70% all year long.

Figure 8. TL - Relative Humidity - 2016-2021

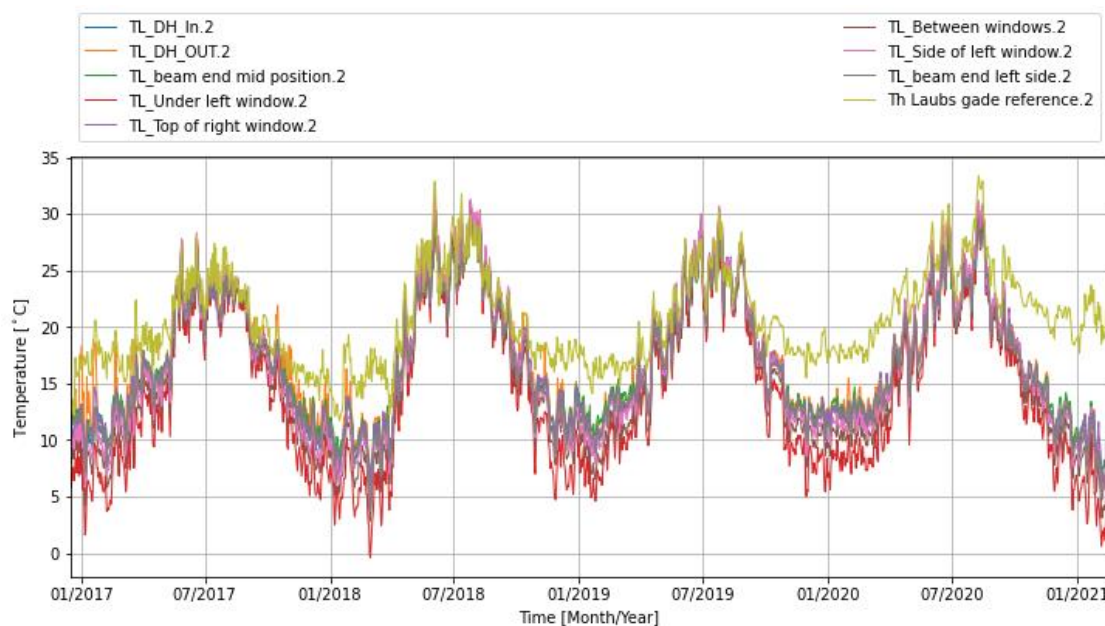
Figure 9 shows the temperatures for all sensors, and for the period in which it registered a higher relative humidity of 90%, the temperature was ranging down to 5 degrees Celsius. It would take at least 16 consecutive days to consider spore germination if temperature and humidity kept stable.

Figure 9. TL -Temperature - 2016-2021

As it could be seen in this test case, the only critical place is “under window”, which could have some extra hose to redirect airflow, as the wooden beams have it.

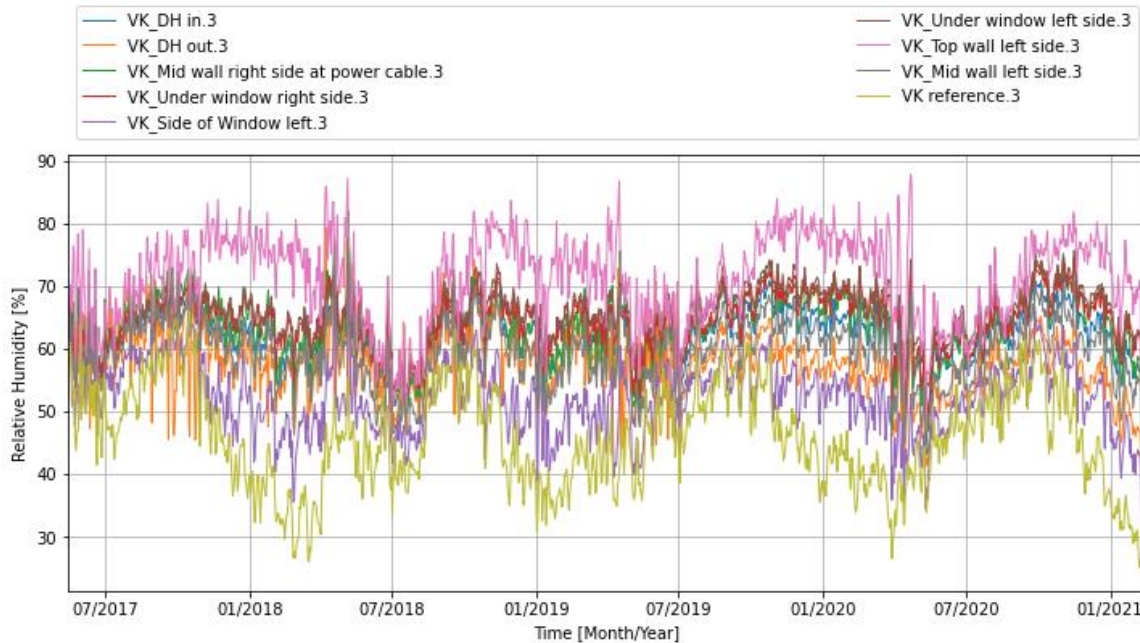
According to Figure 10, it can be seen the Relative Humidity was kept under 70% for all sensors with the exception of the Top Wall Left side, which is not expected. It could be the sensor got in contact with the wall, or there is a crack.

Figure 10. VK - Relative Humidity - 2016-2021

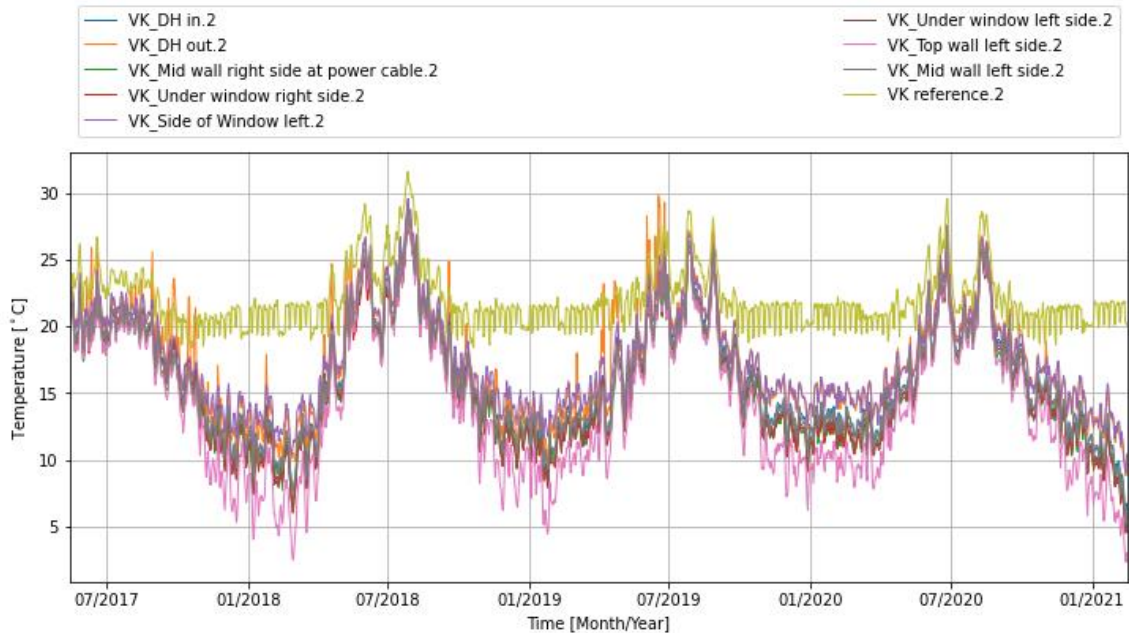
Given that the top of the wall sensor is close to the duct, which supplies heated air from the Dehumidifier is also not expected to get the lowest temperature, as shown in the plot in Figure 11.

Figure 11. VK - Temperature - 2016-2021
