Published in:
COLD CLIMATE HVAC 2009

Performance of the Low-energy House in Sisimiut

Low-energy house, Arctic climate, design, measurements

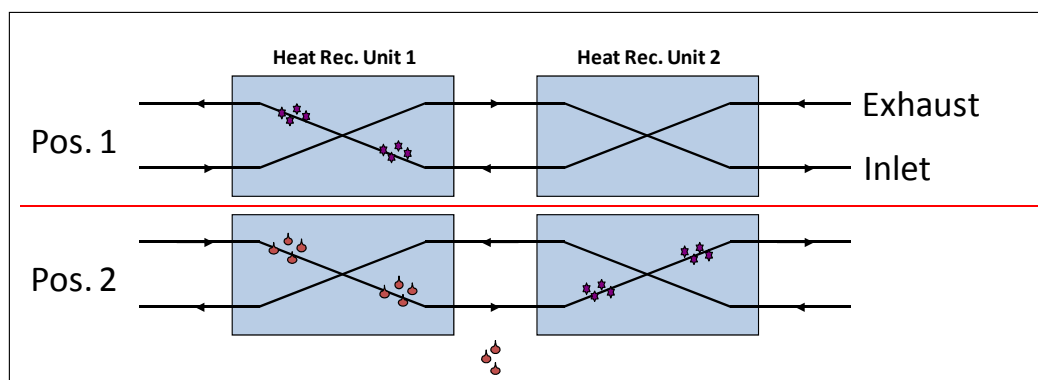
A new heat recovery unit was developed for the low-energy house in Sisimiut in cooperation between EXHAUSTO A/S and the Technical University of Denmark. The dimensions of the unit are: Length 1,760 mm, width 930 mm and height 660 mm. The unit consists of two highly efficient aluminium counter flow heat exchangers coupled in a serial connection. A valve is able to switch the air flow direction through the units. When ice formation starts to reduce the airflow in the coldest exchanger the air flow direction is switched. The exchangers, valve and filters are mounted in a cabinet with 50 mm insulation, although the unit is recommended to be placed in a heated place to minimize risks of frost damages from the condensing water. The theoretical temperature efficiency of the heat recovery unit is approximately 90 %. A diagram of the system is shown in Figure 2.

Figure 2. Diagram of the heat recovery unit with two heat exchangers.

The heat recovery system has in some periods been blocked by ice. Beginning ice formation in the system has had the effect to impair the cyclic change of the order of the two parts of the heat recovery system, so the defrosting function has not been fully functional, and the frosting situation has gotten worse. In October 2006, an insulated box was built around the heat exchanger unit, and an electric heater ensured heating of the air around the box to a temperature that approaches normal indoor air temperature. However this initiative has not eliminated the problem, and the temperature efficiency of the heat exchanger remains around 50% (in some periods only 30%), while the system was expected to have an efficiency of 80% (Rode et al., 2007 and 2008). Wasted energy by insufficient heat recovery (estimate): 30% of ventilation heat loss = approximately 25 kWh/m².

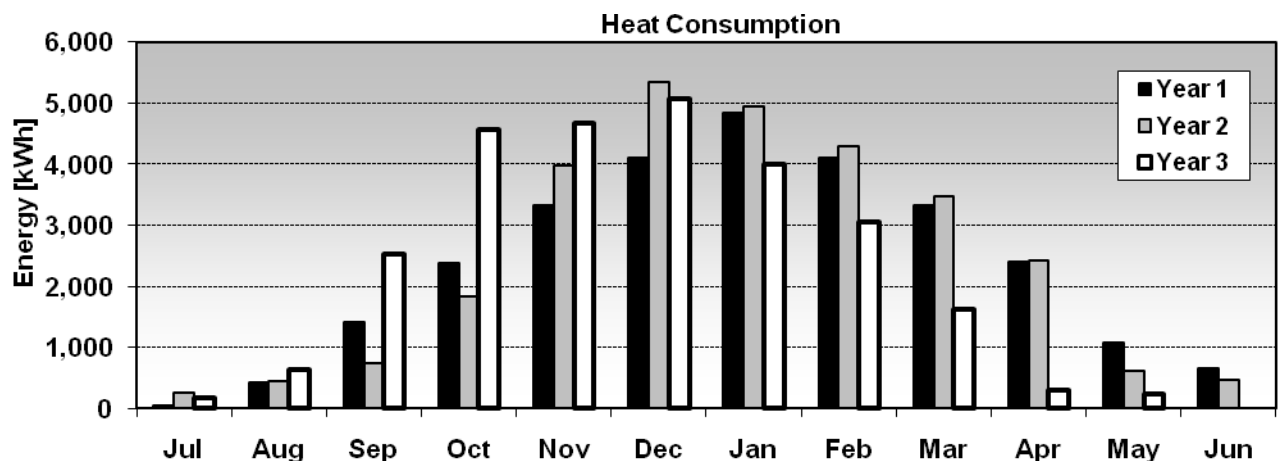
Figure 4 shows the monthly energy consumption for heating (exclusive of domestic hot water), where year 1 is for the period July 2005 – June 2006. The house has not been inhabited during the period July 2007 – April 2008 during which period the house underwent some renovation activities: A separation wall was erected in the boiler room, and the wooden floor of the living rooms was changed because of a failure with the first delivered floor. The house was heated during the construction period, although in a somewhat unusual pattern.

Figure 4. Heat consumption during the months of the first three full years of operation.

The realized annual energy consumption for heating has been around 140 kWh/m² during all three years of operation. This energy consumption is considerably above the targeted 80 kWh/m². Explanations for this discrepancy have been sought, and the following identified:
