PARTIAL DISCHARGE PATTERNS AND SURFACE DETERIORATION IN VOIDS IN FILLED AND UNFILLED EPOXY.

J.T. Holbøll and M. Henriksen,
Electric Power Engineering Department
Technical University of Denmark
Building 325, DK-2800 Lyngby, Denmark

Abstract

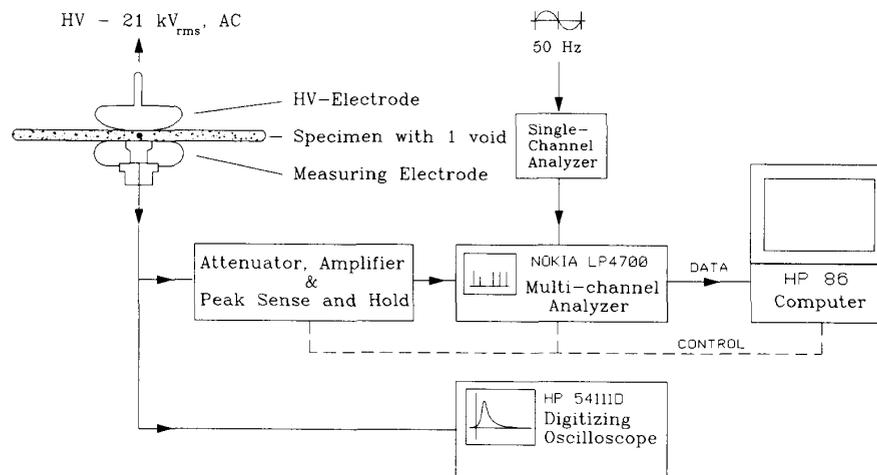
PD detection was based on in-line measurements of the discharge current through a 50Ω measuring impedance formed by oscilloscope and analyzer. The apparent charge is calculated by the time integral of the current pulse $i(t)$ visible on the oscilloscope, and the calibration of the system is performed by relating this value to the signal read by the analyzer.

Fig.1: Measuring system

Pulse detection and analysis was performed with the measuring system shown in fig.1.

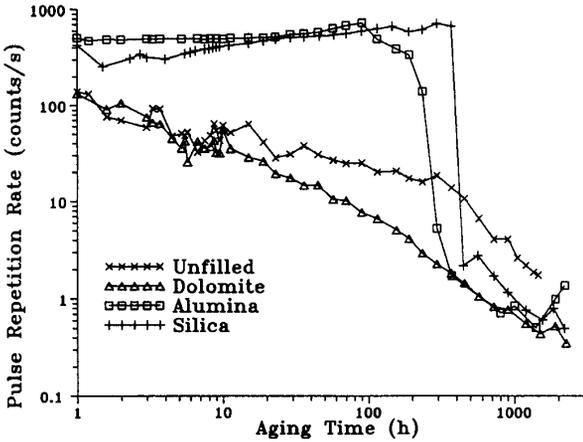
Fig.2 and fig.3 show the pulse repetition rate and the maximum detected apparent charge as the average of the results from 5 specimens for each material combination.

Fig.2: Pulse repetition rate as a function of aging time.

Discharges in voids in unfilled and dolomite filled epoxy showed a periodical discharge activity, which decreased continuously, while the maximum apparent charge was nearly constant. Discharges in alumina and silica filled epoxy showed a continuous and slowly increasing activity, until it after 2-300 hours within few hours dropped with a factor near 1000 to the level of the other materials and changed to periodical characteristic. The maximum apparent charge before this transition was about 20 dB below the one of unfilled and dolomite filled specimens. After the transition the maximum apparent charge of all filler specimens reached the same level. The change of the discharges' character in alumina and silica filled epoxy also resulted in a change of the charge distribution. Fig.4 shows the charge distribution after the transition.

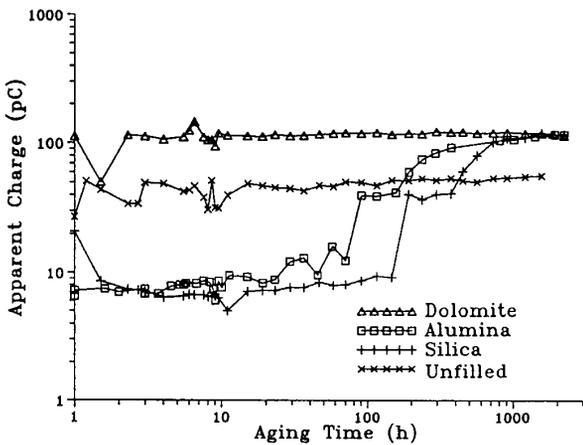
Fig.3: Maximum apparent charge as a function of aging time.

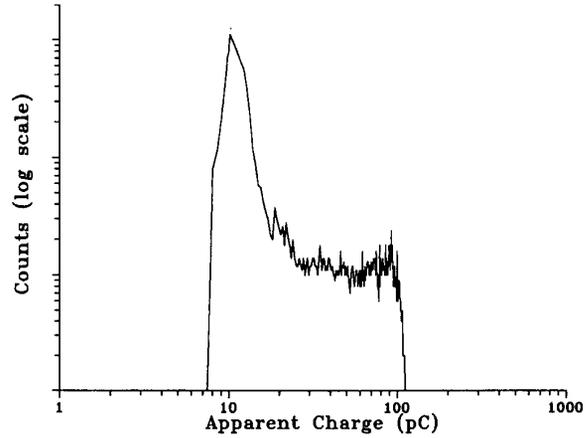
Fig.4: Typical distribution of the apparent charge for discharges in voids in unfilled and dolomite filled epoxy. Similar to the distribution for alumina and silica filled epoxy after transition to periodical activity.

Before the transition to periodical activity alumina and silica showed a charge distribution consisting only of a large number of discharges of about 10 pC.

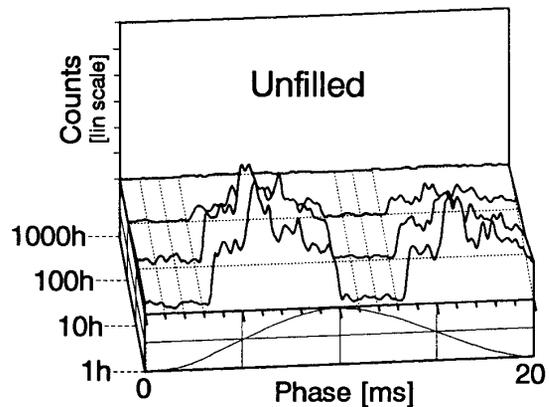
Fig.5: Phase distribution of pulses from discharges in voids in unfilled and dolomite filled epoxy as a function of aging time.

Phase analyses of discharges in the unfilled and dolomite filled specimens showed a decreasing activity, decreasing inception voltage, and a discharge pattern with only few and difficult to define pulse concentrations. The phase distributions of alumina and silica filled epoxy were characterized by very well defined pulse concentrations increasing from 5 to 9 per halfcycle before the transition to periodic activity.

In fig.5 and fig.6 can be seen the phase distributions of pulses from the discharges. Again, unfilled and dolomite filled epoxy showed comparable characteristics, as did alumina and silica.

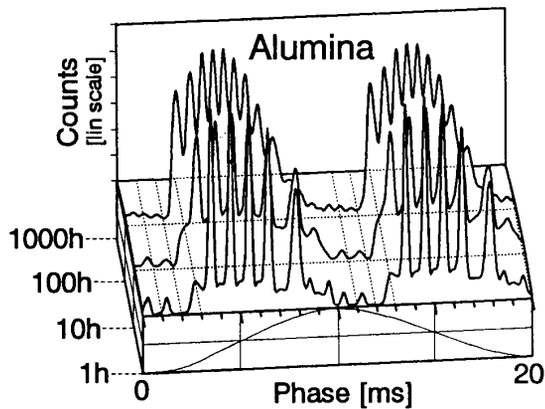
Fig.6: Phase distribution of pulses from discharges in voids in alumina filled and silica filled epoxy as a function of aging time.

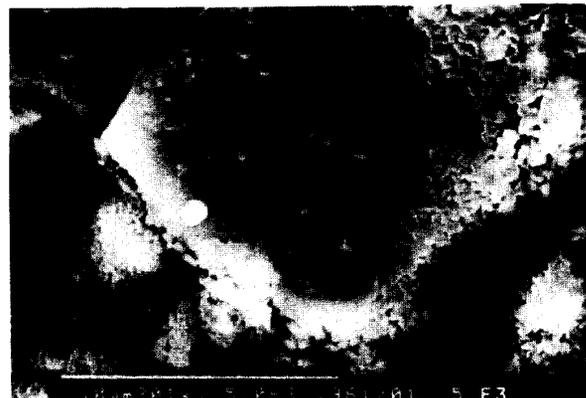
Fig.8: Surface of a spherical void (1.2mm \varnothing) in dolomite filled epoxy after 2400h of exposure to discharges (SEM picture).

As can be seen in fig.8,9 & 10 some of the epoxy was removed from the surface of the filler particles under the exposure to discharges. Unfilled, dolomite and alumina filled epoxy showed an even deterioration, with the epoxy forming round shapes of less than 1 μm radius (fig.11). In silica filled epoxy the deterioration seemed to be more severe, but was limited to certain areas (fig.10). The rest of the exposed area was also affected, but only in a degree as seen in the equatorial area.

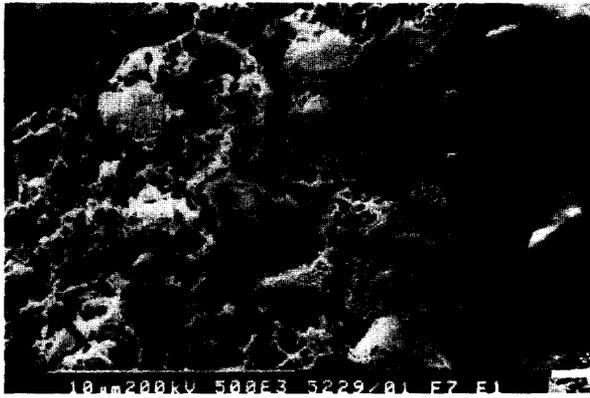
Fig.10: Surface of a spherical void (1.2mm \emptyset) in silica filled epoxy after 2400h of exposure to discharges (SEM picture).

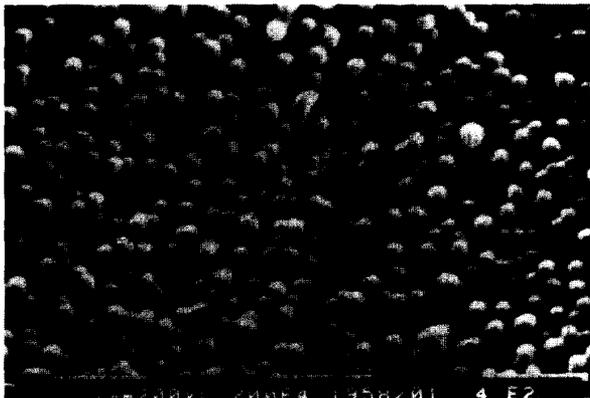
Fig.11: Surface of a spherical void (1.2mm \emptyset) in unfilled epoxy after 1500h of exposure to discharges (SEM picture).

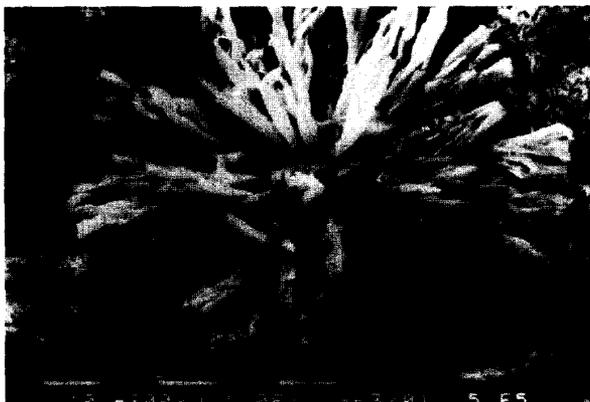
Fig.12: Crystal like structure on the surface of a void in dolomite filled epoxy after exposure to discharges in 2400 hours (SEM picture).

In all of the unfilled and dolomite filled specimens some crystal-like structures were found (fig.12). The crystals could be dissolved in water but not in ethylene. The aqueous solution was non-acidic, which means that the crystals did not contain oxalic acid as earlier suggested [2]. In the same paper it was implicated that these crystals could cause a sudden high discharge activity, which we feel could possibly be due to fieldenhancements by the crystals.
