Published in:
Proceedings of the European Corrosion Congress 2012

Effect of Ionic Contamination on Corrosion Reliability of Printed Circuit Board Assemblies

Vadimas Verdingovas, Morten Stendahl Jellesen, and Rajan Ambat
Materials and Surface Engineering, Department of Mechanical Engineering,
Technical University of Denmark, DK-2800 Lyngby, Denmark
vaver@mek.dtu.dk

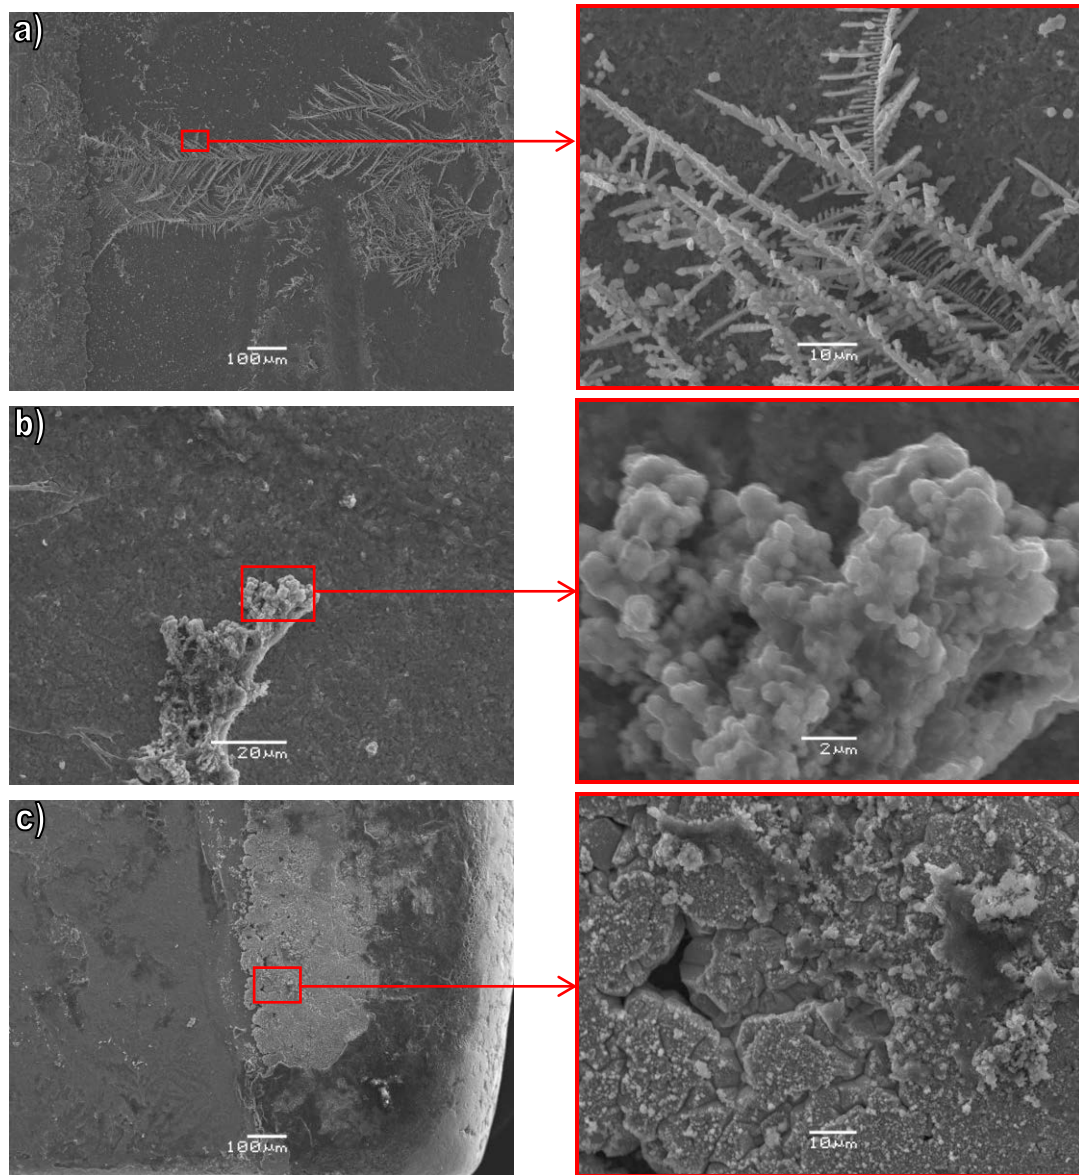
Figure 6: (a) – ECM on the size 0805 capacitors with $92 \mu\text{g}/\text{cm}^2$ of flux residue; (b) – deposition of corrosion product (black deposits) nearby cathode terminal with $342 \mu\text{g}/\text{cm}^2$ of flux residue and (c) – corrosion of anode terminal with $342 \mu\text{g}/\text{cm}^2$ of flux residue

The EDS analysis of corrosion products on the anode terminal (**Figure 6 (c)**) indicated mainly tin (85 wt.%, however some amount of copper (10 wt.%) and small amount of chromium (less than 5 wt.%) were identified. Both elements are known to be used as termination materials for multilayer chip capacitors [17–19], and indicate a heavy dissolution of electroplated top layer of tin. The copper and chromium were mostly

identified on the very edges of the anode terminal, where the dissolution rate of metal is expected to be the highest.

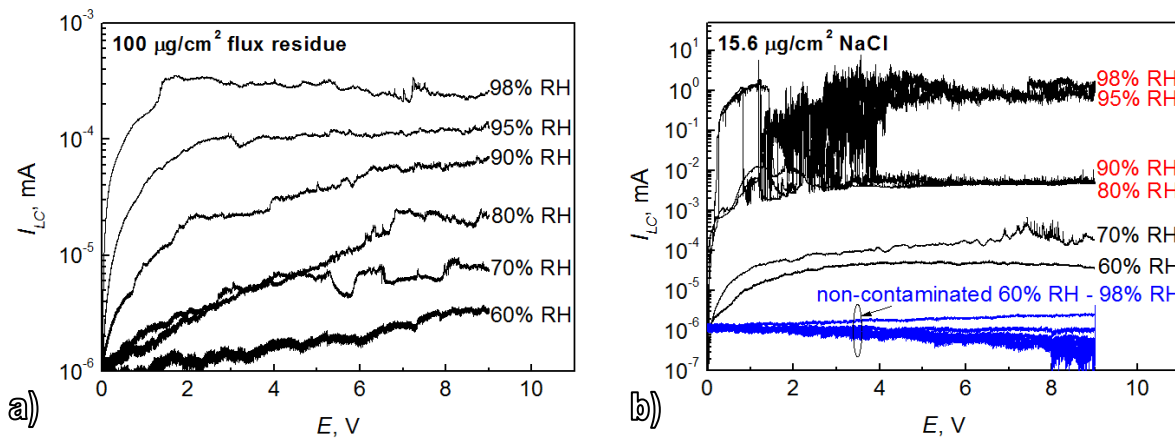
measured in the range from 0 V to 9 V with a sweep rate of 2 mV/s. The measured voltammetry curves as a function of RH are presented in **Figure 8**. The temperature during the experiment was kept constant at 25°C.

Figure 8: Leakage current as a function of applied potential and relative humidity: (a) – solder flux residue and (b) – NaCl and non-contaminated surface

The presence of flux residues (Cobar 390-RX-HT) is less effective in generating leakage current at all humidity levels compared to NaCl. With the increase of relative humidity from 60% to 98%, the leak current measured on the SIR comb pattern pre-contaminated with the flux residues has increased somewhat more than two orders of magnitude and no ECM initiation has been observed after the testing. Whereas in case on NaCl a more than four orders of magnitude increase in leak current has been observed when the relative humidity exceeded 80 % value. The observation of considerable increase of leak current is assumed to be an indication of NaCl dissolution and water layer formation on the SIR pattern. According to Kohler theory and Pöschl study on sodium chloride interaction with water vapour, the hygroscopic properties of NaCl enables adsorption of water molecules at RH around 75% [22]. The optical inspection of SIR comb pattern after the experiment revealed dendrite growth between the adjacent conductive lines. The increase of leakage current with increase of RH from 60% to 98%, measured on the non-contaminated SIR pattern was in scale of nA and negligible, indicating an importance of PCBA cleanliness for climatic reliability of electronics.
