Low-energy house in Sisimiut

Annual report of Low-energy house performance July 2009 to June 2010

LOW-ENERGY HOUSE IN SISIMIUT

Annual report of Low-energy house performance
July 2009 to June 2010

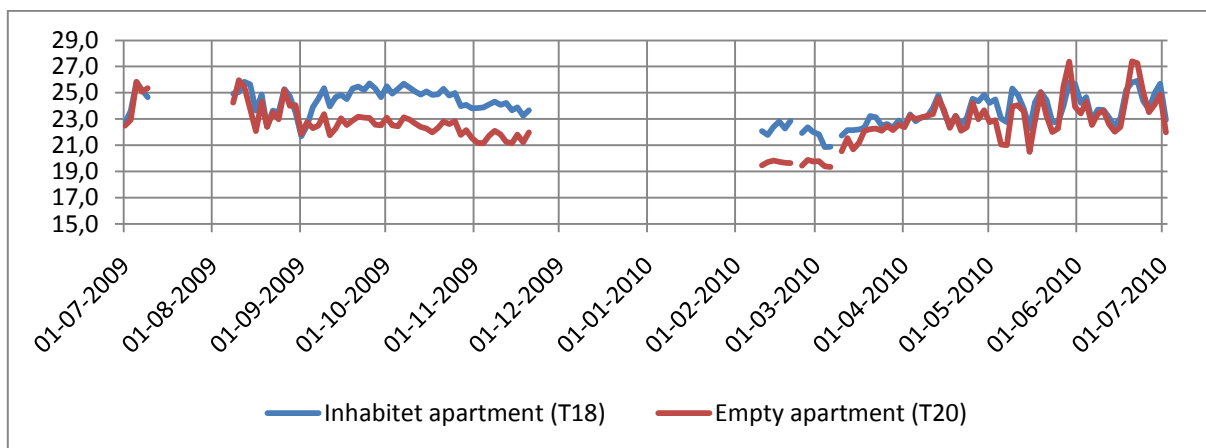
Figure 4 Measured air temperature in kitchens/living rooms from July 2009 to June 2010

The average temperature in the inhabited apartment has been rather high. Also the measurements from previous years showed the same phenomena. It is probably caused by the different demands of the people living in the arctic. However it might also be caused by the improper control of the heating and ventilation system where in case that the temperature in the space is above the set point, the after heater in the ventilation system should heat the air up to lower temperature.

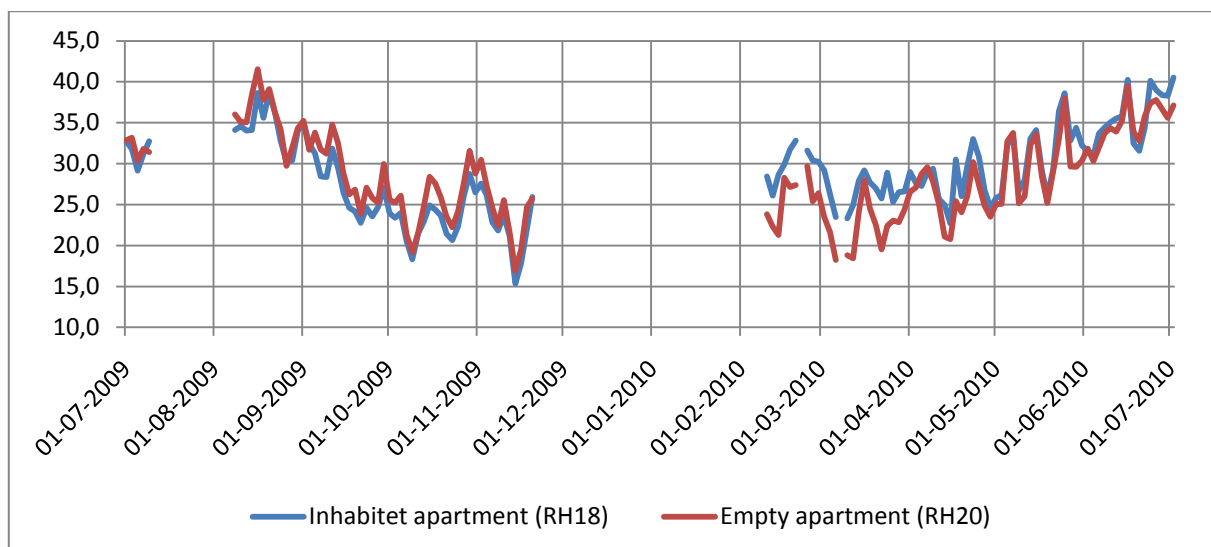
Figure 5 Measured relative humidity in kitchens/living rooms from July 2009 to June 2010

As expected, the relative humidity is seen to be lower than normal for Danish conditions.

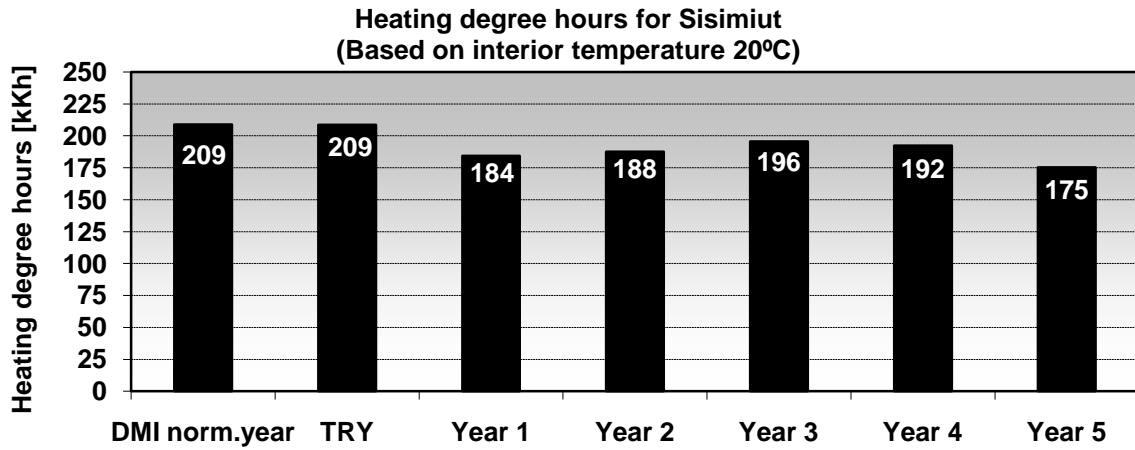
Figure 7 Calculated heating degree hours with interior temperature 20°C.

Figure 7 shows the estimated total annual number of degree hours. These values are compared with DMI's normal year and reference year (TRY).

Compared to the first four years of operation and to TRY data, the year 5 was milder. The number of heating degree hours in the year 5 was 10% lower than the coldest year 3 and 16% lower than the TRY.

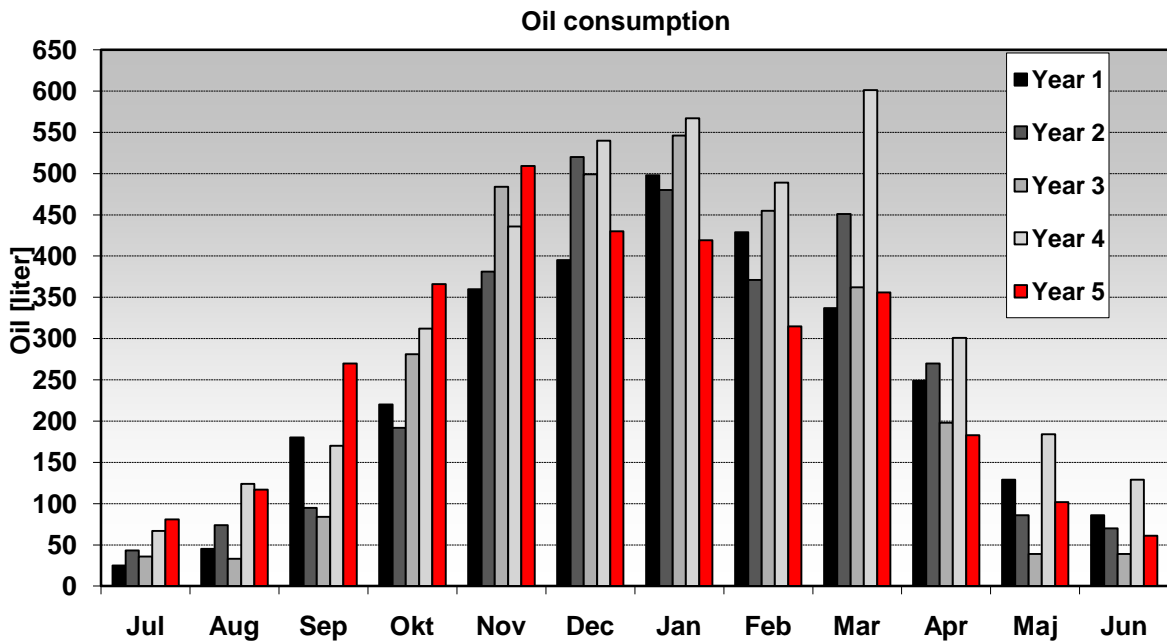
Figure 8 Oil consumption throughout the years

Figure 8 shows the measured oil consumption spread over the months of the year.

The oil consumption has decreased by 20% when compared to year 4. Part of this savings is caused by milder winter (app. 50%) and the rest is probably caused by fixing the broken damper in the heat exchanger in December 2009. After the damper has started working, the efficiency of the heat exchanger has increased¹.

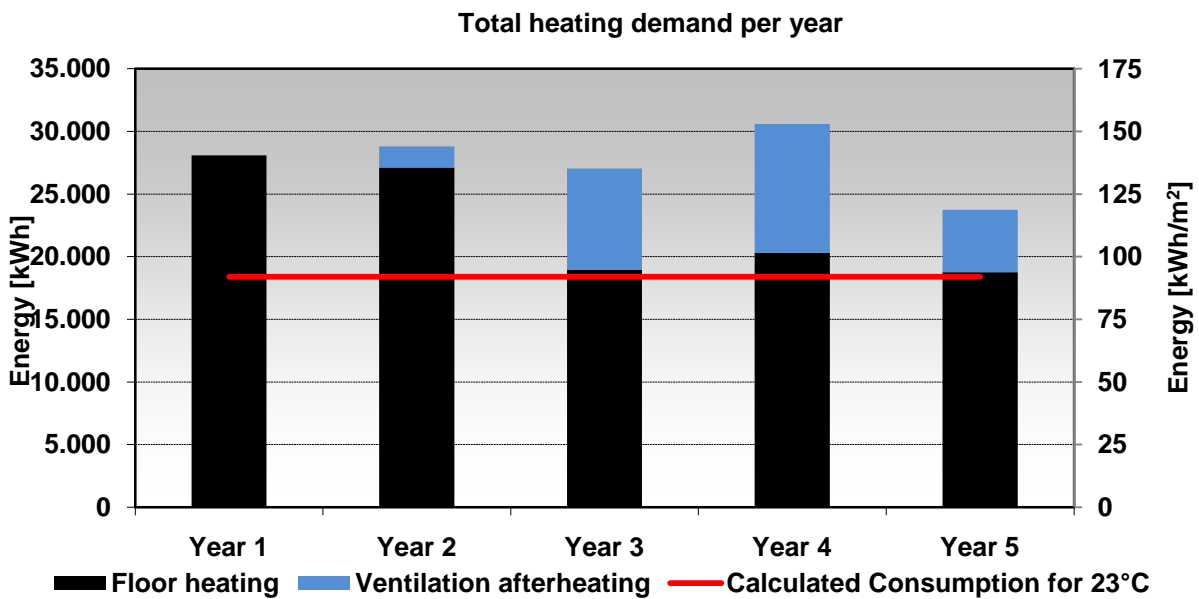
Figure 11 Comparison of heating consumption for each year

Figure 11 shows comparison of the annual heating consumption for each year and the targeted heating consumption.

As it could be seen from the Figure 11 the energy demand of the floor heating has been more or less identical for last three years. The only thing what has varied is the ventilation energy demand.

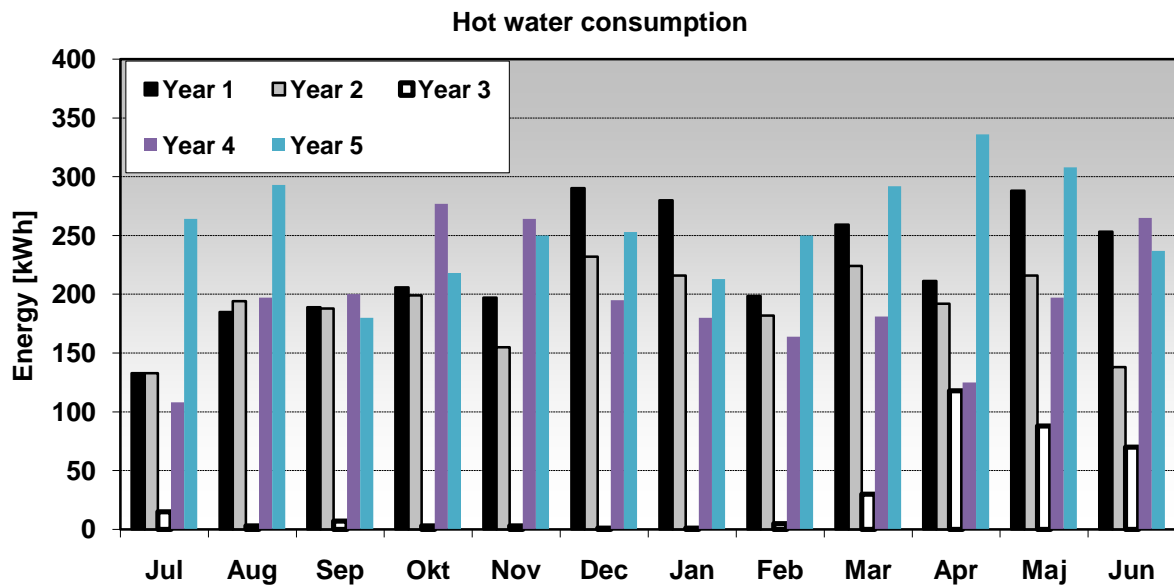
Figure 13 Measured energy consumption for hot water

Figure 13 shows the measured energy needed for domestic hot water.

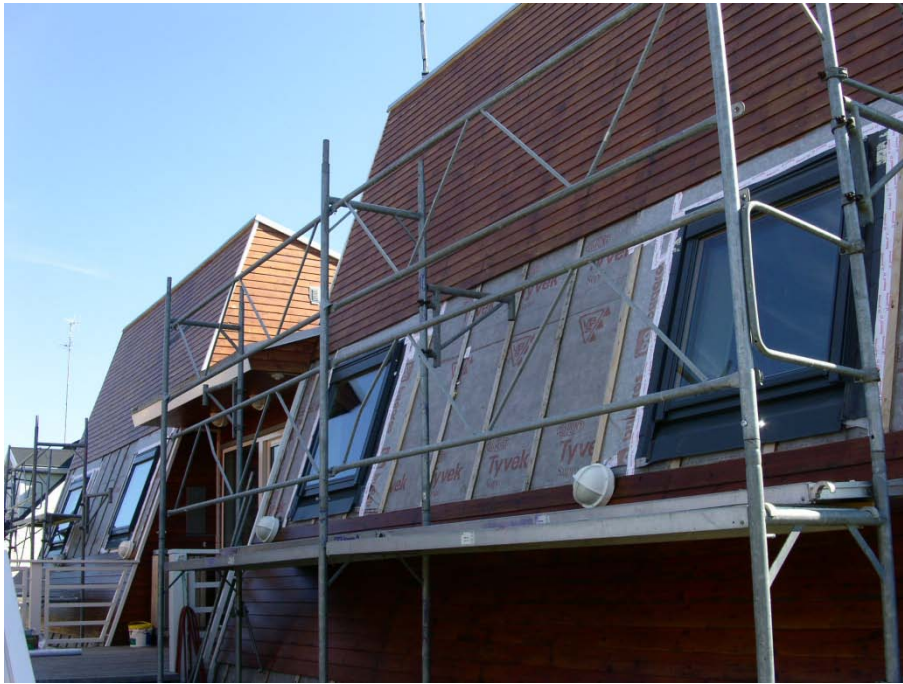
Improving the air tightness (summer 2010)

During the summer 2010 the wooden cladding on the façade was partly removed and the leakages of the wind barrier by the windows and corners were sealed after the cladding was back in place the new paint was applied on the entire outer surface. It is expected that the air tightness has been improved which will be tested by the blower-door test.

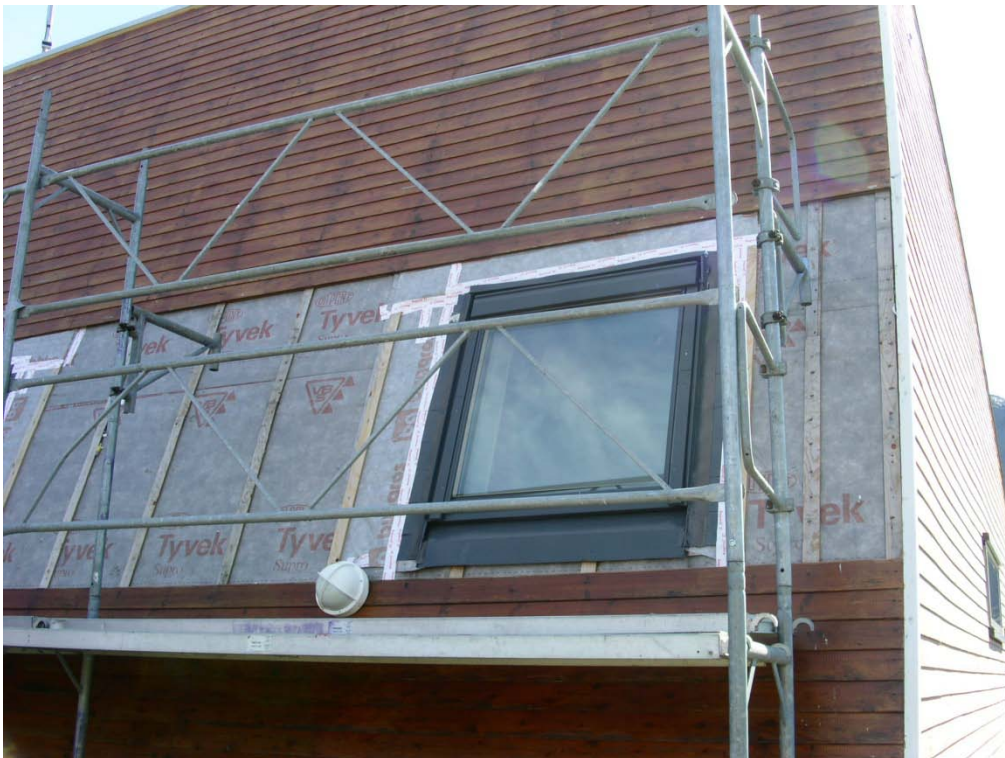
Improving the air tightness (summer 2010)
