# Bondlines – Online blade measurements (October 2012 and January 2013)

Department of  
Wind Energy  
E Report 2013

DTU Wind Energy E-0036

Some local deformations in an operating Wind Turbine blade (V80) have been measured during October 2012. Displacement and load values generated between the trailing edge panels at blade radius R9,2m, R10,2m, and R11,2m were obtained. A fluctuating loading of between 100 - 200N existed when the two panels were connected, and with a displacement of between 6.5 - 10mm when the panels were free to flex as they do in normal operating conditions. Shear distortion within the main loading spar of the blade (at approximately R10m) showed a fluctuating cross beam shear distortion of about 9mm.

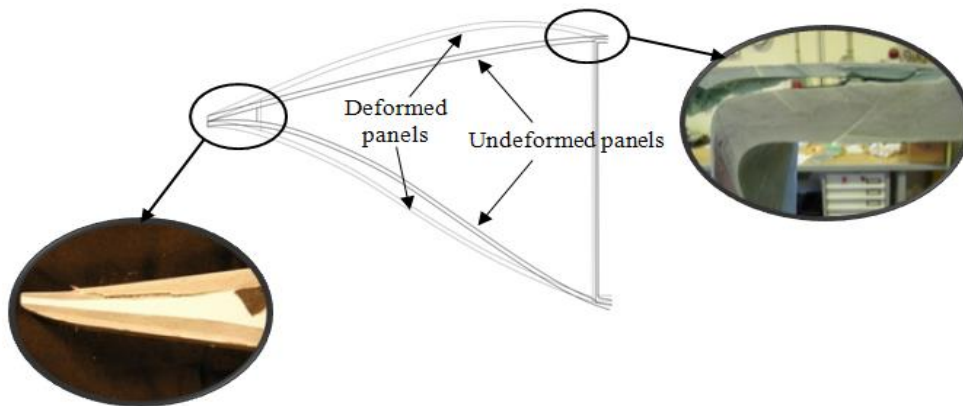
Fig. 1 - Sketch of the trailing edge shells with out-of-plane deformations (the deformations are scaled for clarity). The close-ups show failure at the trailing edge as well as debonding of the outer aerodynamic shell on the box girder.

Looking at the pronounced deformations of the shells, one can have an idea of the “pumping phenomena” which occurs on the blade during operation. Based on this model it is therefore supposed that the cause of debonding is the opening loads near the trailing edge (TE). A strong assumption made on this model is that only MODE I (peeling mode) occurs at the TE debonding, and this can be justified considering that bond-lines have a lower strength when exposed to peeling stresses (MODE I), compared to shear stresses (MODE II). Therefore the interest is to measure only the loads and the displacements normal to the shells surface.

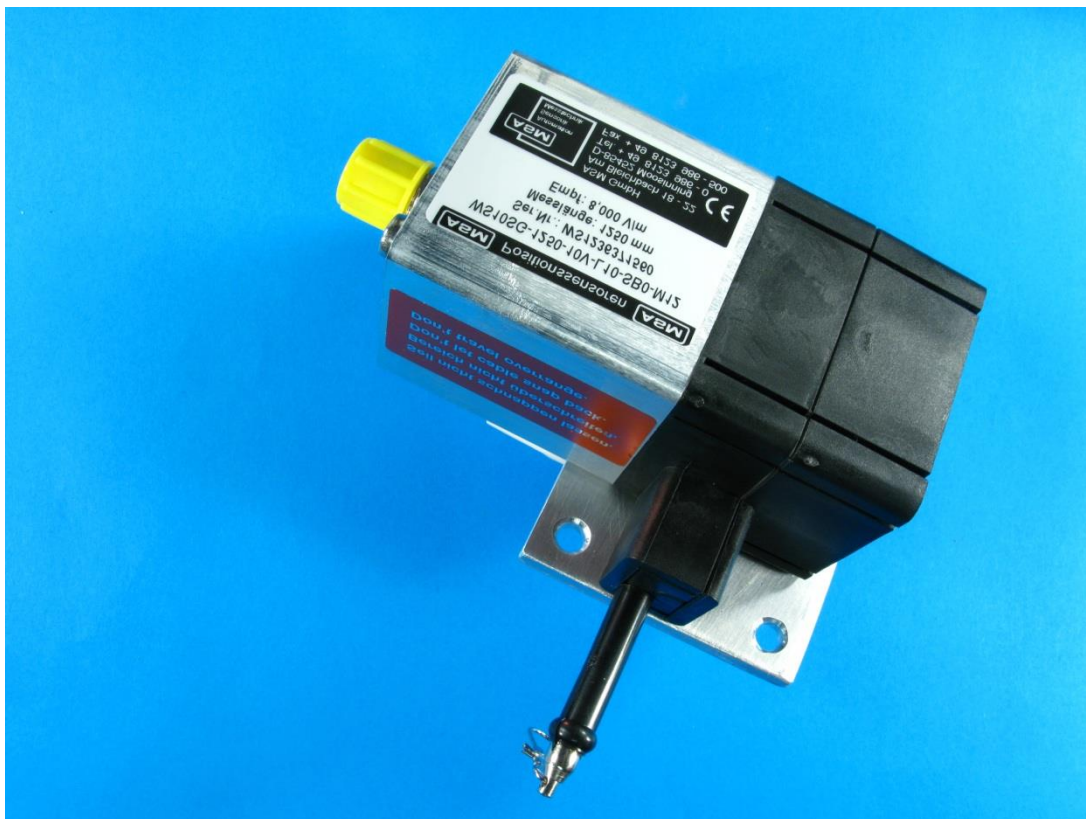
Fig. 3 – POSIWIRE WS10SG string pot from ASM, which was used in the test to measure the relative displacement between the shells in the defined points. In the picture can be noticed the connection plate then screwed to the laminate.

In figure 3 the adopted displacement transducer with the wiring and fixing solution can be seen. Basically the string potentiometer is a transducer which gives a linear response of the displacement using a cable on a spring-loaded spool.

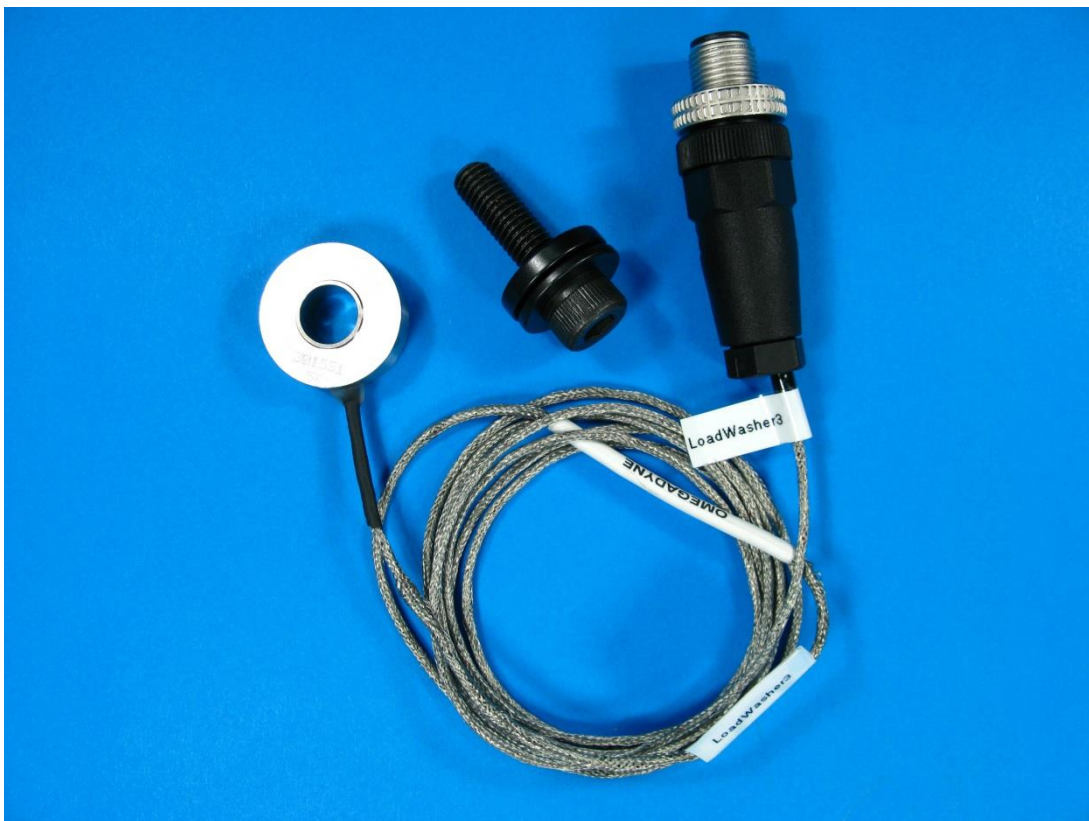
*Fig. 4– LOAD WASHER LCMWD-20KN from OMEGA adopted to measure the compressive load on the bolt connecting the two shells of the TE. The load cell is mounted by means of a proper designed plate through the drilled holes in the sandwich panel. The load washer is connected to a 2,5 mm diameter string fixed through a plate to the lower panel. Any adjustment in the alignment is allowed thanks to the spherical washer set – “IGUS washer”, which provide a proper load distribution on the load cell. The initial tension on the string (compression on the load cell) is adjusted by screwing the fitting button on top (not showed in figure), in order to have a stiff configuration.*

In figure 4 one can see the load cells adopted to measure the compressive load on the bolted connection at the TE. This specific design of load cell is called load washer, due to the fact that it is mounted as a washer in a rigid bolted connection.

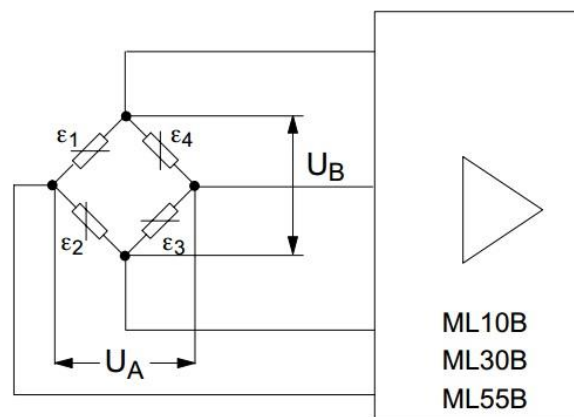
Fig. 5 – Full bridge strain gauge configuration:  $U_A$  correspond to the output voltage, while  $U_B$  is the excitation voltage

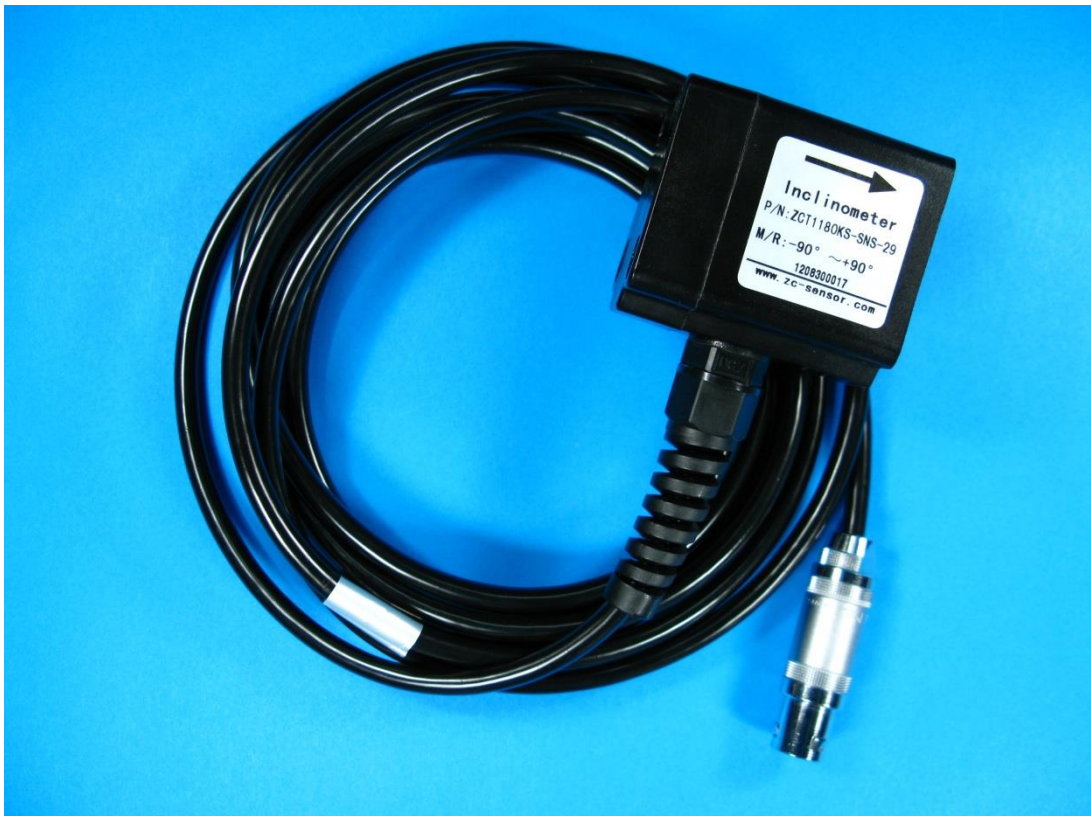
Fig. 6 – 1-axis Inclinometer sensor ZCT1180KS-SNS-29 by ZC Tech. The measuring range goes from  $-45^{\circ}$  ( $-90^{\circ}$ ) to  $135^{\circ}$  ( $90^{\circ}$ ) and the analog voltage output vary from 0,5V to 4,5V.

In order to couple the measured load and displacement to the rotational angle of the blade, an inclinometer was used. This could give us a better understanding of the worse load situation depending on the influencing parameters and, moreover, it could help us to interpret the dependency of the loads and displacements at the TE with the rotational speed. In figure 6 the selected inclinometer is showed.

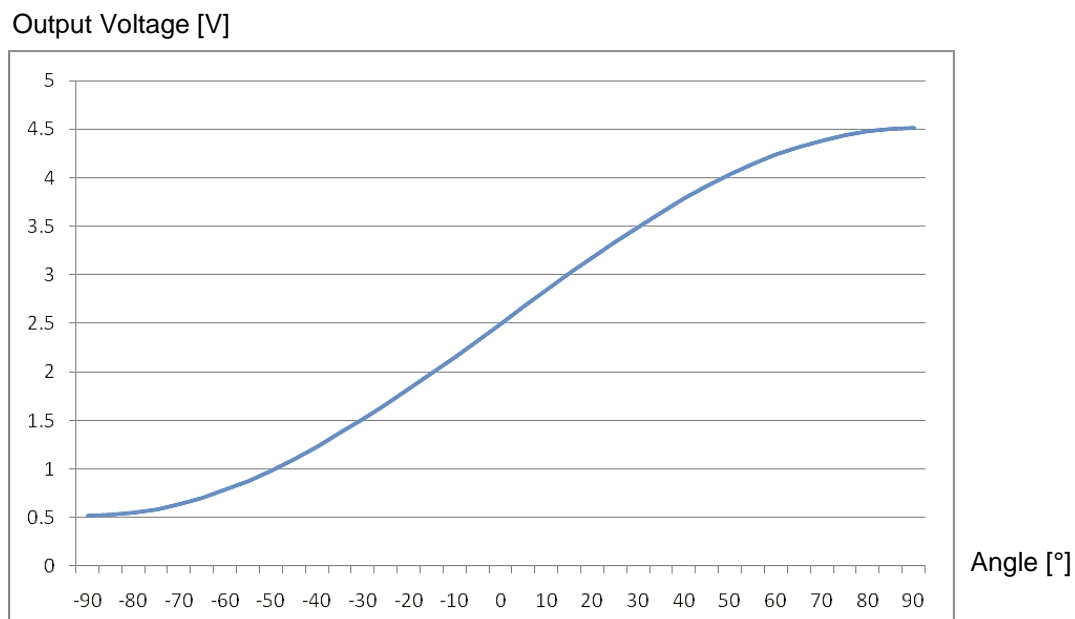
Fig. 7 – Characteristic transfer curve for the inclinometer: the output voltage from the inclinometer is not a linear function of the angle. This means that, as the angular speed is constant (19 rpm) and the acquisition frequency rate too, the acquired points will be differently spaced (time based acquisition rate) in the non-linear region.

The characteristic curve for the inclinometer is shown in figure 7: as can be noticed the transfer function is not linear along the full range of the instrument. This has revealed to be an issue, since the acquisition rate was time based (fixed acquisition frequency), and the resulting acquired points were differently spaced in the region close to -90° and 90°.

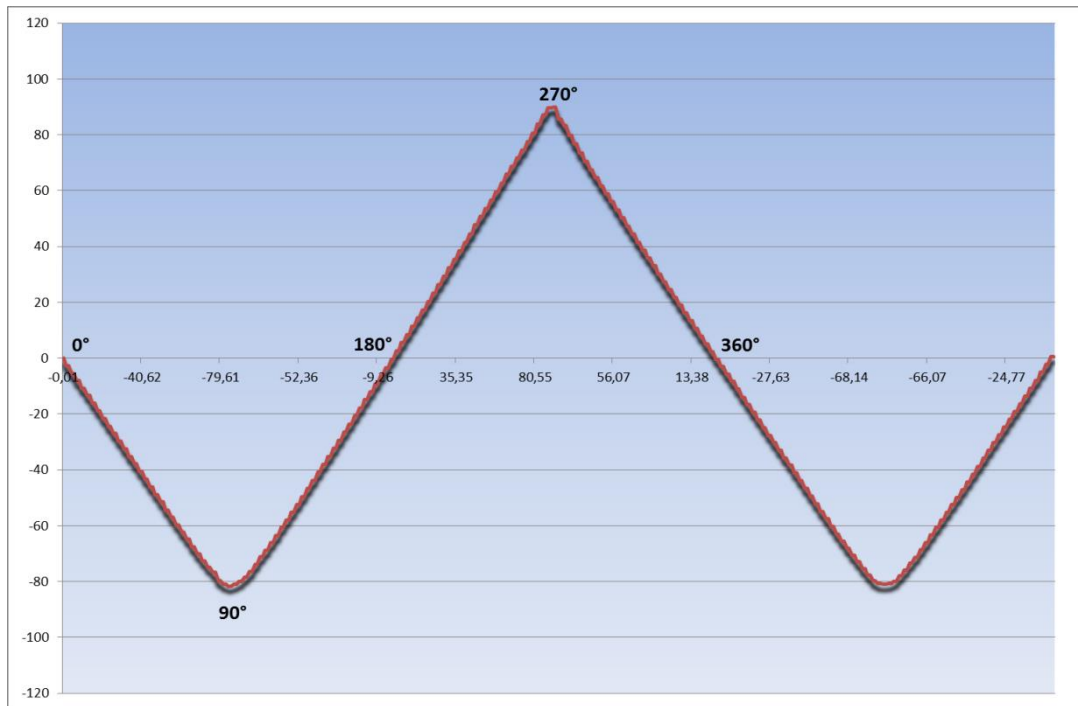
Fig. 8 – Zoom resulting from an acquired set of data through the inclinometer sensor. The raw data were acquired in Volt and further post processed, applying the transfer function of the instrument, to obtain the indicated curve in degrees versus time. It can be noticed that each position (min, max and intersections with the time axis) correspond to an absolute position of the blade.

In figure 8 a screenshot of the acquired data from the inclinometer is proposed with the evidence that the position is always known even in a range of 180°.

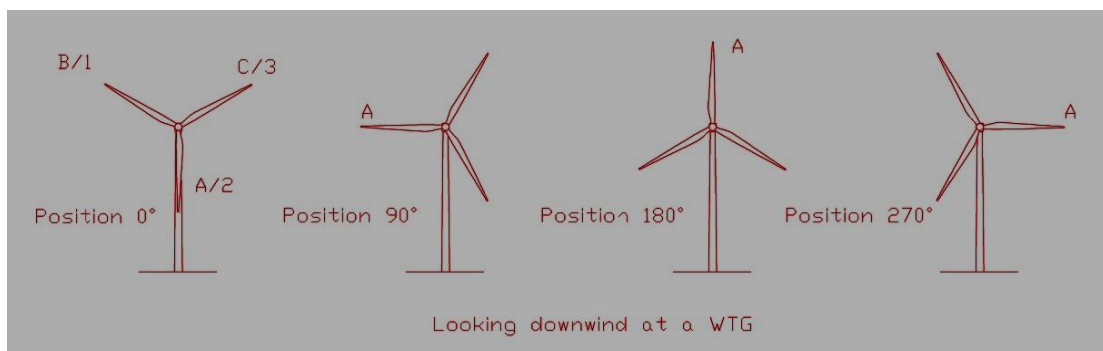
Fig. 9 – Reference position for the instrumented blade A/2 with respect to the angle measured from the inclinometer.

The adopted reference positions for the instrumented blade can be recognized from figure 9.

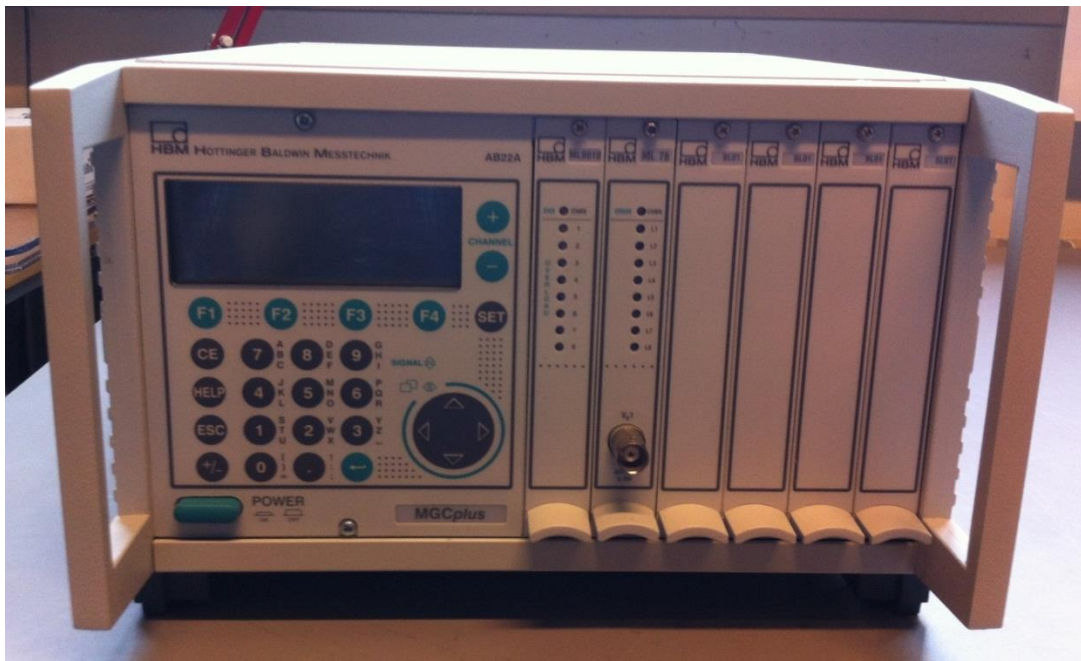
Fig. 10– MGCplus Amplifier from HBM interconnected between the load washers and the data acquisition card in order to allow the read out the signal measured from the compressive load cells.

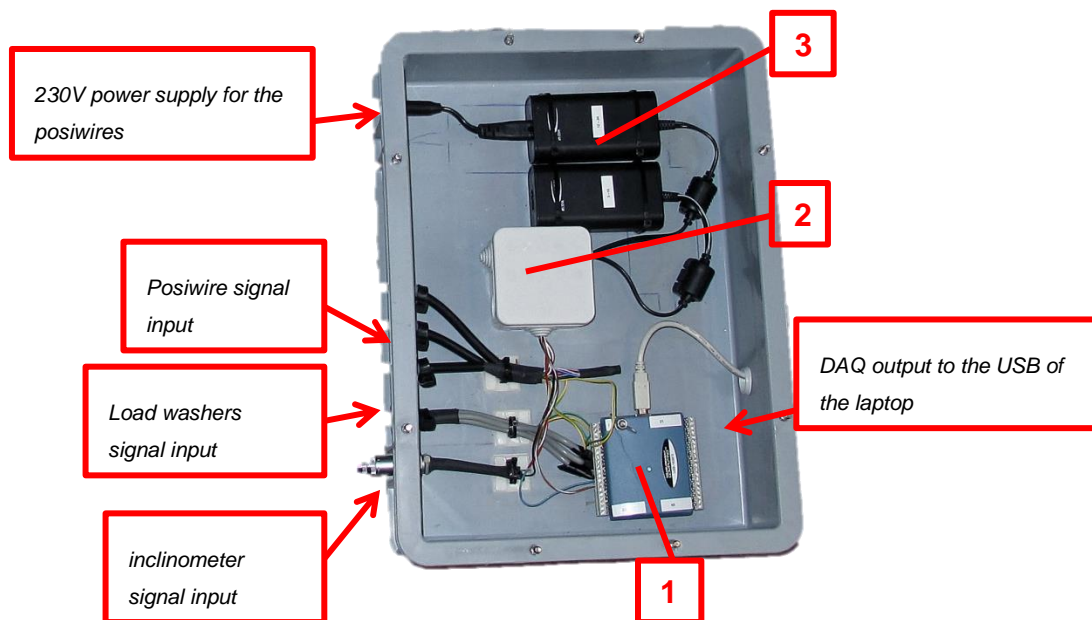
Fig. 11 - Connections case 50x30x10 cm where the DAQ card was allocated (1) with the cabling box (2) and the posiwires power supply (3). On the bottom left side one can see the cables from the posiwires, the load washers and the inclinometer, while on the right side the output to the Laptop running the DasyLab acquisition program. On the upper left the power plug for the posiwire transformer supply.

As already mentioned all the measured signals were sent to the Data Acquisition Card USB-1608FS from Measurement Computing, which was allocated in the grey plastic case, showed in figure 11.

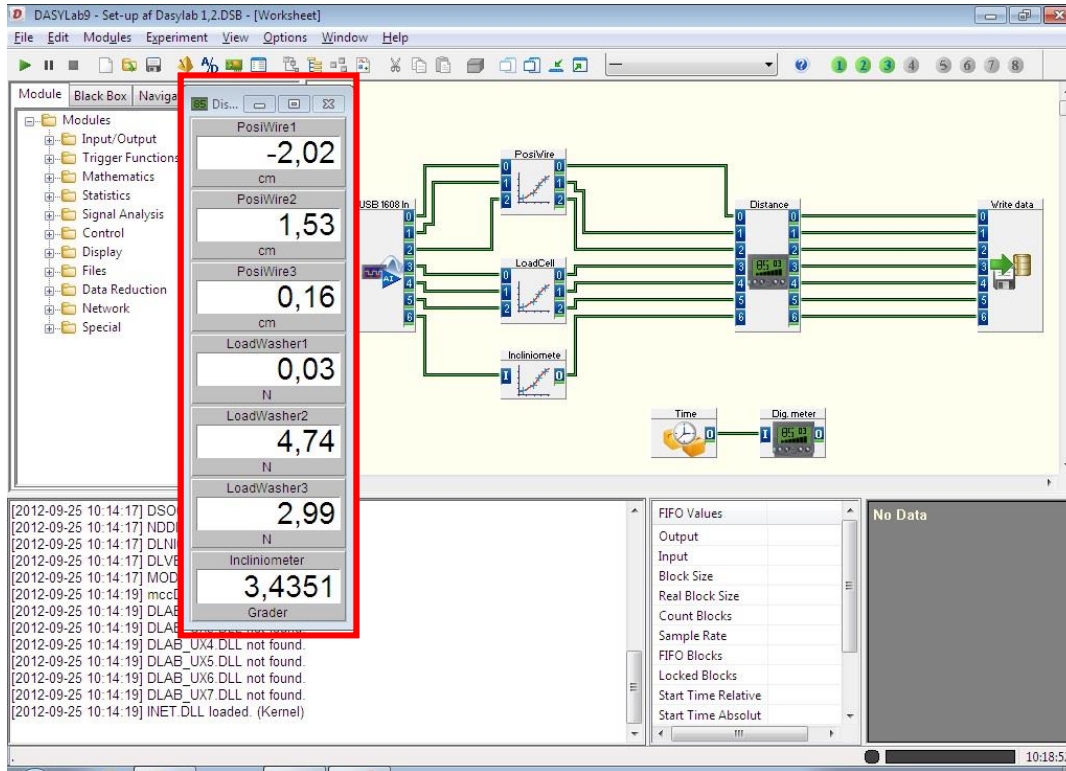
Fig. 12 – Block diagram main window of DasyLab: the highlighted in red window shows all the instant values acquired. As can be easily understood the signal coming from the DAQ – USB 1608 In block – are defined **RESPECTIVELY** – PosiWire, LoadCell and Inclinometer block diagram – and then stored through the write data block. The time block synchronize the laptop internal clock with the starting of the acquisition.

In order to acquire all the data, a block diagram was designed in DasyLab which allow us to store in the local solid disk of the laptop a text file with a header related to the test conditions. For brevity in this subparagraph the DasyLab block diagram main window is shown, while the start-up procedure will be explained in the following sections.

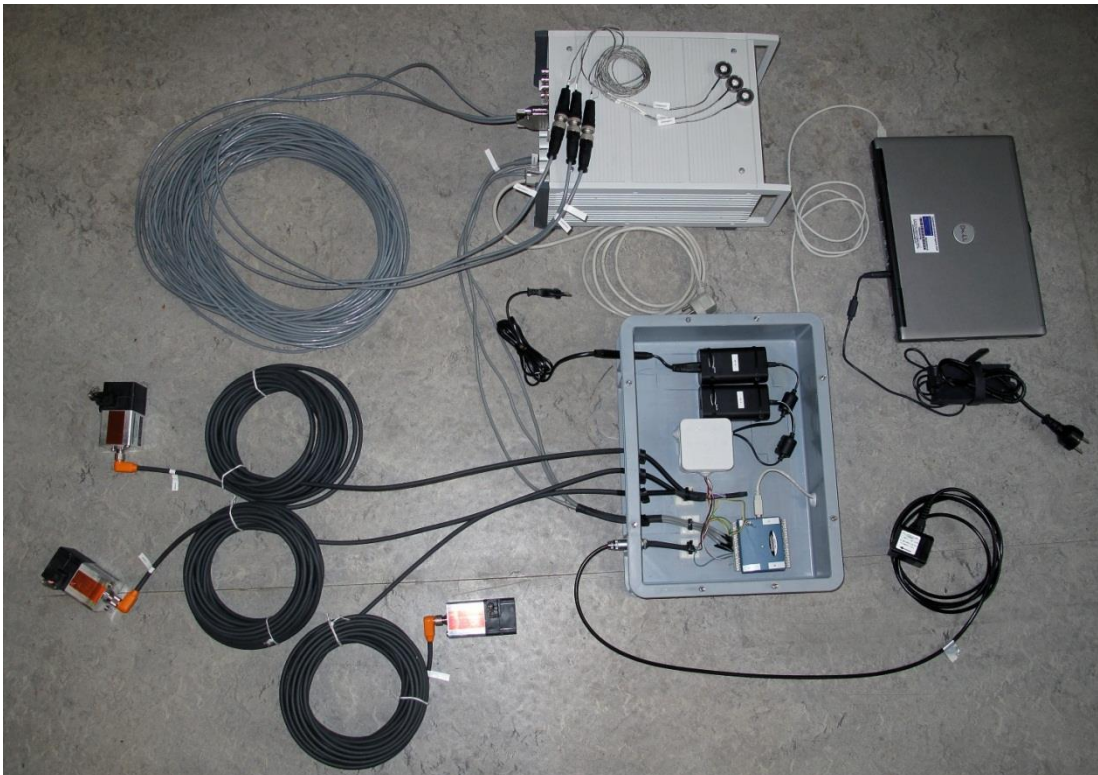
Fig. 13- Complete view of the instrumental set-up used for the field measurements. The laptop running DASYSLab (point 1), 3 load washers with the relative amplifier (indicated with 2 and 3), 3 “posiwire” string pots (indicated with 4), the connections box with the data acquisition card (point 5 and 6), the inclinometer (point 7).

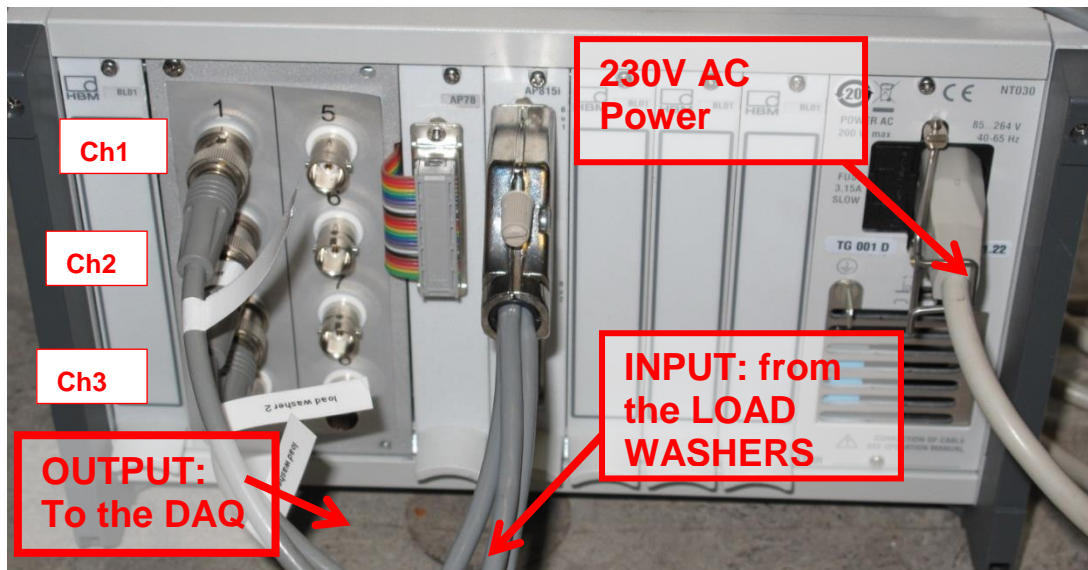
Fig. 14 - Detailed view of the back HBM amplifier connection: as one can see the 3 coaxial cable are the numbered output and are connected to the DAQ through the connections box, while the input coming from all the 3 load washers are connected through a 25-pins connector. On the right the power source of the amplifier can be noticed.

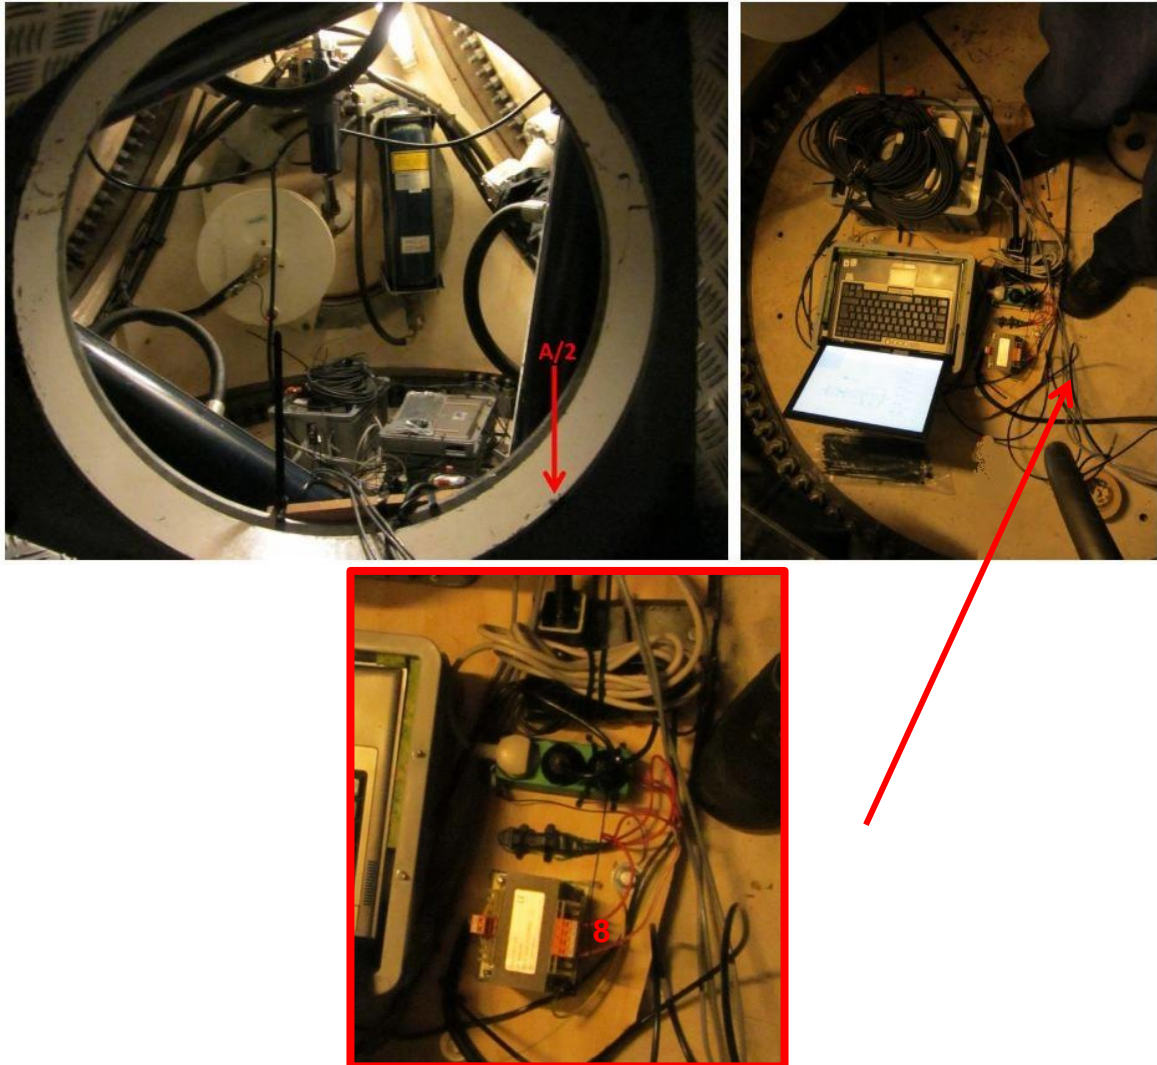
*Fig. 15 – Rotor hub hollow space view where the DAQ system was mounted. Both the Laptop and the Amplifier were enclosed in a grey box properly modified with cooling hollows and Plexiglas cover; these were stacked one to each other close to the rotational axis of the WTG. In the bottom figure indicated with a red arrow, zoomed view of the inverter (point 8 on the list) which was needed to convert the power supply took from the auxiliary to a proper 230V AC required from the instruments.*

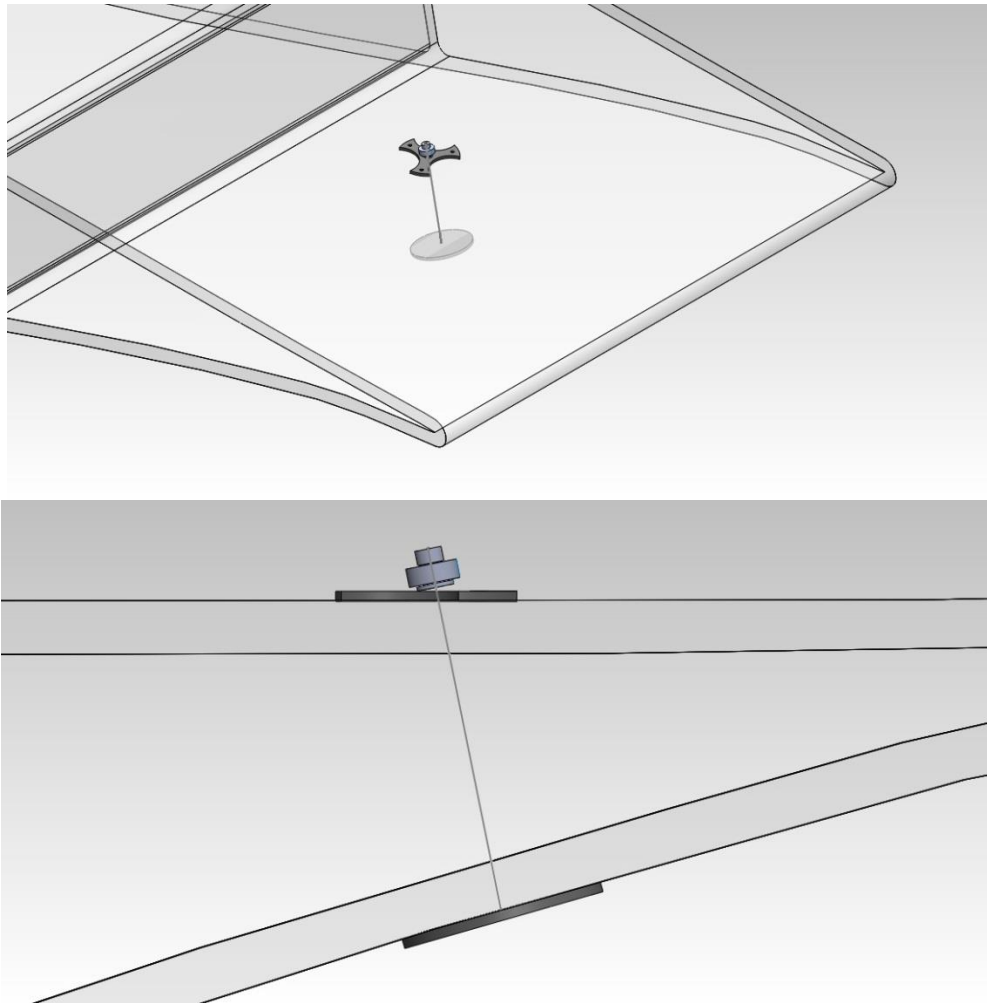
*Fig. 17 - Schematic 3D model of the adopted fixing solution for the load washer on the suction profile of the WTB V80 from Vestas. A hole on the shell allows the bolt to be connected through a string to the lower shell.*

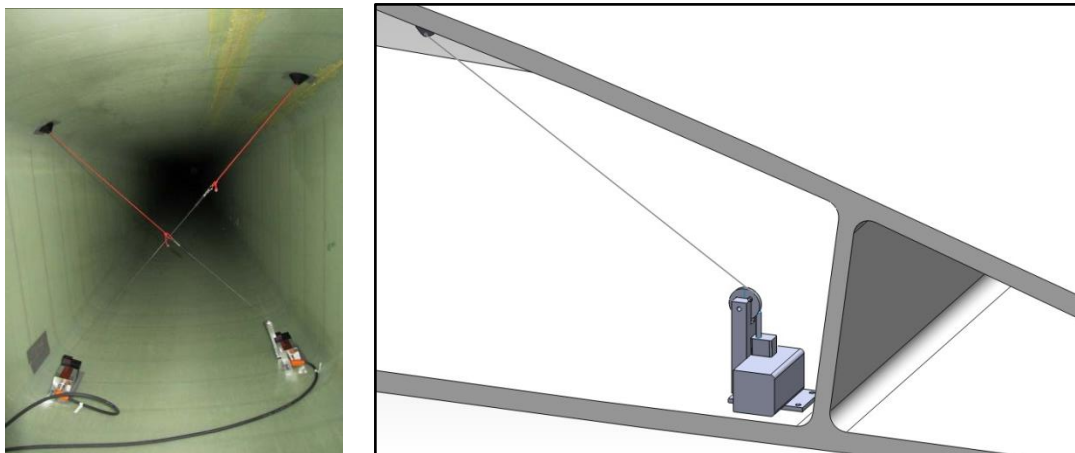
Fig. 19– Realized (left) and 3D schematic (right) fixing solution for the internal “shear displacements” measured with the posiwires at a 10 meters length inside the spar cap. A string was attached with some double side flash tape to the GFRP surface, by means of a plastic cone. The posiwire was mounted in a vertical position on the opposite surface, using this double side flash tape. A pulley was manufactured in order to direct the string in a correct way, avoiding any friction.

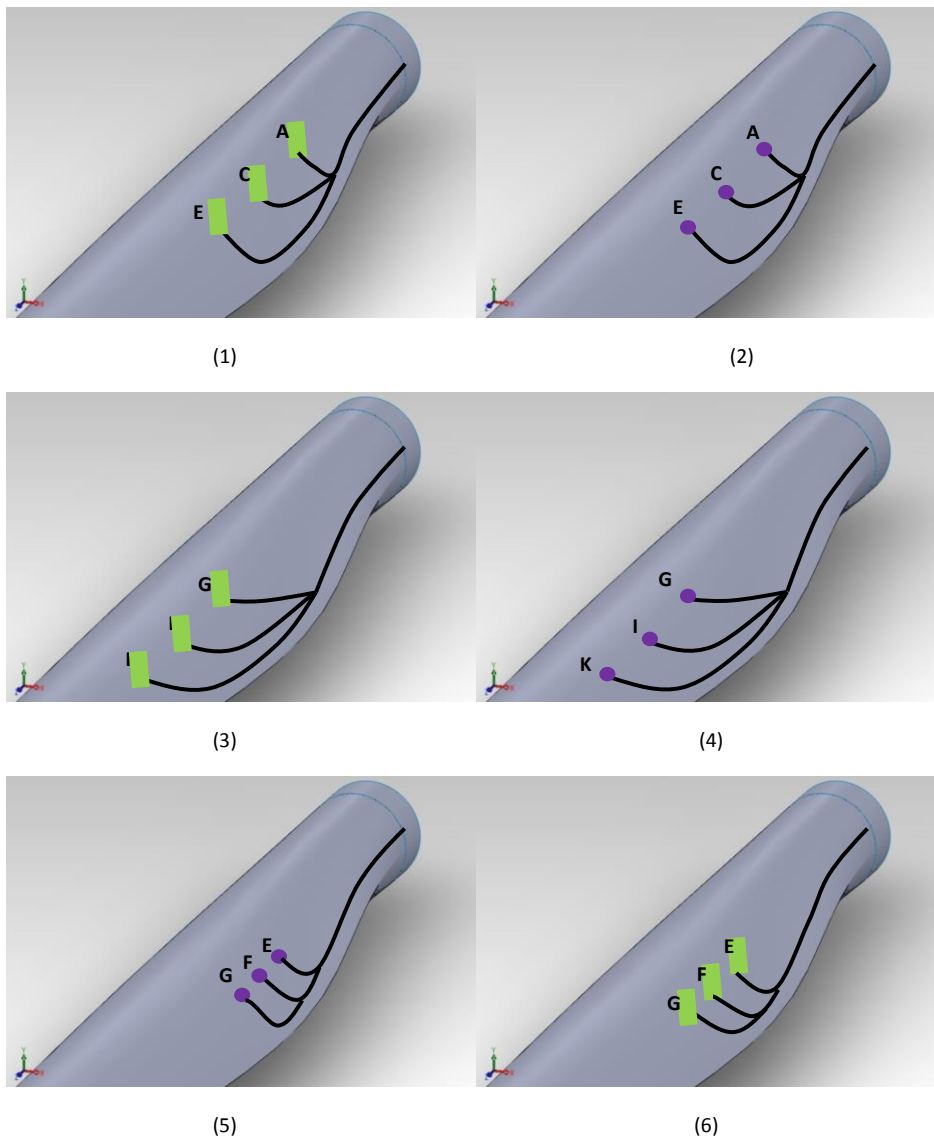
*Fig. 25 - Main view of the instrumented blade with highlighted the cables arrangement along the TE. In green colour the 3 string pots, while in purple colour the 3 load washers. (1) 1<sup>st</sup> set of displacement measurements on section A, C, E in order to find the point where the maximum displacement occur. (2) 1<sup>st</sup> set of load measurements to acquire the corresponding loads at the same sections A, C, E. (3) 2<sup>nd</sup> set of displacement measurements on section K, I, J in order to find the point where the maximum displacement occur. (4) 2<sup>nd</sup> set of load measurements to acquire the corresponding loads at the same sections K, I, J. (5) 3<sup>rd</sup> set of measurement to acquire the corresponding loads around the maximum displacement point – i.e. F – at different pitch angles. (6) 3<sup>rd</sup> set of measurement to acquire the corresponding displacements on the same sections – i.e. F – at different pitch angles.*

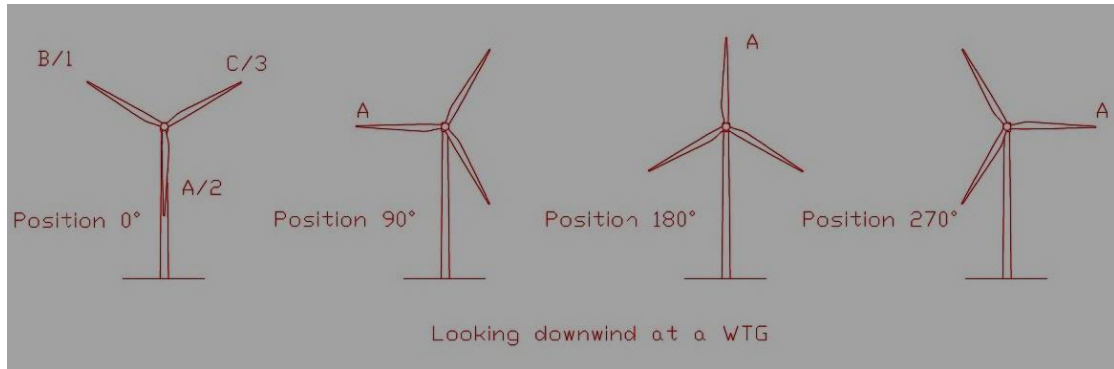
Fig.26 – Schematic representation of different blade positions of interest for the tests. Blade signed A/2, set a 0° reference position, is the chosen one to be instrumented.

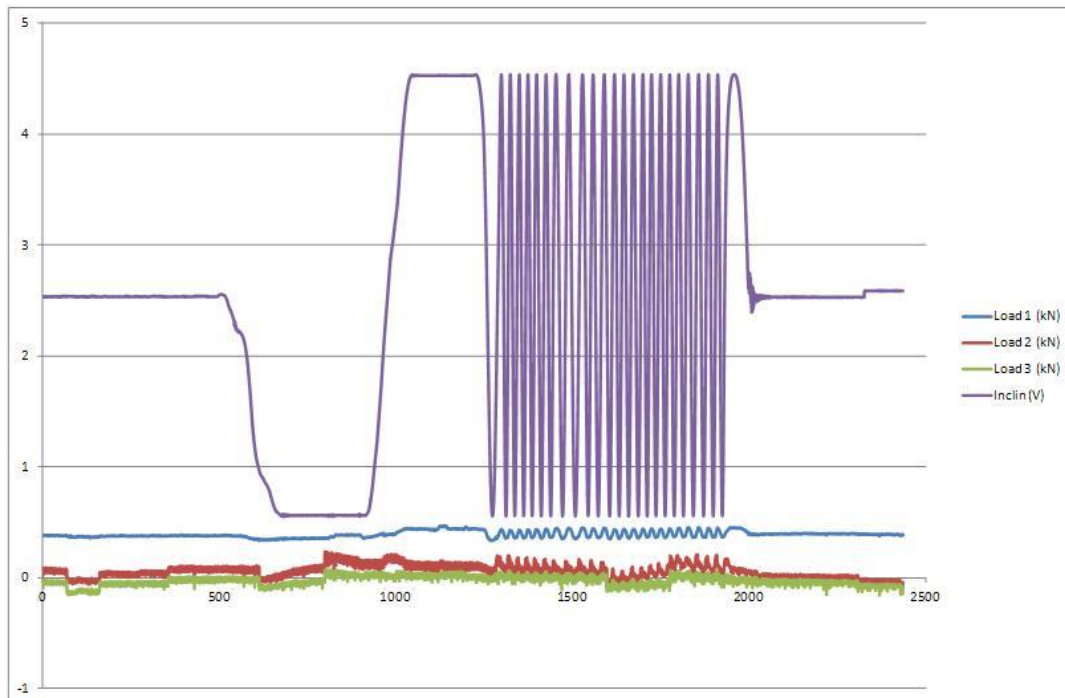
*Fig. 27 - Full trace for test 1 (23/oct)*

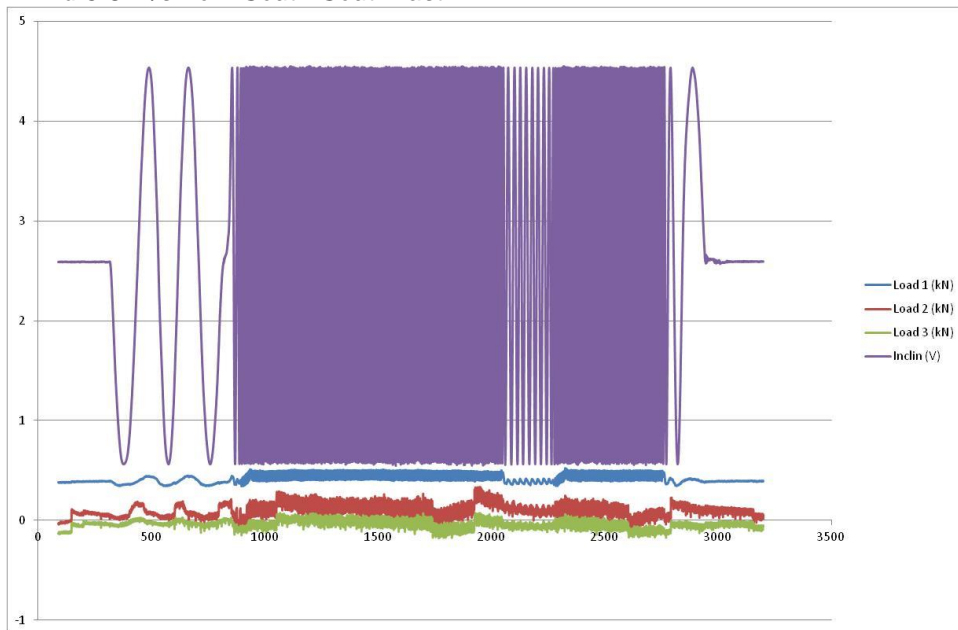
Fig. 33 Full trace for Test 2 (23/oct)

The overview trace for Test 2 shows the data acquisition starts with Blade A pointing down (position 0°). At around 300s the blade begins to rotate in idle condition (around 82-84 deg pitch). Around 850s the blade enters autorun operation (close to 0 deg pitch). Around 2050s the turbine automatically changes to blade pitch 30 deg due to very low wind speeds. At 2275s the turbine changes the blade pitch back to being close to 0 deg again and normal operation resumes. At 2760s the turbine goes to idle again (around 82-84 deg pitch). At 2940s the turbine is halted with Blade A in position 0°.

Again it can be noted that the output from Load Washers 2 and 3 is “noisy”.

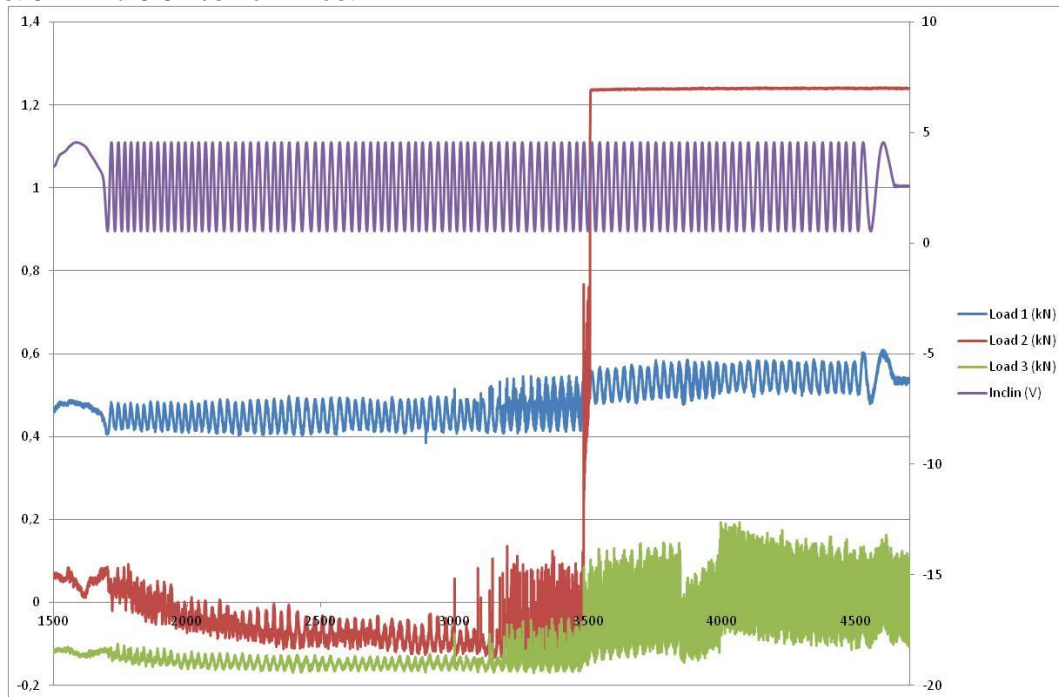
Fig. 38 Detail of the full operation period during Test 3 (24/oct)

At around 1650s following the start of data acquisition, the turbine enters autorun operation (with the blade close to 0 deg pitch). At around 3000s some event appears to occur that changes the response on all the load transducers. At about 3450s a sudden change is noted in the response of load washer 2, although load washers 1 and 3 are also affected. A noise is also heard by the Bondlines personnel. At 4500s the turbine is placed in idle condition (blade pitch around 82-84 deg).

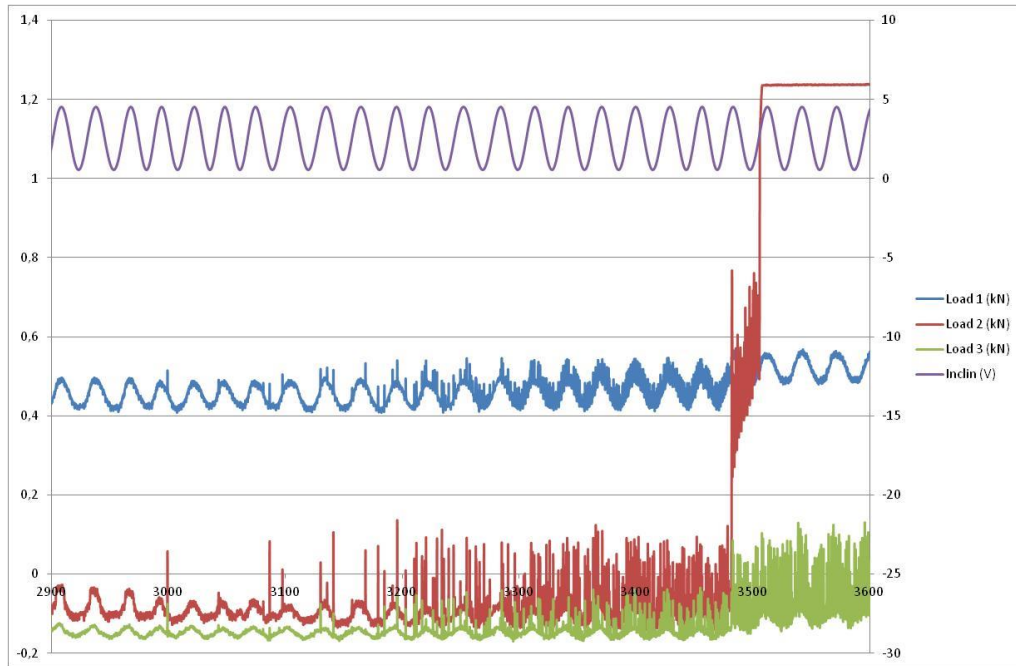
Fig. 40 - Detail from Test 3 showing the event on Load washer 2

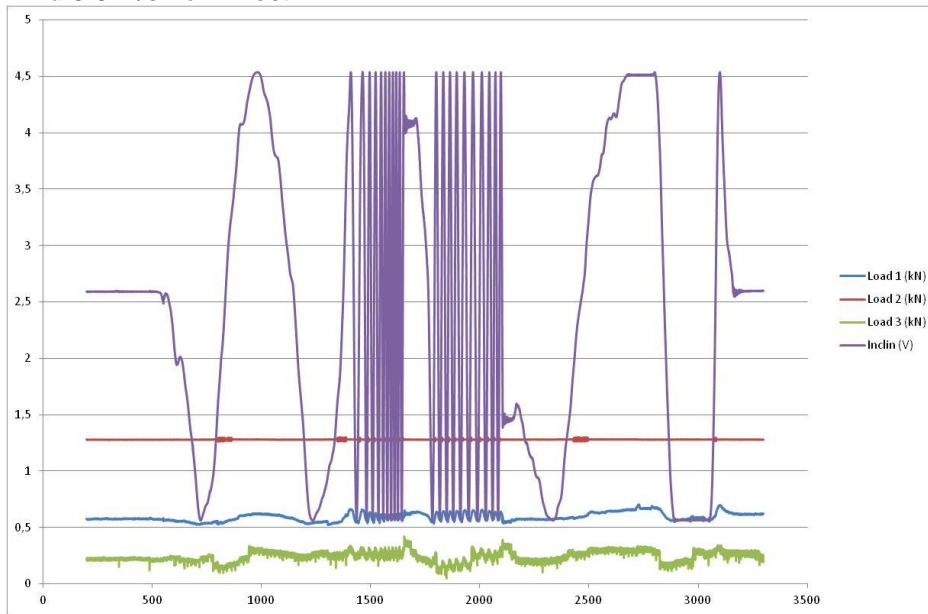
Fig. 42 - Full trace for Test 4 (24/Oct)

The overview trace for this measurement shows that data acquisition starts with Blade A pointing down (position 0°). At around 525s the blade begins to rotate in idle condition (around 82-84 deg pitch). Around 1400s the blade is placed at 30 deg pitch until 1650s when there is an emergency stop on the turbine. Around 1750s the blade is placed at 22 deg pitch until 2100s when there is another emergency stop on the turbine. At around 2175s the blade begins to rotate in idle condition (around 82-84 deg pitch) again. At 2650s the blade is halted in the 270° position and the pitch is cycled from 90 deg to 0 deg and then back again. At 2800s the blade is rotated round to the 90° position and the pitch is cycled from 90 deg to 0 deg and then back again. At 3050s the blade is rotated round to the 0° position and data acquisition is halted at 3300s.

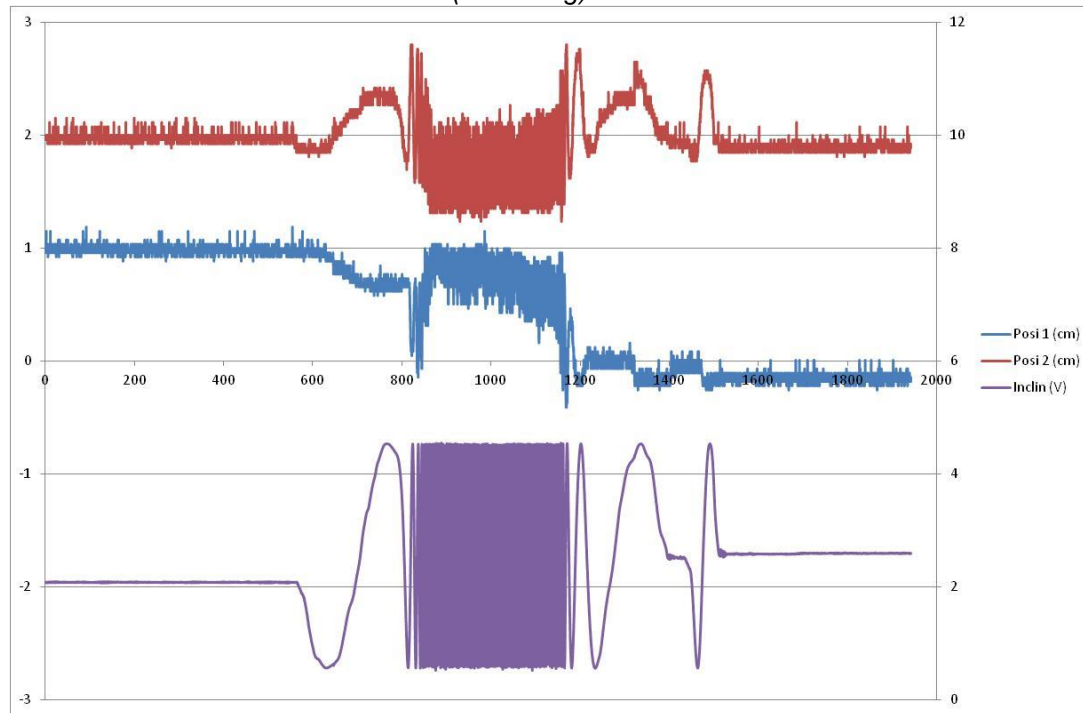
*Fig. 57 - Full trace for posiwire beam test 1 (25/Oct)*

550s after data acquisition begins the turbine is placed in autorun condition and begins a slow rotation in "idle" condition as the slip ring heats up. At 775s the turbine automatically goes into production condition and runs at between 0 and 3 deg pitch angle. After 1150s the turbine is placed in manual control and the pitch changed to 90 deg at which point the turbine slows. At 1500s the turbine is halted and at 1950s the data acquisition is stopped.

Note also that Posiwire 1 does not return to the original displacement condition (normalised to 1 cm) but ends the measurement around -0.14 cm. And to a lesser degree Posiwire 2 ends the measurement series slightly below its' normalised 2 cm start condition at 1.89 cm.

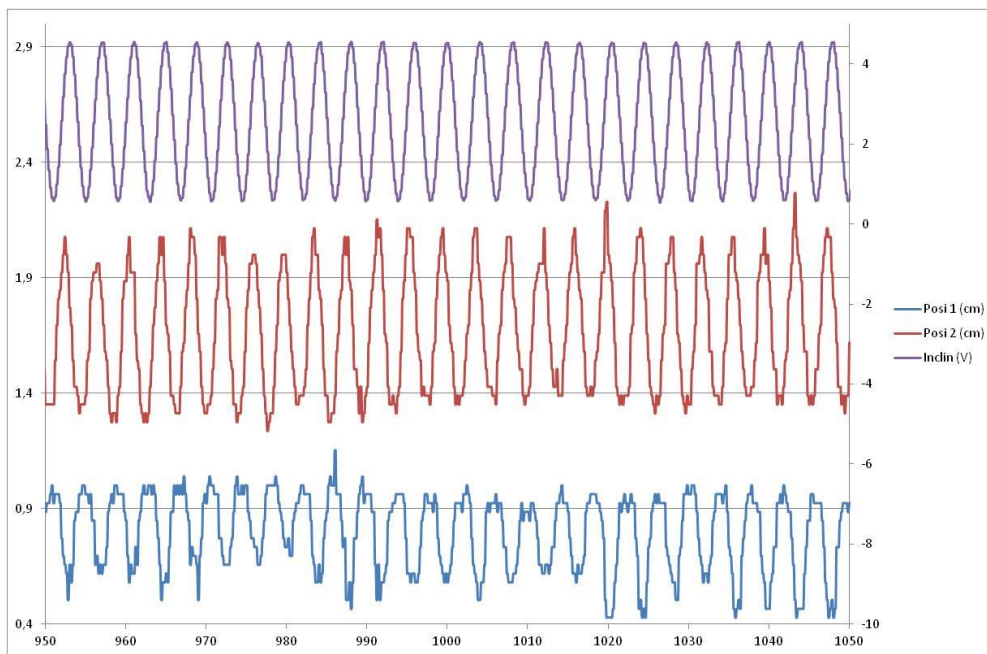
Fig. 59 - Close up detail from Beam test 1 showing the shear behaviour

Beam cross shear distortion during autorun condition average 9mm

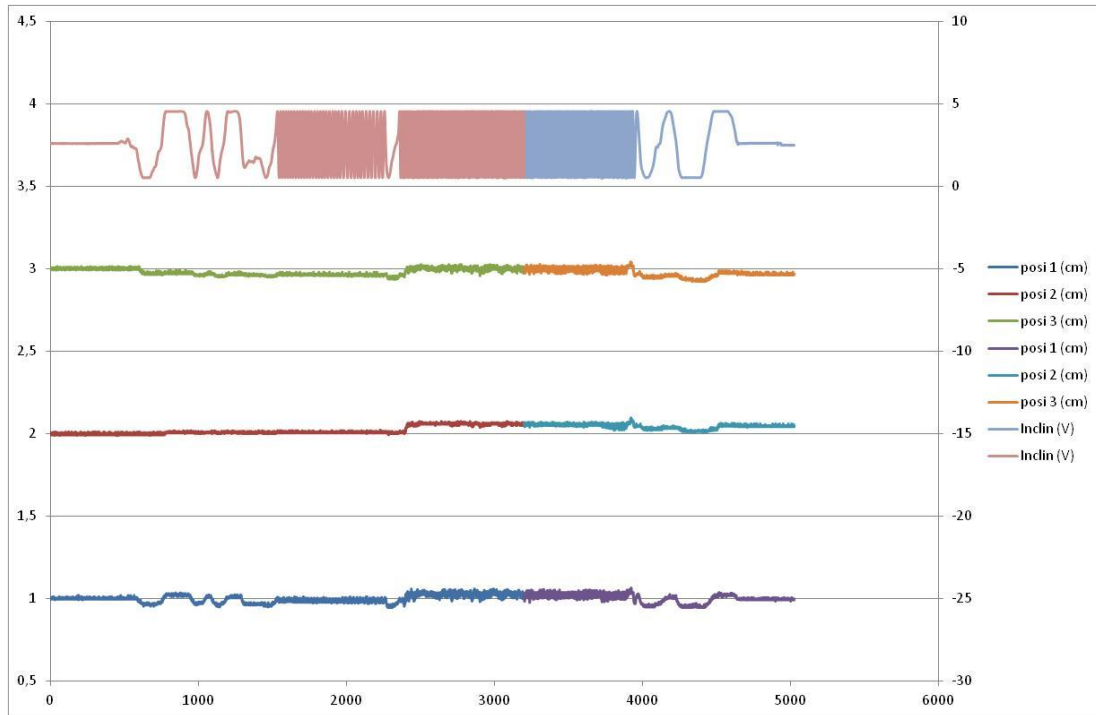
Fig. 64 - Main trace for the 130110 Test 1 showing the full acquisition period

At around 500s the blade is rotated from the 0° to 90°, and then on to 270°. After a brief start up period the turbine is rotated at a pitch angle of 50 deg between 1500 and 2300s. The blade is then placed in full run condition with a pitch value between -1 and 2 deg until approximately 4000s. At the switch to autorun condition there is an approximately 1mm step up observed in all the posiwire outputs. After the autorun condition is over the blade is again cycled to hold periods at 90°, 270°, and then 0°. Pitch changes at the horizontal blade holds caused no effect on the poiswire outputs.
