# Bondlines – Online blade measurements (October 2012 and January 2013)

Department of  
Wind Energy  
E Report 2013

DTU Wind Energy E-0036

Some local deformations in an operating Wind Turbine blade (V80) have been measured during October 2012. Displacement and load values generated between the trailing edge panels at blade radius R9,2m, R10,2m, and R11,2m were obtained. A fluctuating loading of between 100 - 200N existed when the two panels were connected, and with a displacement of between 6.5 - 10mm when the panels were free to flex as they do in normal operating conditions. Shear distortion within the main loading spar of the blade (at approximately R10m) showed a fluctuating cross beam shear distortion of about 9mm.

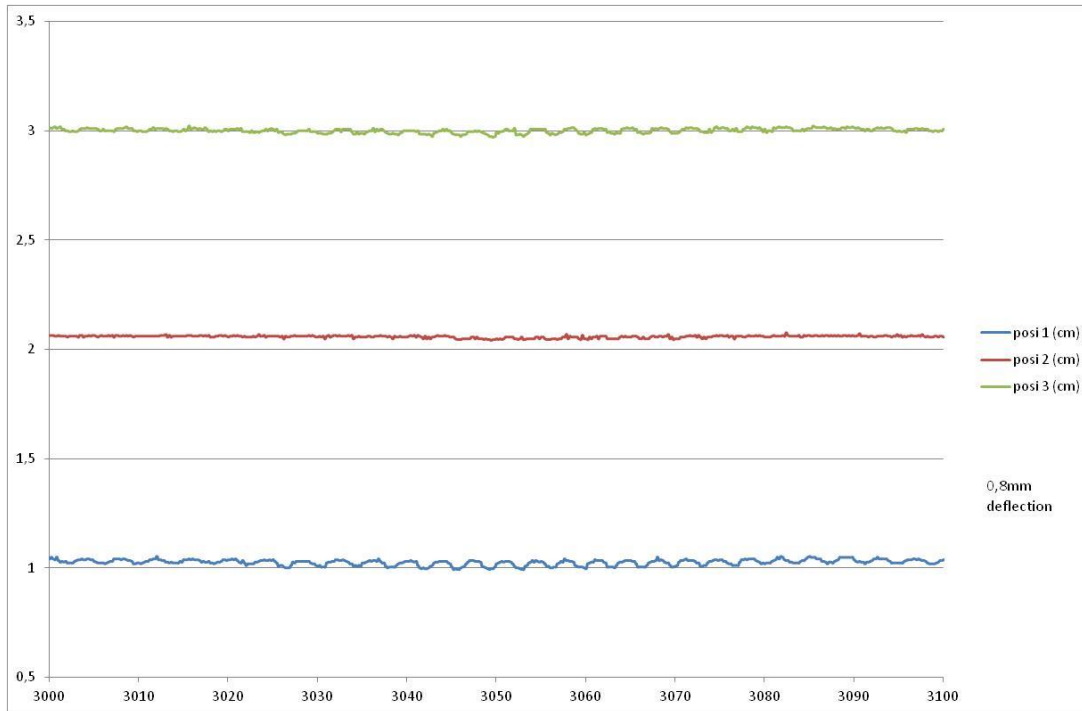
Fig. 69 – Close up detail from 130110 Test 1 showing posiwire response during autorun (-1 to 2 deg)

During autorun condition the posiwire response is very limited (under 1 mm total deflection) although in detail it is possible to see the cyclic response due to the blade rotation.

A reduction in total deformation of 6.5 to 10mm between the two trailing edge panels to below 1mm in the reinforced blade was measured by these trials. The load value fluctuations measured between the trailing edge panels varied between 100 and 200N during autorun condition. And a cross shear beam distortion averaging 9mm was measured by the position wires at blade R 10m.

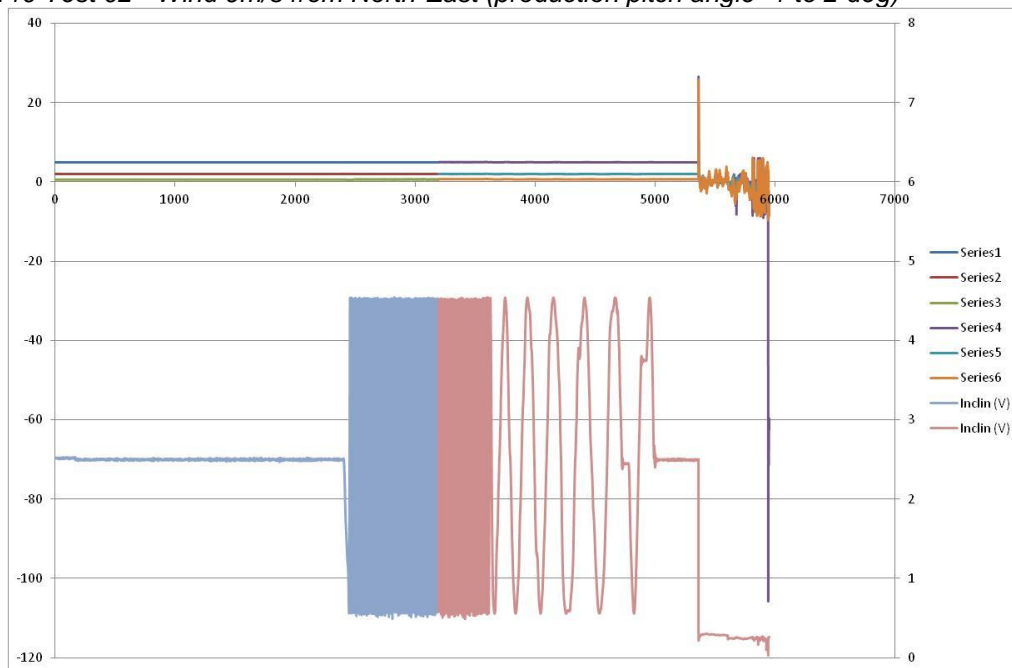
Fig. 70 – Main trace for the 130110 Test 2 showing the full acquisition period

There is a long pause before the turbine begins at autorun condition about 2400s into the acquisition period. When the autorun stops at about 3600s the turbine idles for some time before rotation is halted at 0° and the instrumentation system removed.
