# Bondlines – Online blade measurements (October 2012 and January 2013)

## Department of Wind Energy E Report 2013

DTU Wind Energy E-0036

Some local deformations in an operating Wind Turbine blade (V80) have been measured during October 2012. Displacement and load values generated between the trailing edge panels at blade radius R9.2m, R10.2m, and R11.2m were obtained. A fluctuating loading of between 100 - 200N existed when the two panels were connected, and with a displacement of between 6.5 - 10mm when the panels were free to flex as they do in normal operating conditions. Shear distortion within the main loading spar of the blade (at approximately R10m) showed a fluctuating cross beam shear distortion of about 9mm.

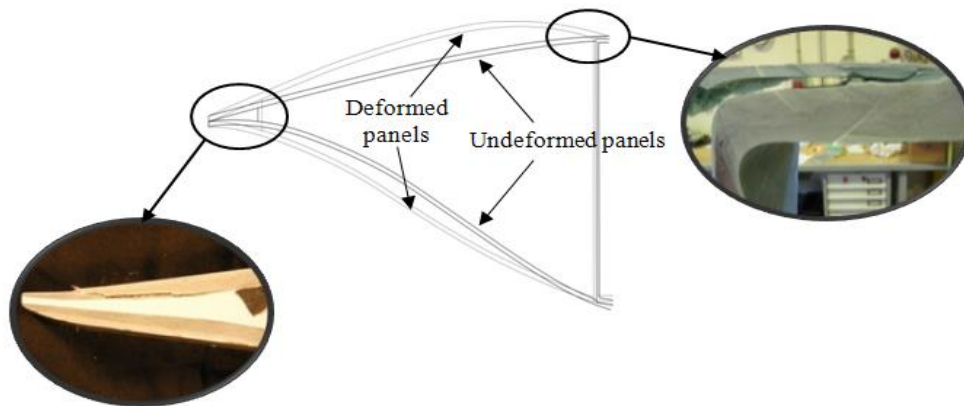
*Fig. 1 - Sketch of the trailing edge shells with out-of-plane deformations (the deformations are scaled for clarity). The close-ups show failure at the trailing edge as well as debonding of the outer aerodynamic shell on the box girder.*

Looking at the pronounced deformations of the shells, one can have an idea of the “pumping phenomena” which occurs on the blade during operation. Based on this model it is therefore supposed that the cause of debonding is the opening loads near the trailing edge (TE). A strong assumption made on this model is that only MODE I (peeling mode) occurs at the TE debonding, and this can be justified considering that bond-lines have a lower strength when exposed to peeling stresses (MODE I), compared to shear stresses (MODE II). Therefore the interest is to measure only the loads and the displacements normal to the shells surface.

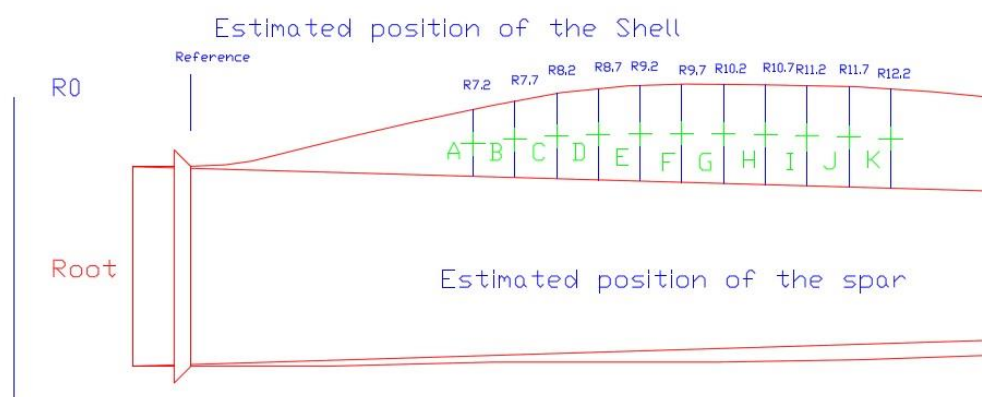
Fig. 2 - Top view of the V80 Vestas WT blade which was tested. 11 sections were defined and the measurement position for each of these can be seen marked with a green cross.

The instruments were intentionally placed on the suction face, which has a flatter profile compared to the higher pressure surface and therefore more suitable to house the devices.

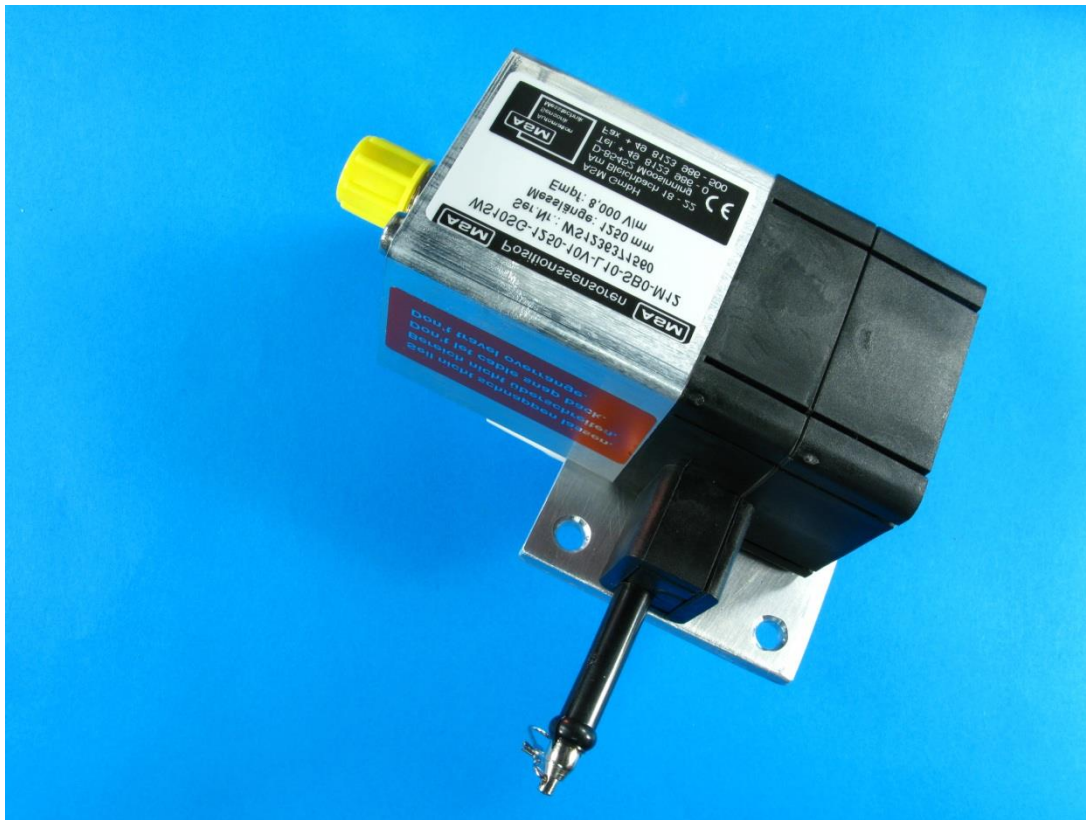
*Fig. 3 – POSIWIRE WS10SG string pot from ASM, which was used in the test to measure the relative displacement between the shells in the defined points. In the picture can be noticed the connection plate then screwed to the laminate.*

In figure 3 the adopted displacement transducer with the wiring and fixing solution can be seen. Basically the string potentiometer is a transducer which gives a linear response of the displacement using a cable on a spring-loaded spool.

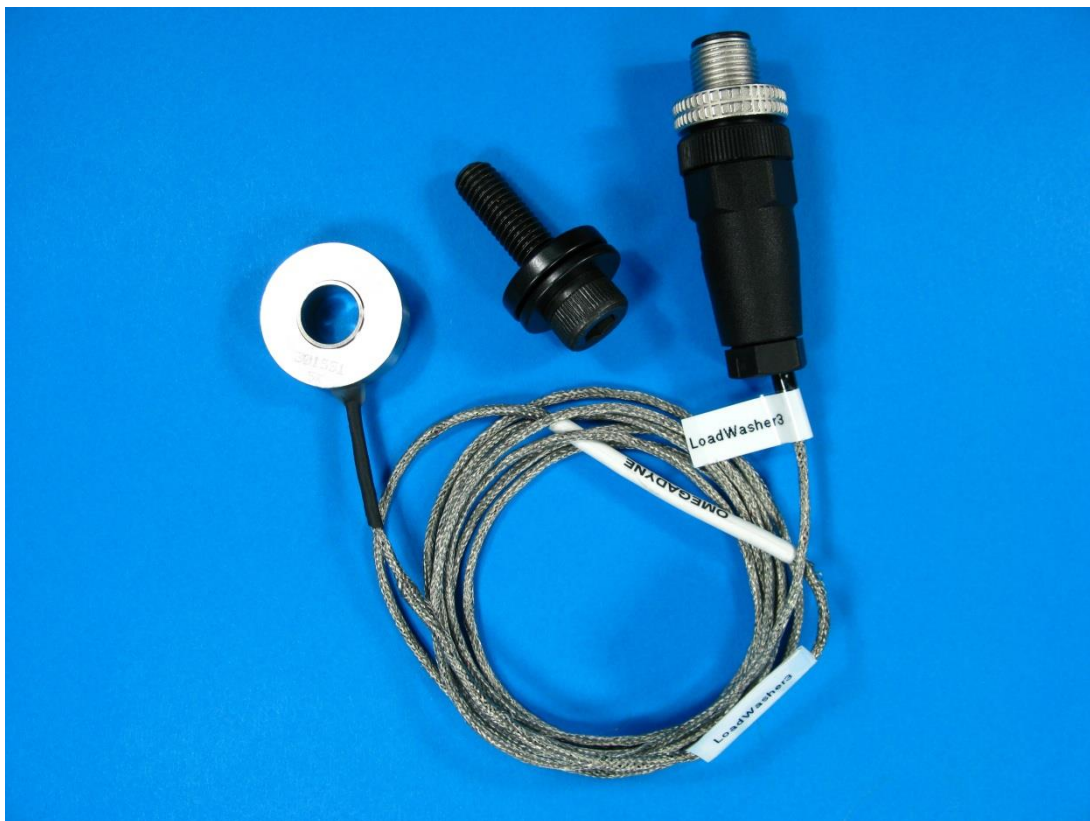
*Fig. 4– LOAD WASHER LCMWD-20KN from OMEGA adopted to measure the compressive load on the bolt connecting the two shells of the TE. The load cell is mounted by means of a proper designed plate through the drilled holes in the sandwich panel. The load washer is connected to a 2,5 mm diameter string fixed through a plate to the lower panel. Any adjustment in the alignment is allowed thanks to the spherical washer set – “IGUS washer”, which provide a proper load distribution on the load cell. The initial tension on the string (compression on the load cell) is adjusted by screwing the fitting button on top (not showed in figure), in order to have a stiff configuration.*

In figure 4 one can see the load cells adopted to measure the compressive load on the bolted connection at the TE. This specific design of load cell is called load washer, due to the fact that it is mounted as a washer in a rigid bolted connection.

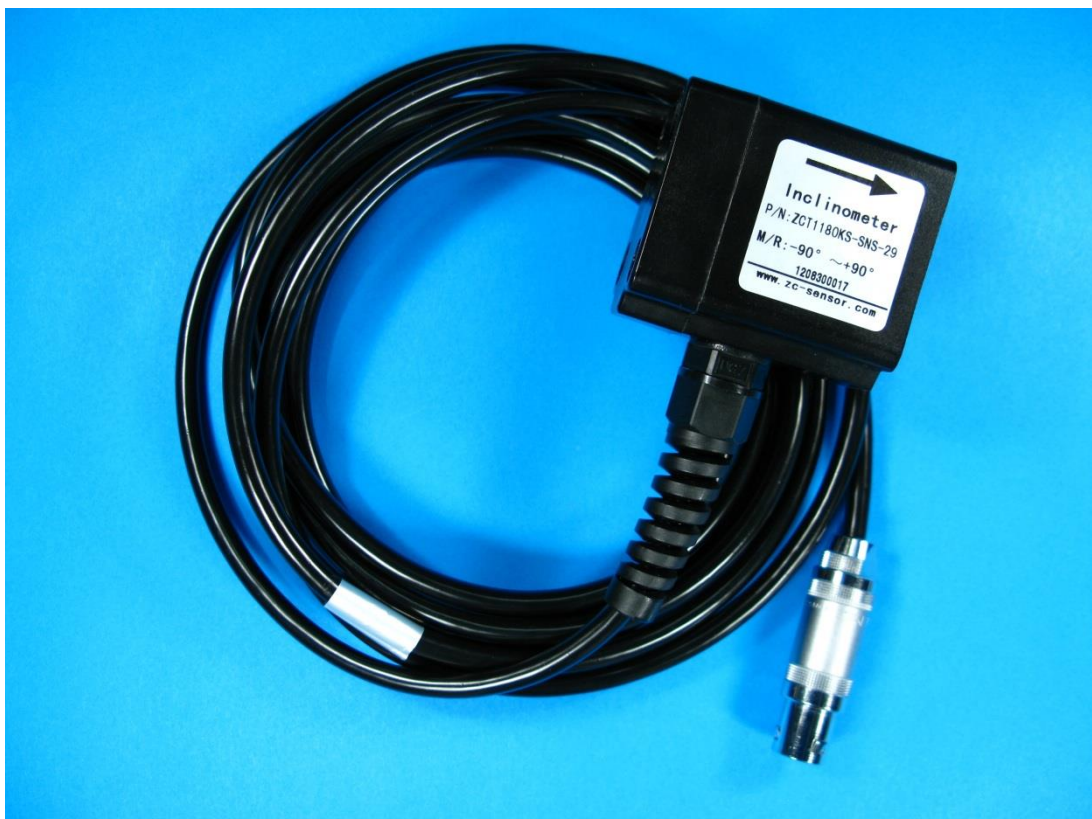
Fig. 6 – 1-axis Inclionometer sensor ZCT1180KS-SNS-29 by ZC Tech. The measuring range goes from  $-45^{\circ}$  ( $-90^{\circ}$ ) to  $135^{\circ}$  ( $90^{\circ}$ ) and the analog voltage output vary from 0,5V to 4,5V.

In order to couple the measured load and displacement to the rotational angle of the blade, an inclinometer was used. This could give us a better understanding of the worse load situation depending on the influencing parameters and, moreover, it could help us to interpret the dependency of the loads and displacements at the TE with the rotational speed. In figure 6 the selected inclinometer is showed.

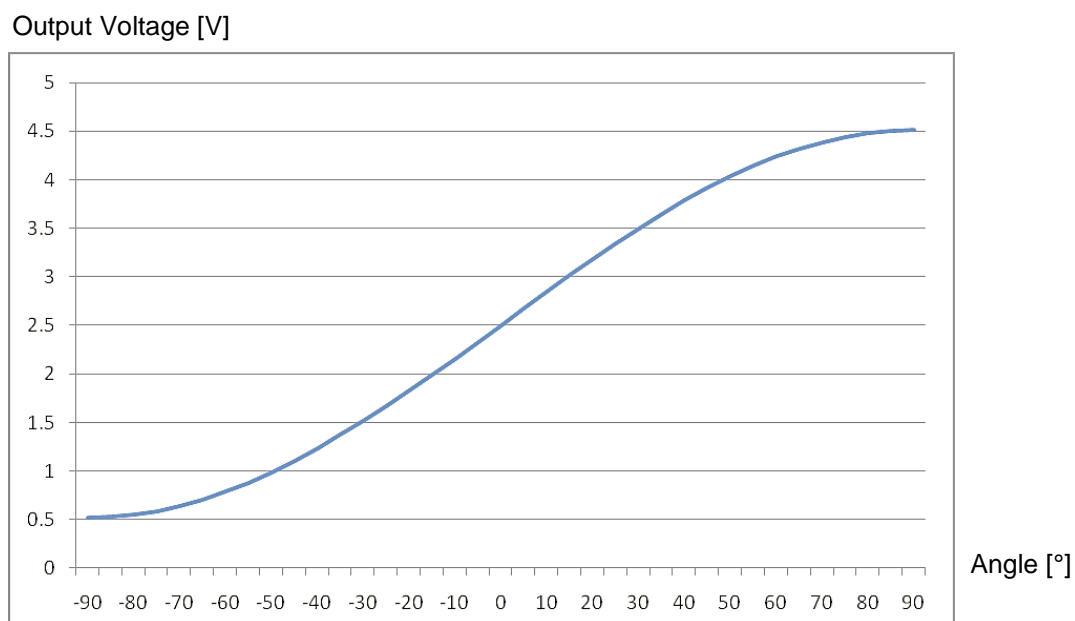
*Fig. 7 – Characteristic transfer curve for the inclinometer: the output voltage from the inclinometer is not a linear function of the angle. This means that, as the angular speed is constant (19 rpm) and the acquisition frequency rate too, the acquired points will be differently spaced (time based acquisition rate) in the non-linear region.*

The characteristic curve for the inclinometer is shown in figure 7: as can be noticed the transfer function is not linear along the full range of the instrument. This has revealed to be an issue, since the acquisition rate was time based (fixed acquisition frequency), and the resulting acquired points were differently spaced in the region close to -90° and 90°.

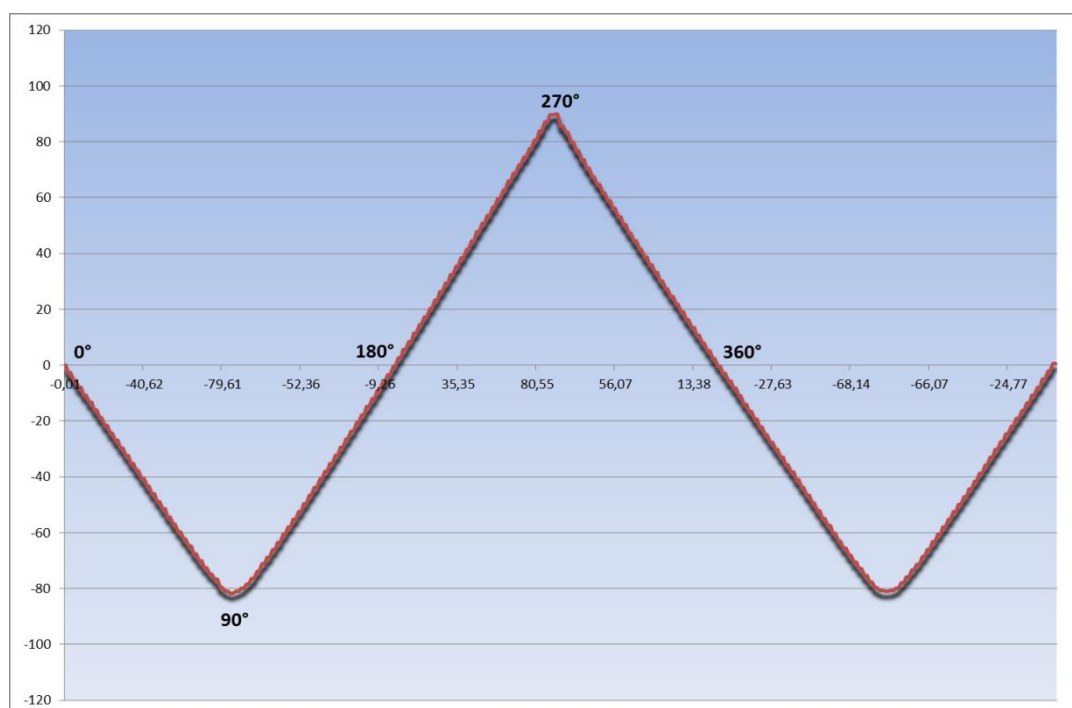
Fig. 8 – Zoom resulting from an acquired set of data through the inclinometer sensor. The raw data were acquired in Volt and further post processed, applying the transfer function of the instrument, to obtain the indicated curve in degrees versus time. It can be noticed that each position (min, max and intersections with the time axis) correspond to an absolute position of the blade.

In figure 8 a screenshot of the acquired data from the inclinometer is proposed with the evidence that the position is always known even in a range of  $180^\circ$ .

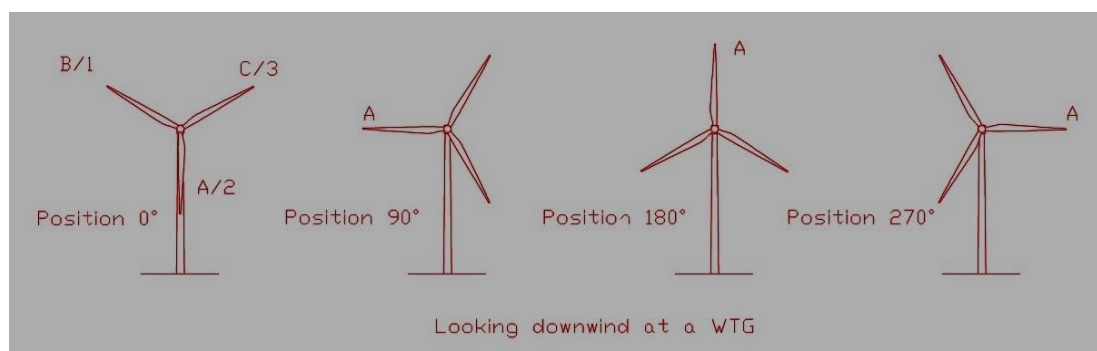
Fig. 9 – Reference position for the instrumented blade A/2 with respect to the angle measured from the inclinometer.

The adopted reference positions for the instrumented blade can be recognized from figure 9.

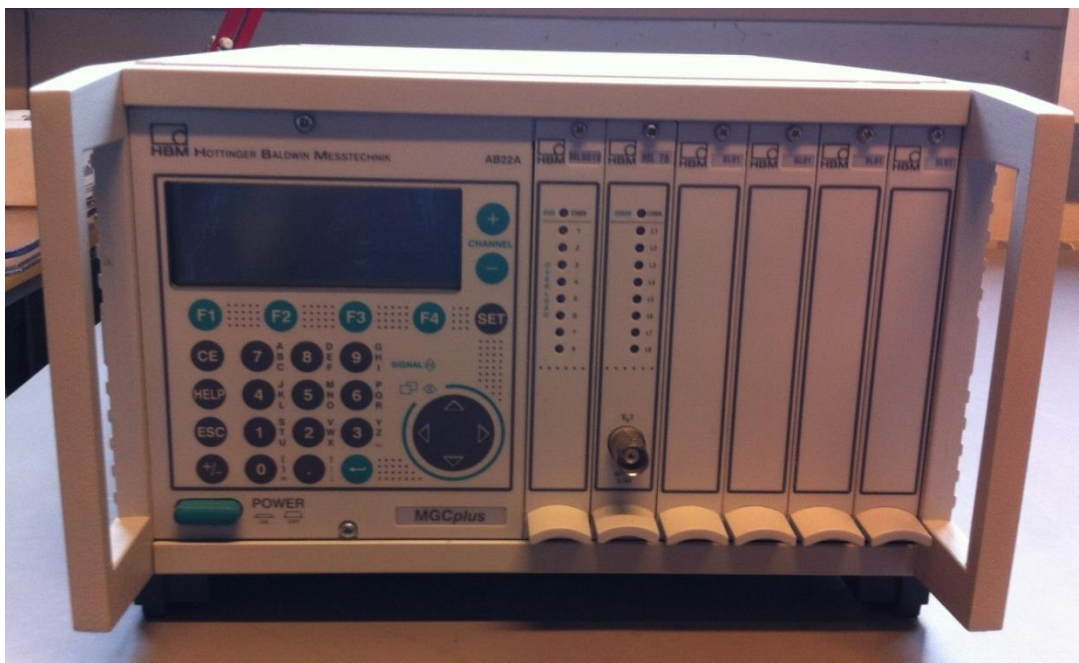
*Fig. 10– MGCplus Amplifier from HBM interconnected between the load washers and the data acquisition card in order to allow the read out the signal measured from the compressive load cells.*

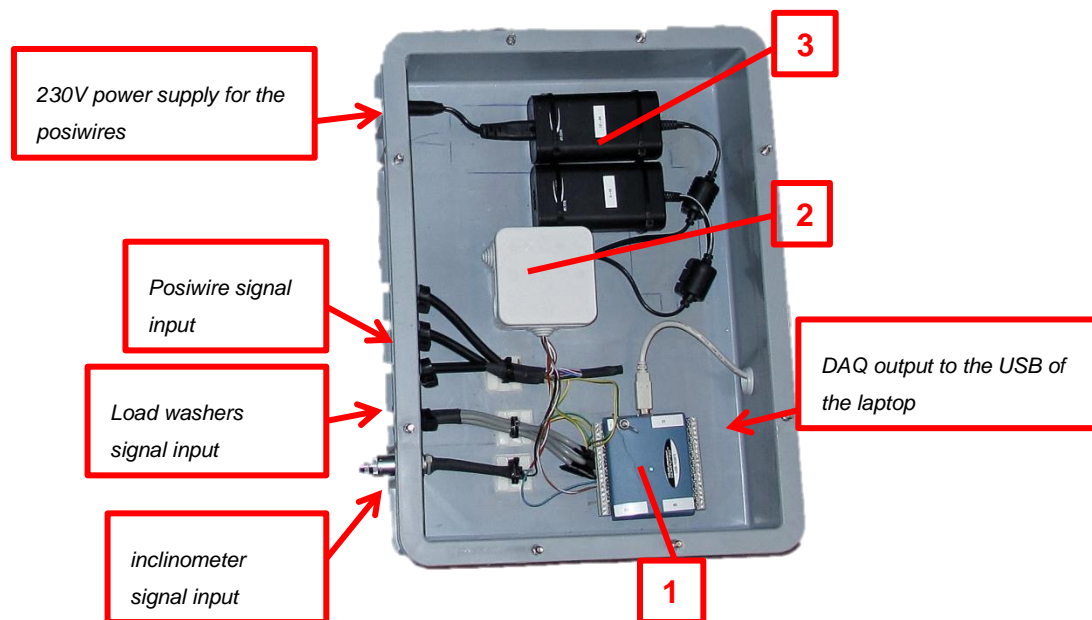
Fig. 11 - Connections case 50x30x10 cm where the DAQ card was allocated (1) with the cabling box (2) and the posiwire power supply (3). On the bottom left side one can see the cables from the posiwire, the load washers and the inclinometer, while on the right side the output to the Laptop running the DasyLab acquisition program. On the upper left the power plug for the posiwire transformer supply.

As already mentioned all the measured signals where sent to the Data Acquisition Card USB-1608FS from Measurement Computing, which was allocated in the grey plastic case, showed in figure 11.

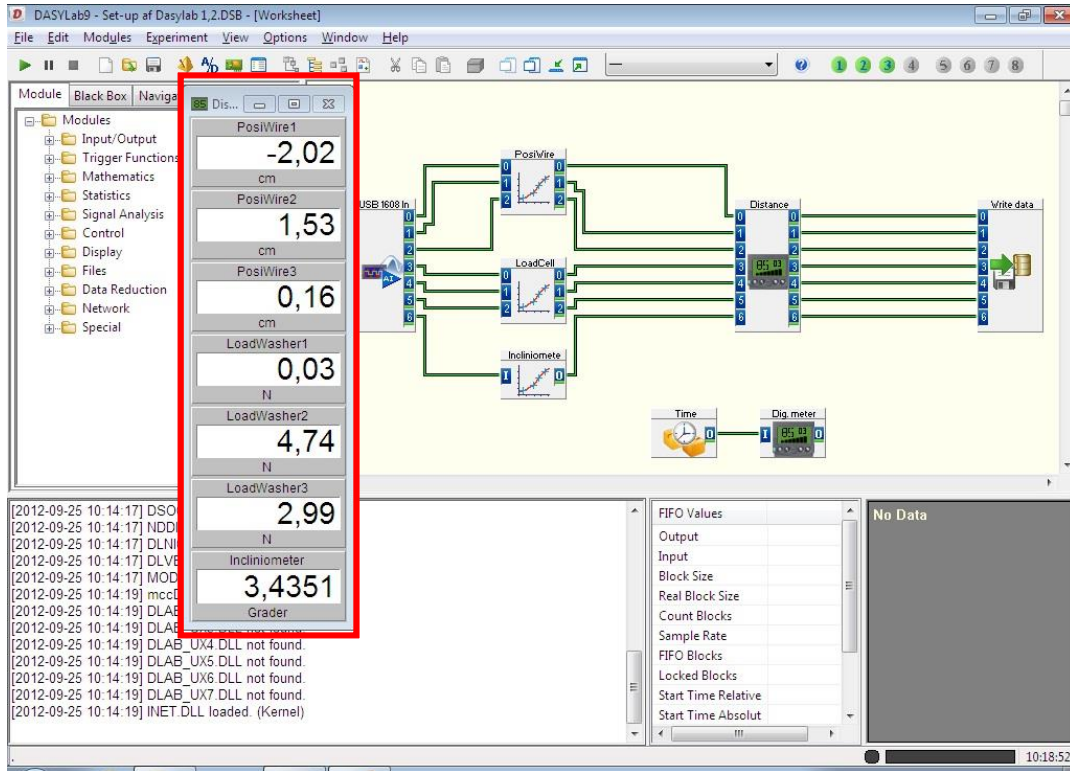
Fig. 12 – Block diagram main window of DasyLab: the highlighted in red window shows all the instant values acquired. As can be easily understood the signal coming from the DAQ – USB 1608 In block – are defined **RESPECTIVELY** – PosiWire, LoadCell and Inclinometer block diagram – and then stored through the write data block. The time block synchronize the laptop internal clock with the starting of the acquisition.

In order to acquire all the data, a block diagram was designed in DasyLab which allow us to store in the local solid disk of the laptop a text file with a header related to the test conditions. For brevity in this subparagraph the DasyLab block diagram main window is shown, while the start-up procedure will be explained in the following sections.

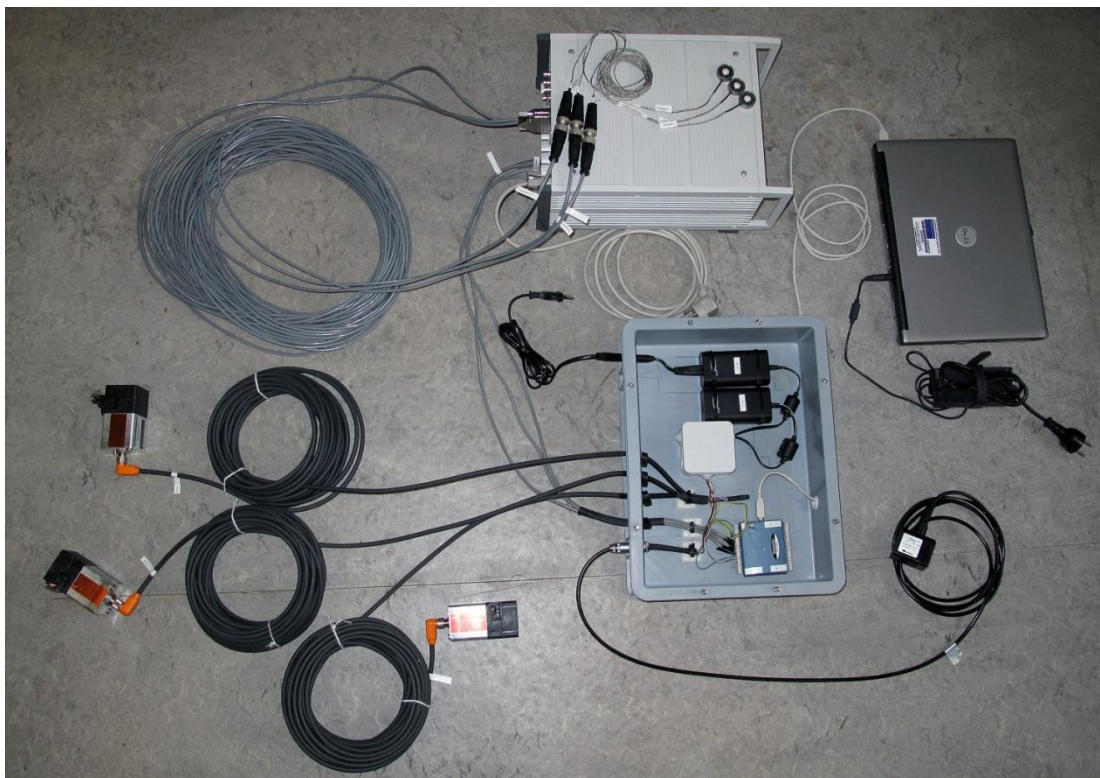
Fig. 13- Complete view of the instrumental set-up used for the field measurements. The laptop running DASyLab (point 1), 3 load washers with the relative amplifier (indicated with 2 and 3), 3 “posiwire” string pots (indicated with 4), the connections box with the data acquisition card (point 5 and 6), the inclinometer (point 7).

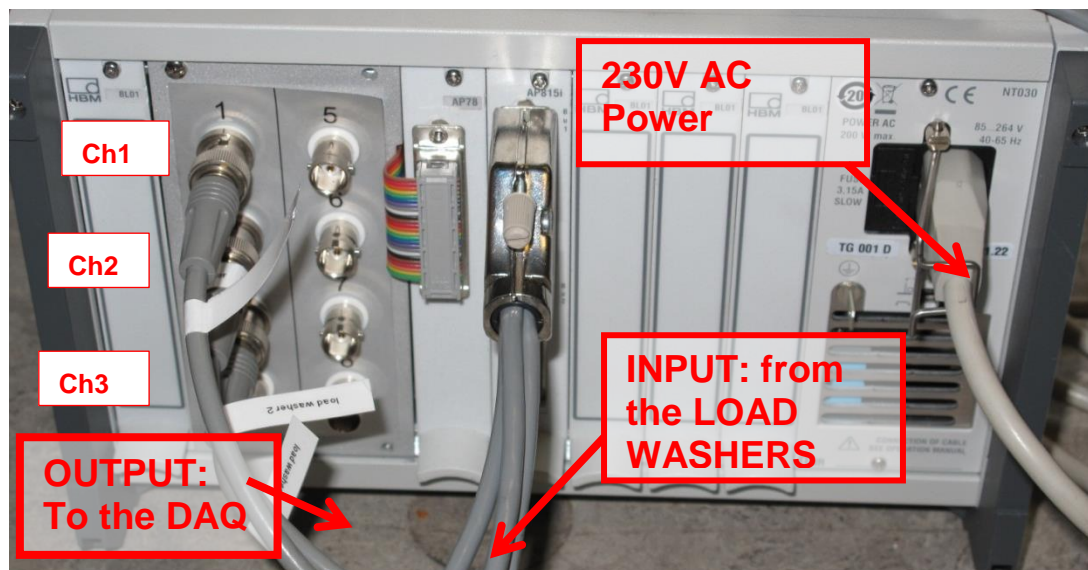
Fig. 14 - Detailed view of the back HBM amplifier connection: as one can see the 3 coaxial cable are the numbered output and are connected to the DAQ through the connections box, while the input coming from all the 3 load washers are connected through a 25-pins connector. On the right the power source of the amplifier can be noticed.

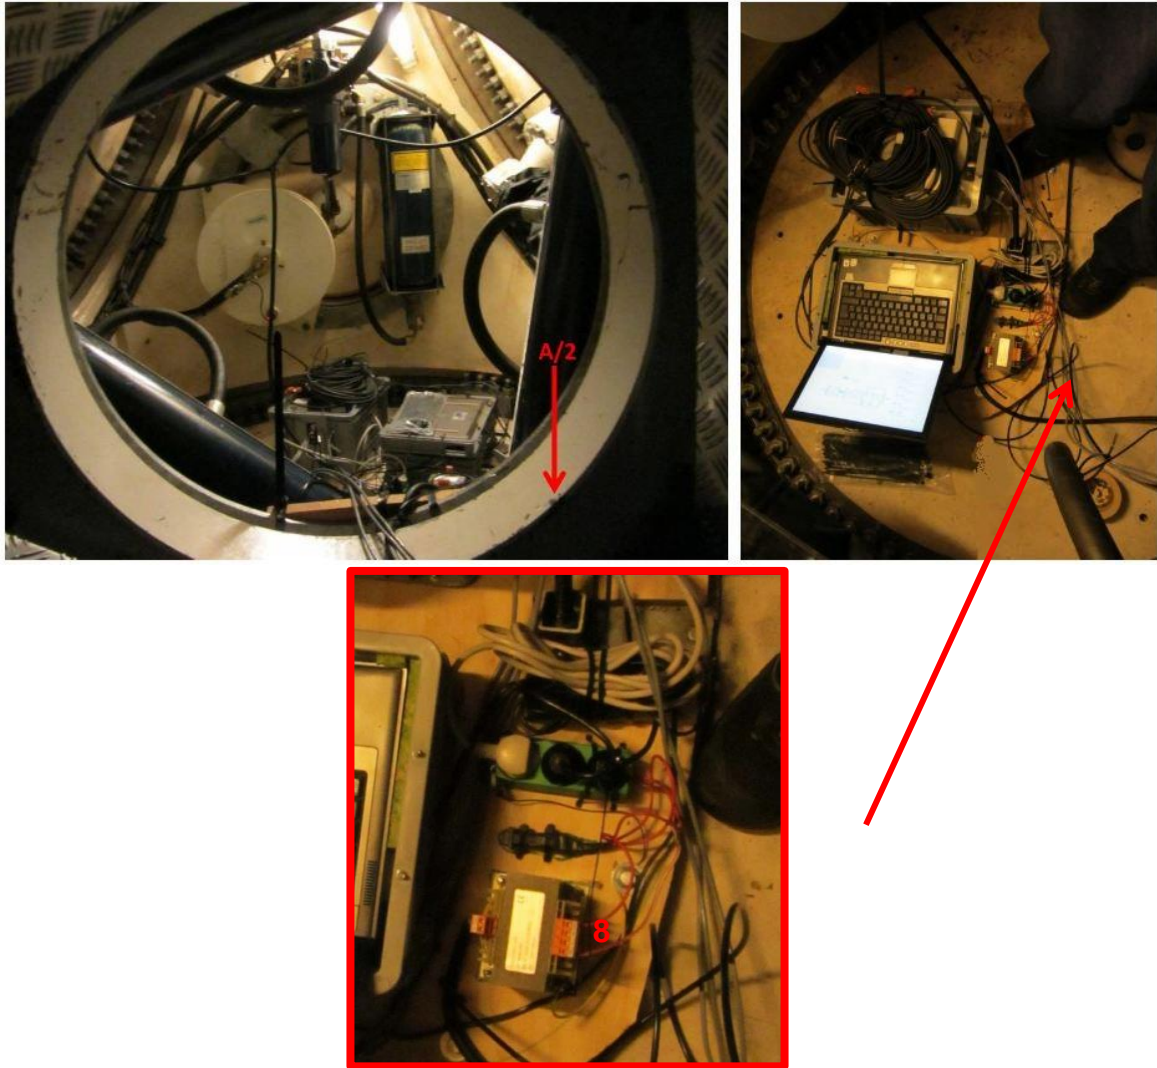
*Fig. 15 – Rotor hub hollow space view where the DAQ system was mounted. Both the Laptop and the Amplifier were enclosed in a grey box properly modified with cooling hollows and Plexiglas cover; these were stacked one to each other close to the rotational axis of the WTG. In the bottom figure indicated with a red arrow, zoomed view of the inverter (point 8 on the list) which was needed to convert the power supply took from the auxiliary to a proper 230V AC required from the instruments.*

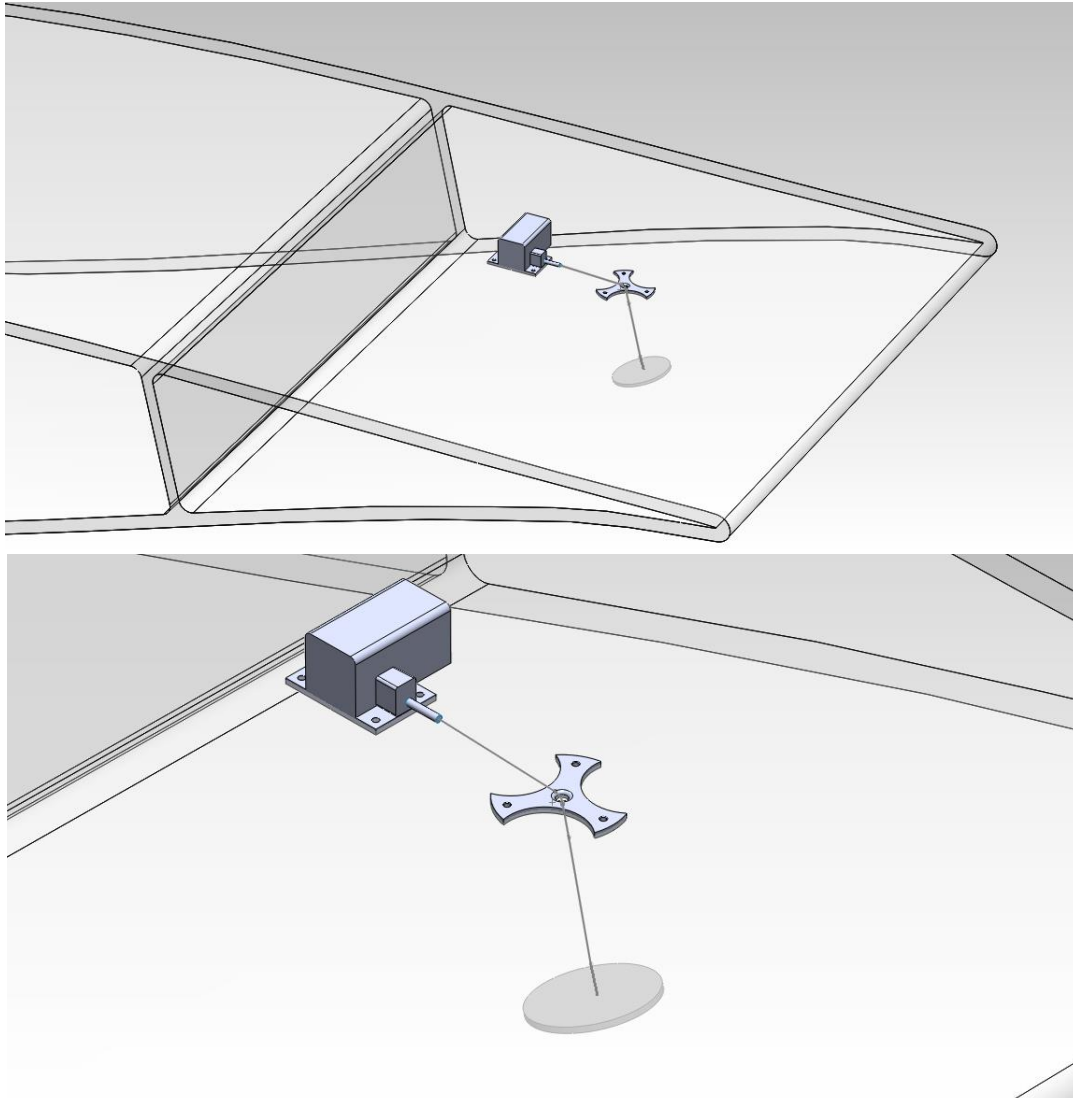
*Fig. 16 – Schematic 3D model of the adopted fixing solution for the posiwires on the suction profile of the WTB V80 from Vestas. The posiwire is screwed through an aluminium plate directly to the sandwich panel, the (triskelion) shaped plate on the upper surface allows the string to be aligned with the axis of the posiwire and ensure a smooth curvature of the string. A hole on the shell allows the string to connect upper and lower shells and measure the relative displacements, the lower end of the string is attached to the lower panel by means of an aluminium plate screwed directly on it.*

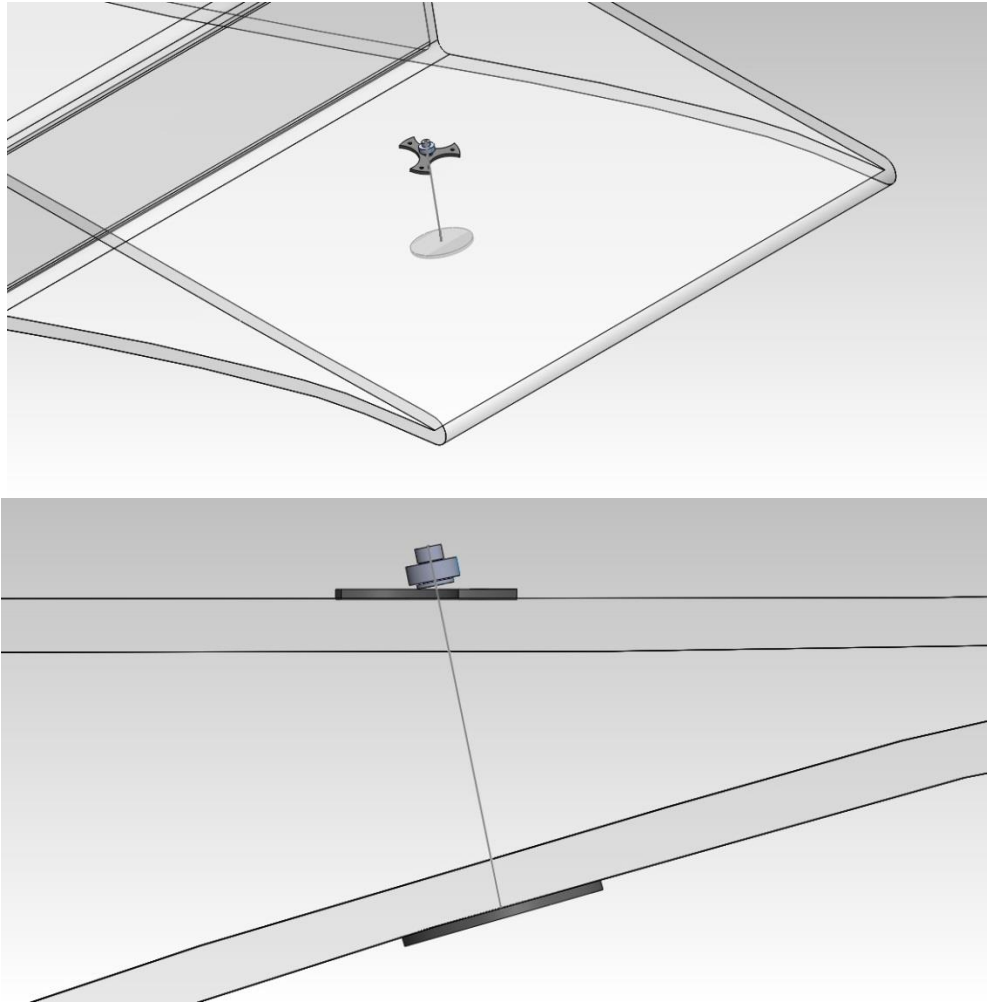
*Fig. 17 - Schematic 3D model of the adopted fixing solution for the load washer on the suction profile of the WTB V80 from Vestas. A hole on the shell allows the bolt to be connected through a string to the lower shell.*

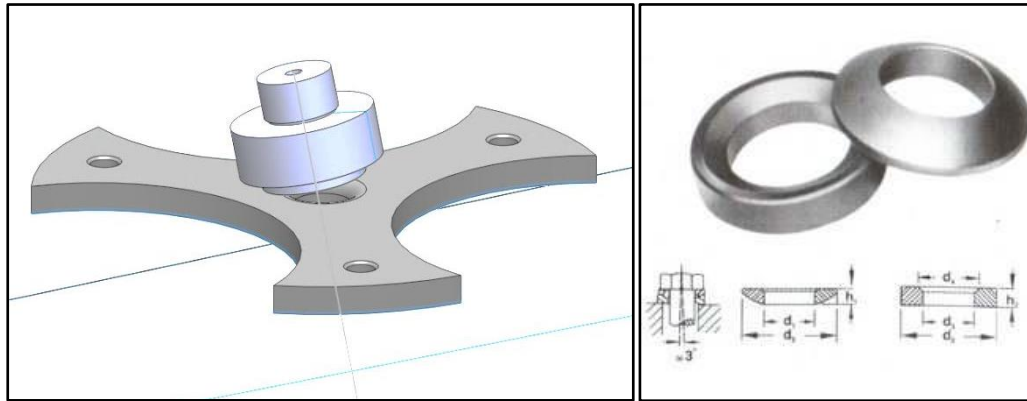
*Fig. 18 – Detailed view of the load washer mounting solution adopted: on the left it can be noticed that it was necessary to tilt of an adequate angle the load washer/string connection to have a pure compression stress. We achieved to this adopting proper spherical washers – IGUS washers – showed here on the right.*

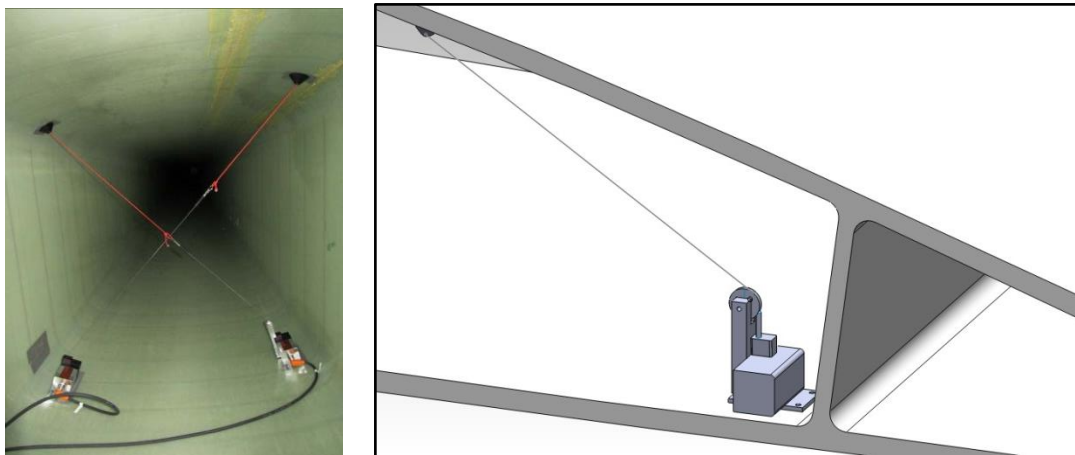
*Fig. 19– Realized (left) and 3D schematic (right) fixing solution for the internal “shear displacements” measured with the posiwires at a 10 meters length inside the spar cap. A string was attached with some double side flash tape to the GFRP surface, by means of a plastic cone. The posiwire was mounted in a vertical position on the opposite surface, using this double side flash tape. A pulley was manufactured in order to direct the string in a correct way, avoiding any friction.*

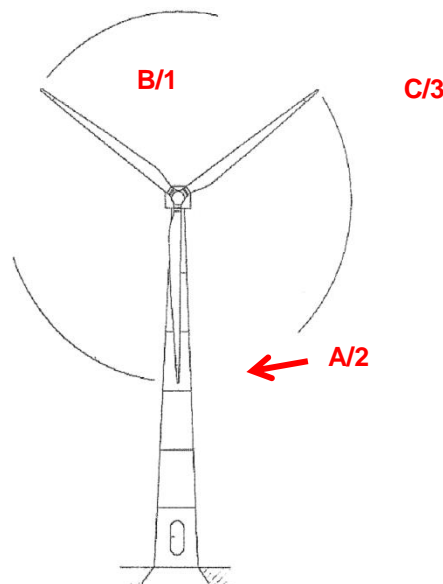
Fig. 20- Schematic illustration of a wind turbine fixed in the “maintenance configuration”. The instrumented blade is the vertical one, and is commonly denominated the A/2.

The adopted inclinometer has a range of  $180^\circ$  between  $-90^\circ$  and  $+90^\circ$ . The  $0^\circ$  position corresponds to the vertical position of the instrumented blade A/2 as shown in figure 20.

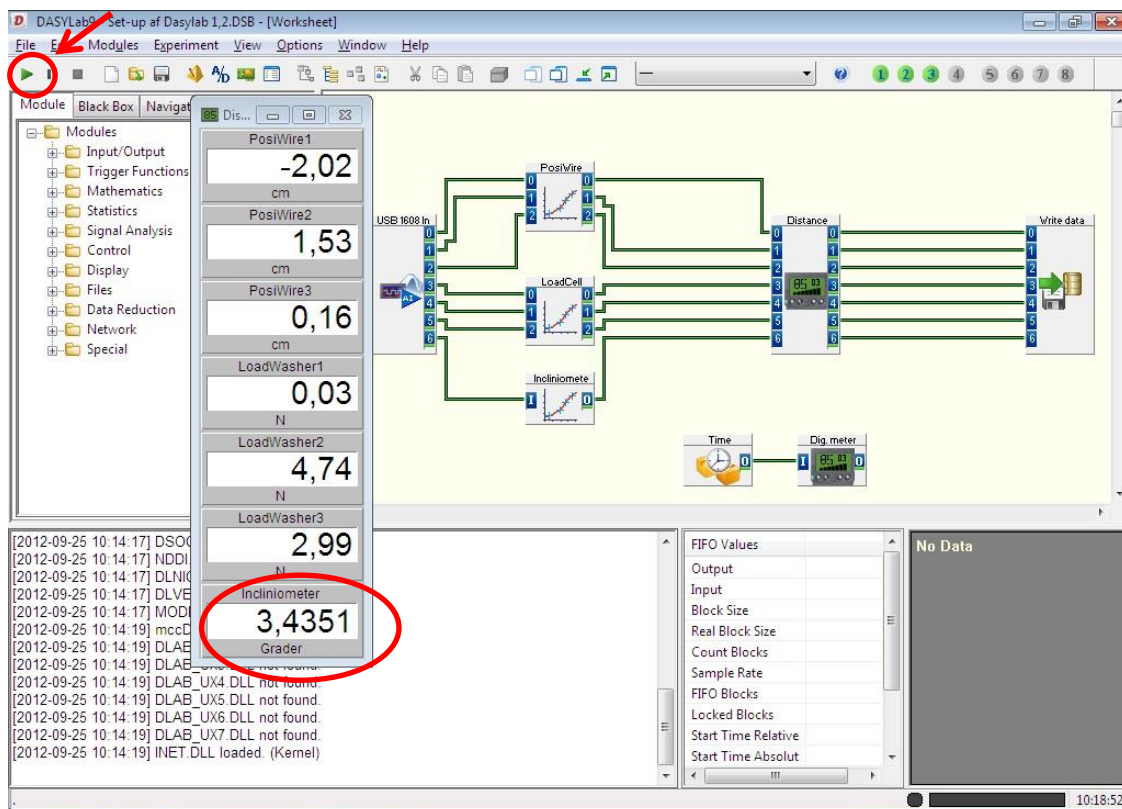
Fig. 22 - Main screenshot of the DASYLab setup file. The vertical window displays the instant acquired values from the connected instruments. The angle for the inclinometer is identified by the red colour circle and in the calibrating procedure it has to be as close as possible to 0° degree reference.

By starting up the laptop and launching an acquisition session in DASYLab, one can control the alignment to the reference position as can be seen in figure 22 and the inclinometer can be manually adjusted and screwed on the wooden plate.

Once the setup file is loaded one has to press the “play button” highlighted in figure 22 and the system start to acquire and write the data in a text file located in the same folder of the setup file.

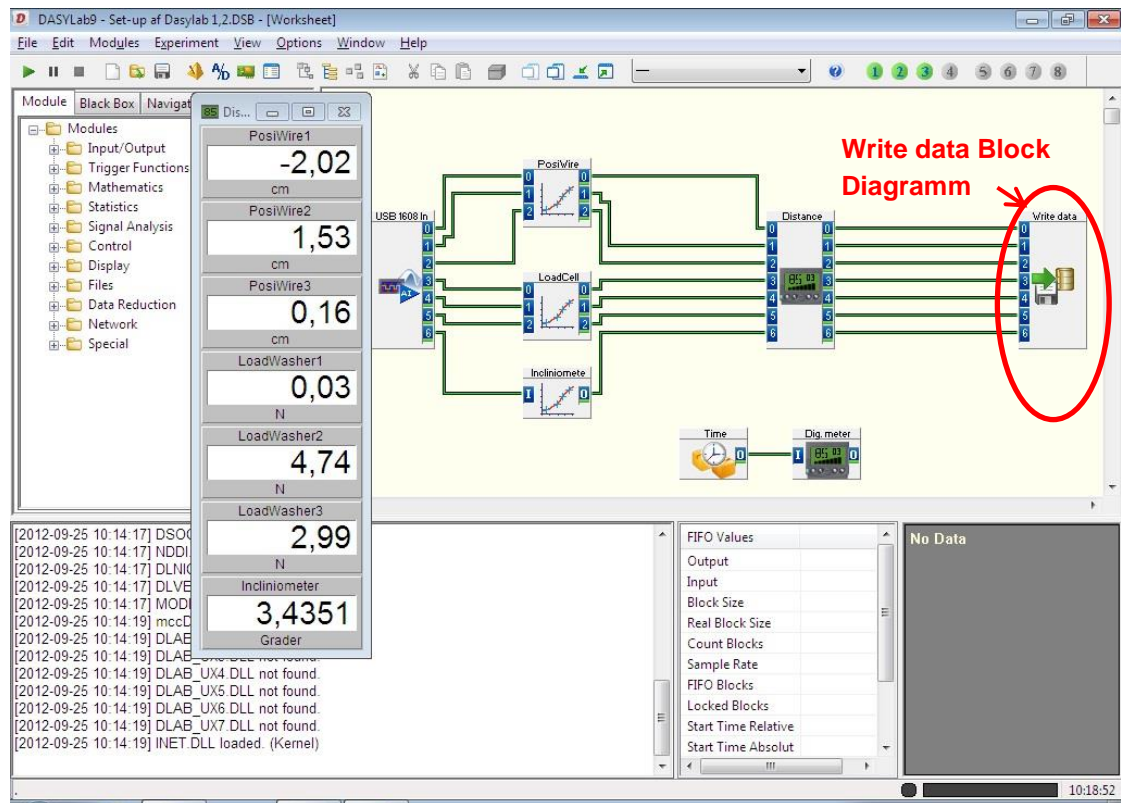
Fig. 23 - Main screenshot of the block diagram: the write data module is highlighted in red colour on the upper right.

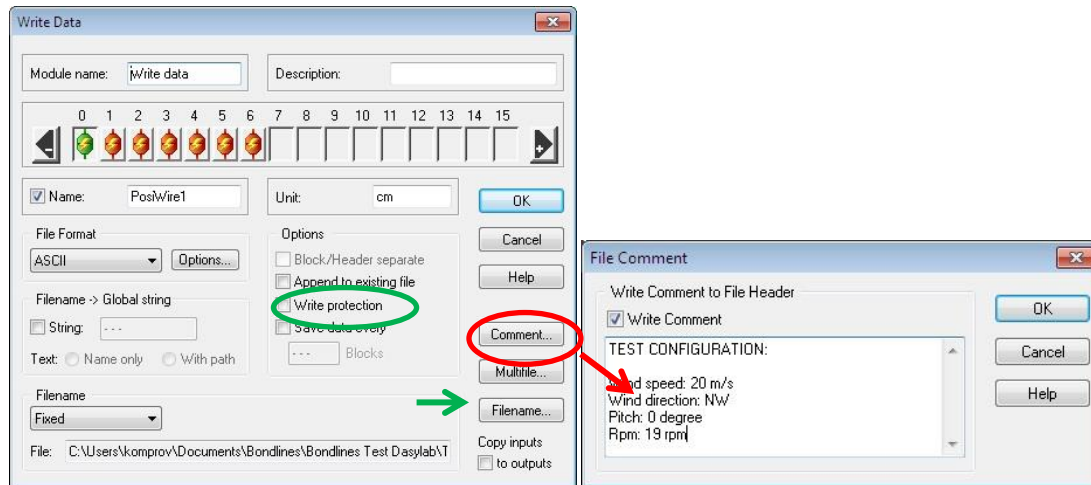
Fig. 24 – Window screenshot of the Write data module at the left and File Comment window on the right. In addition also the Write protection selection has to be flag (circled in green colour) and the Filename (indicated with a green arrow) has to be defined each time a new acquisition is started.

From the main block diagram window, double click on the *Write data block* and the window showed in figure 24 will appear, then by clicking on the *Comment selection* one can have the possibility to write any comments to append to the header of the stored file. All the steps to follow are shown in the following page.

Moreover, in order to be sure not to overwrite the test file once another acquisition is launched the *Write protection* selection in flagged, as highlighted in figure 24, and when pressing the “play button” a message error will occur saying to rename the filename for the new acquired dataset. This can be done, with reference to figure 24, by clicking on *Filename* and renaming the test file as: YYYY-MM-DD Test N.XX.

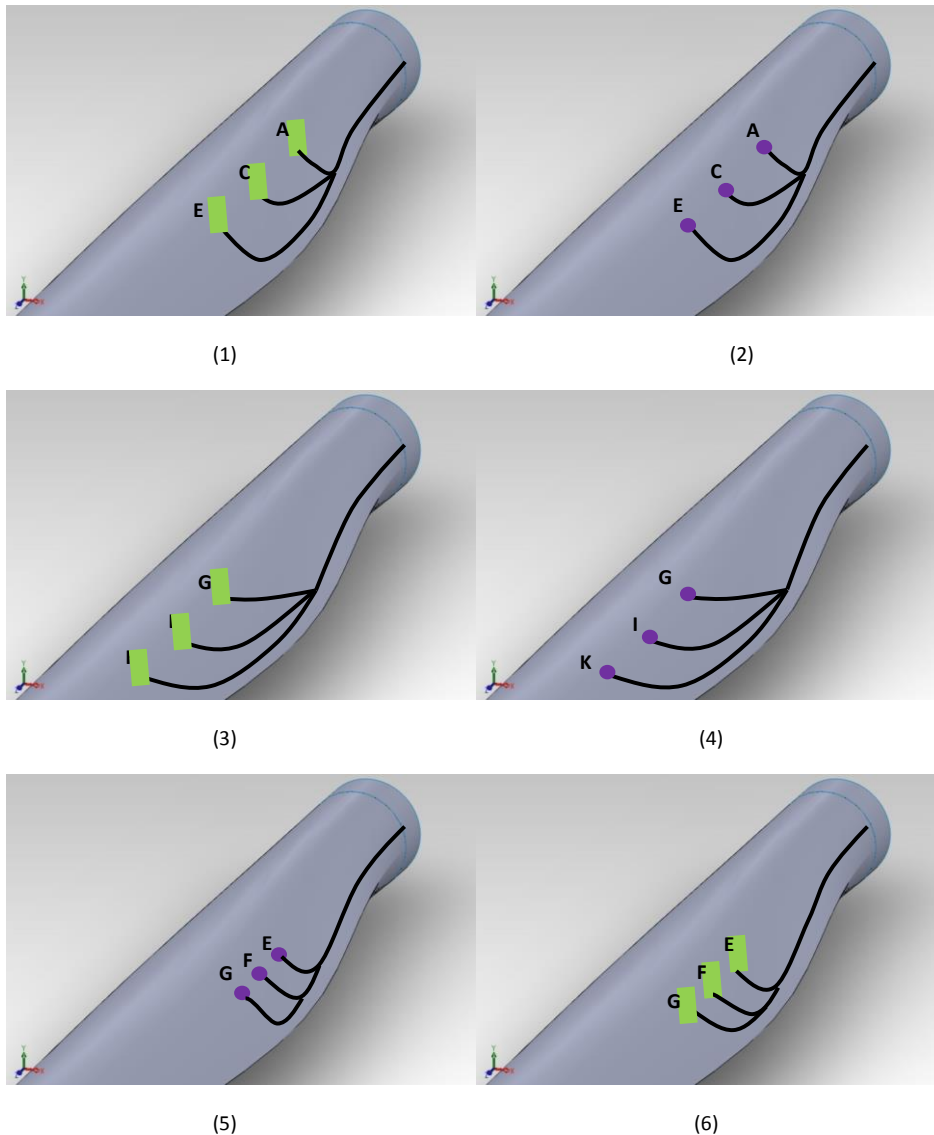
*Fig. 25 - Main view of the instrumented blade with highlighted the cables arrangement along the TE. In green colour the 3 string pots, while in purple colour the 3 load washers. (1) 1<sup>st</sup> set of displacement measurements on section A, C, E in order to find the point where the maximum displacement occur. (2) 1<sup>st</sup> set of load measurements to acquire the corresponding loads at the same sections A, C, E. (3) 2<sup>nd</sup> set of displacement measurements on section K, I, J in order to find the point where the maximum displacement occur. (4) 2<sup>nd</sup> set of load measurements to acquire the corresponding loads at the same sections K, I, J. (5) 3<sup>rd</sup> set of measurement to acquire the corresponding loads around the maximum displacement point – i.e. F – at different pitch angles. (6) 3<sup>rd</sup> set of measurement to acquire the corresponding displacements on the same sections – i.e. F – at different pitch angles.*

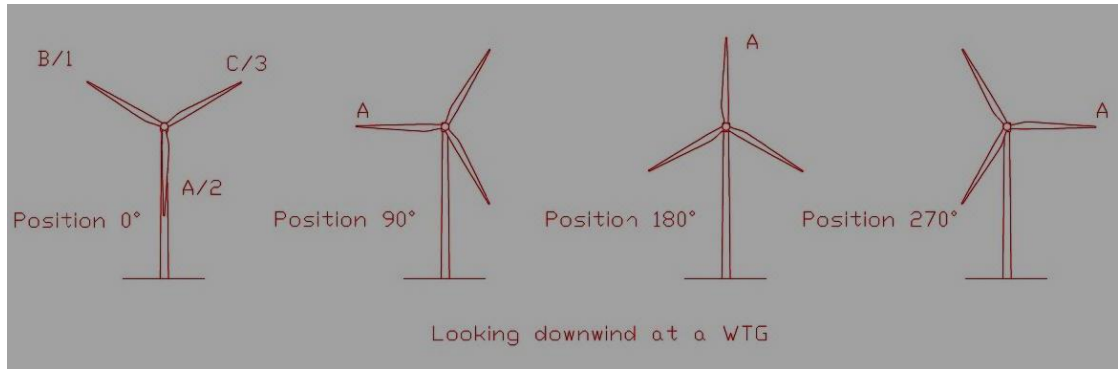
*Fig.26 – Schematic representation of different blade positions of interest for the tests. Blade signed A/2, set a 0° reference position, is the chosen one to be instrumented.*

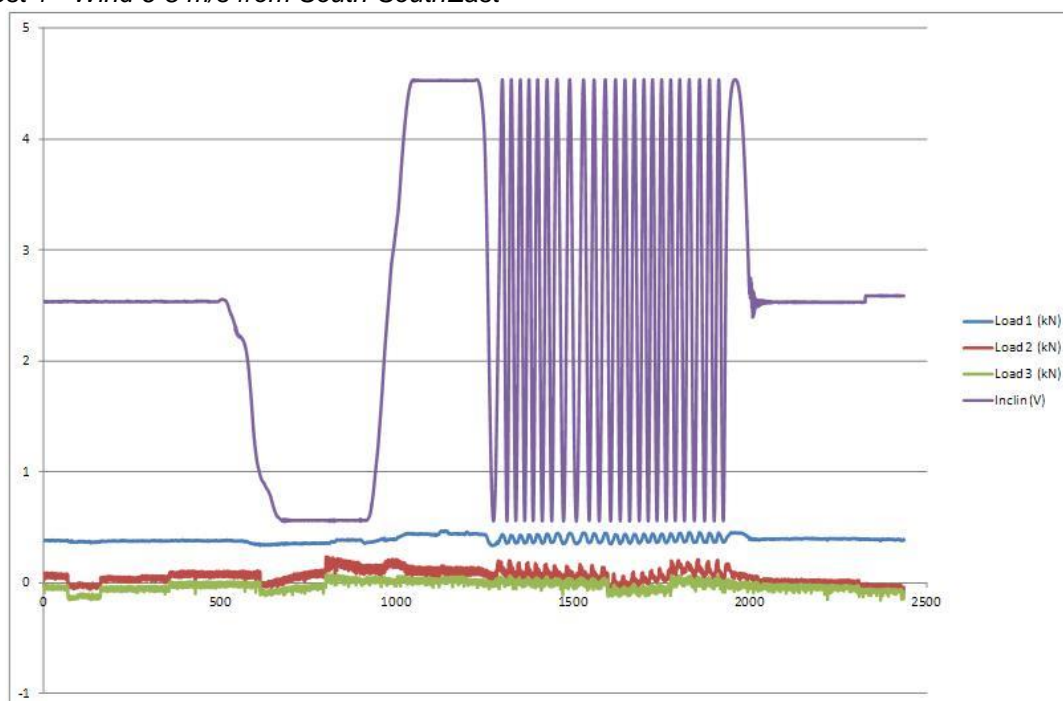
*Fig. 27 - Full trace for test 1 (23/oct)*

Note that the output from load washers 2 and 3 is “noisy”.

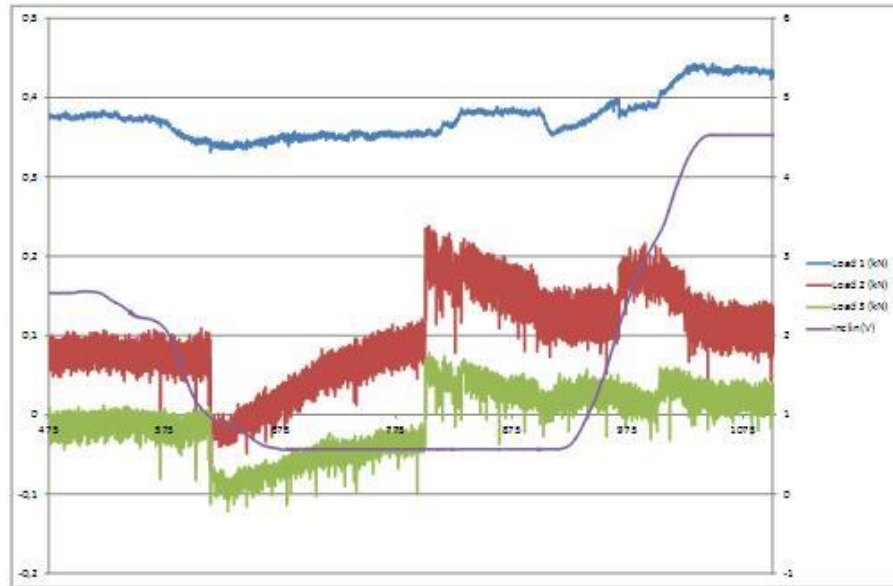
Fig. 28 - Detail from Test 1 showing the blade rotating to the 90° position where the pitch is cycled from 90 deg to 0 deg and then back again

Note that the output from load washers 2 and 3 is not stable during this time. At around 800s it is possible to see the effect on the load washers from the cycle from 90 deg pitch to 0 deg pitch. And at around 900s it is possible to see the effect of the cycle back from 0 deg to 90 deg pitch. This is most evident on the more stable Load washer 1 output.
