# Bondlines – Online blade measurements (October 2012 and January 2013)

## Department of Wind Energy E Report 2013

DTU Wind Energy E-0036

Some local deformations in an operating Wind Turbine blade (V80) have been measured during October 2012. Displacement and load values generated between the trailing edge panels at blade radius R9.2m, R10.2m, and R11.2m were obtained. A fluctuating loading of between 100 - 200N existed when the two panels were connected, and with a displacement of between 6.5 - 10mm when the panels were free to flex as they do in normal operating conditions. Shear distortion within the main loading spar of the blade (at approximately R10m) showed a fluctuating cross beam shear distortion of about 9mm.

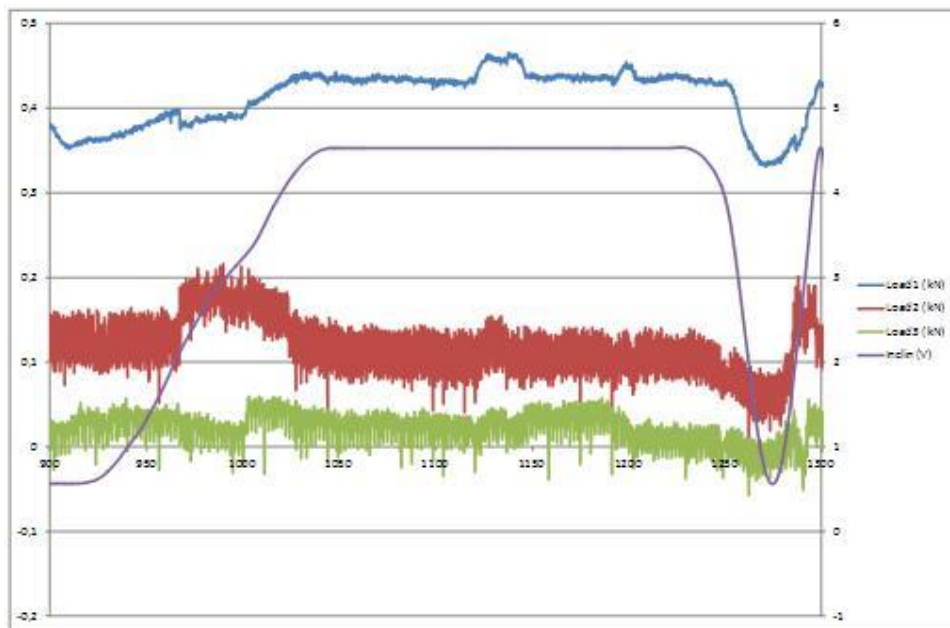
Fig. 29 - Detail from Test 1 showing the blade rotating to the 270° position where the pitch is cycled from 90 deg to 0 deg and then back again

At around 1120s it is possible to see the effect on the load washers from the cycle from 90 deg pitch to 0 deg pitch. And at around 1200s it is possible to see the effect of the cycle back from 0 deg to 90 deg pitch. This is most evident on the more stable Load washer 1 output.

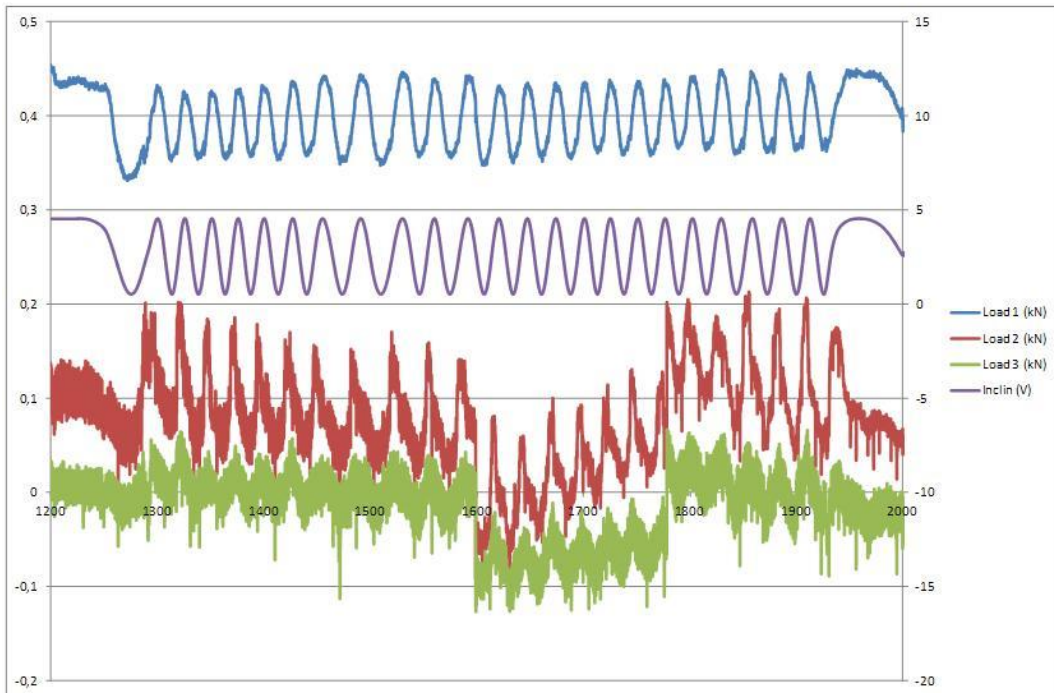
*Fig. 30 - Detail from test 1 showing the autorun startup and operation (at close to 0 deg pitch)*

Again the Load 1 output is stable whereas the Load 2 and 3 output is “noisy” and has an unexplained drop in load at 1600s followed by a response ramping gradually upwards to 1780s, and then downwards for the remainder of the measurement.

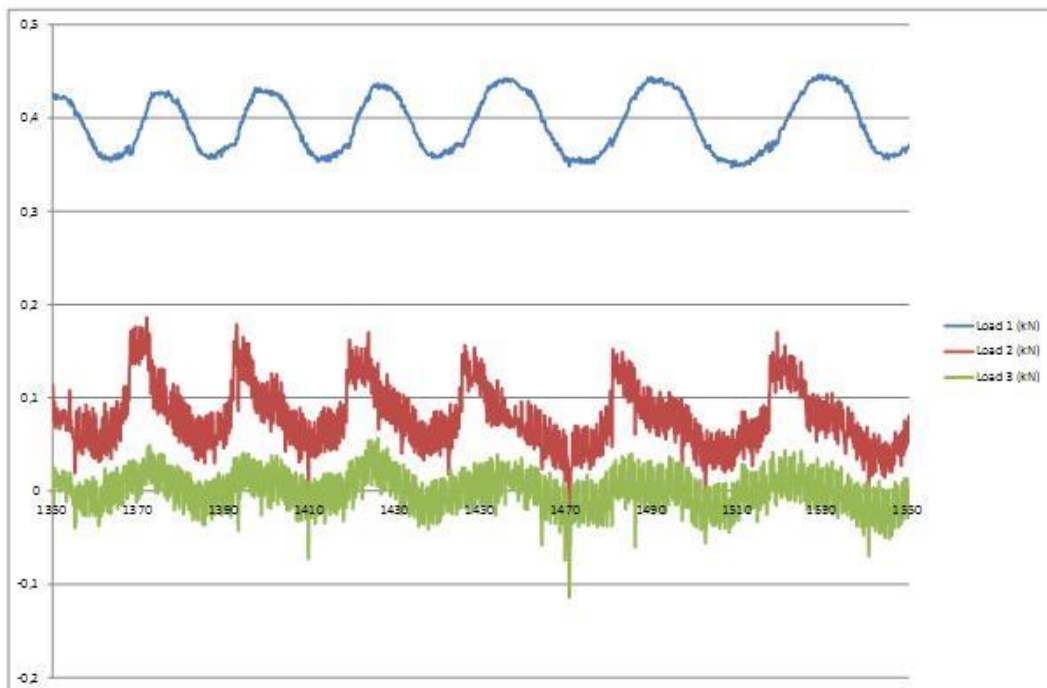
*Fig. 31 - Detail of the output from Test 1 showing the most stable part of the autorun condition*

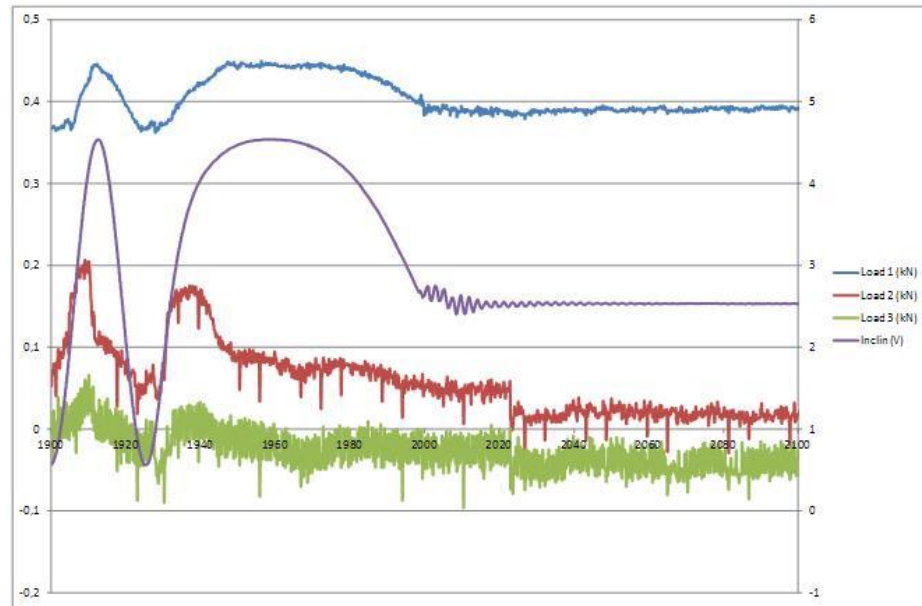
Fig. 32 - Detail of the output from Test 1 showing the turbine deceleration and stop at blade position 0°

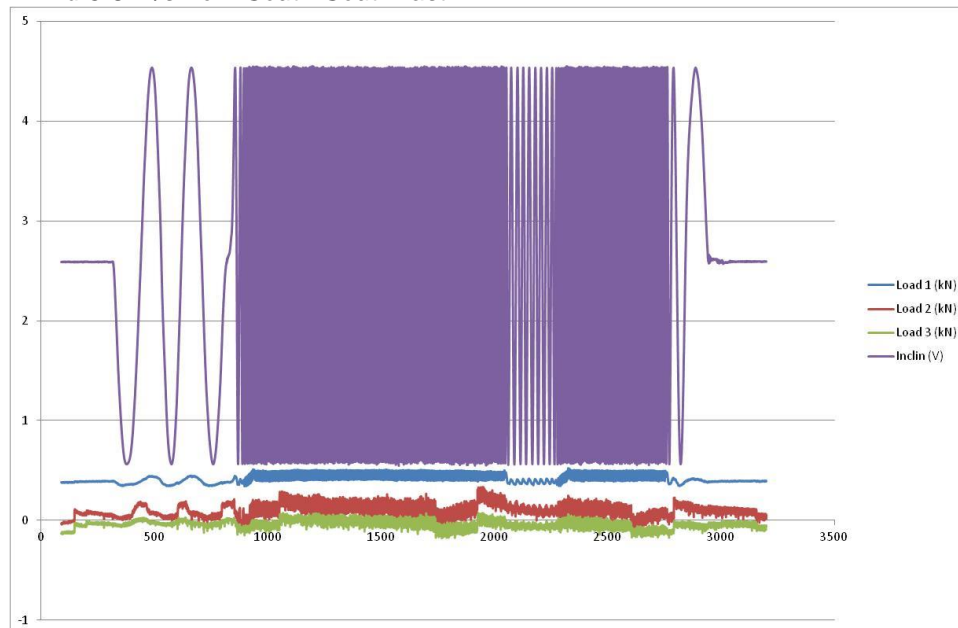
Fig. 33 Full trace for Test 2 (23/oct)

The overview trace for Test 2 shows the data acquisition starts with Blade A pointing down (position 0°). At around 300s the blade begins to rotate in idle condition (around 82-84 deg pitch). Around 850s the blade enters autorun operation (close to 0 deg pitch). Around 2050s the turbine automatically changes to blade pitch 30 deg due to very low wind speeds. At 2275s the turbine changes the blade pitch back to being close to 0 deg again and normal operation resumes. At 2760s the turbine goes to idle again (around 82-84 deg pitch). At 2940s the turbine is halted with Blade A in position 0°.

Again it can be noted that the output from Load Washers 2 and 3 is “noisy”.

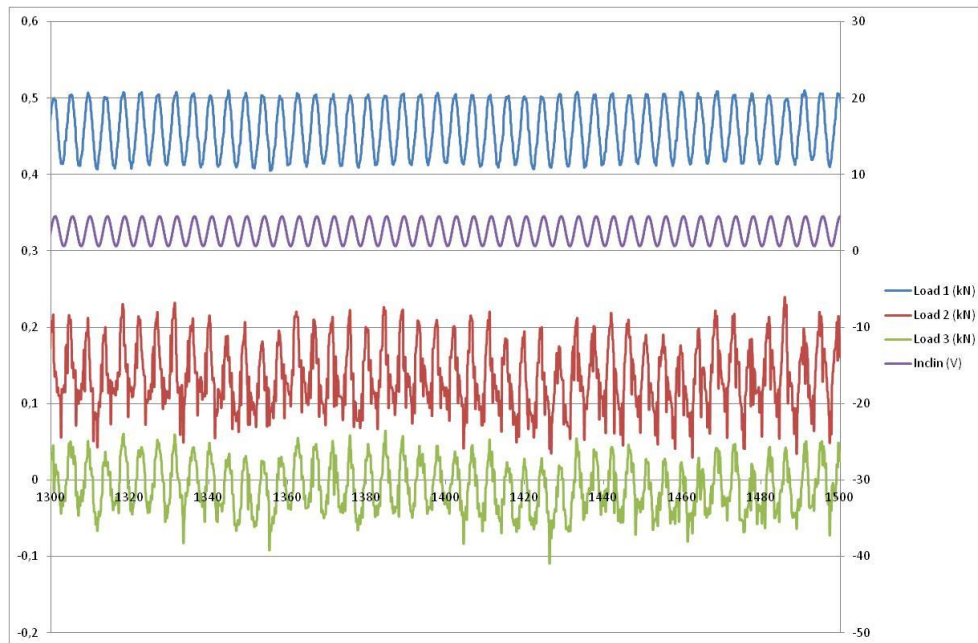
Fig. 34 - Detail from Test 2 showing the first autorun period

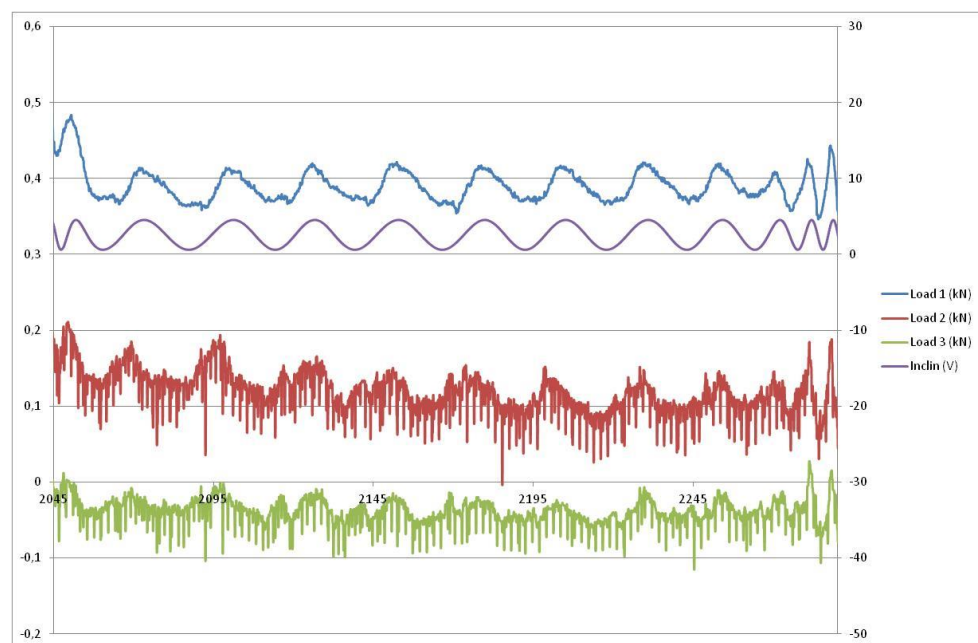
Fig. 35 - Detail from Test 2 showing the automatic change to 30° pitch during low wind conditions

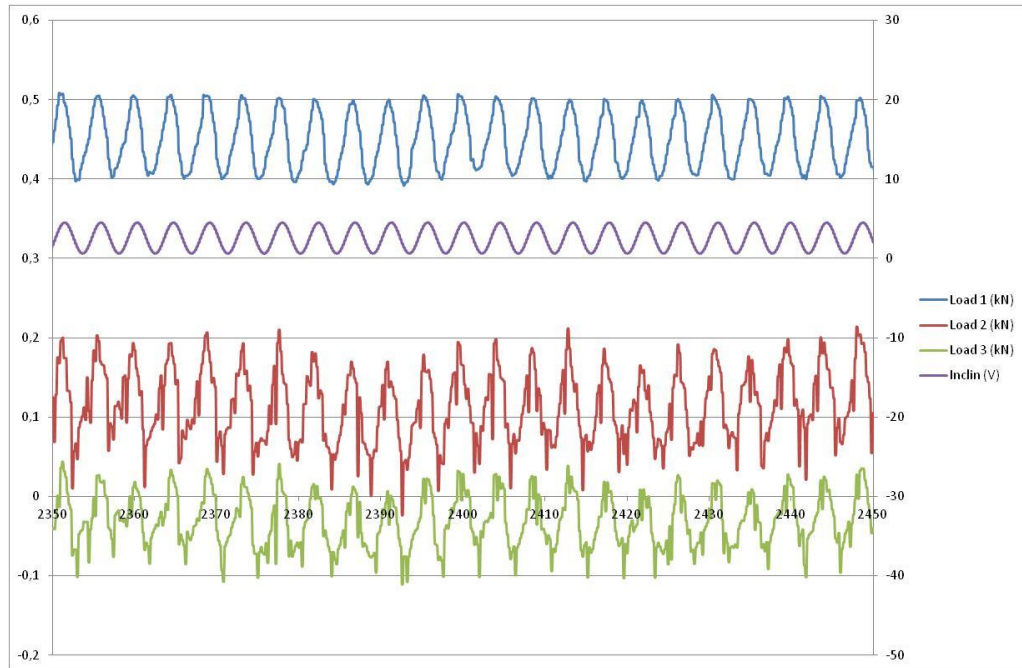
Fig. 36 - Detail from Test 2 showing the first autorun period

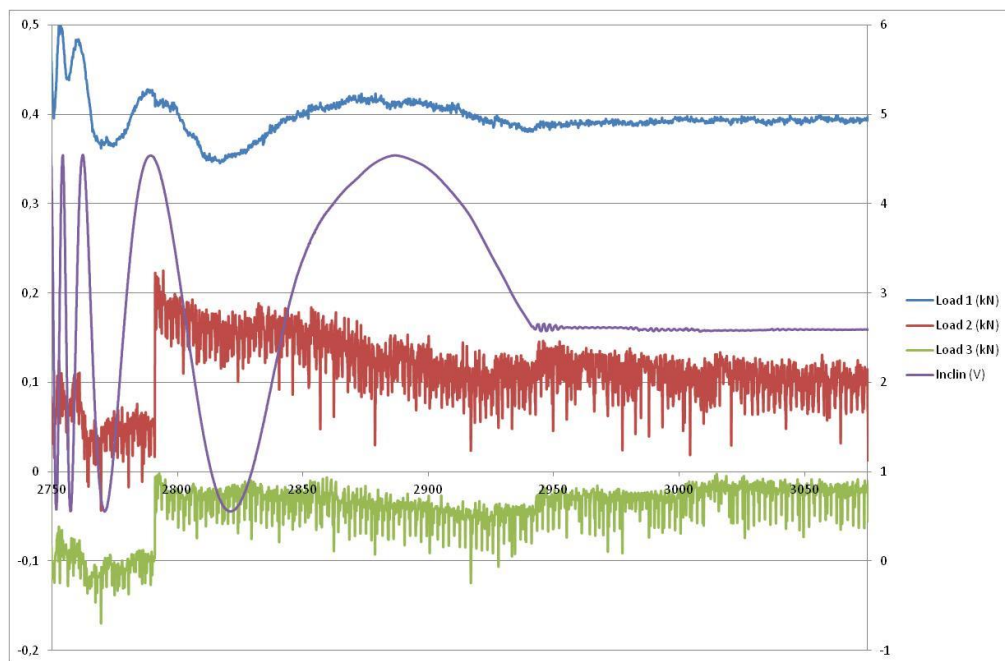
Fig. 37 - Detail of the output from Test2 showing the turbine deceleration and stop at blade position 0°

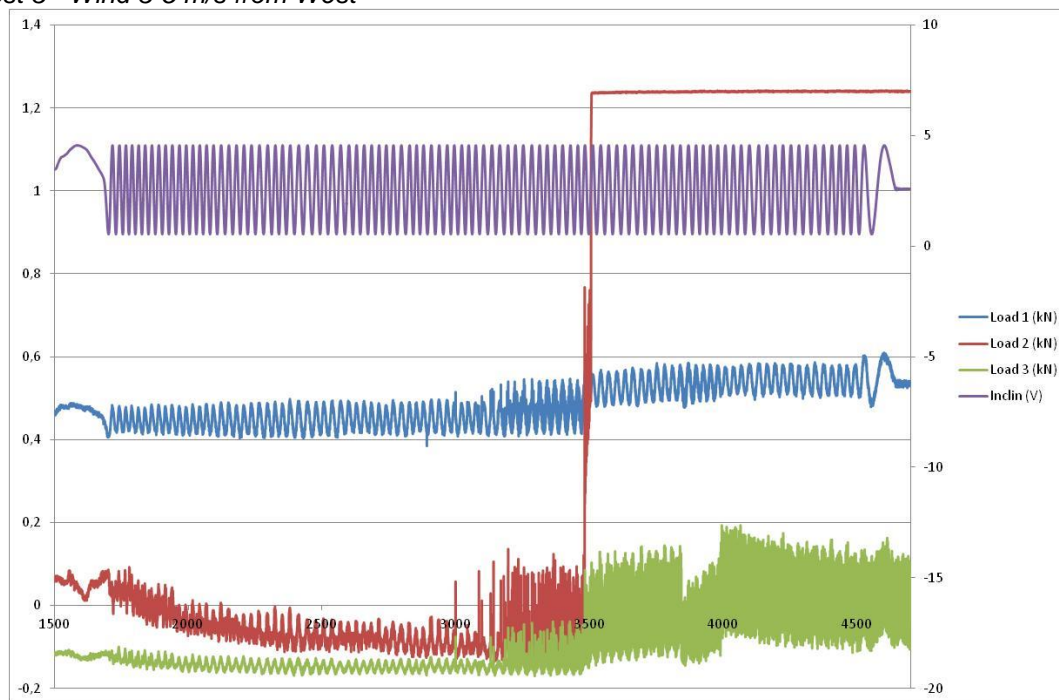
Fig. 38 Detail of the full operation period during Test 3 (24/oct)

At around 1650s following the start of data acquisition, the turbine enters autorun operation (with the blade close to 0 deg pitch). At around 3000s some event appears to occur that changes the response on all the load transducers. At about 3450s a sudden change is noted in the response of load washer 2, although load washers 1 and 3 are also affected. A noise is also heard by the Bondlines personnel. At 4500s the turbine is placed in idle condition (blade pitch around 82-84 deg).

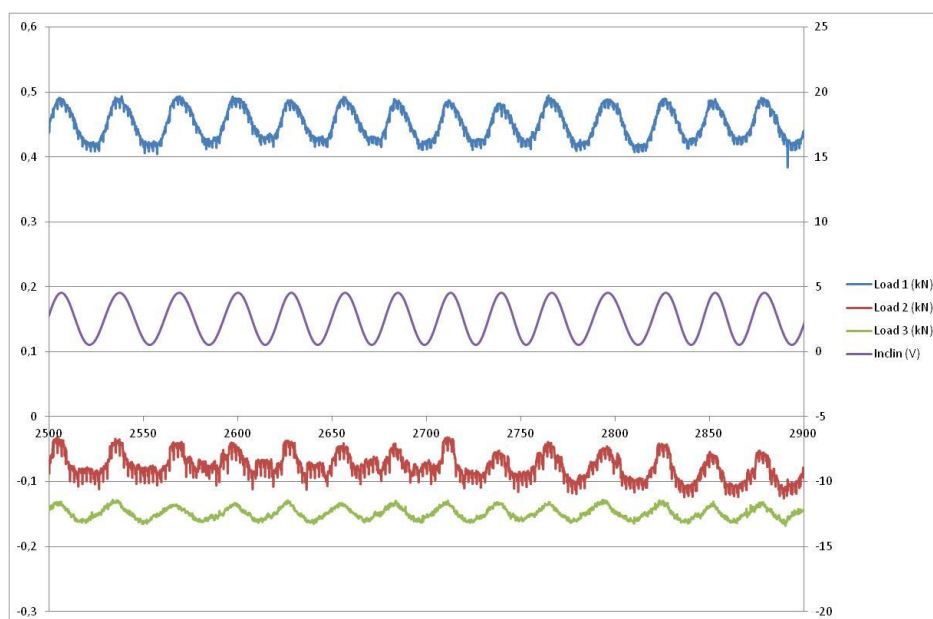
Fig. 39 - Detail from Test 3 showing output during the early stage of autorun condition

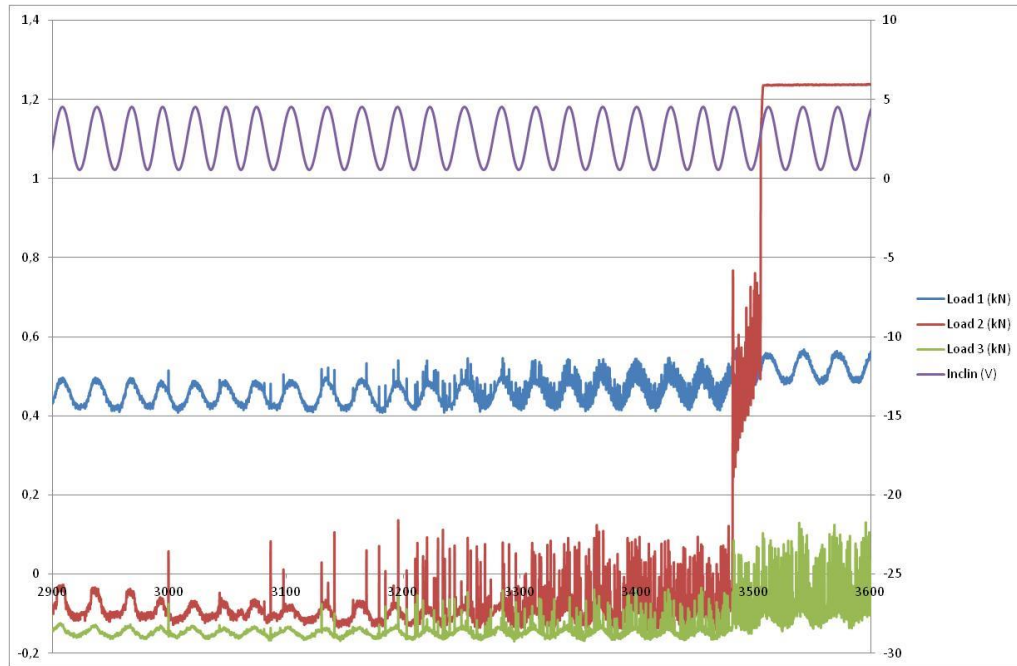
Fig. 40 - Detail from Test 3 showing the event on Load washer 2

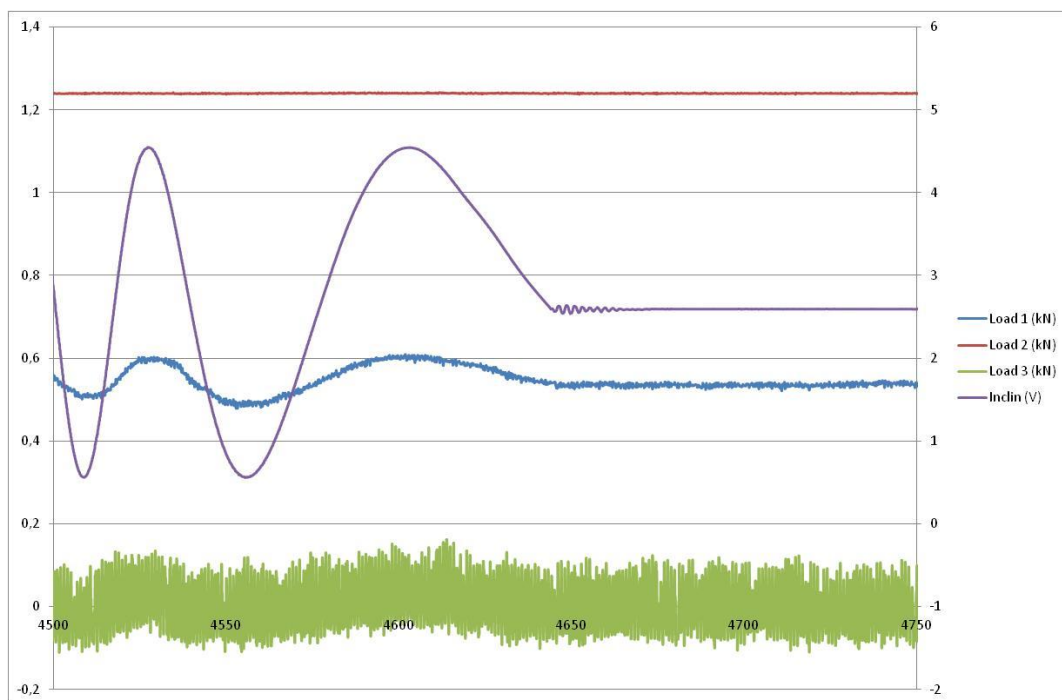
Fig. 41 - Detail from Test3 showing the turbine deceleration and stop at blade position 0°

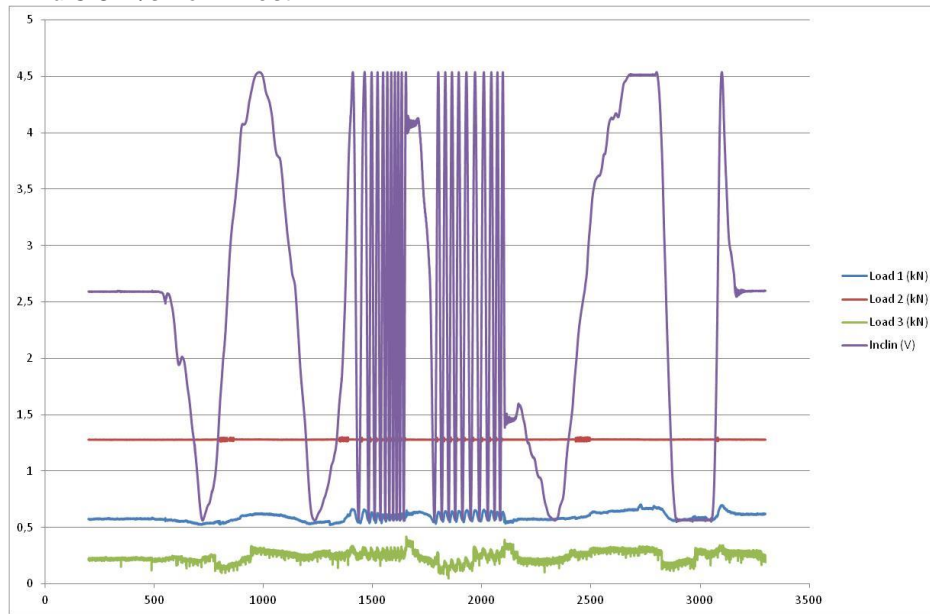
Fig. 42 - Full trace for Test 4 (24/Oct)

The overview trace for this measurement shows that data acquisition starts with Blade A pointing down (position 0°). At around 525s the blade begins to rotate in idle condition (around 82-84 deg pitch). Around 1400s the blade is placed at 30 deg pitch until 1650s when there is an emergency stop on the turbine. Around 1750s the blade is placed at 22 deg pitch until 2100s when there is another emergency stop on the turbine. At around 2175s the blade begins to rotate in idle condition (around 82-84 deg pitch) again. At 2650s the blade is halted in the 270° position and the pitch is cycled from 90 deg to 0 deg and then back again. At 2800s the blade is rotated round to the 90° position and the pitch is cycled from 90 deg to 0 deg and then back again. At 3050s the blade is rotated round to the 0° position and data acquisition is halted at 3300s.

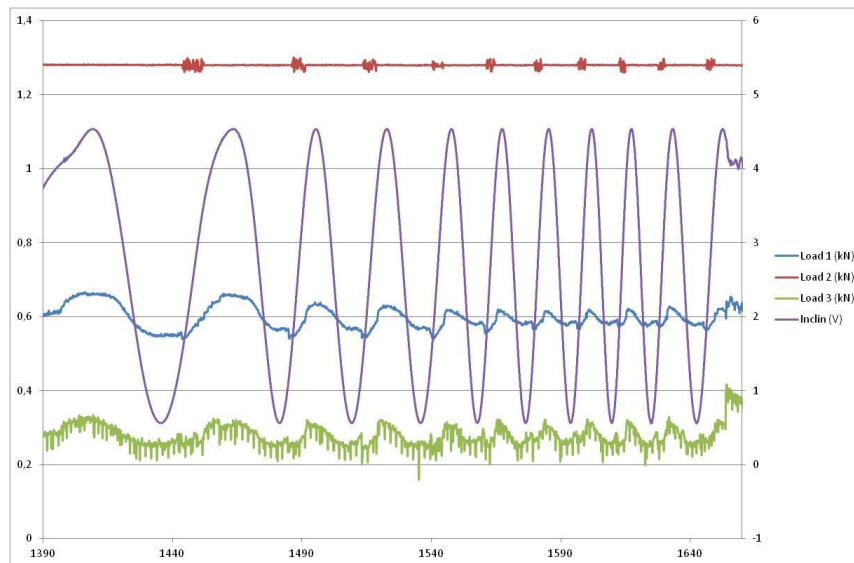
Fig. 43 - Detail from test 4 showing the blade going into operation at 30 deg pitch

Note that while load 1 seems to show good data, load 2 shows only a small pulsed response once per rotation, and the output from load 3 is quite “noisy”.

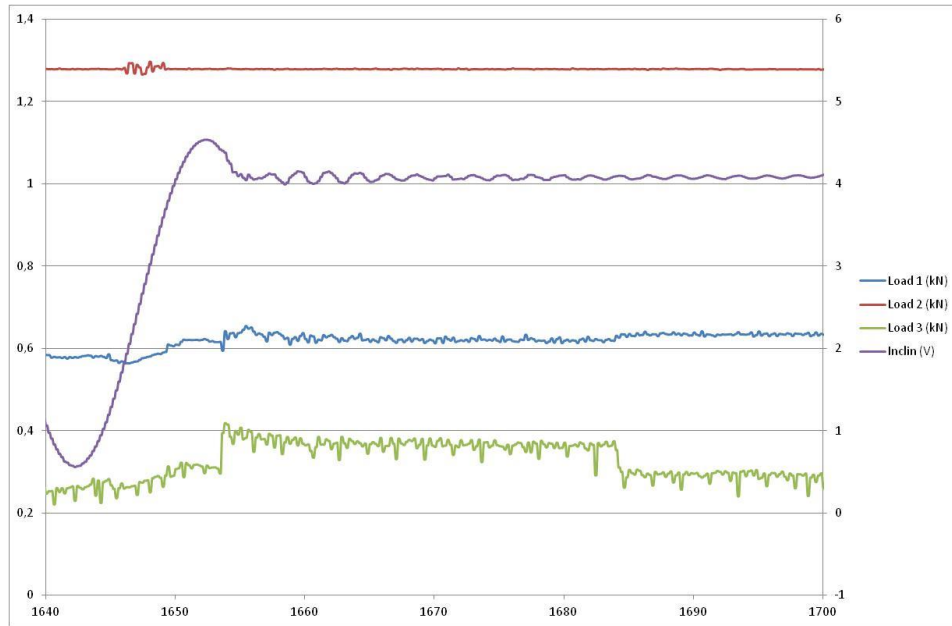
*Fig. 44 - Detail from test 4 showing the blade doing an emergency stop whilst rotating at 30 deg pitch*

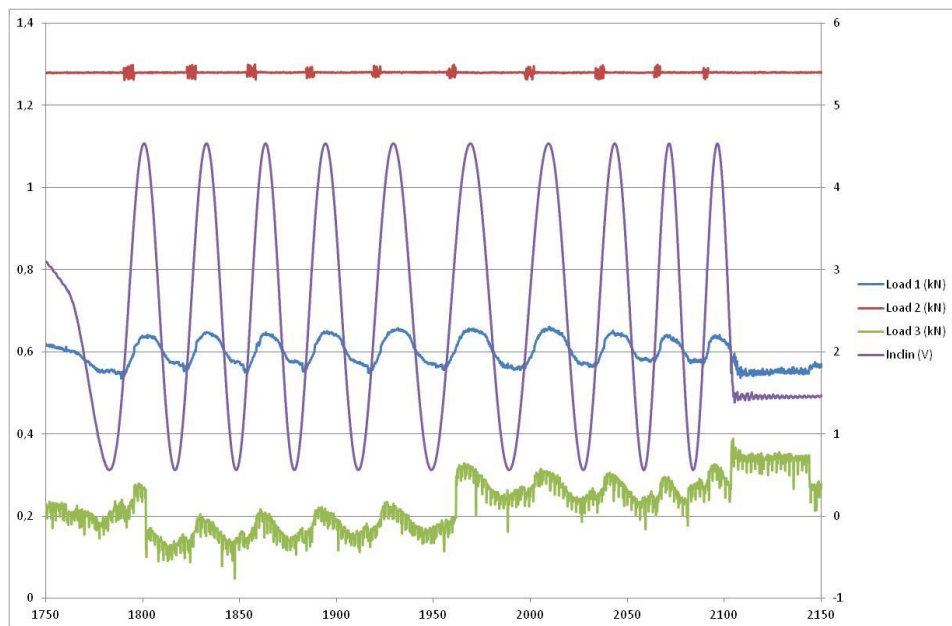
*Fig. 45 - Detail from test 4 showing the blade going into operation at 22 deg pitch*

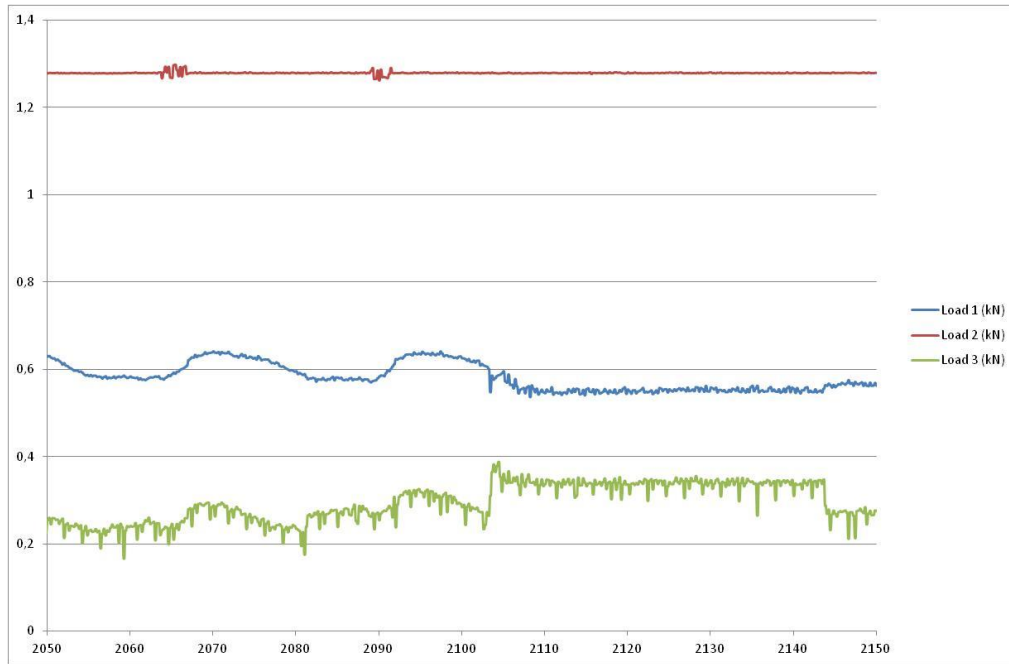
Fig. 46 - Detail from test 4 showing the blade doing an emergency stop whilst rotating at 22 deg pitch

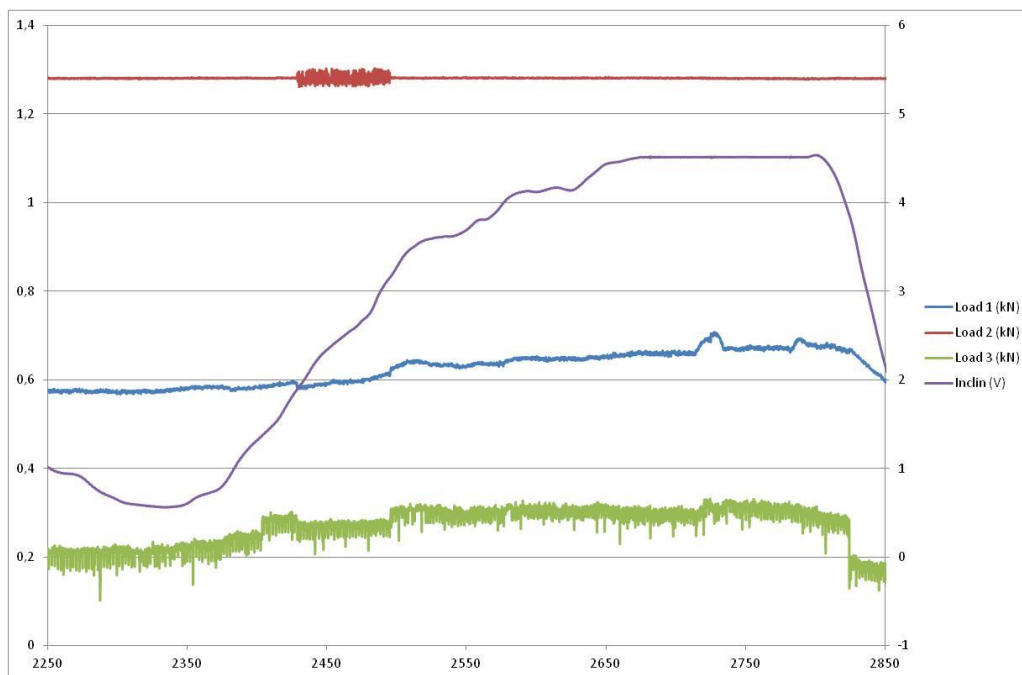
Fig. 47 - Detail from test 4 showing the blade at position 270° and changing blade pitch from 90 deg to 0 deg and then back again

The blade pitch is changed from 90 deg to 0 deg at around 2715s and back from 0 deg to 90 deg again at 2785s. This is apparent on load 1 trace, but difficult to see on load 2 trace. Load 3 shows no effect.

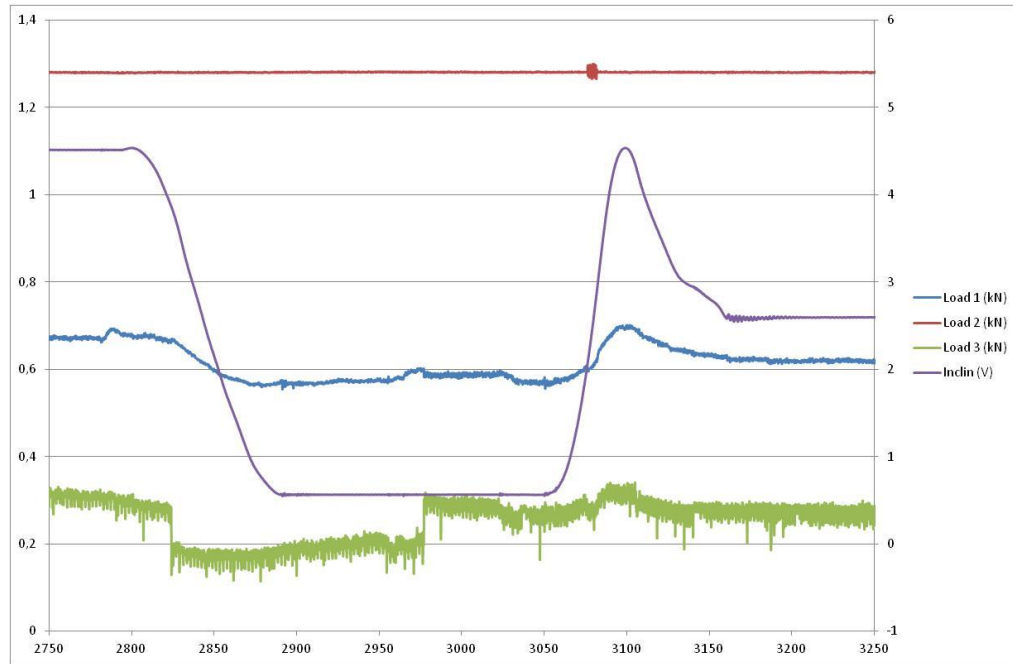
*Fig. 48 - Detail from test 4 showing the blade at position 90° and changing blade pitch from 90 deg to 0 deg and then back again*

The blade pitch is changed from 90 deg to 0 deg at around 2950s and back from 0 deg to 90 deg again at 3020s. This is only slightly apparent on load 1 trace, the load 2 trace shows a major effect at 2975s (just after the pitch changed is completed), but very little effect on the pitch back again. Load 3 shows no effect during pitch changes.

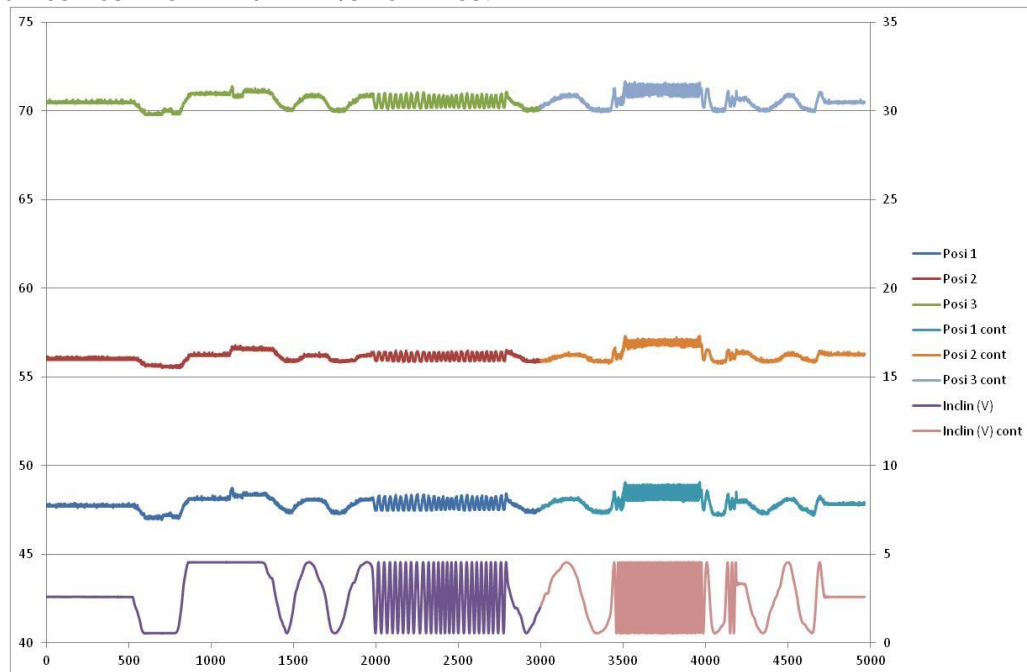
Fig. 49 - Full trace for posiwire measurement (24/oct)

The overview trace for this measurement shows that data acquisition starts with blade A pointing down (position 0°). After about 500s the turbine is rotated so that Blade A is at position 90°, the blade pitch is then cycled 90 deg to 0 deg and back again. After about 800s Blade A is rotated further to position 270°, the blade pitch is then again cycled from 90 deg to 0 deg and back. At about 1300s the turbine begins a slow rotation (with the blade pitch around 85 deg). Around 1950s the pitch is changed to 45 deg and there is a more rapid rotation of the turbine. At 2780s the turbine is changed to “autorun” and begins with an “idle” condition while the slip ring heats up. At 3440s the turbine automatically switches to full run condition (with the blade pitch close to 0 deg). At 4000s the turbine is placed into manual control again and the pitch changed to 90 deg, the turbine slows. At 4130s the pitch is changed to 30 deg and the turbine speeds up again. Finally, at 4180s there is a manual “emergency” stop. The turbine is then allowed to idle until 4720s when the blades are locked with blade A at position 0°. Data acquisition is stopped after about 5000s.

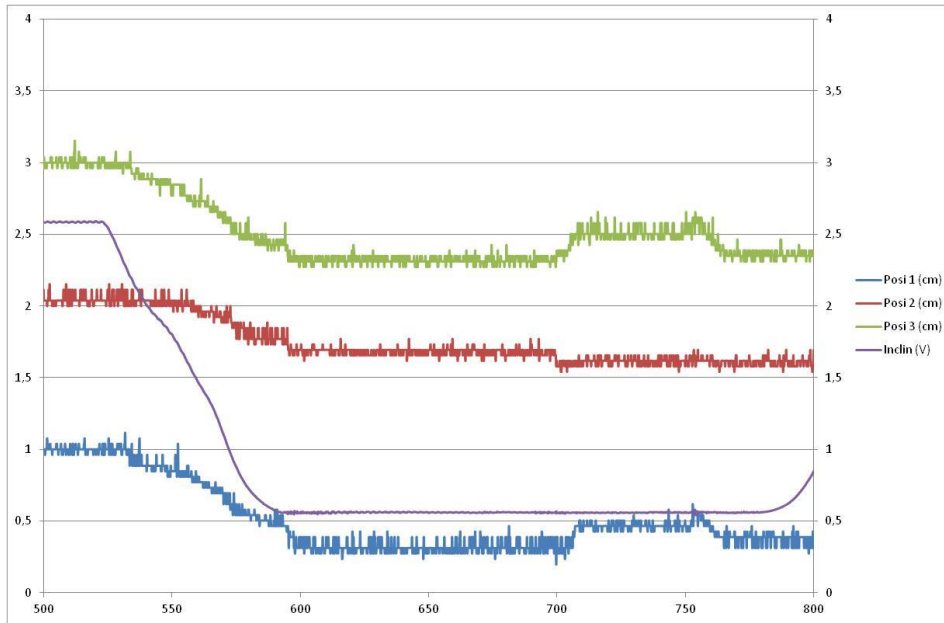
*Fig. 50 - Detail from posiwire showing the blade rotating to the 90° position where the pitch is cycled from 90 deg to 0 deg and then back again*

Note that the output from the displacement sensors has been normalised so that Posi 1 starts the measurement with an output of 1cm, Posi 2 (2cm) and Posi 3 (3cm). At 600s the blade is locked in the 90° position, the blade is then pitched from 90 deg to 0 deg at 700s and then pitched from 0 deg back to 90 deg at 750s. Posiwire 1 and 3 behave in a similar way, flexing slightly outwards when the blade is pitched the first time, and in again when pitched back to 0 deg. However Posiwire 2 contracts at the first pitch change, and shows no response when the blade is pitched back to 0 deg.

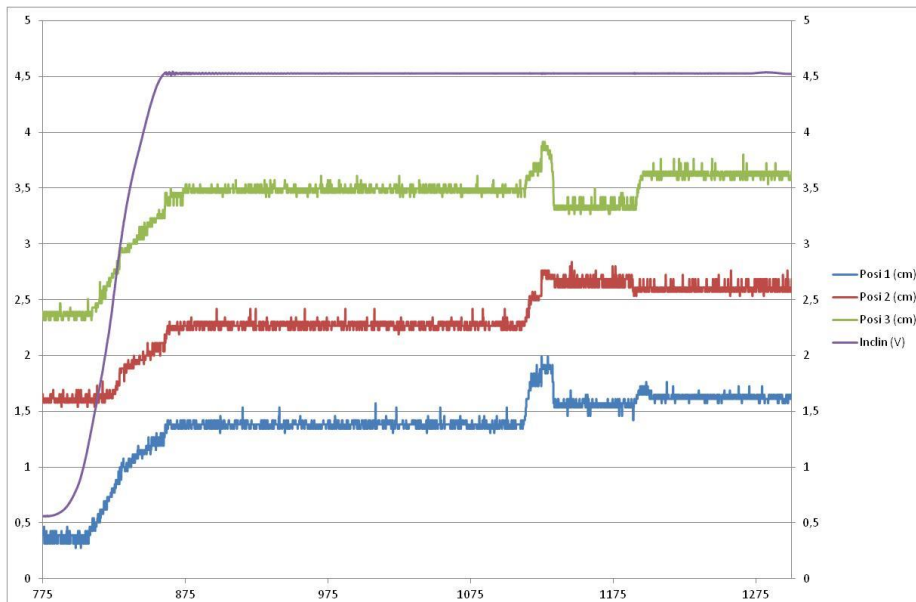
*Fig. 51 - Detail from posiwire showing the blade rotating to the 270° position where the pitch is cycled from 90 deg to 0 deg and then back again*

By 875s the blade has been locked in the position 270°. At 1110s Blade A is pitched from 90 deg to 0 deg, and at 1190s pitched back to 90 deg again. On this occasion the Posiwire output shows that the trailing edge flexes out as the blade is pitched towards 0 deg, but that a sudden contraction occurs when fully pitched to 0 deg. The posiwires show the trailing edge flexes out again when the blade is pitched back to 90 deg.

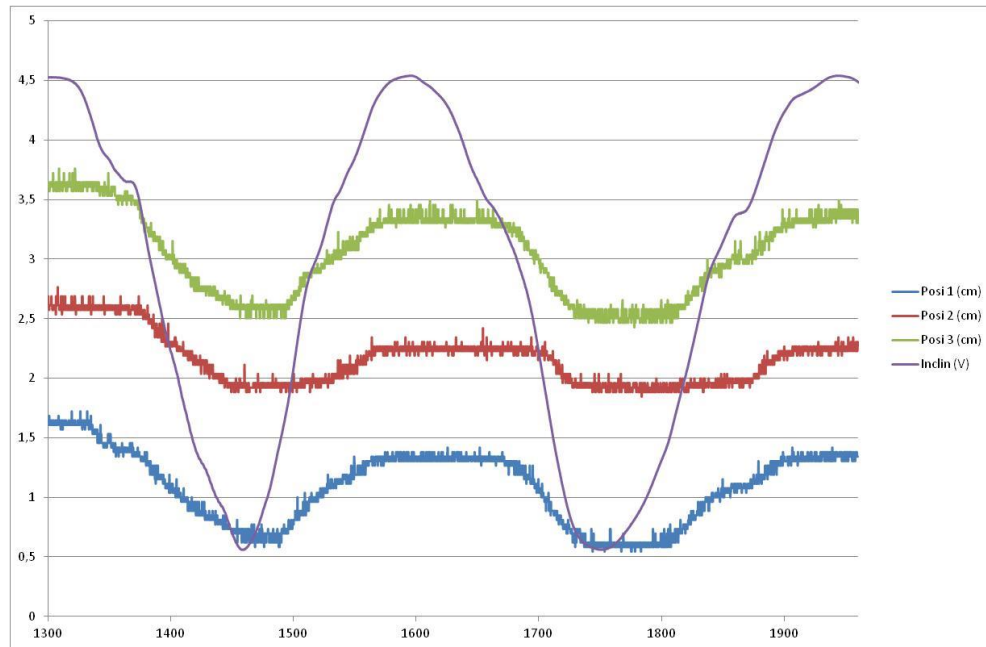
*Fig. 52 - Detail from Posiwire showing the rotation while at blade pitch 85 deg*

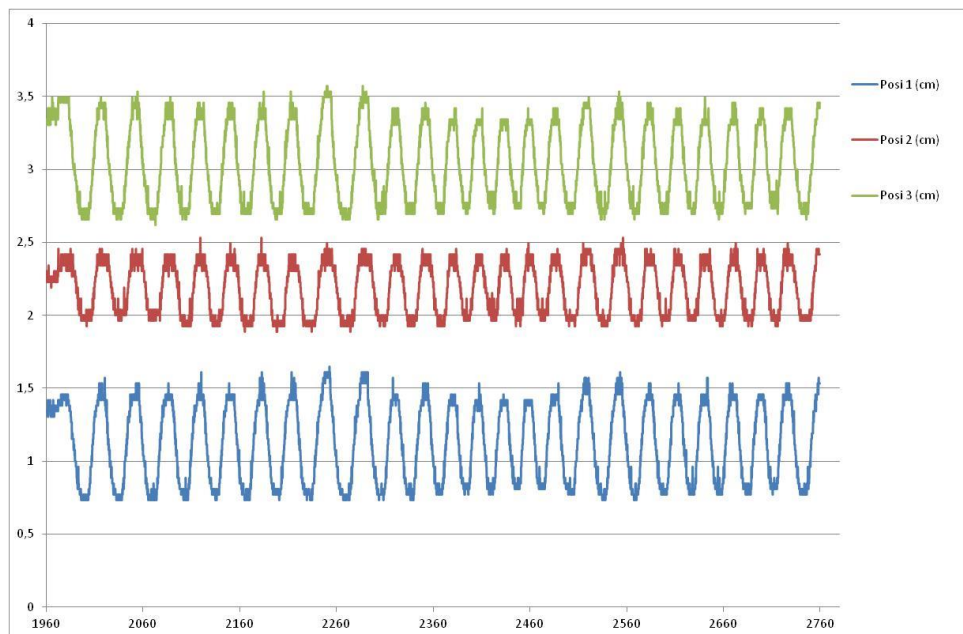
*Fig. 53 - Detail from Posiwire showing the rotation while at blade pitch 45 deg*

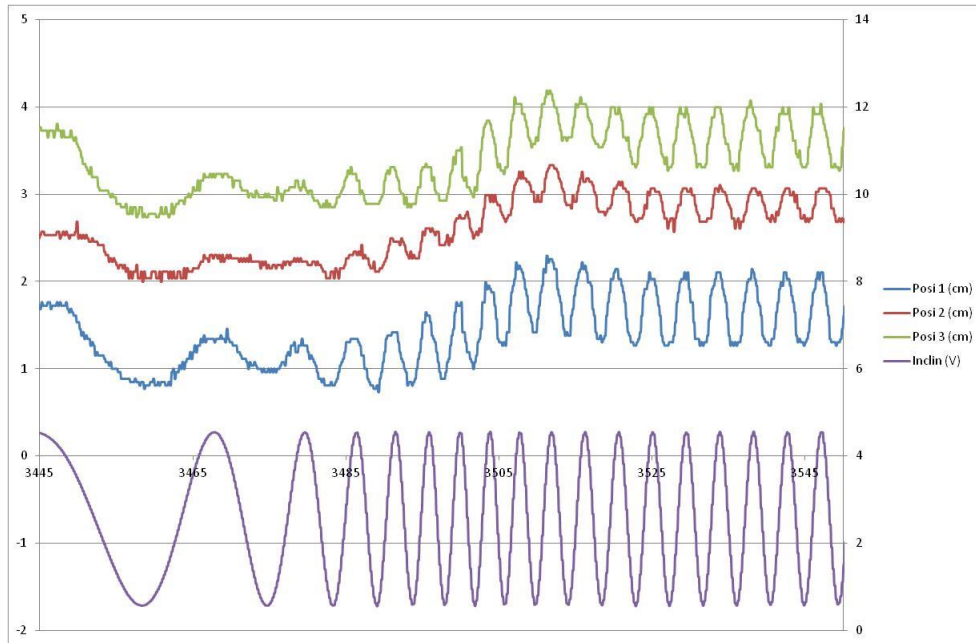
Fig. 54 - Detail from Posiwire showing the rotation while the blade accelerates at blade pitch 0 deg

Note that the posiwire response ramps upwards while the blade is accelerating to full rotation speed at 0 deg pitch.

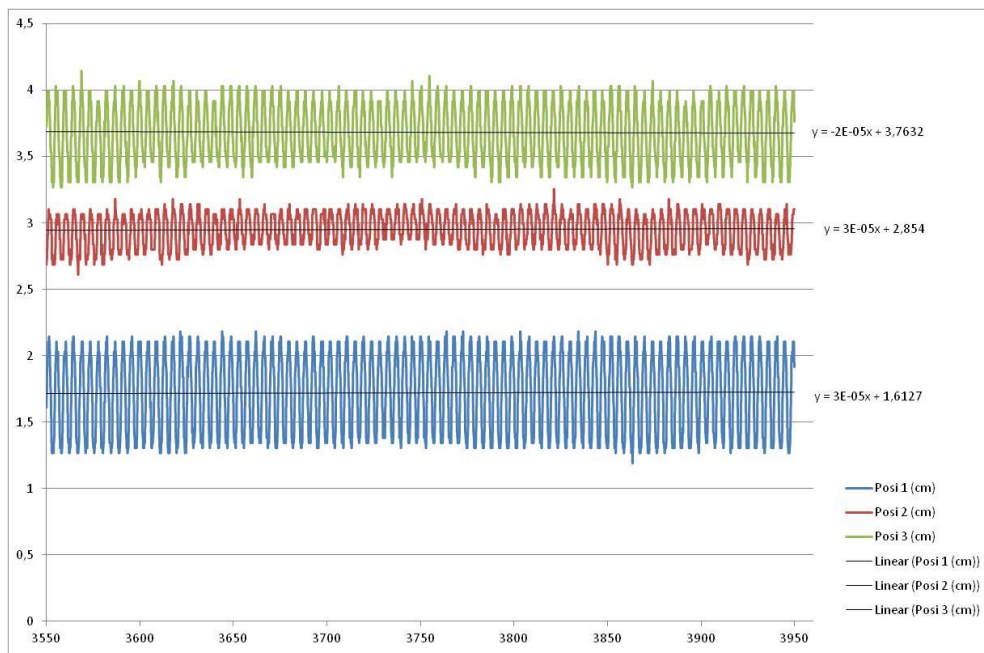
Fig. 55 - Detail from Posiwire showing the rotation while at blade pitch 0 deg

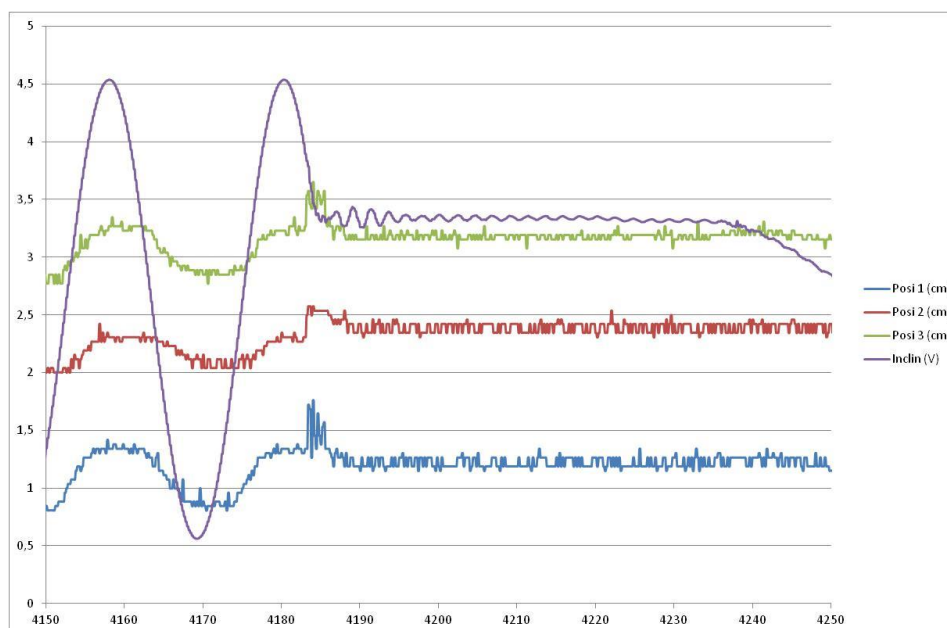
Fig. 56 - Detail from Posiwire showing the “emergency” stop while at blade pitch 30 deg

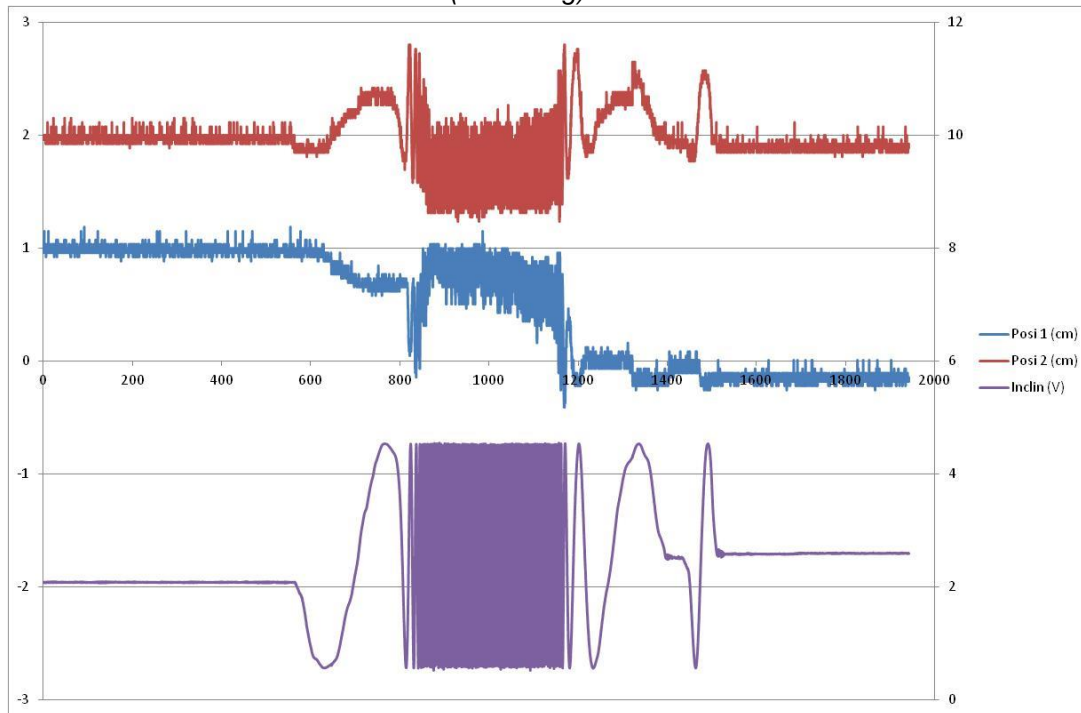
*Fig. 57 - Full trace for posiwire beam test 1 (25/Oct)*

550s after data acquisition begins the turbine is placed in autorun condition and begins a slow rotation in "idle" condition as the slip ring heats up. At 775s the turbine automatically goes into production condition and runs at between 0 and 3 deg pitch angle. After 1150s the turbine is placed in manual control and the pitch changed to 90 deg at which point the turbine slows. At 1500s the turbine is halted and at 1950s the data acquisition is stopped.

Note also that Posiwire 1 does not return to the original displacement condition (normalised to 1 cm) but ends the measurement around -0.14 cm. And to a lesser degree Posiwire 2 ends the measurement series slightly below its' normalised 2 cm start condition at 1.89 cm.

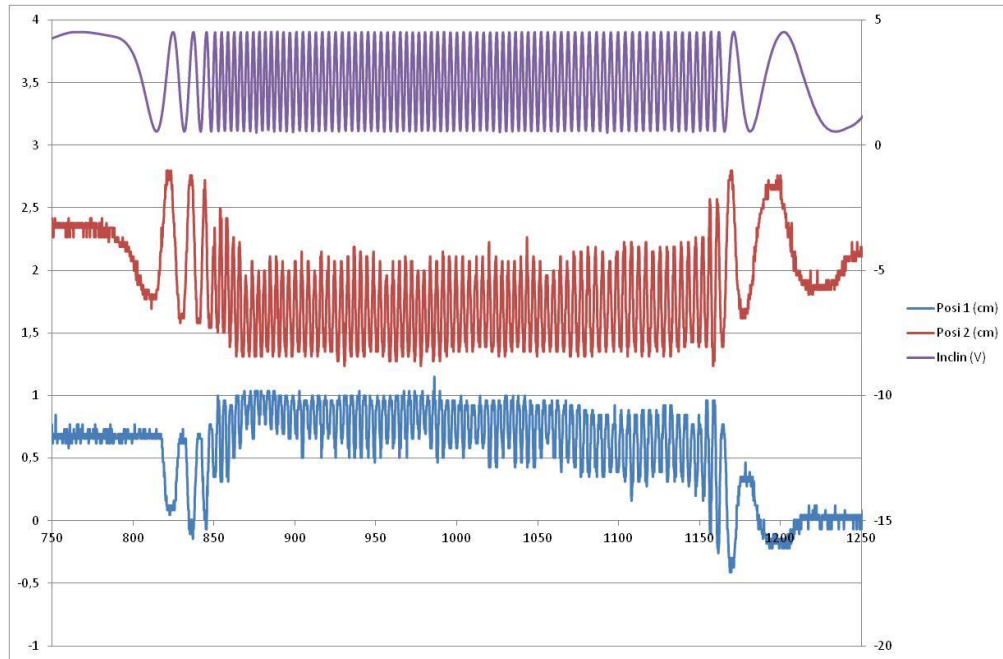
*Fig. 58 - Detail from Posiwire beam test 1 showing the main data acquisition period*

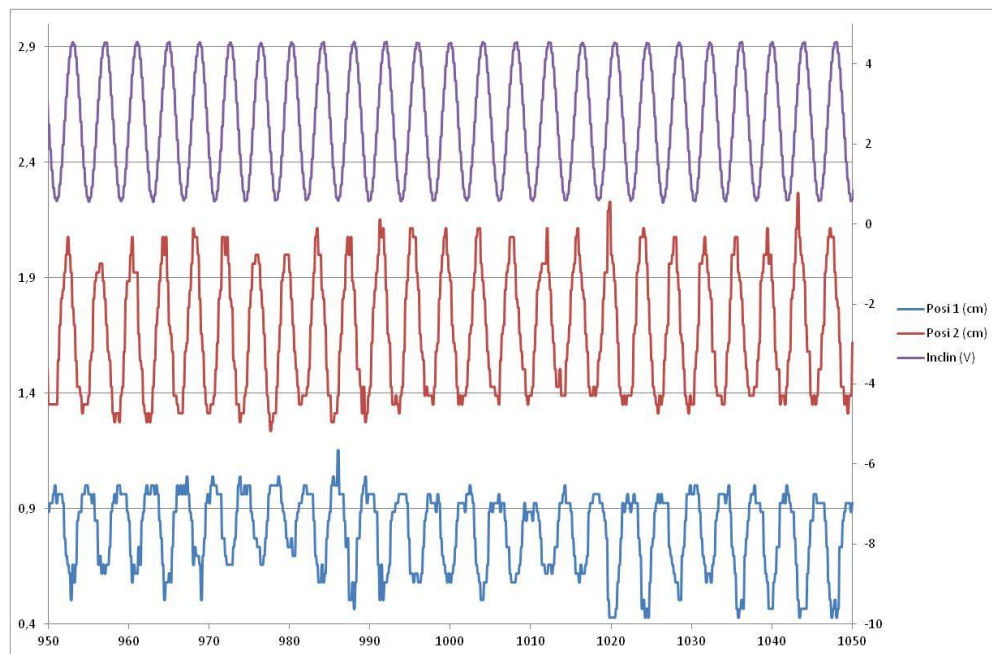
*Fig. 59 - Close up detail from Beam test 1 showing the shear behaviour*

Beam cross shear distortion during autorun condition average 9mm
