# Bondlines – Online blade measurements (October 2012 and January 2013)

## Department of Wind Energy E Report 2013

DTU Wind Energy E-0036

Some local deformations in an operating Wind Turbine blade (V80) have been measured during October 2012. Displacement and load values generated between the trailing edge panels at blade radius R9.2m, R10.2m, and R11.2m were obtained. A fluctuating loading of between 100 - 200N existed when the two panels were connected, and with a displacement of between 6.5 - 10mm when the panels were free to flex as they do in normal operating conditions. Shear distortion within the main loading spar of the blade (at approximately R10m) showed a fluctuating cross beam shear distortion of about 9mm.

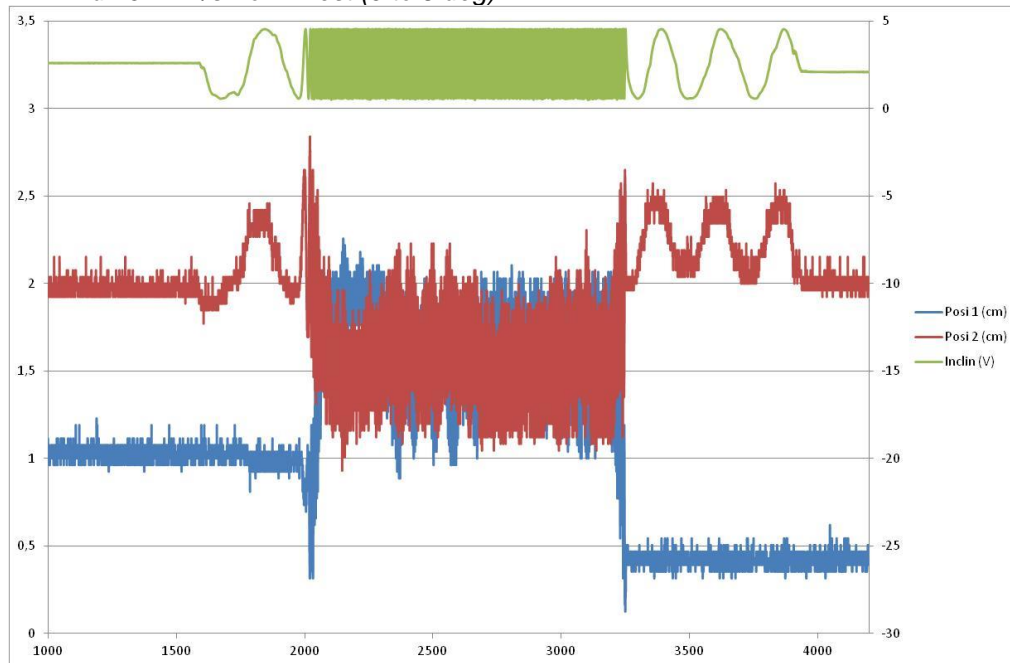
*Fig. 60 - Main trace for the Posiwire Beam Test 2 showing the full acquisition period*

Around 1575s after data acquisition begins the turbine is placed in autorun condition and begins a slow rotation in “idle” condition as the slip ring heats up. At 2000s seconds the turbine automatically goes into production and accelerates to run at between 0 and 5 deg pitch angle. At 3250s the turbine is placed under manual control again and the pitch changed to 90 deg causing the turbine to slow. At 3950s the turbine is halted. Between 4300 and 5700s the system was dismantled from the box beam while the data acquisition system is still running, the data from this period has been excised from the output graph show here.

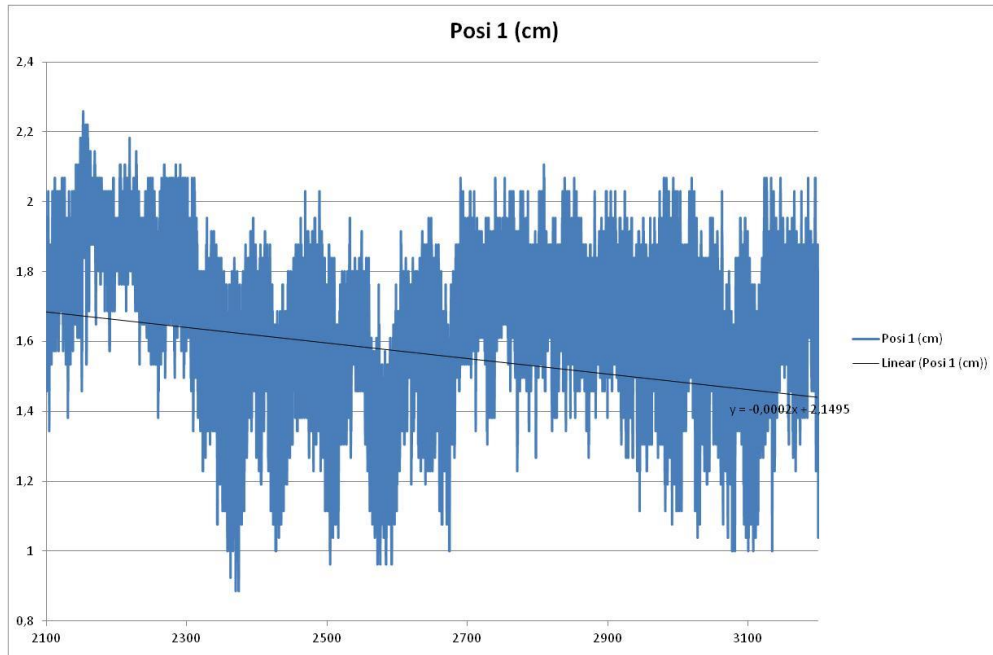
Note that Posiwire 1 shows no displacement during the slow rotation “idle” periods at the start and end of the main run, whereas Posiwire 2 responds with a 0.5cm displacement during each rotation. Posiwire 1 does respond to the full speed rotation period.

*Fig. 61 - Detail from Posiwre Beam Test 2 showing the response of Posiwire 1 only*

These graphs show that whereas the response from Posiwire 2 is stable over the duration of the main rotation period, the output from posiwire 1 is ramping downwards.

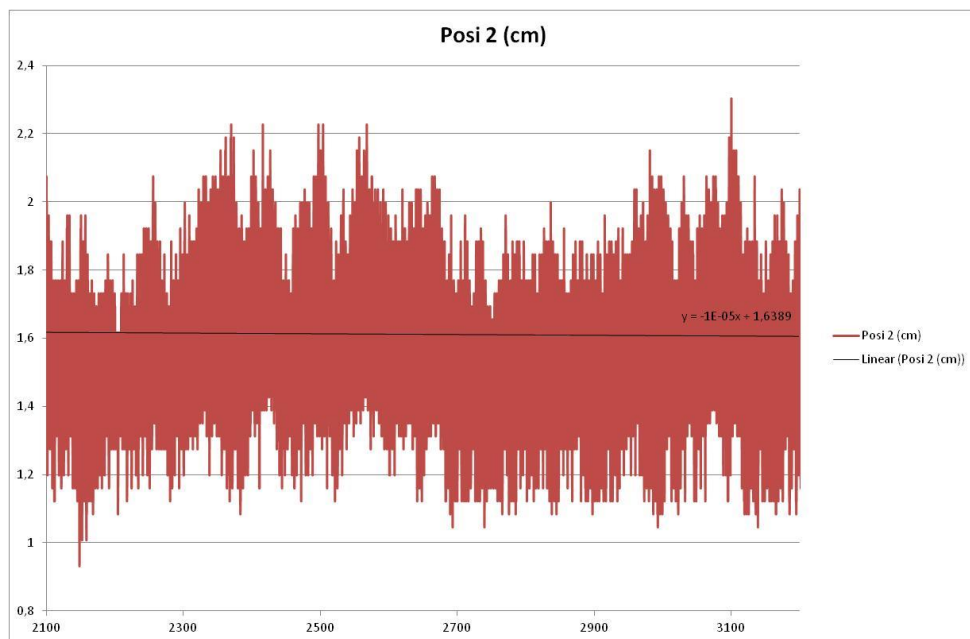
*Fig. 62 - Detail from Posiwre Beam Test 2 showing the response of Posiwire 2 only*

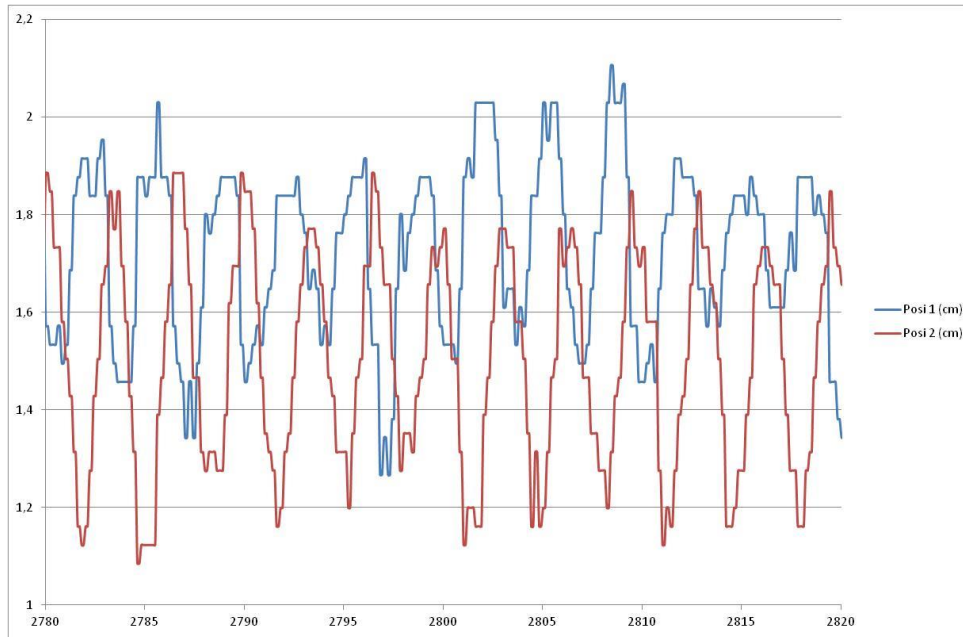
Fig. 63 - Close up detail of the Posiwire output from Beam Test 2

In this trace it is possible to see the shear response of the beam during normal loading by comparing the period of the displacement measurements on Posiwire 1 and 2.

Beam cross shear distortion during autorun condition average 9mm

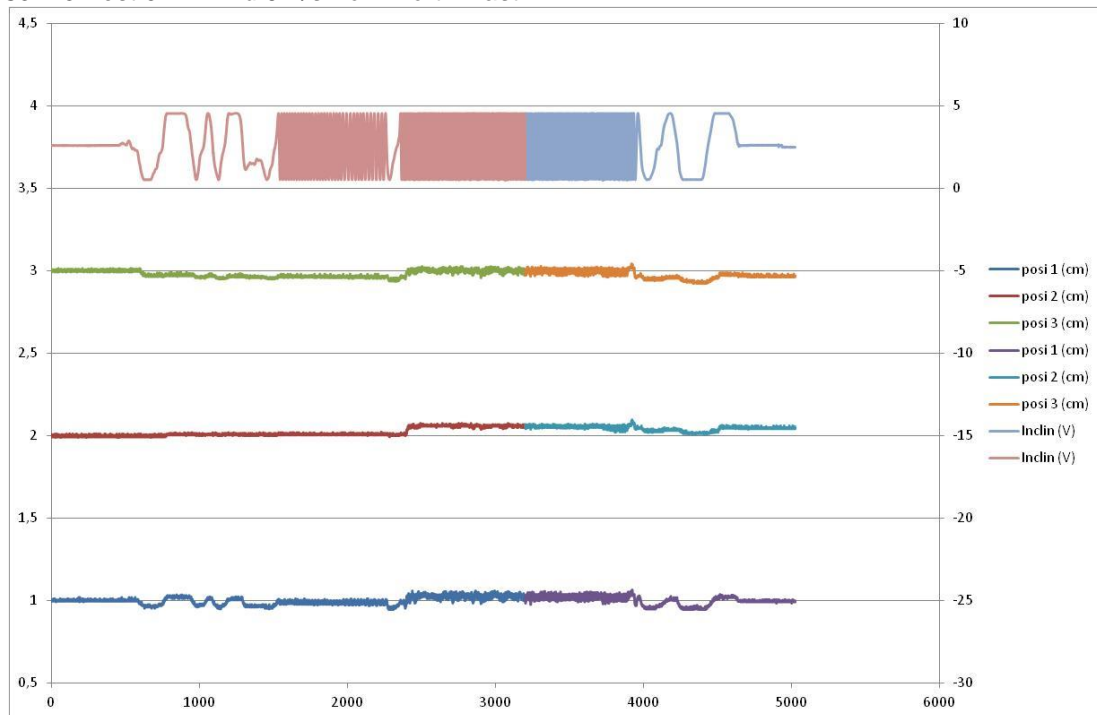
*Fig. 64 - Main trace for the 130110 Test 1 showing the full acquisition period*

At around 500s the blade is rotated from the 0° to 90°, and then on to 270°. After a brief start up period the turbine is rotated at a pitch angle of 50 deg between 1500 and 2300s. The blade is then placed in full run condition with a pitch value between -1 and 2 deg until approximately 4000s. At the switch to autorun condition there is an approximately 1mm step up observed in all the posiwire outputs. After the autorun condition is over the blade is again cycled to hold periods at 90°, 270°, and then 0°. Pitch changes at the horizontal blade holds caused no effect on the poiswire outputs.

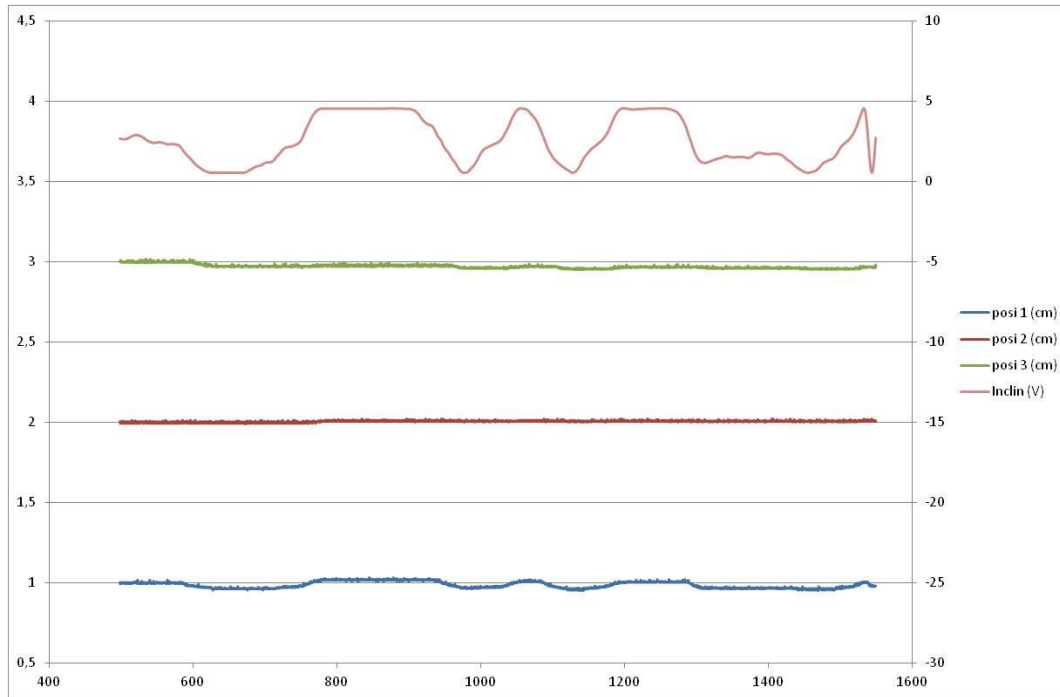
*Fig. 65 – Detail from 130110 Test 1 showing the start up*

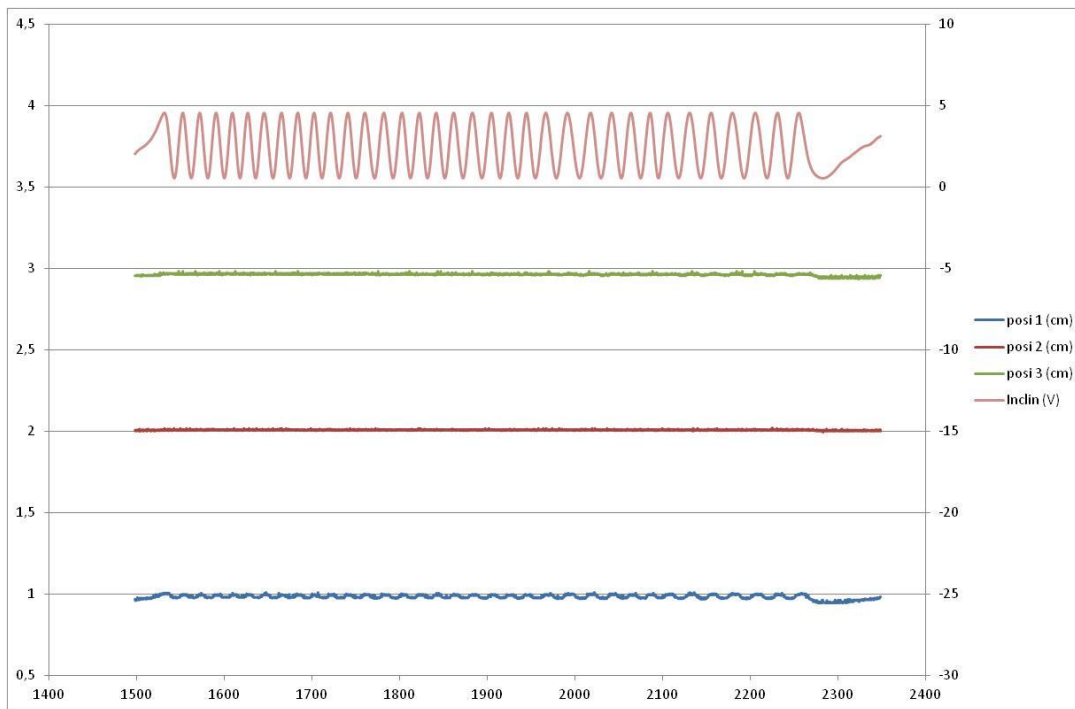
*Fig. 66 – Detail from 130110 Test 1 showing turbine running at 50 deg pitch angle*

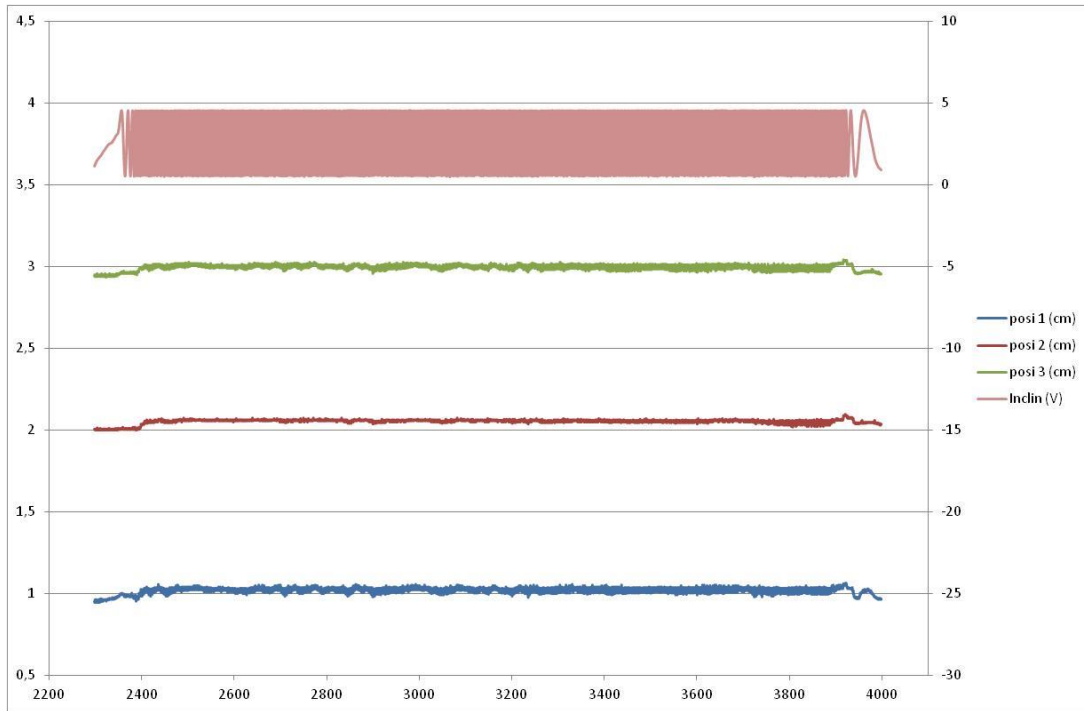
Fig. 67 – Detail from 130110 Test 1 showing turbine during autorun at -1 to 2 deg pitch angle

During autorun condition the posiwire response is very limited (under 1 mm total deflection) although in detail it is possible to see the cyclic response due to the blade rotation.

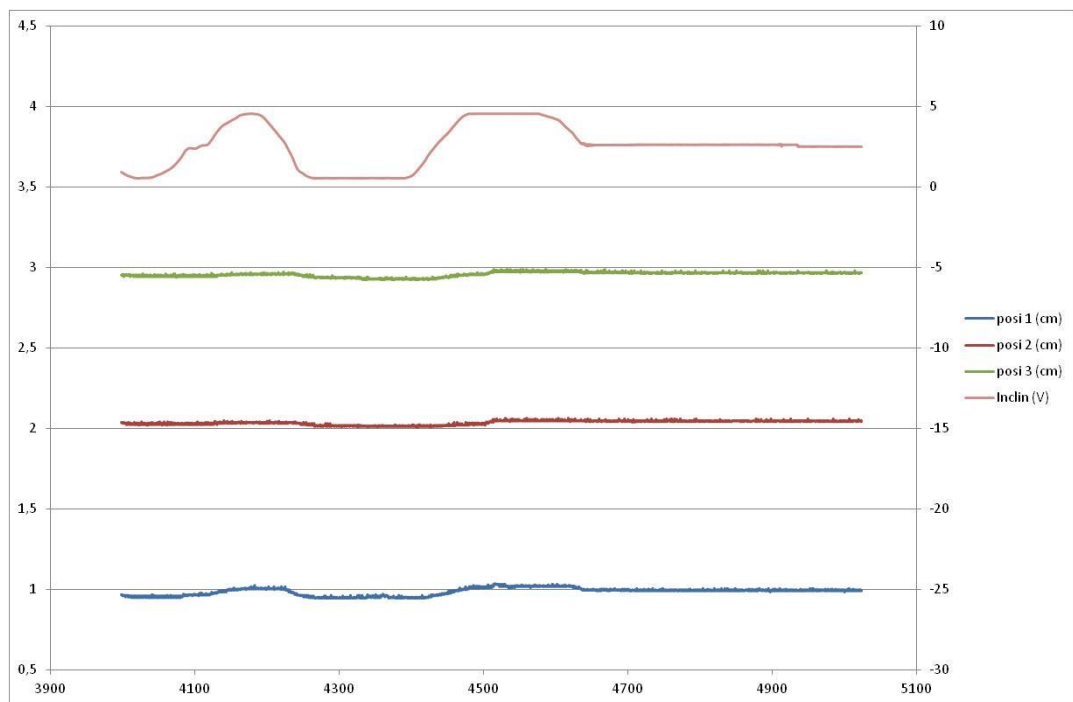
Fig. 68 – Detail from 130110 Test 1 showing effect of pitch change (0-90-0 deg) during horizontal blade hold

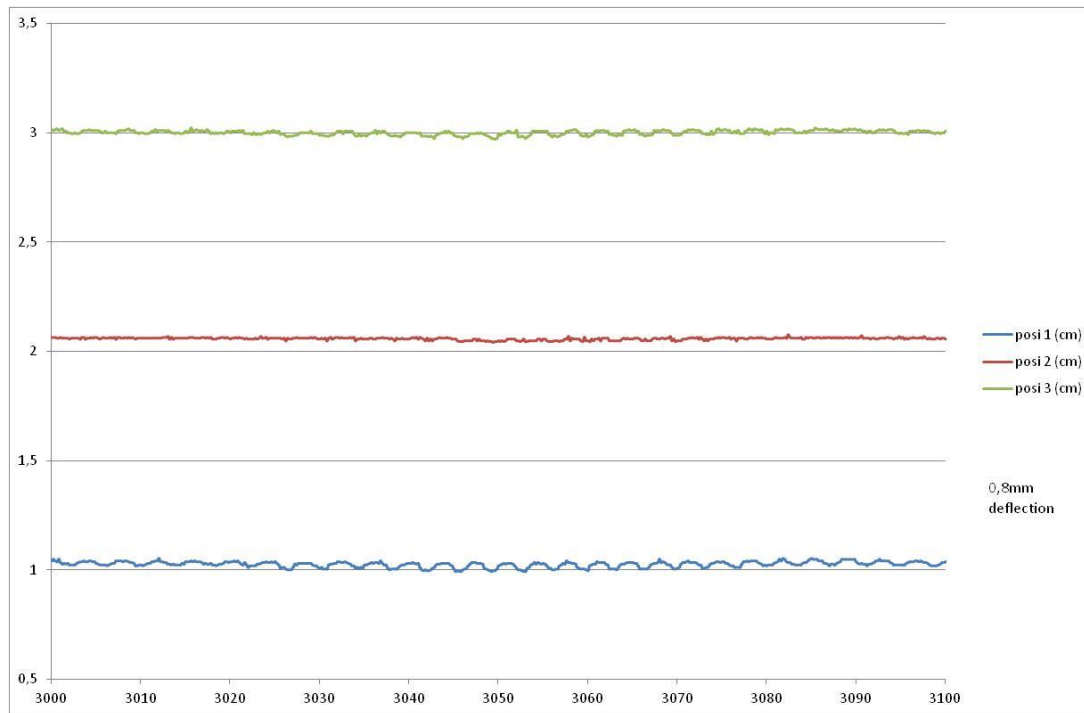
Fig. 69 – Close up detail from 130110 Test 1 showing posiwire response during autorun (-1 to 2 deg)

A reduction in total deformation of 6.5 to 10mm between the two trailing edge panels to below 1mm in the reinforced blade was measured by these trials. The load value fluctuations measured between the trailing edge panels varied between 100 and 200N during autorun condition. And a cross shear beam distortion averaging 9mm was measured by the position wires at blade R 10m.

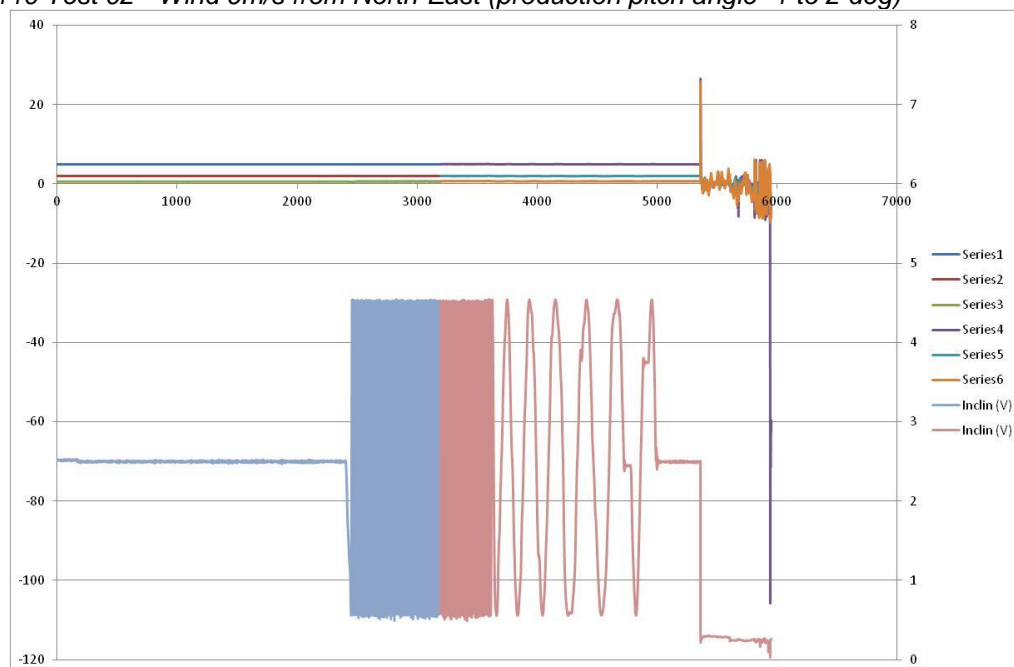
Fig. 70 – Main trace for the 130110 Test 2 showing the full acquisition period

There is a long pause before the turbine begins at autorun condition about 2400s into the acquisition period. When the autorun stops at about 3600s the turbine idles for some time before rotation is halted at 0° and the instrumentation system removed.

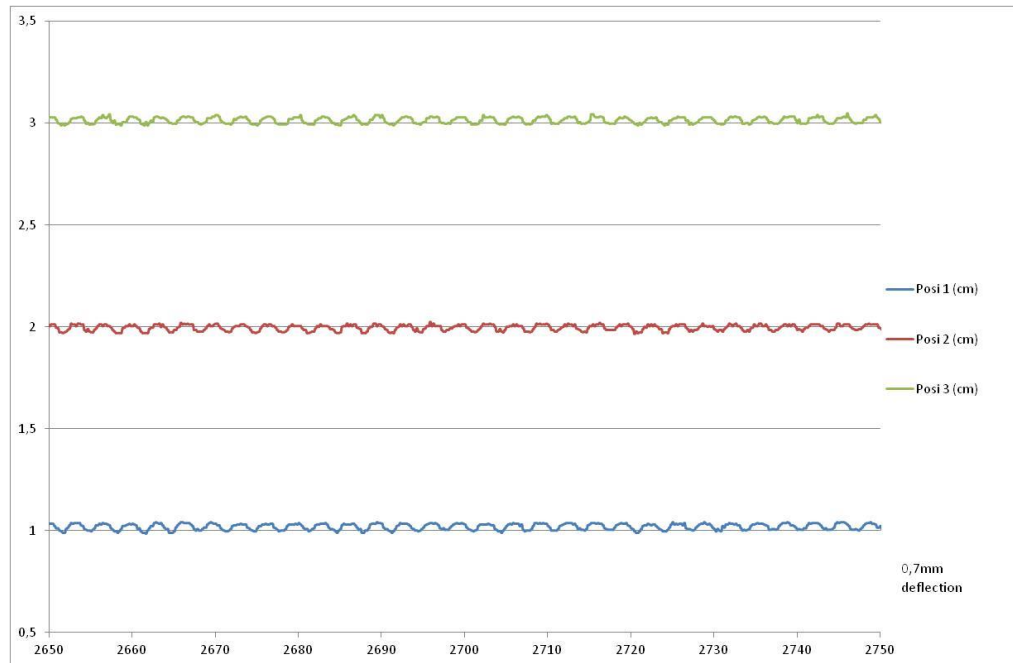
*Fig. 71 – Close up detail of the posiwire response during autorun condition*
