Corrosion in electronics: Overview of failures and countermeasures

Published in:
Proceedings of EuroCorr 2014

Summary

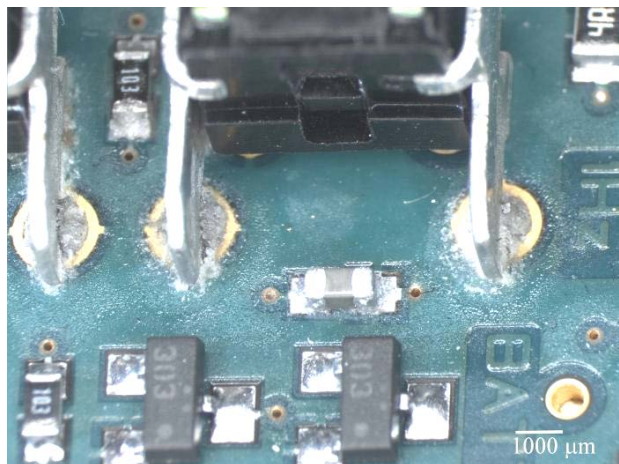
One example of an electronic device failure due to solder flux residue is shown in figure 1. Tactile switches are mounted on the PCBA by hand soldering process due to the presence of a large copper layer inside the PCB laminate under the switches. Due to the high heat capacity of copper, heat will be taken away during the automated soldering process resulting in a weak solder joint. Therefore, as an alternative, hand soldering is performed using a standard lead containing solder assisted by excessive use of “No-clean” hand soldering flux. The purpose of the flux is to act as a wetting agent and surface activator during the soldering process. Although the idea of using “no-clean” flux is to leave minimal residue after soldering, in practice large amounts of residues are left on the PCB surface, depending on the skills of the technical personnel performing the soldering work. ¹

Figure 1 A micro tactile switch mounted on a PCBA with excessive amounts of remains of no-clean flux. Flux residues are visible on laminate as well as on surrounding components.

The “No-clean” hand solder flux systems often contain carboxylic acid- or/and halogenide (activator) in order to facilitate the chemical reactions that remove oxides on the metal surface. Resin is added to prevent re-oxidation of the cleaned metal. The effect of temperature on the degradation of flux residue showed that a temperature above 250 °C is needed for complete decomposition of carboxylic acid components in a no-clean wave solder flux.² When hand soldering is used, a temperature of 350 °C for a few seconds is advised, but this temperature is very local and the regions close by will only experience much lower temperatures. This causes a risk of large amounts of unreacted flux remaining on the PCBA, which will influence the long term reliability of the electronic component/product during application.

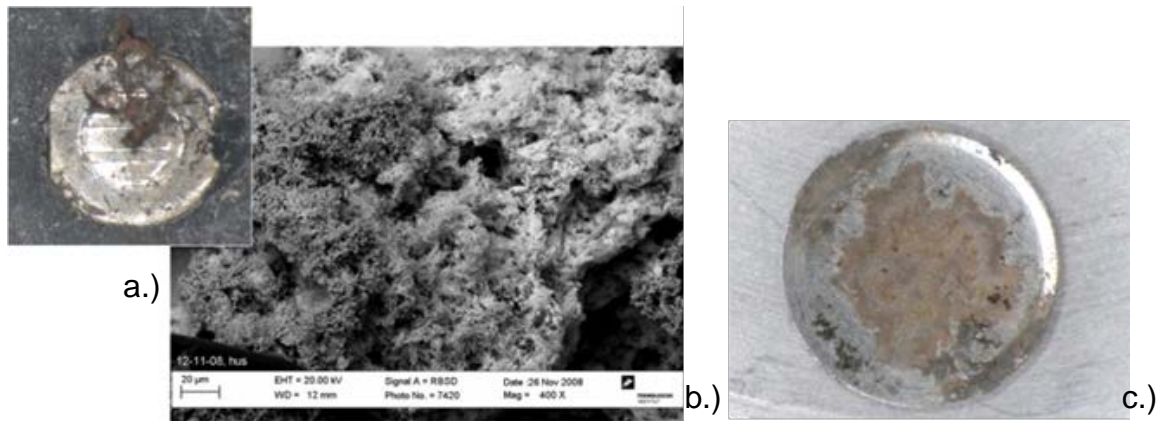
Figure 2 Pictures of a.) failed switch center terminal, b.) SEM micrograph of corrosion products and c.) backside dome showing corrosion of the silver layer.

Failed PCBA's were sent for analysis after use in atmospheric conditions with high humidity and temperature cycles (day and night shifts). The tactile switches gave 2 types of failure; one failure mode was seen as the failed PCBA's were returned at an early service life stage where it was observed that the resetting action of the switch failed due to high ohmic resistance as a result of substantial amount of resin part of flux residue inside the switch acting as a dielectric barrier. The other failure mode is due to severe corrosion resulting in resetting due to short circuiting inside the switch. The corrosion of tin and silver inside the switch was accelerated by the intrusion of active flux activator into the switch house, caused by the low surface tension of the flux.

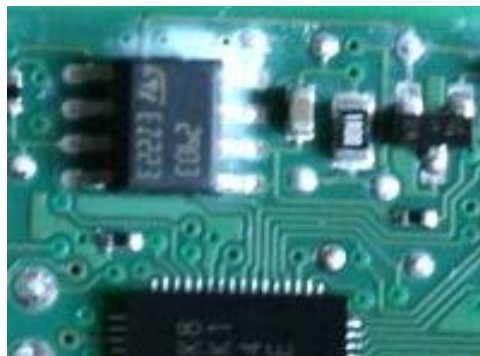
An example of a field failure return showing white residues is given in figure 3. The white coloration can be due to various reactions of the flux residue rosin e.g. oxidation or hydration.

Figure 3 Field failure returned PCBA showing white residues near integrated circuit chip component.

As such the white residues are not necessarily harmful for the electronic circuit, but if active acid residues are present it can cause unwanted leakage currents and corrosion. A Fourier transformation infrared spectroscopy (FTIR) analysis of a reference PCB laminate compared with the white residues shows correlation to succinic acid indicating that for this field failure there are active acid left in the residues. It is likely that humidity have reacted with the resin part of the reflow flux residue causing a release of the activator part.

Leakage current and corrosion is more likely to occur if active acid is present in an area on the PCBA that is populated with components having closely distanced biased lines e.g. integrated circuits as is the case shown in figure 3.

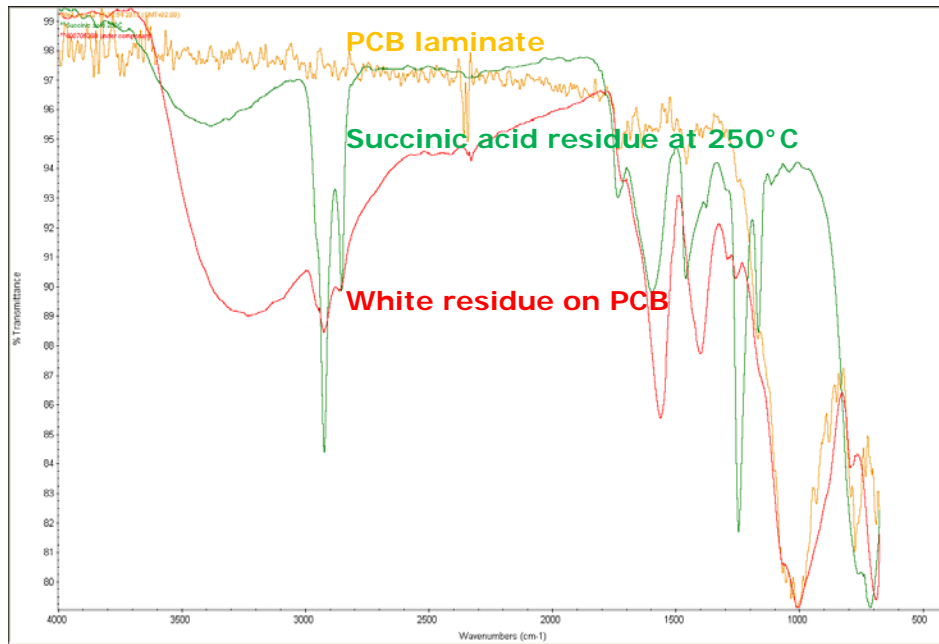
Figure 4 Fourier transformation infrared spectroscopy analysis of white residues shown in figure 3. The peaks seen for spectrum made in white residues area differ from spectrum made in a reference area on the same PCBA and these peaks corresponds to peaks found for succinic acid.

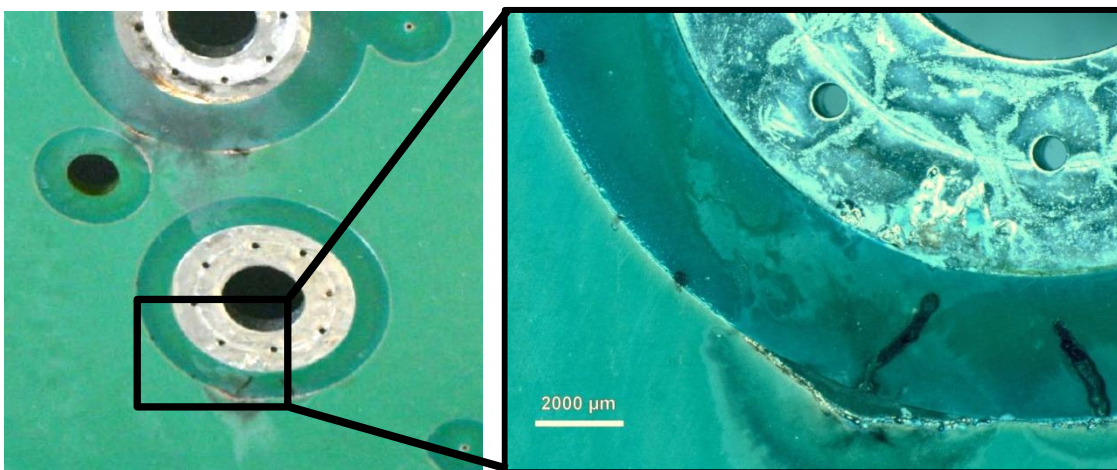
During change to lead free soldering a product was humidity tested in same manner as when the PCBA was lead containing soldered. Despite the soldermask not being intended to be used as an electrical insulator and water barrier for the PCBA it fulfilled this for the lead soldered PCBA. With the higher soldering temperature when going to lead free, more pinholes at the edges were seen in the soldermask (figure 5).

Figure 5 Condensation test of wave solder lead free high power PCBA showing electrical short circuiting due to solder mask pin holes. The black spots seen are due to corrosion of Cu under the pin holes in the solder mask.

High humidity and varying temperatures caused condensation and flash over between 400V biased points on the PCBA, one of them being the bare copper under a pinhole in solder mask.

Residues rat gel testing (figure 6) indicated flux and droplet formation on the PCBA surface so overall the combined effects of high bias, high humidity and pin holes in solder mask caused leakage current and finally short circuiting. One possible countermeasure could be to make a double solder mask in order to minimizing risk of pin holes, yet solder mask itself cannot be expected as a reliable water barrier layer, thus also measures for encapsulation in order to minimize the risk of condensation is needed.

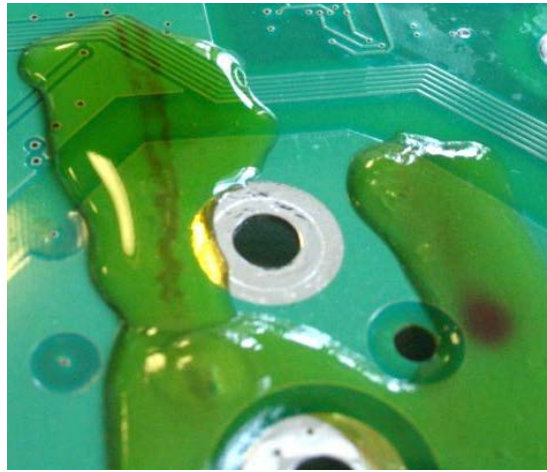
Figure 6 Residues Rat testing of high power PCBA indicating droplet formation during condensation test and red coloration due to active acid residues left on the PCBA surface.

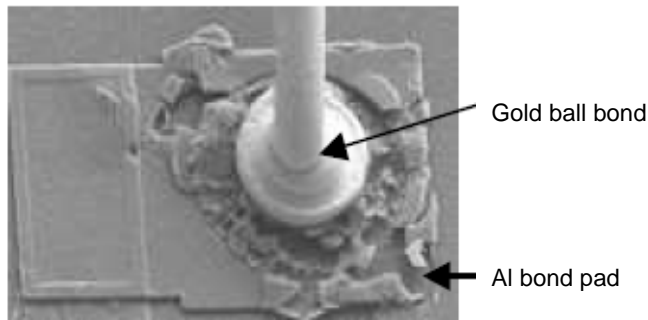
Another example of dissimilar metal contact is Al bond pad corrosion (figure 7), which occurs due to the high electrochemical potential difference between Al and Au.

Figure 7 Corrosion of Al bond pad in contact with Au ball bond

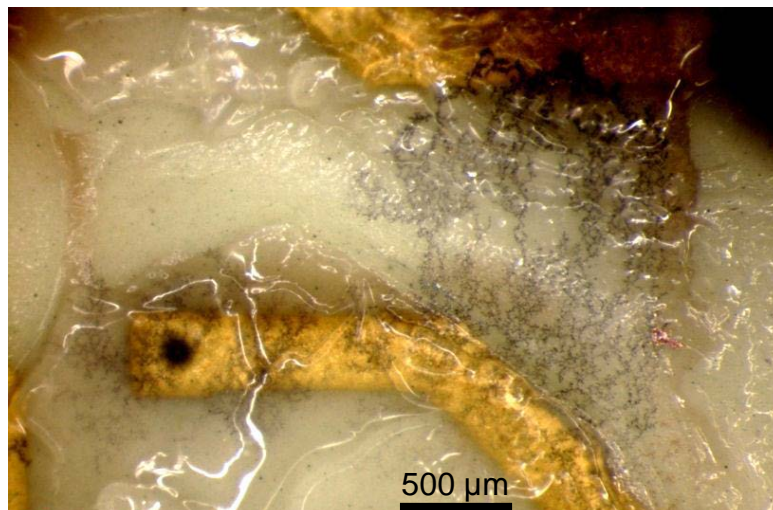
Figure 9 Field failure return showing silver dendrites formed between conducting lines under conformal coating.

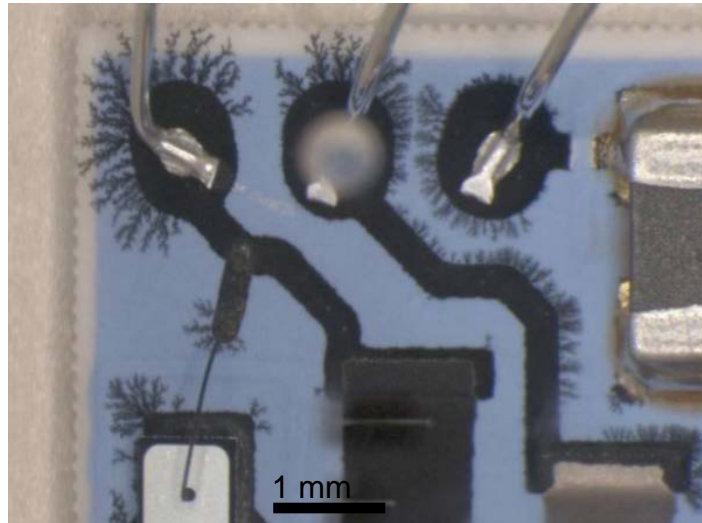
In a field failure return from a pig farm sulfide corrosion of silver surfaces was observed on a hybrid due to permeation of corrosive sulphur gasses through the silicone coating (figure 10).

Figure 10 Severe sulphide corrosion of silver lines in a power module after use in pig farm environment containing sulphur gases. The power module was covered with silicone coating through which sulphur gas permeated.⁷

Three types of corrosion features were observed namely: uniform distribution of silver sulfide, dendritic growth, and creep corrosion of silver on gold wires.⁸

Countermeasures against sulphur corrosion involves the control of several atmospheric factors (wherever possible), including lowering of air humidity and temperature and the level of contaminants in order to avoid silver corrosion and improve the reliability of electronic products.

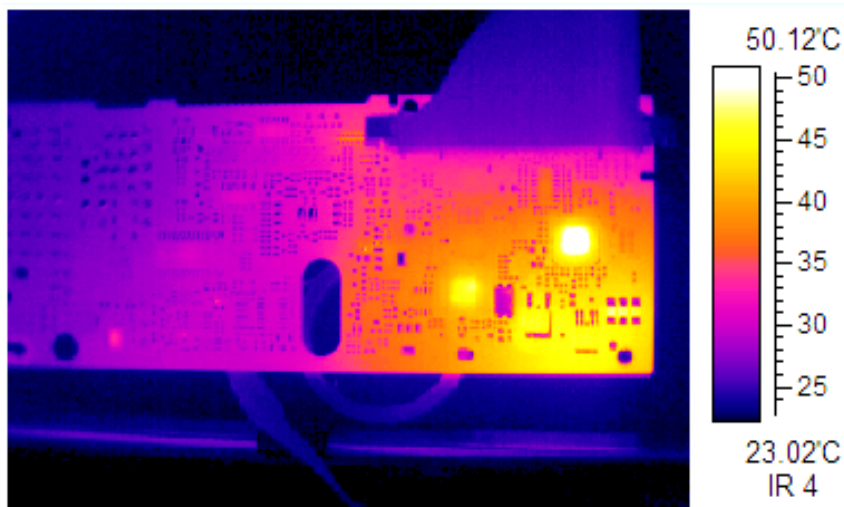
Temperature variation on a PCBA plays a major role in its reliability, especially when exposed to outside application environments. An Infrared (IR) image of a circuit board under biased condition is shown in figure 11. The temperature of the board varies from 25°C to 50°C. There are certain electronic components with high resistance, which dissipate heat more than other components like transistors or capacitors.

Figure 11 Thermal image of a PCBA under biased condition showing variation in temperature as 50°C maximum to 25°C minimum.

From a corrosion point of view, the local temperature variation can change the way humidity interact with the PCBA surface. There is a significant possibility for more interaction of humidity (water layer formation, slow drying etc.) in the colder part of the boards depending on the outside temperature and level of humidity when a PCBA is exposed to the humid environment. Thus, maintaining uniform heat distribution throughout the board or placing the corrosion sensitive components near the hot zone of the board protects the circuit from condensation effects.

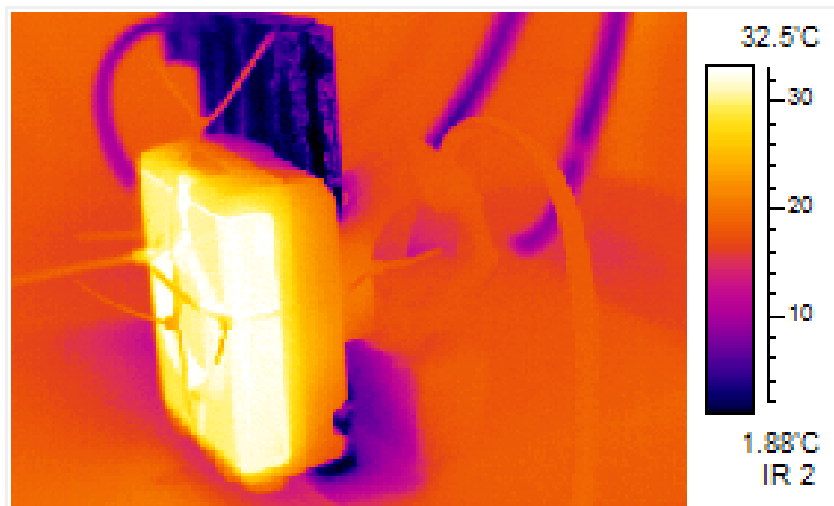
Figure 12 Thermal image of a biased electronic product exposed to condensation test in humid environment. The electronic encapsulation is placed on a water cooled metal block in order to promote condensation.

Another type of electronic product was investigated in a condensation test using thermal infrared camera (figure 12). For this product the self-heating when biased is distributed homogeneously and it was not possible to create condensation on the PCBA surface inside the encapsulation as long as the product is biased.
