Energy retrofitting of a typical old Danish multi-family building to a “nearly-zero” energy building based on experiences from a test apartment

Published in:
Energy and Buildings

Publication date:
2012

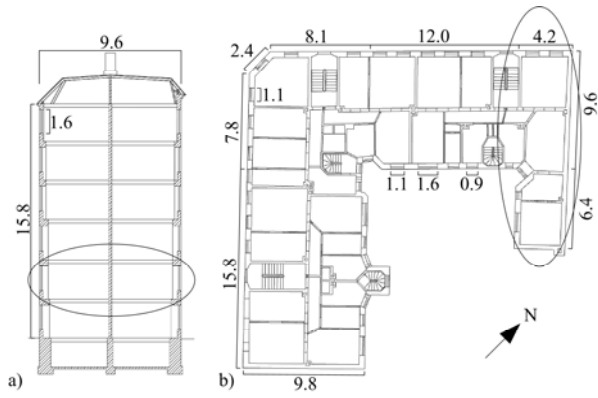
Fig. 1. a) Section and b) plan of the building. The test apartment is marked with a circle. Measurements in meters

The case building is located in Copenhagen, Denmark and is a multi-family building built in 1896 having six stories and a full height basement below ground level. The total gross heated floor area is 2717 m² which is divided amongst 30 apartments in three stairways (Fig. 1). The building faces an urban renewal that includes renovation of the windows, installation of outside insulation of the northeast facing end wall, and installation of mechanical ventilation in the apartments.

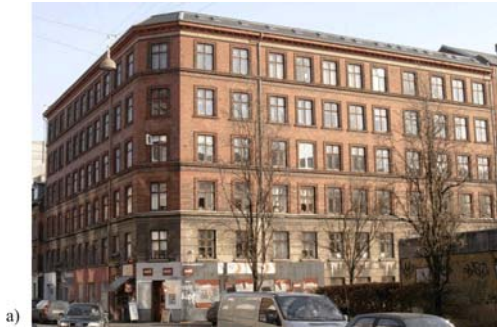
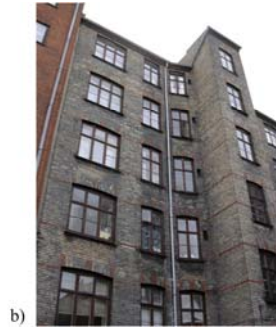
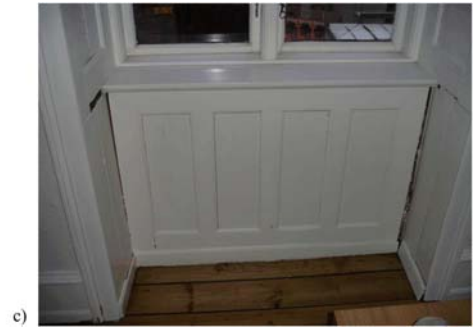
Fig. 2. a) Street facade, b) courtyard facade and c) spandrel seen from the apartment

The facades are built of solid brick masonry having a thickness from 360-720 mm; these have been considered by the municipality as being worthy of preservation. The spandrel was 240 mm thick and covered with wooden sheathing (Fig. 2). The northeast end wall was unattached to neighbour buildings and 360 mm thick.

The windows located on the street facade were predominantly single glazed 4-light windows having a secondary glazing. The windows facing the courtyard were single glazed windows that varied between 4-and 6-lights windows. The un-insulated roof was a typical roof as built in Copenhagen (Fig. 1a). The floor divisions were constructed with wooden beams and clay pugging and the floor divisions towards the unheated attic and basement were un-insulated. Table 1 provides the calculated U- and Ψ -values for the building envelope before and after retrofitting. The negative Ψ -values arise from the definition of the building envelope areas. In some instances the U-values include the linear thermal transmittance for the assembly; however, if the U-values include too large a heat loss through the assembly, this was then corrected by the negative Ψ -value.

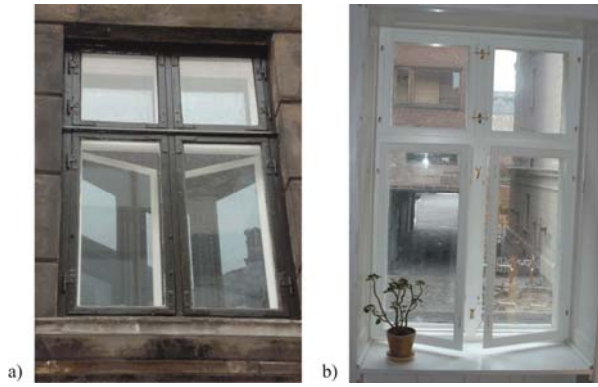
Fig. 4. Energy retrofitted 4-lite of type Window 2 with a secondary frame seen a) exterior of building and b) interior

Window 2 as shown in Fig. 4 was a retrofitting of the existing window in which a traditional secondary frame with a Low-E coated glazing was applied. The design for Window 2 was similar to that of Window 1 but did not include a third pane as shown in Fig. 5a.

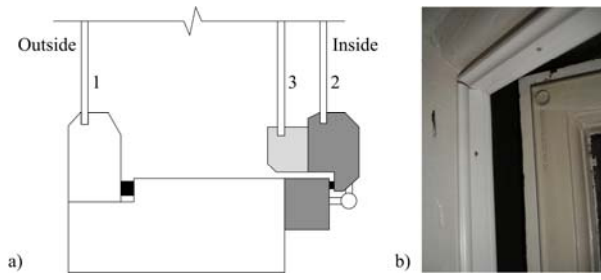
Fig. 5. a) Horizontal principal section of the frame and casement of Window 1. b) Window 3 with installed sash

Window 1 was a retrofitting measure of the existing single glazed window in which a secondary frame was applied as shown in Fig. 4b but having double glazing. In Fig. 5a a horizontal section of the frame and casement illustrates the

assembly for Window 1 and in which the original window frame is marked with white whereas the secondary frame is the dark grey area, which was installed onto the original frame. However, on the secondary frame an extra glazing was installed (light grey) at a minimum distance of 20 mm between the two glazing surfaces (pane 2 and 3 in Fig. 5a); hence, the two panes in the secondary frame function as a glazing unit. The outer glazing (1) was a normal pane and the two inner panes (2 and 3) both had Low-E coatings towards the outside. This window can also be equipped with an insulating and reflective curtain in the cavity between the original frame and the secondary frame which could improve the energy saving potential given that 75% of the heating degree-days in Denmark are in darkness.

Window 3 was renovated but instead of a secondary frame a sash with a 4 mm tempered low-E coated glazing (Optoglas) was installed directly on the casement using a special fitting. Fig. 5b shows the corner of the casement with the installed glazing. The difference between this window and the previously described windows was that the newly installed glazing would always be fixed to the casement and thereby make up for a glazing unit that was air tight whereas the secondary frames would open to the inside and make the cavity more greatly exposed to humid room air entering the cavity and pose a risk of mould growth and condensation.

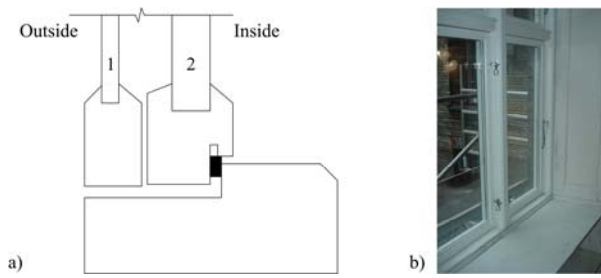
Fig. 6. a) Horizontal principal section of the frame and casement of Window 4 and 5. b) The new Window 4 seen from the apartment

Window 4 was a newly installed coupled window with a single pane and a glazing unit whereas Window 5 was a new coupled window with two single panes. The design of the window structures are shown in Fig. 6a where pane 2 was either a glazing unit or single pane for Window 4 or Window 5, respectively, and in Fig. 6b is shown the newly installed window 4 seen from the interior.

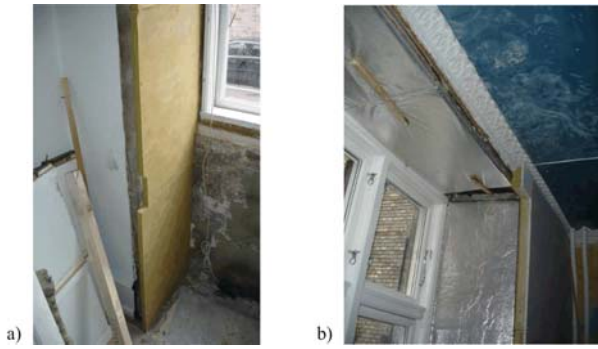
Fig. 7. Insulation applied in the window reveals where a) is Aerowolle and b) is Vacupor NT

The window reveals were insulated with 20 mm deep Aerowolle (Fig. 7a) or Vacupor NT (Fig. 7b). It was found that the gap behind the reveal panel did not fit the 20 mm insulation material and the size of the window opening was thus reduced. This also influenced the spandrel panel which as a consequence had to be adjusted to the new window size. The Vacupor NT insulation product constitutes a vapour barrier itself but to install the Vacupor NT to the window and the inside Aerowolle insulation an additional vapour barrier was installed to complete the vapour tight layer.

In comparison to the Aerowolle product, which was easy to work with given that it could be cut to size on site and affixed to the wall with an adhesive, the Vacupor NT product was a challenge to work with. Specifically, the Vacupor NT product needed to be ordered in specific sizes given that no on site changes could be made if incorrect sizes were delivered. In this case the measurements of the panel size were made before dismantling the reveals which involved too small Vacupor NT panels. Secondly, the material needed special care as the panels were easily punctured thereby losing their insulation value. Given both these factors, the installation of the Vacupor NT panel products was difficult in particular in the upper reveals (Fig. 7b).

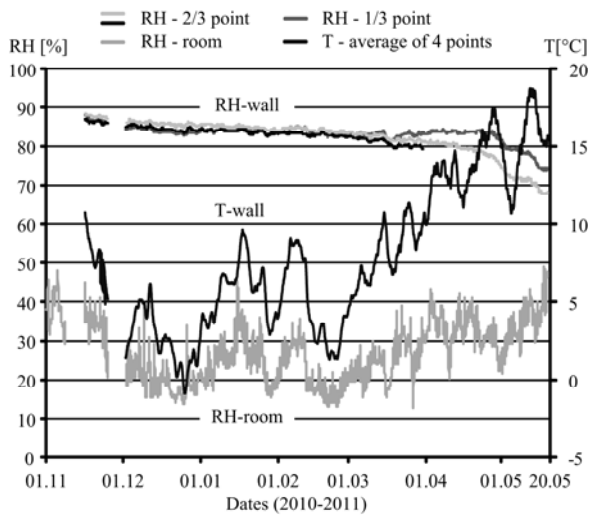
Fig. 8. Temperature and relative humidity behind inside insulation and relative humidity in room

Provided in Fig. 8 are the values for the temperature and RH measurements behind the inside insulation and in the room as of November 1, 2010 to May 20, 2011. Notably, in the period between November and May, the RH in the room ranged from 40% to 55% RH; this was slightly lower than the typical values for the interior of Danish homes of this type of construction as given in [23] and similar to the values obtained by measurements in 115 Danish dwellings [24].

In respect to the RH, it is evident from Fig. 8 that an initial value of 85% RH was recorded and that subsequently the RH decreased to 80%; it is also evident that when the temperature increased the RH dropped below 75%. It must be noted that one measurement point located 1/3 up the height of the wall remained constant at 95%; this RH value was determined to be an error in measurement and has not been included in Fig. 8. The high RH values at the beginning could be due to built in moisture from mounting the sensors. The mould growth depends on several factors where the most important are temperature, RH and exposure time. Based on the Isopleths information provided in [25] a risk for mould growth could be present when the temperature is around 10°C and the RH is 85%; in such instances under these conditions the germination time is about 2 days. However, there were no visible signs of mould growth on the wall after dismantling the Aerowolle product, which was also documented through Mycometer surface test for mould growth. Nonetheless, in the ground floor apartment located at street level and in which the Aerowolle product was installed directly onto wallpaper, the results of a Mycometer surface test indicated extensive mould growth.

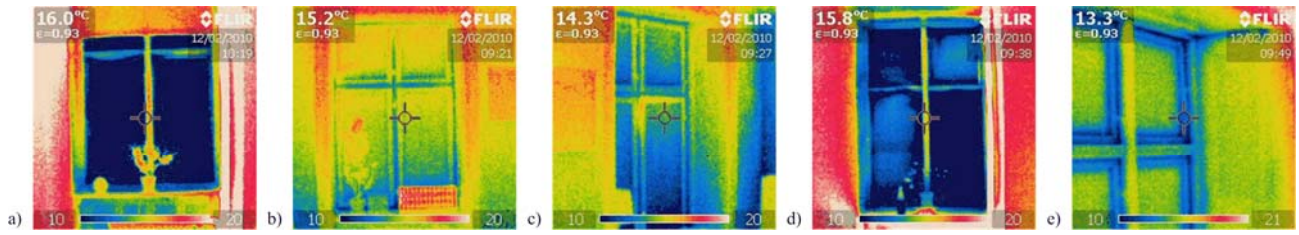
Fig. 9. Thermal imaging of the a) single pane reference window and b-e) the four investigated Windows 1-4

The surface temperatures of the windows were measured using thermographs shown in Fig. 9. Window 1 and 4 had the highest surface temperature as was expected given that their respective U-values had the same magnitude. Window 2 (U=1.62W/m²K) and Window 3 (U=1.76W/m²K) also had comparable U-values but the surface temperatures were very different where Window 2 performed better but had also a lower U-value. The surface temperature of Window 3 was almost the same as for the single glazed reference window.

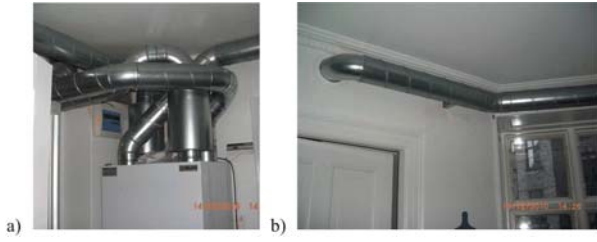
Fig. 10. Ventilation ducts in apartment. a) Inlet and outlet from the air handling unit; b) duct located in rooms

The first issue was the installation of the ducts in the test apartment that was built in 1896 and evidently not designed for accommodating mechanical ventilation. Furthermore the space under the ceiling was limited even though the room height was ca. 2.5 m; however, the top of the windows were about 20 cm below the ceiling. In Fig. 10 is shown how the final installation was carried out as the initial installation of the 125 mm diameter ducts was not deemed acceptable and therefore was reinstalled.

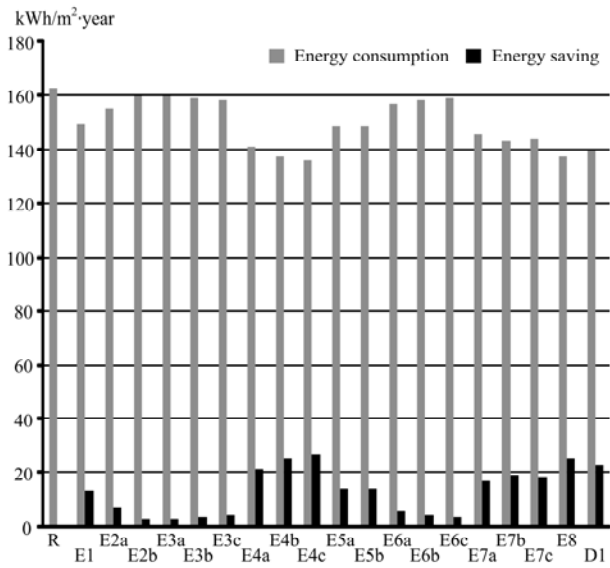
Fig. 11. Energy use and savings for building envelope measures

- R: Existing building
- E1: End wal, 250 mm outside insulation
- E2a: Ceiling to attic, injection of 100 mm insulation
- E2b: New insulated roof construction, average insulation 350 mm

- E3a: Floor to the basement, 50 mm mineral wool
- E3b: Floor to the basement, 100 mm mineral wool
- E3c: Floor to the basement, 150 mm mineral wool
- E4a: Window, retrofitted as window 2

- E7c: Wall, 40 mm inside Aerowolle
- E8: Wall, spandrel and window reveal, Aerowolle combination
- D1: Roof dwellings, 350 mm insulation and increased heated floor area

mechanical ventilation system, these measures are provided in Fig. 11 for the building envelope and Fig. 12 for the mechanical equipment. In Fig. 11 and Fig. 12 are shown the theoretical calculated energy savings that could be obtained for the respective proposed retrofit measures and the theoretical energy use of the building after implementation of the different measures.

In respect to retrofit measures to be made to the building envelope, it was seen from a review of the information, that the most effective measures were new window installation, the installation of insulation on the walls, and a new highly insulated roof structure (incorporating 350 mm insulation). In the project it was planned replace the existing roof with a new roof and convert the previously unheated attic to dwellings, thus the heat loss to the attic was eliminated and the heated floor area increased by 455 m². If only a new highly insulated roof structure was installed the energy savings would not be significant as shown in Fig. 11 as measure E2B.

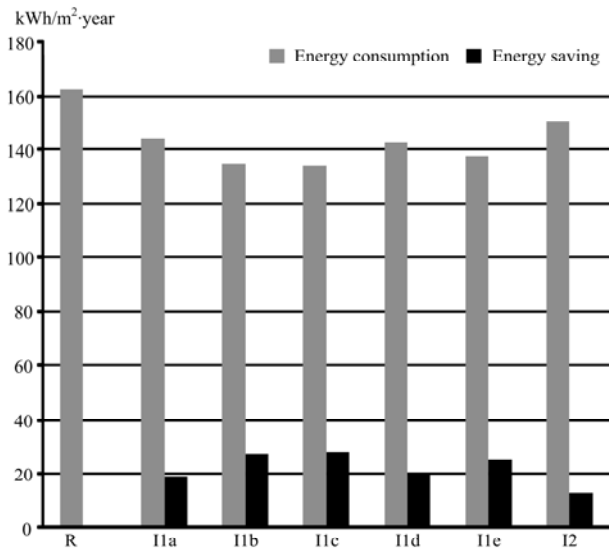
Fig. 12. Energy use and savings for mechanical equipment measures

- R: Reference building
- I1a: Centralised ventilation without DCV
- I1b: Centralised ventilation with DCV
- I1c: Decentralised ventilation with DCV
- I1d: Decentralised micro ventilation units
- I1e: Ventilations combination, I1a, b and c
- I2: Domestic hot water pipes, 40 mm insulation

Five ventilation retrofit measures were considered as part of the retrofit of the mechanical equipment. Two ventilation systems were considered: (i) centralised system, and; (ii) decentralised system. Either of these systems could be chosen with a DCV control. The largest energy savings were achieved with the DCV system. This was due to the reduced ventilation rate independent of the ventilation unit. A combination of three ventilation systems was also assessed; thus each stairway had one ventilation system. Two stairways were chosen to have centralised units with either DCV or not and one stairway had decentralised units with DCV.

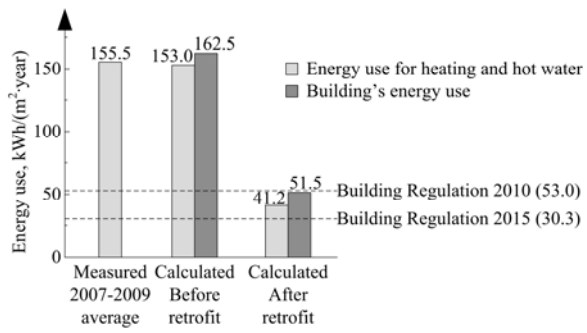
Fig. 13. Energy use before and after whole building retrofitting

The combination of energy saving measures reduced the theoretical energy use of the building to 51.5 kWh/(m² year). In Fig. 13 the calculated energy use for the building as well as heating and hot water is given but also that measured before retrofitting. The result meets the requirements for new residential buildings in 2010 but not the energy use requirements in 2015 for similar new buildings which is 30.3 kWh/(m² year). The theoretical energy savings obtained in the building with only passive measures was 68%.
