Retrofit with Interior Insulation on Solid Masonry Walls in Cool Temperate Climates

An Evaluation of the influence of Interior Insulation Materials on Moisture Condition in the Building Envelope

6th International Building Physics Conference, IBPC 2015

Bjarløv SP^{a*}, Finken GR^b, Odgaard, T^{a,c}

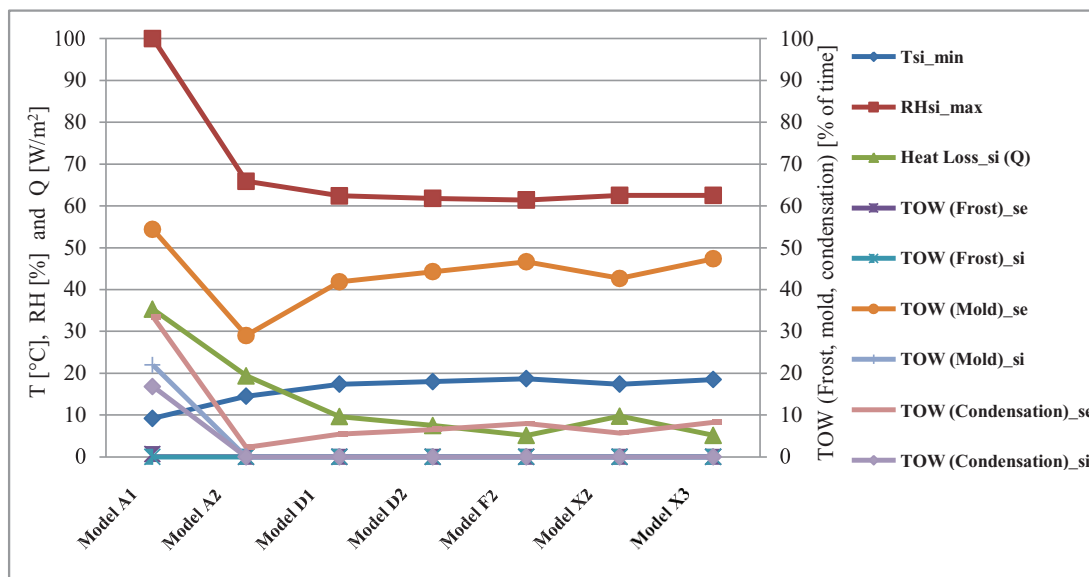
Fig. 1. Graphical presentation of TOW analysis (Last year of 10-year period).

Table 2 shows the results of some key parameters included in the TOW analysis based on minimum temperature and maximum RH on both the exterior and the interior surface of the façade during the last year of a 10-year period. In addition, the heat loss through the interior surface is given in total numbers and as the heat loss reduction compared to the original, uninsulated and unimpregnated historic brick wall. Fig. 1 shows the graphical presentation of the results above, where it can be seen how the interior surface temperature increases after impregnation and additional insulation, how the moisture load on the interior surface decreases from 100 % to an acceptable level under 80 % and how the heat losses decrease when the façade is impregnated and even further when it is insulated.

The TOW analysis for frost risk revealed that on both the exterior and interior surface, it is close to zero, since it only occurs on the exterior surface in 0.01 % of time corresponding to 1 single hour in Model D2 during the last year of a 10-year period. However, this is a reduction from 0.67 % of time corresponding to 59 hours that were apparent in Model A1 (the uninsulated wall). Thus, TOW_{Frost} is no problem in the suggested models.

The TOW analysis for risk of mold and corrosion on the exterior surface shows another picture, since this is the only surface that is wet for a significant time due to driving rain. While the TOW_{Mold, corrosion} in the original wall was apparent in 54 % of time, it dropped to 29 % of time in Model A2 with impregnation. Increasing values are seen for the models with insulation (max. 47 %). Thus, adding façade impregnation improves the situation somewhat, while adding interior insulation worsens it. Nevertheless, the risk of mold growth is negligible due to the fact that UV-radiation inhibits mold growth, but corrosion can occur on ungalvanised metallic parts on the exterior surface. However, on the interior surface there is no risk of mold and corrosion, which is an improvement, compared to the original wall, where there was risk of mold growth during 22 % of time.

The risk of condensation, algae growth and general decay on the exterior surface is very low in the proposed models, since TOW_{Condensation} only occurs in 2 % of time in the model with the shortest wetness exposure (Model A2) and 8 % of time in the model with the longest wetness exposure (Model X3). That is very different from the 33 % of time during which the original wall (Model A1) is exposed. There is no risk of condensation on the interior surface in the proposed models, which is also an improvement compared to the original wall, where this was apparent during 17 % of time.
